**MINERALS PROGRAM INSPECTION REPORT**  
**PHONE: (303) 866-3567**

<b>MINE NAME:</b> Schoolfield Pit	<b>MINE/PROSPECTING ID#:</b> M-1993-027	<b>MINERAL:</b> Gravel	<b>COUNTY:</b> Custer
<b>INSPECTION TYPE:</b> Monitoring	<b>INSPECTOR(S):</b> Timothy Cazier	<b>INSP. DATE:</b> June 19, 2019	<b>INSP. TIME:</b> 09:50
<b>OPERATOR:</b> Seifert Construction dba Seifert Enterprises, LLC	<b>OPERATOR REPRESENTATIVE:</b> Kent Beach	<b>TYPE OF OPERATION:</b> 110c - Construction Limited Impact	
<b>REASON FOR INSPECTION:</b> Normal I&E Program	<b>BOND CALCULATION TYPE:</b> Partial Bond	<b>BOND AMOUNT:</b> \$25,000.00	
<b>DATE OF COMPLAINT:</b> NA	<b>POST INSP. CONTACTS:</b> None	<b>JOINT INSP. AGENCY:</b> None	
<b>WEATHER:</b> Clear	<b>INSPECTOR'S SIGNATURE:</b>

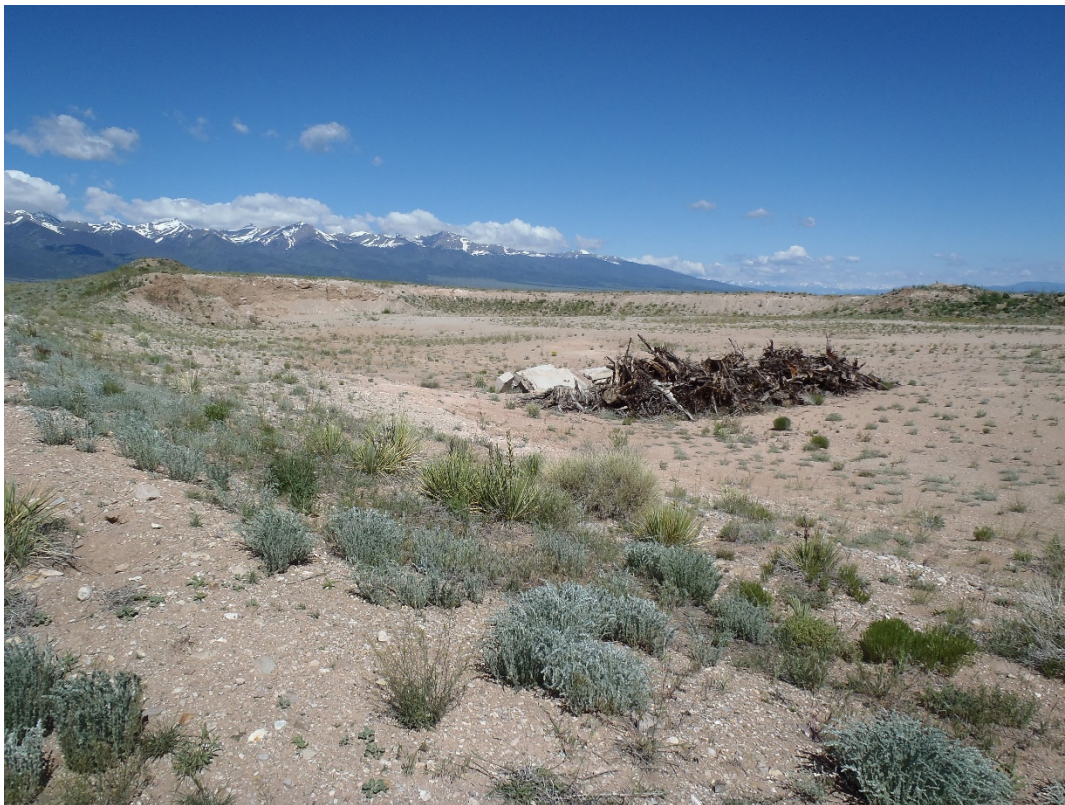
Excess Spoil and Dev. Waste: No significant overburden piles were observed. A debris stockpile was observed in the southeast corner of the pit (see **Photo 1**).

Photo 1. Pit floor with stockpile consisting of broken concrete and woody debris (looking NW from SE corner).

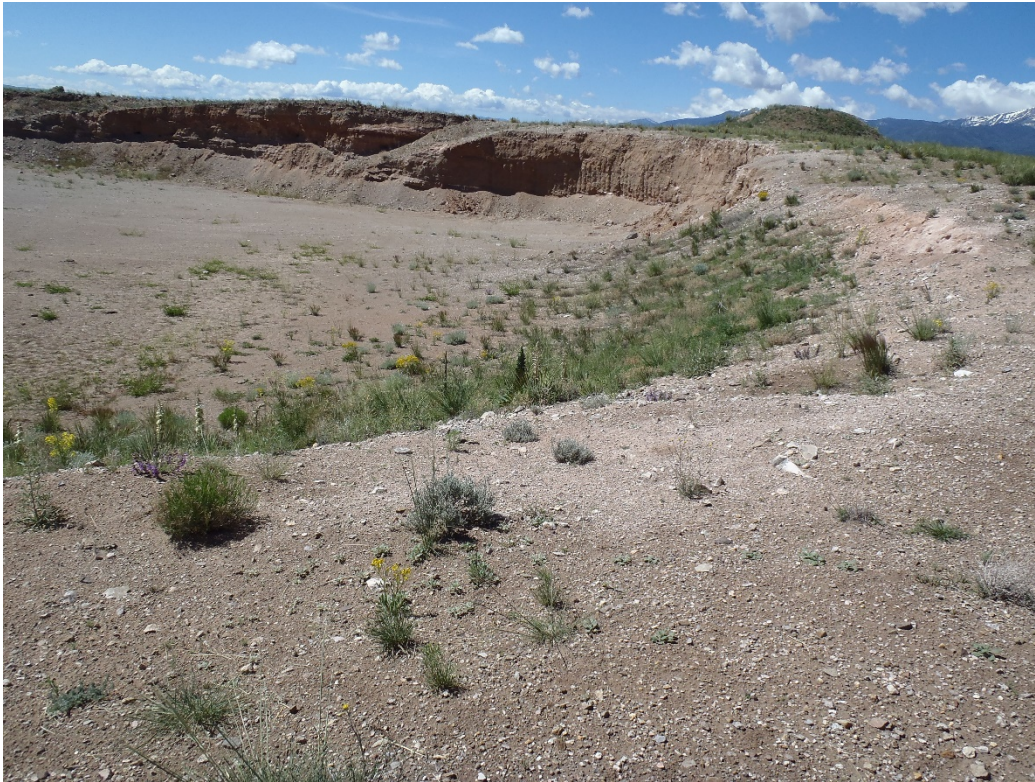
Gen. Compliance with Mine Plan: The operation appeared to be in compliance with the approved mine plan. The maximum allowed disturbed area is 9.9 acres. Google Earth was used to measure the disturbed area, which was estimated to be approximately 5.3 acres (including the access road), based on 2016 imagery. Highwalls were estimated to be 12 feet in height, 150 to 200 feet long, and appeared stable (see **Photo 2**). The mine operation is planned to expand to the west according to Mr. Beach.

Photo 2. Highwall on west side of pit (looking SW).

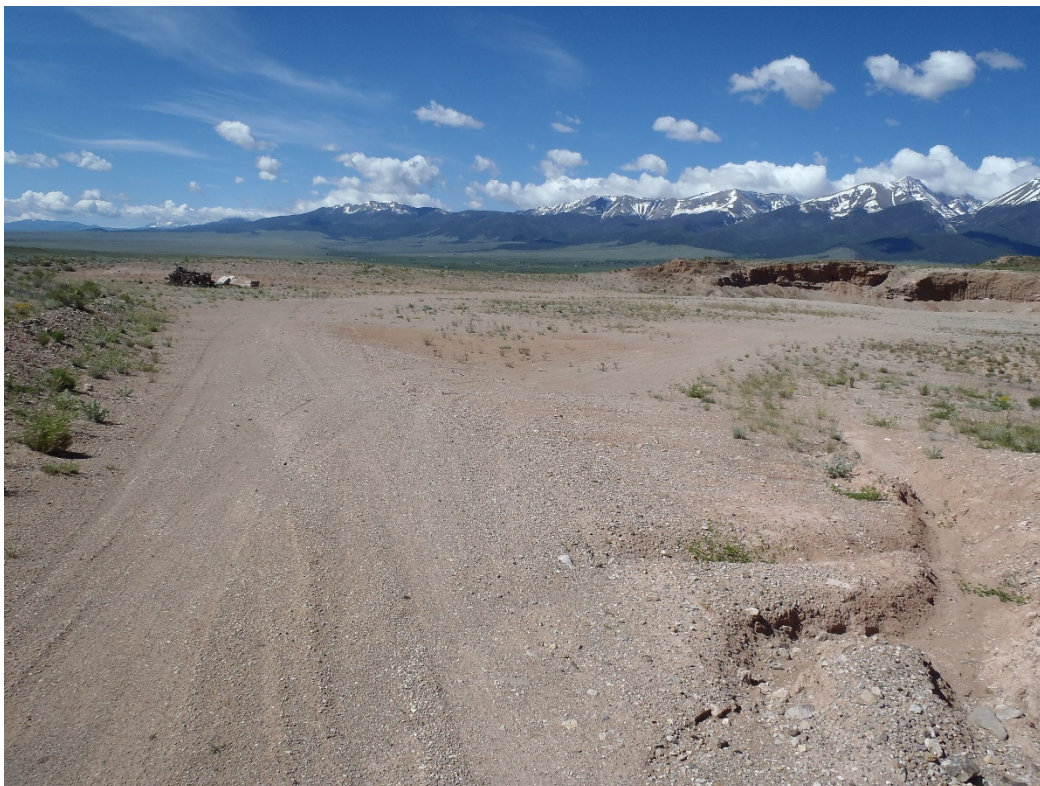
Roads: Haul and access roads did not appear to be a source of sediment that could be tracked offsite. The road side ditch entering the pit showed some minor signs of erosion (see **Photo 3**). As this ditch drains to the pit, the observed erosion is not likely to have off-site impacts.

Photo 3. Access road entering pit (looking SW, note minor erosion feature draining to pit floor).

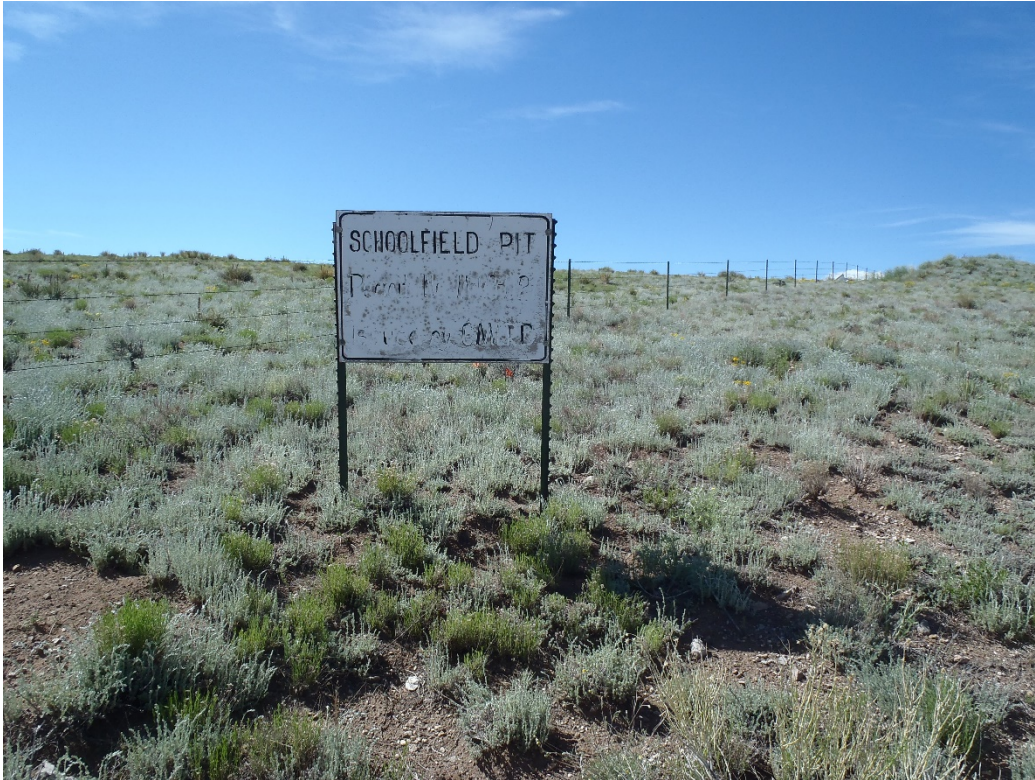
**PROBLEM/POSSIBLE VIOLATION:** Problem No. 2: The permit number and operator name required to be on the mine identification sign posted at the entrance of the mine site have faded to the point they cannot be read. This is a problem for failure to post a mine identification sign as required by Section 3.1.12(1) of the rule.

Signs and Markers: The permit sign was properly posted (see **Photo 4**), but the permit ID number (M-1993-027) and name of Operator had faded. **The missing permit number and operator name are cited as Problem No. 5 on page 1 of this report.** The east boundary is marked with a four-strand barbed wire fence (see **Photo 5**). Marker locations were recorded with a Trimble Juno 3B hand-held GPS (see enclosed **Post Inspection Map**).

Photo 4. Permit sign near pit entrance (looking SSE, note operator & permit number are unreadable).

**CORRECTIVE ACTIONS:** The operator shall, at the entrance of the mine site, post a sign which shall be clearly visible from the access road with the following: the name of the operator, a statement that a reclamation permit for the operation has been issued by the Colorado Mined Land Reclamation Board; and the permit number. The operator shall submit photo documentation that a proper sign has been posted by the corrective action date.

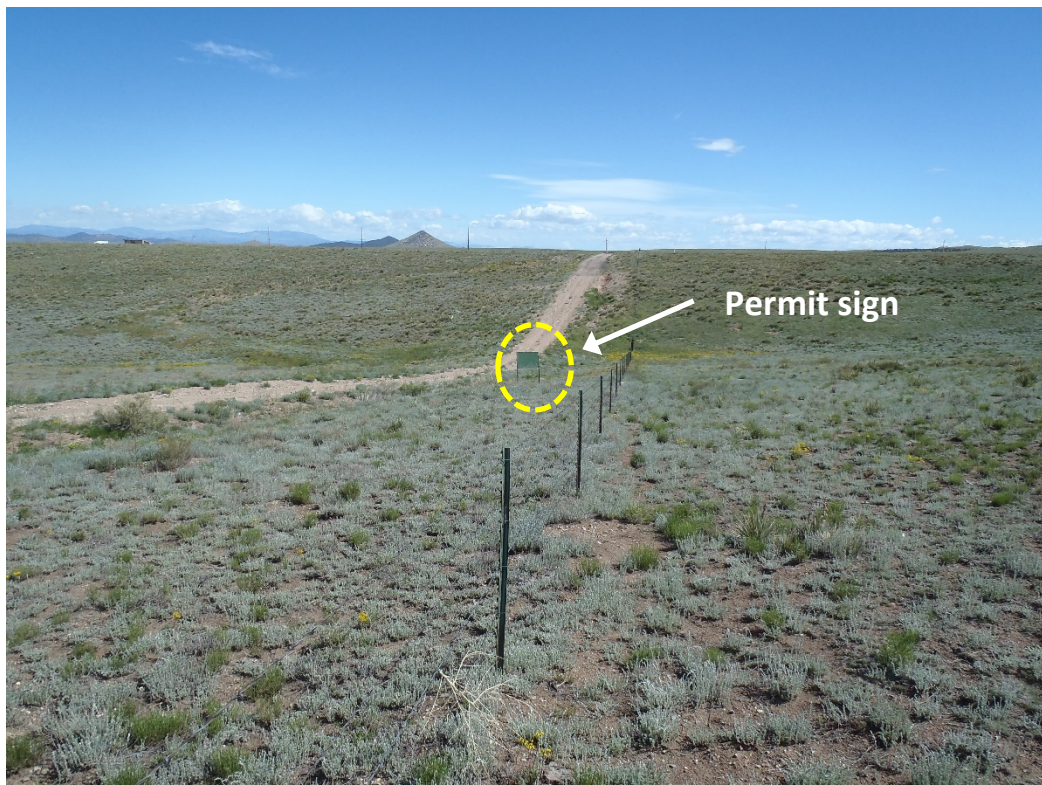
Photo 5. East boundary marked with four-strand barbed wire fence (looking north along access road).

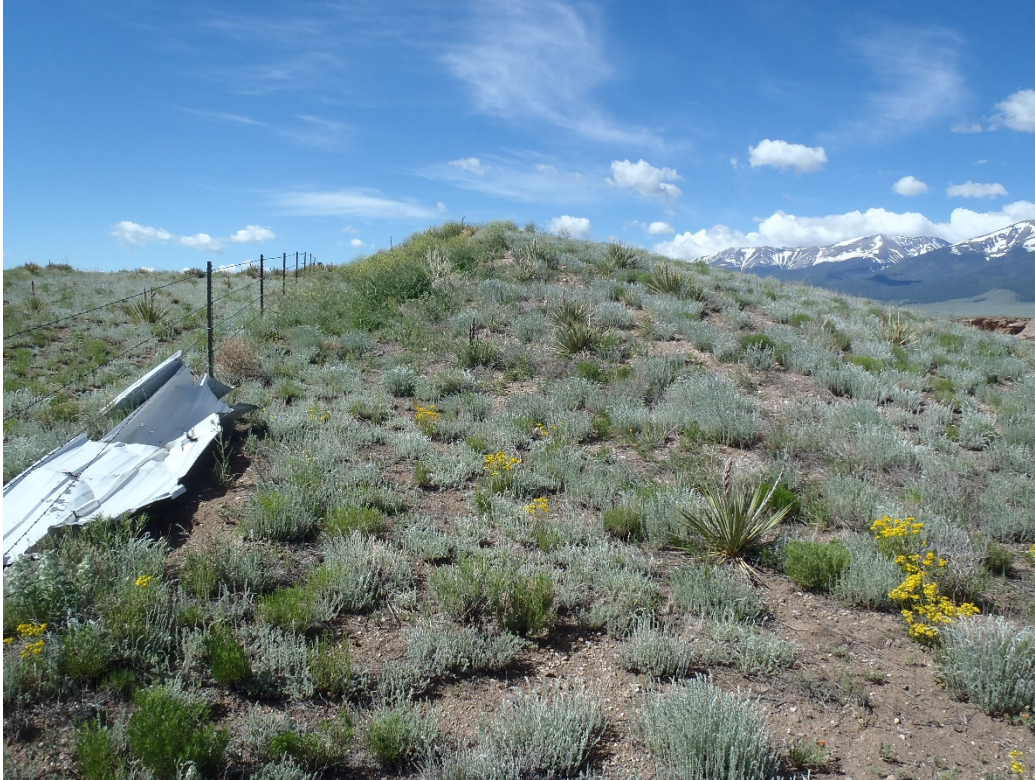
Topsoil: A topsoil stockpile was observed in the northeast corner of the pit (see **Photo 6**).

Photo 6. Topsoil stockpile observed in the northeast corner (looking south along east boundary fence).

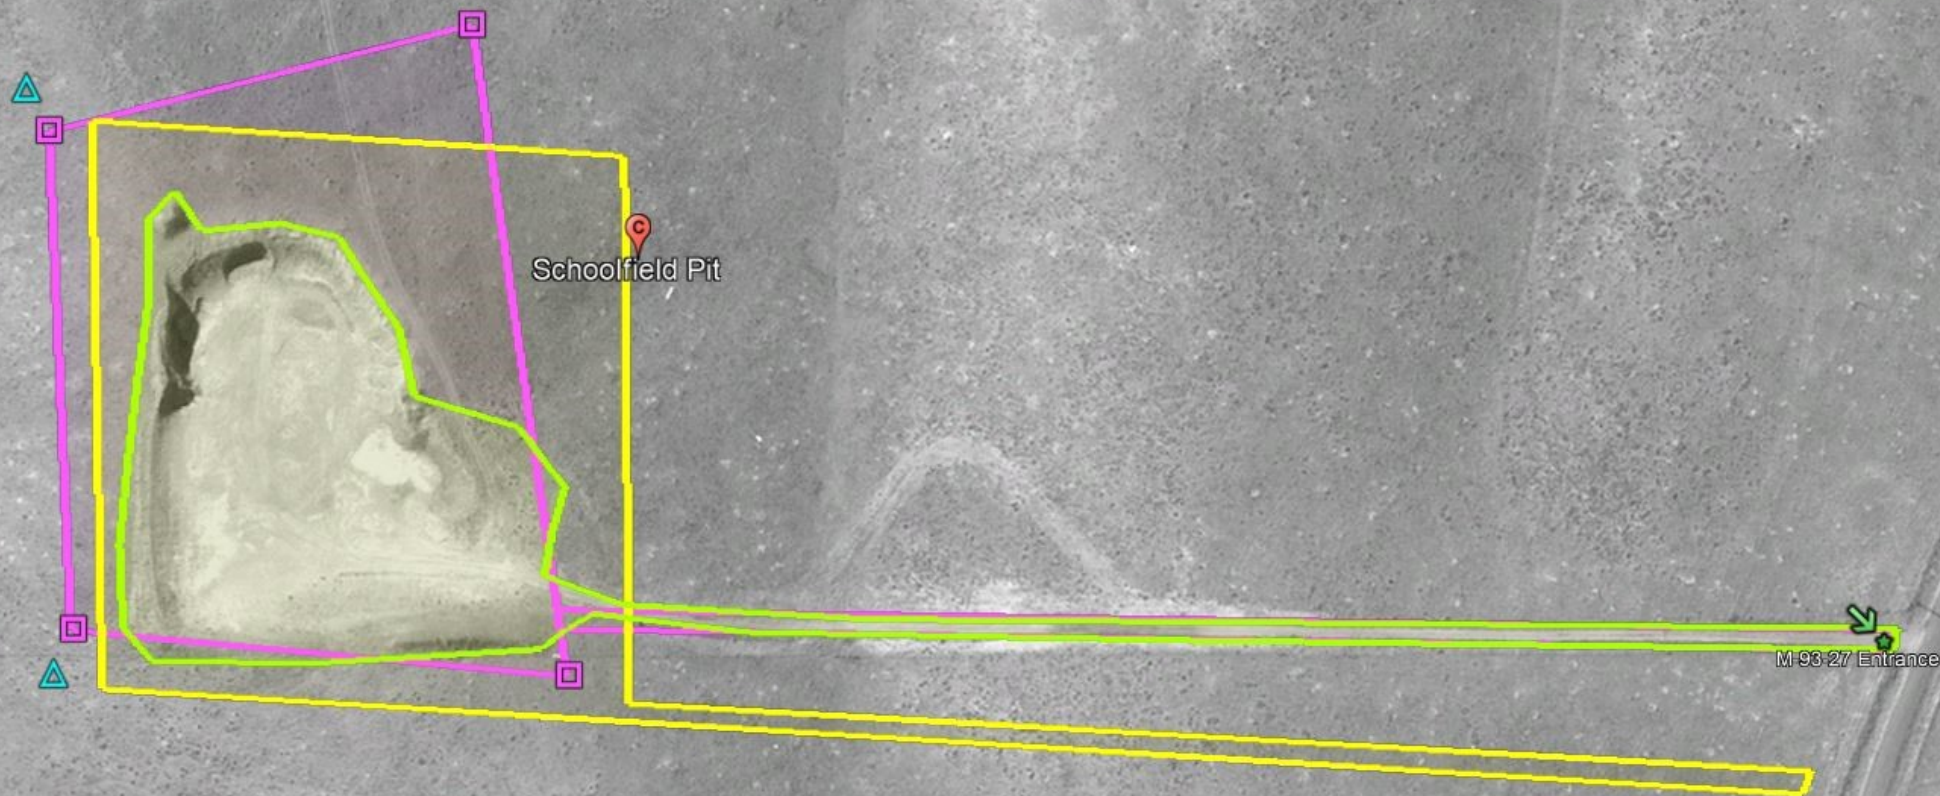
# M-1993-027 Schoolfield Pit 2019 Post-Inspection Map

**PROBLEM/POSSIBLE VIOLATION:** Problem No. 1: The in place boundary markers do not coincide with those of the proposed permit boundary in the approved permit.

Off-site Damage: The operation appeared to be confined to the permit boundary as marked on the ground. However, as shown on the enclosed Post Inspection Map, the boundary markers are inconsistent with the approved permit boundary map (see enclosed **Post Inspection Map**). **The inconsistent permit boundary is cited as a Problem No. 1 on page 1 of this report.**

**CORRECTIVE ACTIONS:** Submit a technical revision (along with the required \$216 fee) with a map clarifying the permit boundary not to exceed 9.9 acres.
