MINERALS PROGRAM INSPECTION REPORT
PHONE: (303) 866-3567

MINE NAME: Keenesburg No. 2 Mine	MINE/PROSPECTING ID#: M-2019-058	MINERAL: Sand	COUNTY: Weld
INSPECTION TYPE: Pre-operation Inspection	INSPECTOR(S): Brock Bowles	INSP. DATE: February 25, 2020	INSP. TIME: 09:00
OPERATOR: Colorado Sand Company LLC	OPERATOR REPRESENTATIVE: Timothy McCarthy and Marv Brown	TYPE OF OPERATION: 112c - Construction Regular Operation	
REASON FOR INSPECTION: Pre-operation Inspection	BOND CALCULATION TYPE: None	BOND AMOUNT: No Bond Held	
DATE OF COMPLAINT: NA	POST INSP. CONTACTS: None	JOINT INSP. AGENCY: None	
WEATHER: Windy	INSPECTOR'S SIGNATURE:

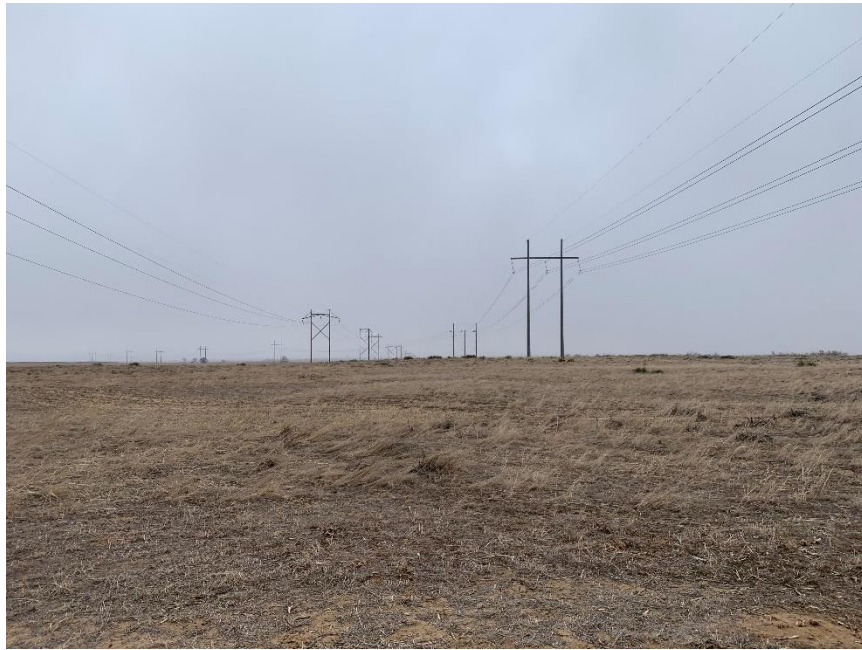
Overhead powerlines on east end of minesite facing east

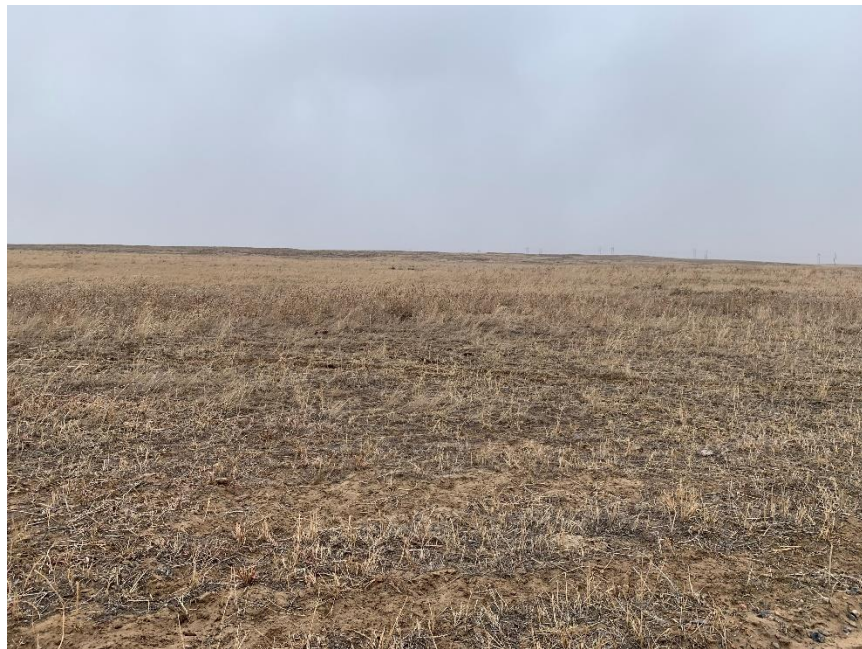
The application proposes to permit 2,925.93 acres for the purposes of mining sand. The topography of the proposed mine site is mostly flat with a few gently rolling hills. The vegetation was mostly comprised of short grasses with a few scattered forb stalks. The area was recently grazed and the vegetation was grazed close to the ground and some areas bare, especially around the ponds in Ennis Draw. Very few shrubs were seen on the site. Some yucca plants were noted but were sparse across the site. No trees were seen. The topography and vegetation of the mine site appears consistent with the description provided in the application.

Typical example of vegetation and topography of minesite

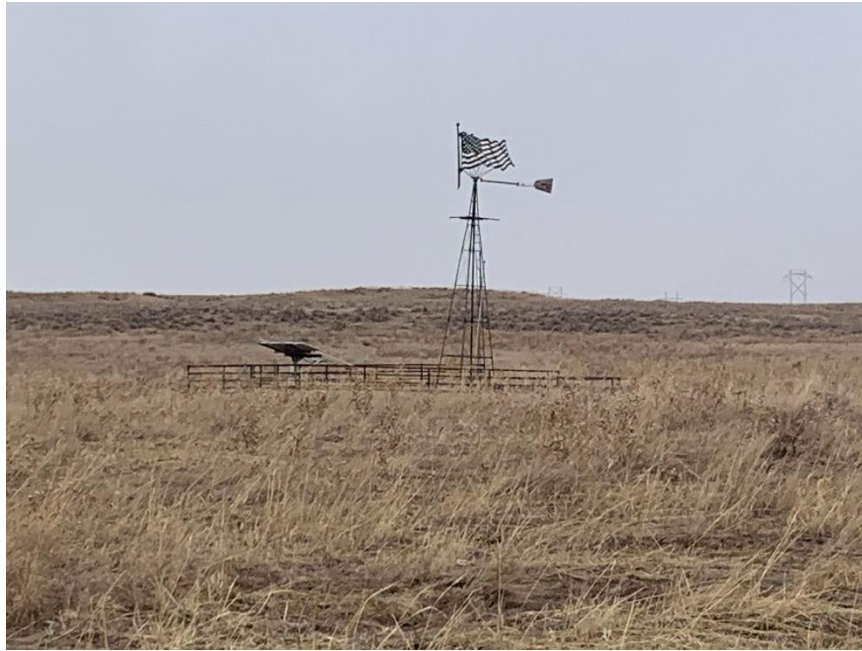
Water well and solar panel on east side of Section 1, T2N-R64W

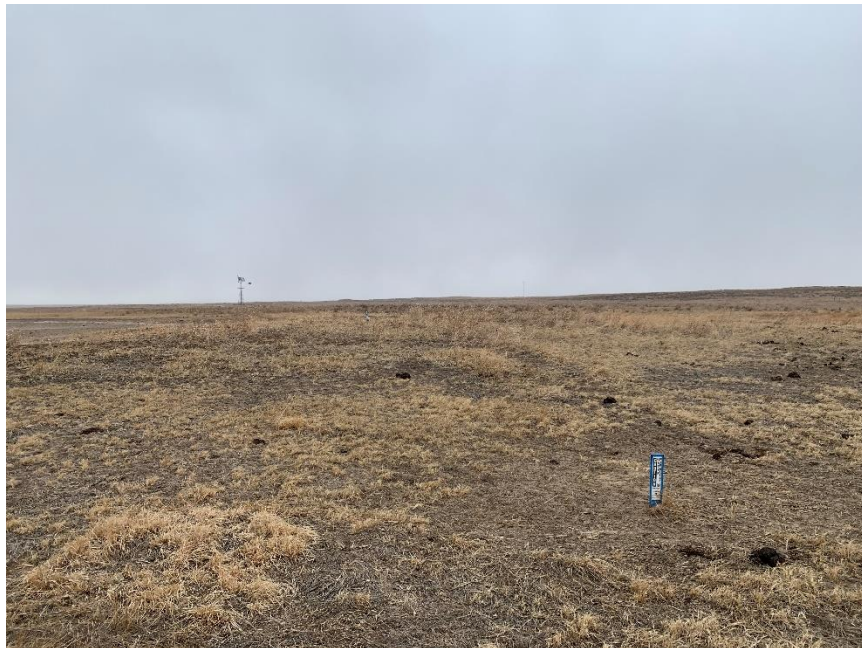
Fencelines, gates, ranch roads, well heads, water wells, stock tanks and overhead power lines were inspected to verify the accuracy and completeness of Map C-1 Relevant Features and Surface Owners. Most of the infrastructures documented on Map C-1 are underground, so it was difficult to verify these structures. Markers were seen at various places across the site showing locations for some of the features. These markers were consistent with Map C-1. A blue marker was seen in the Ennis Draw area that marked a water line. The waterline feature is on Map C-1 but is not described in the legend and will need to be added. Overall, Map C-1 appeared to be accurate and complete.

Blue waterline marker that was not labeled on Map C-1

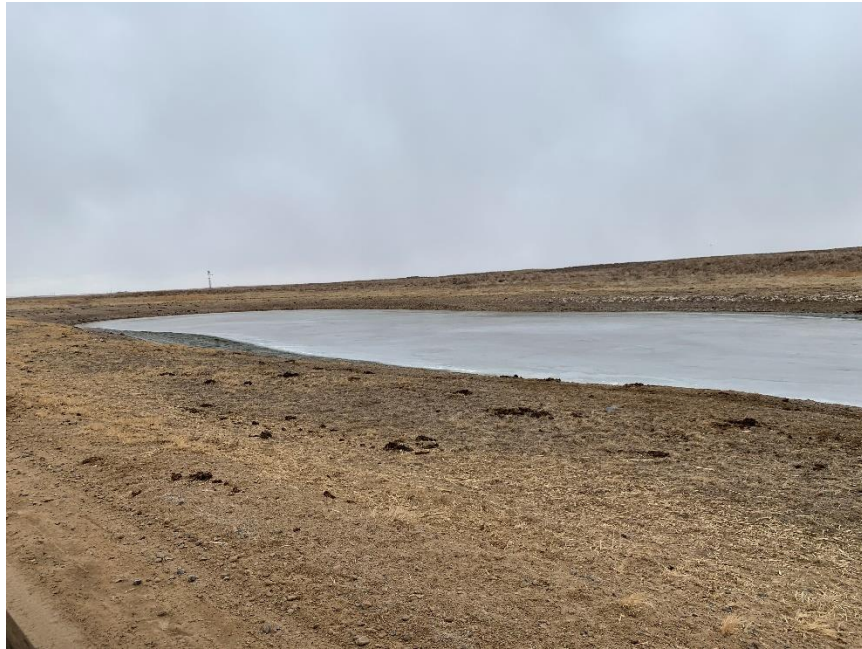
One of the ponds in Ennis Draw contained water and was mostly frozen. The other ponds in the draw were dry. The ranch roads were well maintained and used often to access the oil and gas infrastructure across the area.

A pond in Ennis Draw facing north.

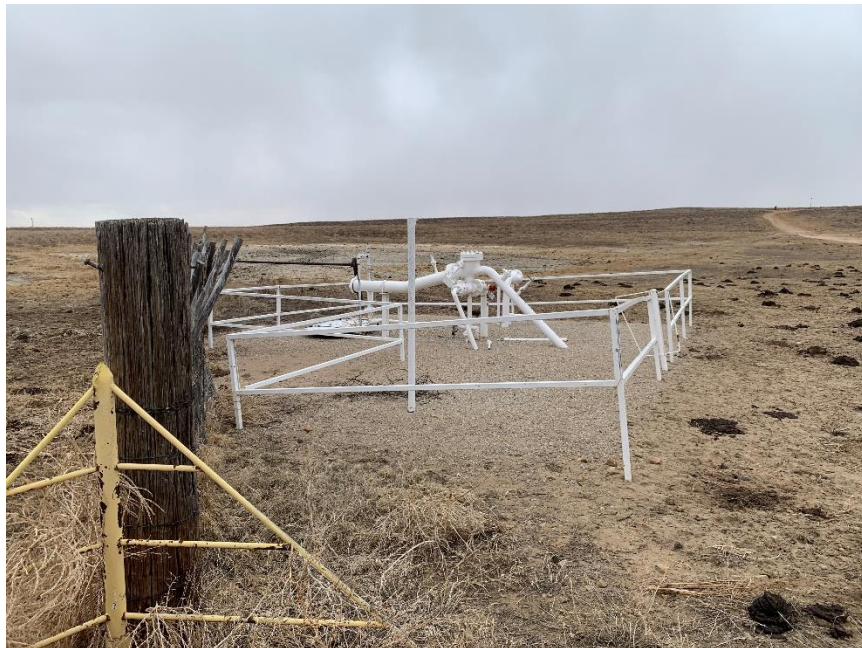
Gas pipeline located in the southwest corner of Section 6, T2N-R63W
