## MINERALS PROGRAM INSPECTION REPORT PHONE: (303) 866-3567

MINE NAME:	MINE/PROSPECTING ID#:	MINERAL:	COUNTY:
Diehl Borrow Pit	M-2018-054	Borrow material for construction	Larimer
INSPECTION TYPE:	<b>INSPECTOR(S):</b>	INSP. DATE:	INSP. TIME:
Monitoring	Amy Eschberger, Rob Zuber	February 13, 2020	11:00
OPERATOR:	OPERATOR	TYPE OF OPERATION:	
SEMA Construction, Inc.	REPRESENTATIVE:	111 - Construction by Goverment Agency	
	Tyson Geist

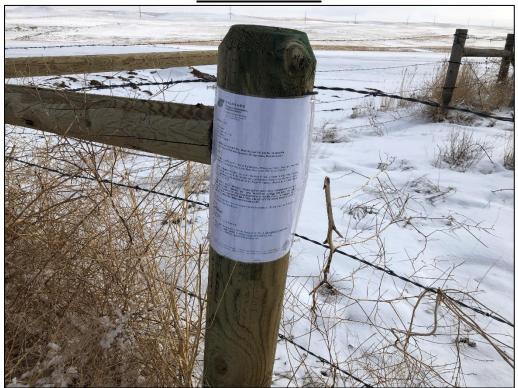
**PROBLEM:** The mine identification sign was not posted at the entrance of the mine site. This is a problem for failure to post a mine identification sign as required by Rule 3.1.12(1).

At the time of the inspection, the weather was clear and the ground was covered with snow. The permit boundary was delineated by barbed wire fencing. The required mine identification sign was not posted at the main site entrance. The public notice sign observed during the pre-operation inspection was still posted at the entrance. However, this sign does not meet the requirements for the mine identification sign. Therefore, a problem is cited in this report (see page 1) for failure to post a mine identification sign as required by Rule 3.1.12(1). The operator will need to post an adequate sign at the site and provide photographic evidence to the Division this was done by the corrective action date.

**Photo 1.** View of public notice sign posted at site entrance which does not meet requirements for a mine identification sign.

**CORRECTIVE ACTIONS:** The operator shall, at the entrance of the mine site, post a sign which shall be clearly visible from the access road, with a minimum size equaling 187 square inches, such as 11 inches in height by 17 inches in width, with appropriate font size, including the following: the name of the operator and operation name, a statement that a reclamation permit for the operation has been issued by the Colorado Mined Land Reclamation Board (can be abbreviated to "CMLRB"); and the permit number. By the corrective action date, the operator shall submit photo documentation that a proper sign has been posted.

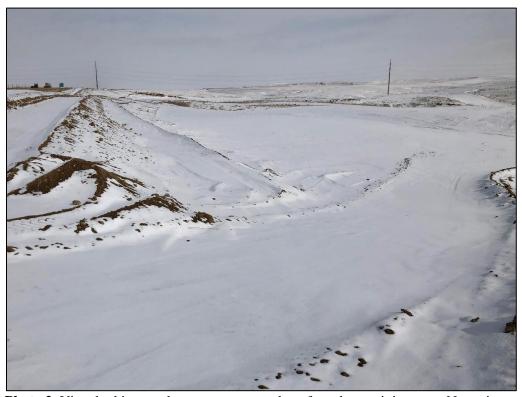
**Photo 2.** View looking north across western edge of southern mining area. Note pit wall slopes at approximately 3H:1V.

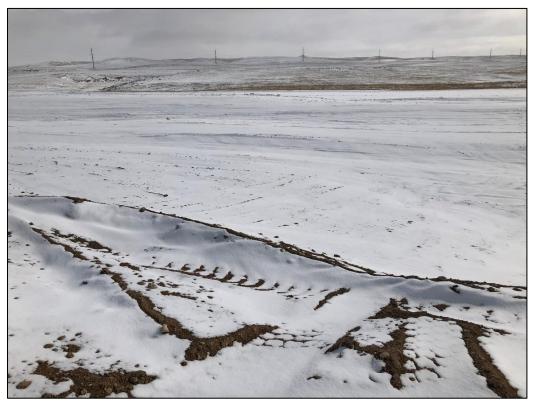
**Photo 3.** View looking east across southern mining area from top of pit wall. This pit may not be mined much deeper due to unfavorable deposits encountered.

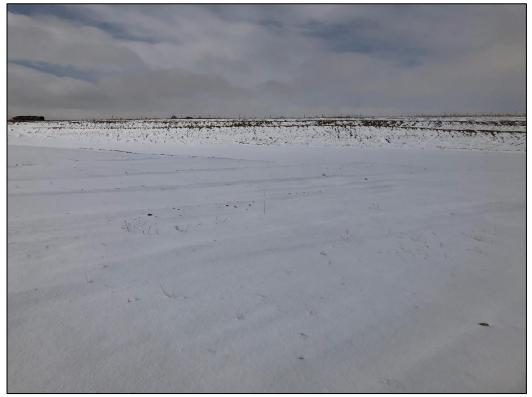
**Photo 4.** View looking west across southern mining area from its eastern edge. Note pit wall (in background) which daylights to the east.

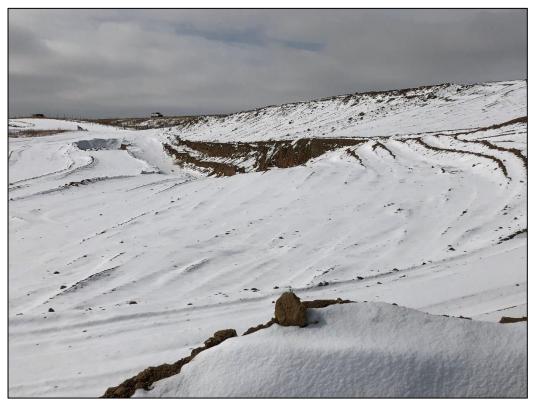
**Photo 5.** View looking south across pit wall along western edge of northern mining area, with near vertical slopes.

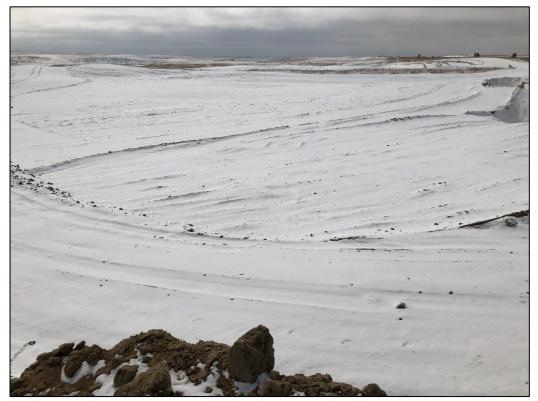
Photo 6. View looking southeast across northern mining area from its northwestern edge.

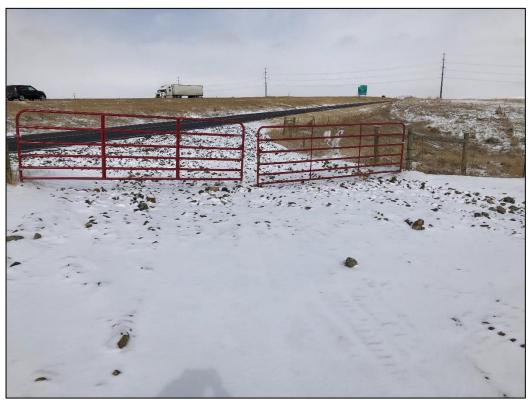
**PROBLEM:** The current mining plan map needs to be updated pursuant to Rules 6.4.3 and 6.4.4. The operator must provide sufficient information to describe or identify how the operator intends to conduct the operation. Specifically, the operator has created a new access road to the site which is not portrayed on the approved mining plan map.

**PROBLEM:** The current reclamation plan map needs to be updated pursuant to Rules 6.4.5 and 6.4.6. The operator must describe how reclamation will be achieved on all affected land. Specifically, the operator has constructed a new access road to the site which is not portrayed on the approved reclamation plan map.

During the inspection, the Division observed a new gated access road has been constructed off the I-25 frontage road to enter the northern half of the permit area. This additional mine entrance is not portrayed on the approved

**Photo 7.** View looking west showing new (gated) access road constructed off I-25 frontage road to enter north mining area.

**CORRECTIVE ACTIONS:** By the corrective action date, the operator shall submit a Technical Revision, with the required \$216 fee, to update the current approved mining plan map to reflect existing and proposed activities at the site, particularly to portray the new access road constructed at the site.

**CORRECTIVE ACTIONS:** By the corrective action date, the operator shall submit a Technical Revision, with the required \$216 fee (can be same revision submitted for problem cited above), to update the approved reclamation plan map to reflect existing and proposed activities at the site, particularly to portray reclamation of the new access road. If the operator proposes to leave any roads for reclamation, this must be reflected on the reclamation plan map. Additionally, the Division would need to receive a notarized letter from the landowner agreeing to leave the road(s) for reclamation.
