**Annual Report – 2019**  
**Henderson Mine and Mill Reclamation Activities**  
**Permit No. M-1977-342**

**HENDERSON MINE**  
MLRB Permit No. M-77-342  
Annual Reclamation Report  
March 4, 2019

**HENDERSON MILL**  
MLRB Permit No. M-77-342  
Annual Reclamation Report  
March 4, 2019

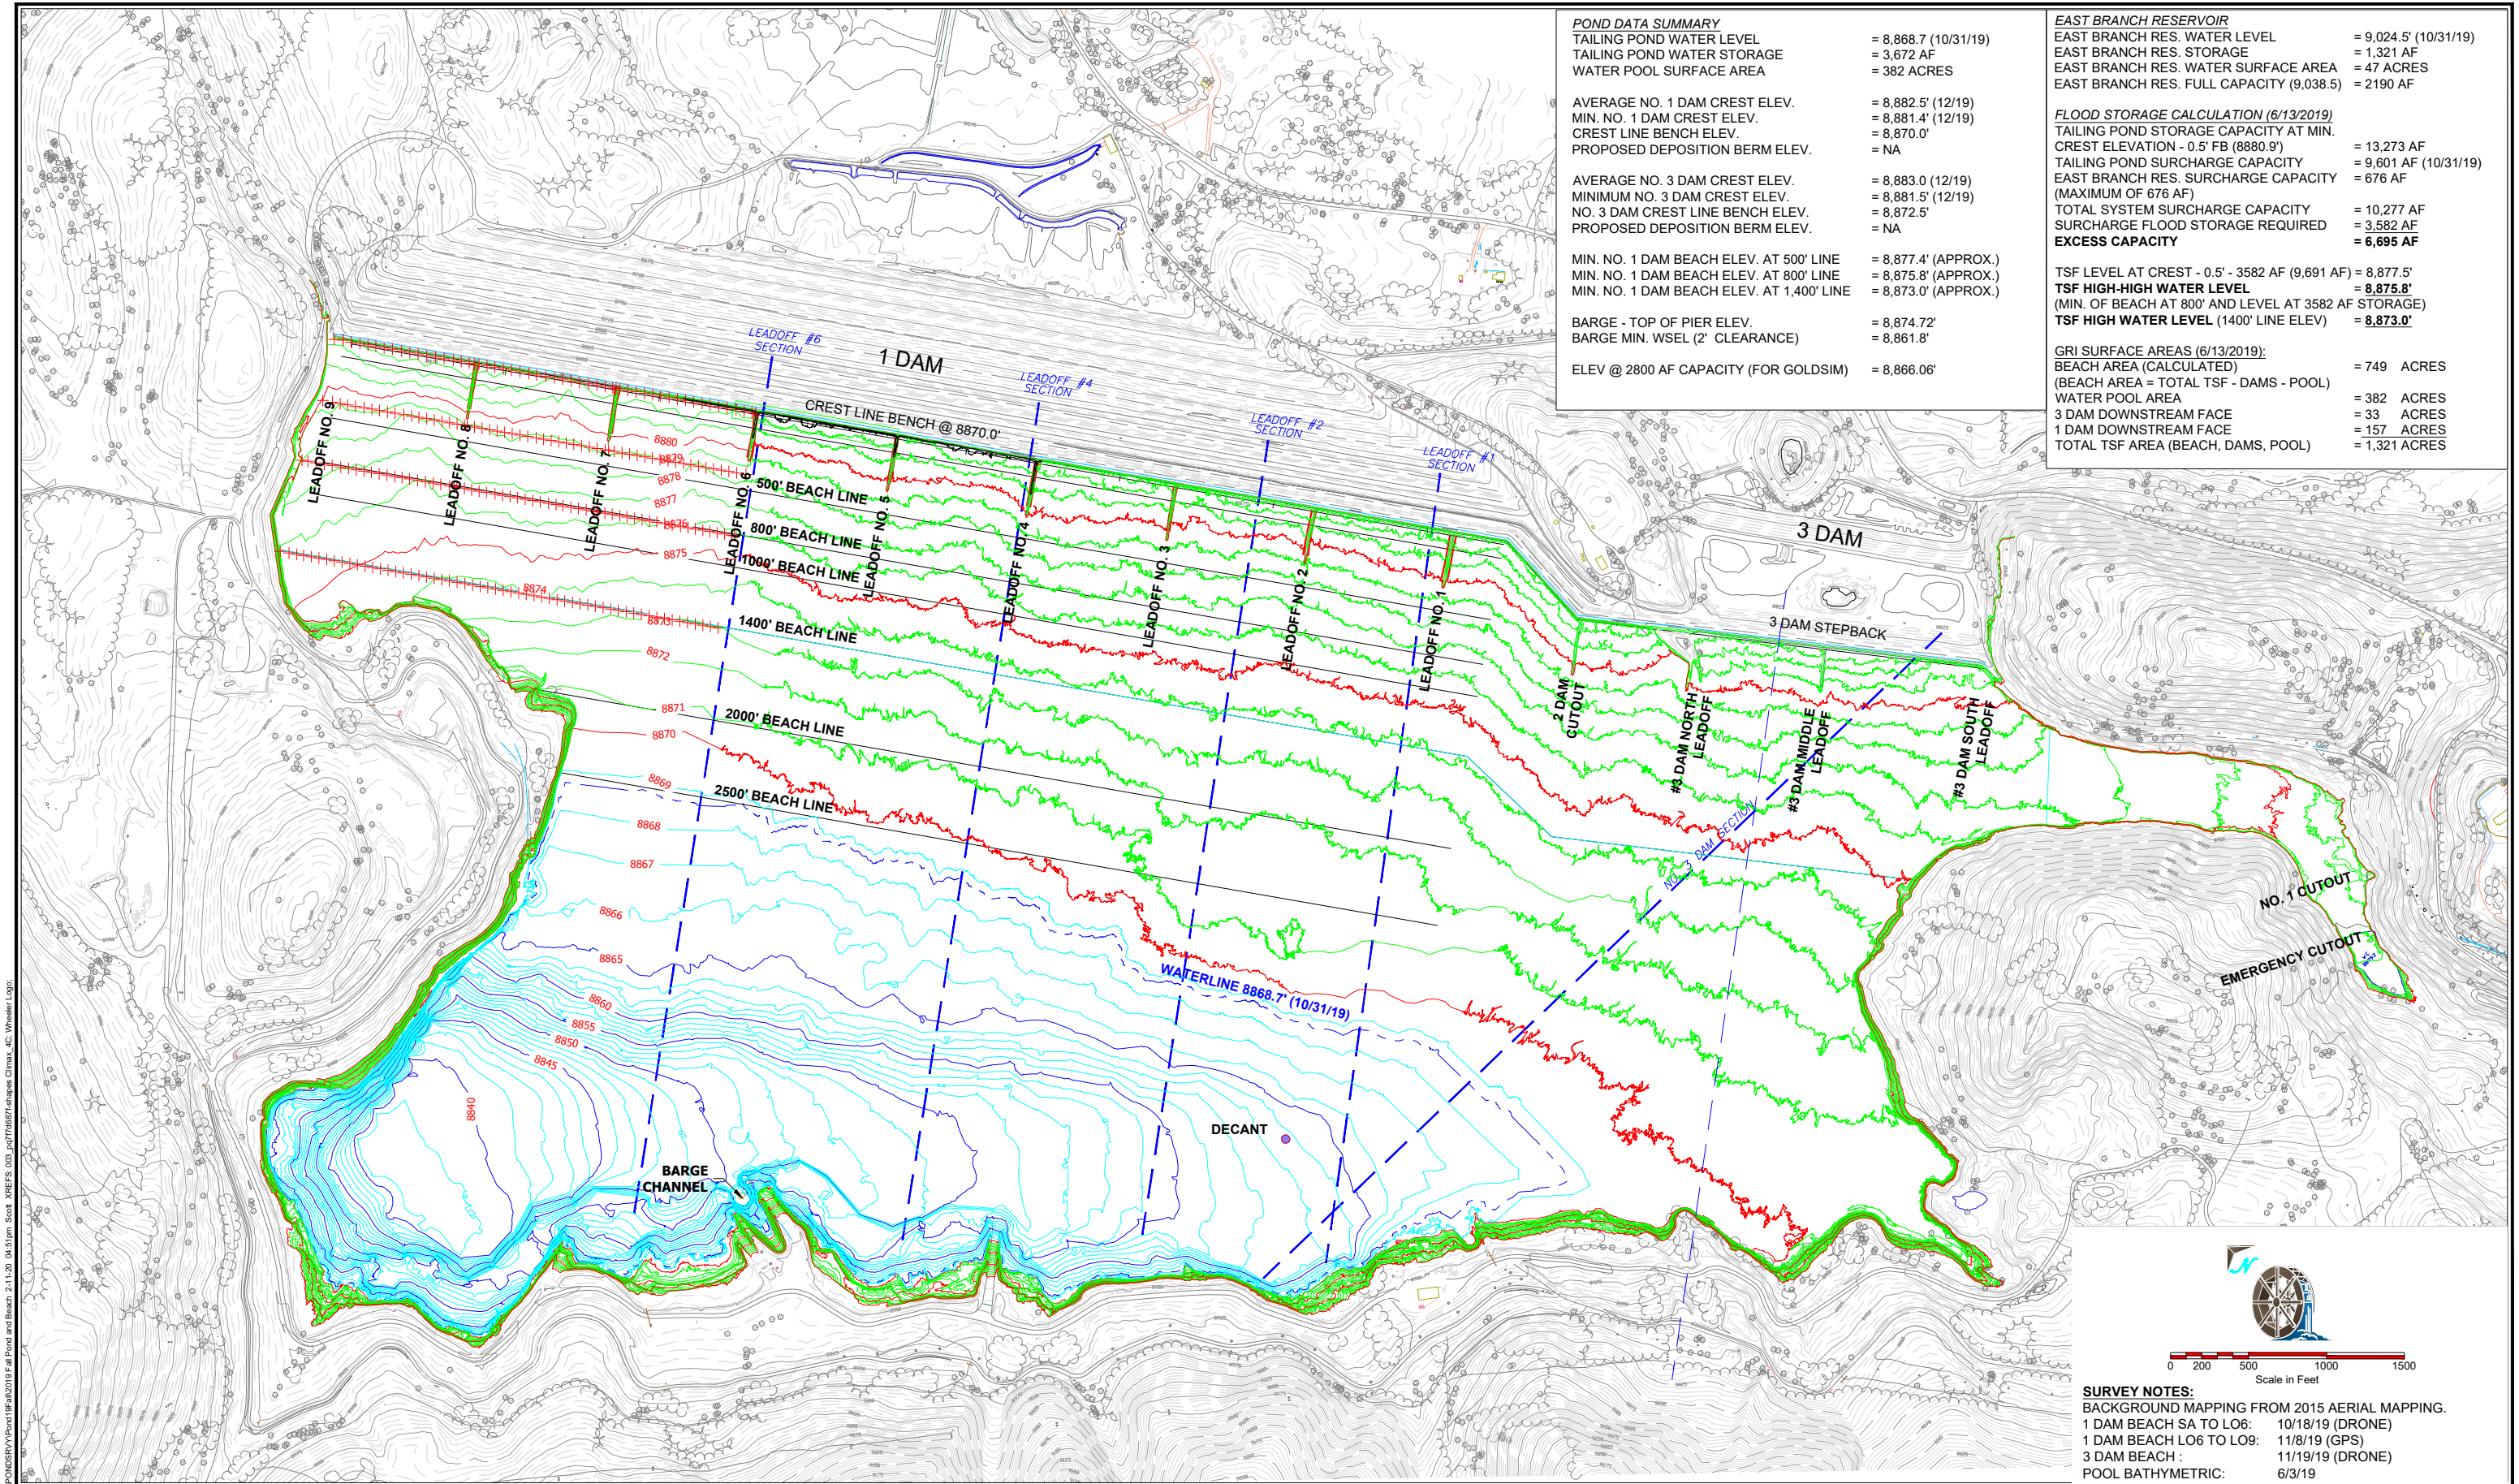
| DATES: SEE SURVEY NOTES | | ACCEPTED BY ... | | FIGURE 1 |

One of the primary uses of the survey data is to evaluate the flood storage capacity conditions in the water system. As summarized on Figure 1, at the approximate time of the fall survey there was a total system surcharge storage capacity of about **10,277 acre-feet** in the system. This capacity includes both the TSF and East Branch Reservoir and is based on 0.5 feet of residual freeboard below the minimum dam crest elevation of 8,881.4' and a October 31<sup>st</sup> water level of 8,868.7 feet. The flood storage requirement for the system is **3,582 acre-feet**. This requirement is based on hydrologic modeling of the probable maximum precipitation (PMP) event. The available flood storage capacity in the system at

the time of the survey significantly exceeds the storage requirement. However, this excess capacity will decrease throughout the coming year as additional inflows to the system occur and a portion of the storage space is filled with deposited tailing.
