Minerals 3600 Mine and Reclamation Inspection
U.S. Department of the Interior
Bureau of Land Management
Royal Gorge Field Office

Date: Sep 4, 2019 Time: 09:00 Weather: Sunny	Operation Name: T.H.E. Aggregate Source Case Number: COC-074982 CDRMS #: M-1977-193
Attendees BLM: S. Carter Operator(s): L. Toxvard Other(s):	General Operation(s) are in compliance with documentation on file <input checked="" type="checkbox"/> Yes <input type="checkbox"/> No <input type="checkbox"/> N/A Operation(s) and disturbance on-site coincide with the operations and access on file <input checked="" type="checkbox"/> Yes <input type="checkbox"/> No <input type="checkbox"/> N/A

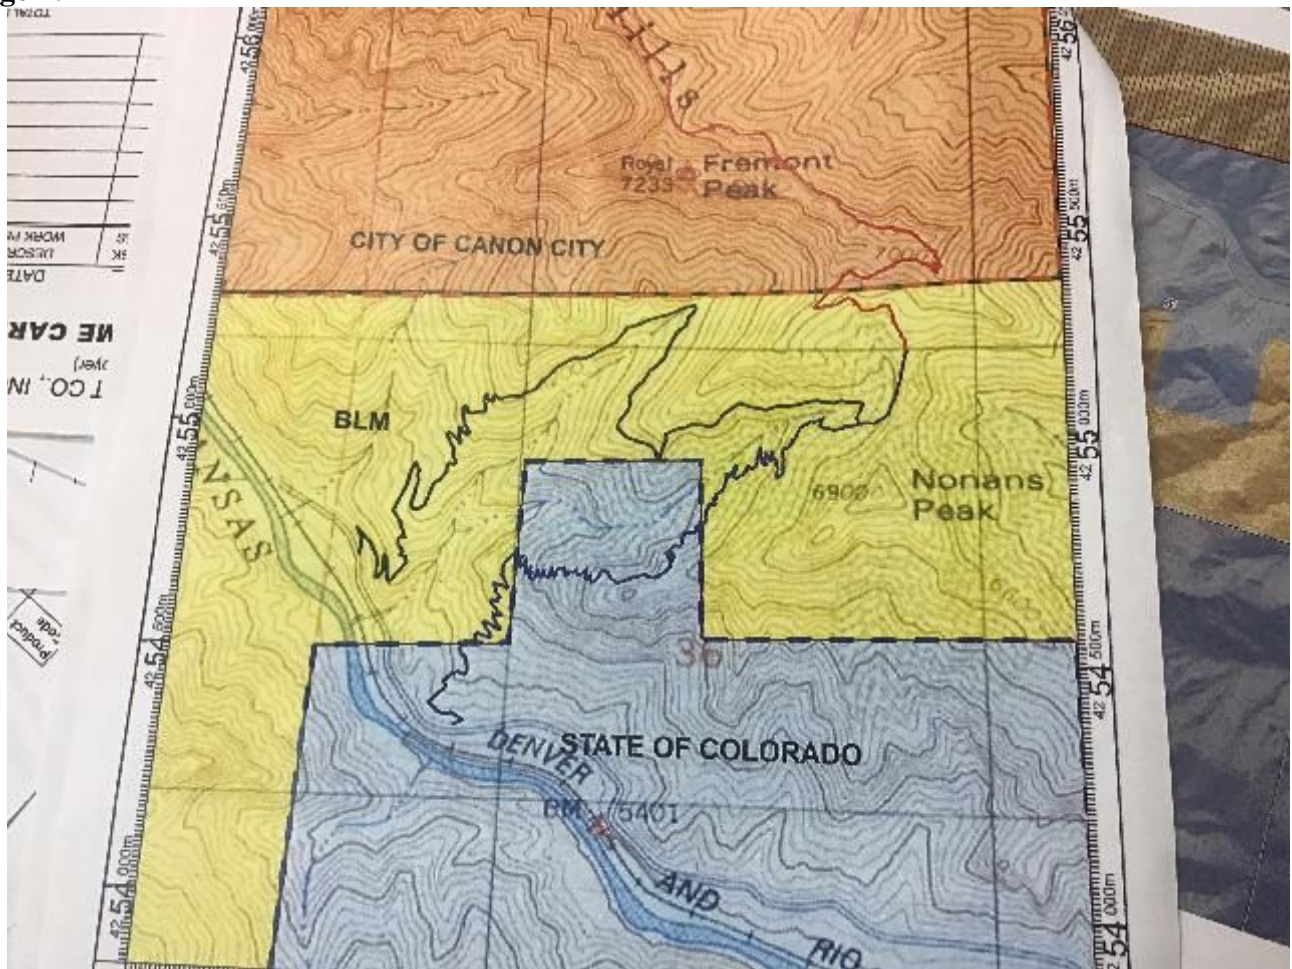
Image 1:

- Talked about proposed trail system providing public access into a remote area west of the quarry that hasn't been very visible in the past.

Comment: Proposed Canon City trail 6/14/18.

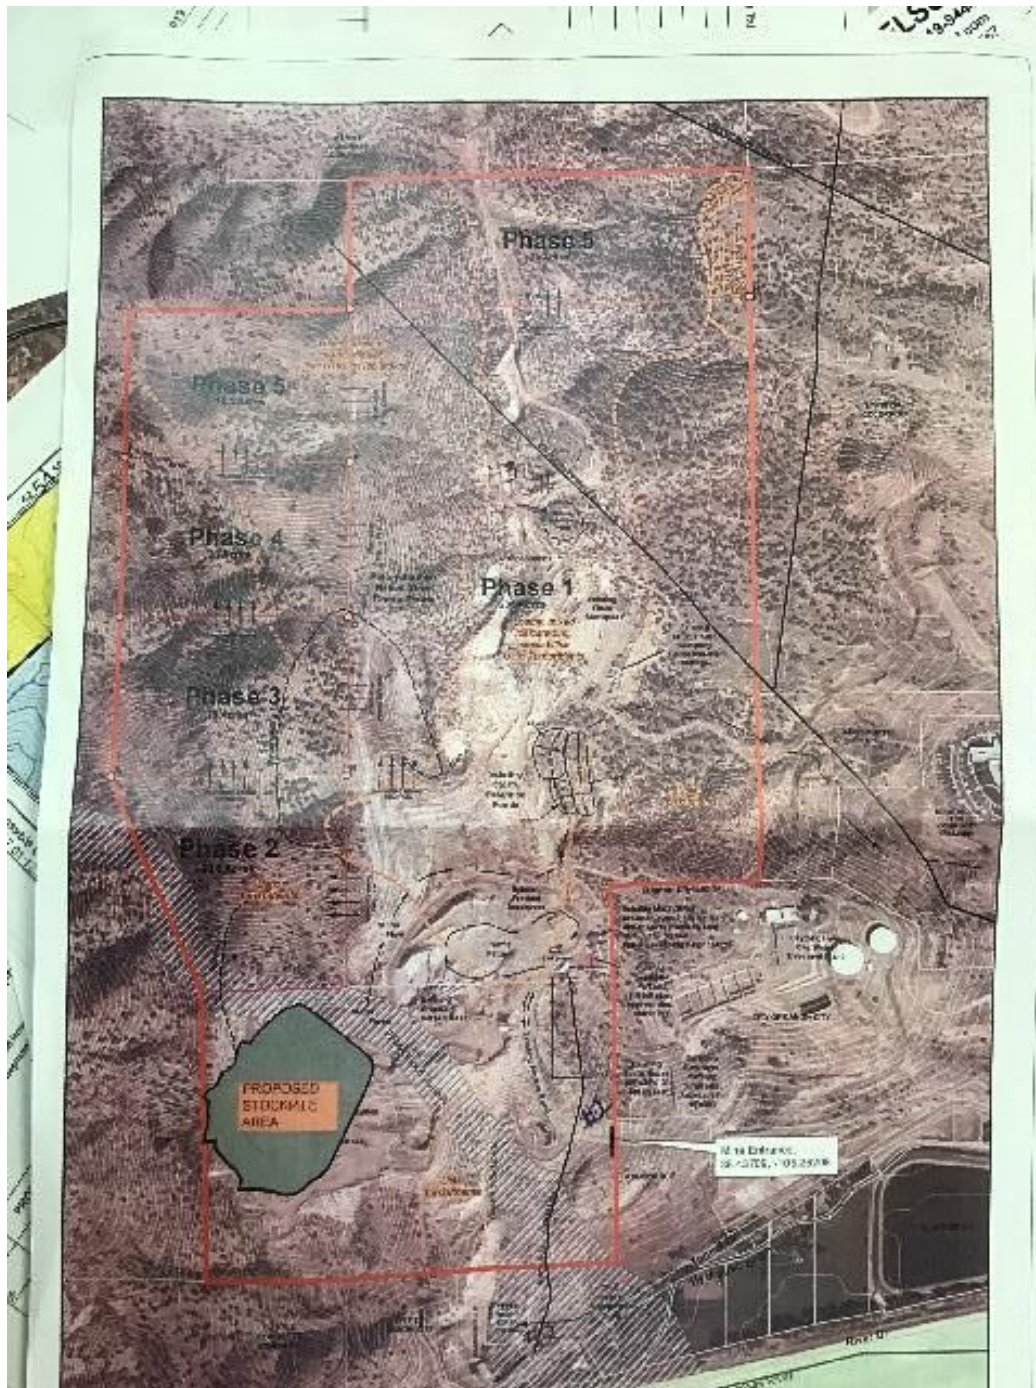
Image 2:

- Signage on the main access road only. For the northern access point, there is a sign on the gate stating, "No Trespassing".
- All entrance points (3) have gate closures when mine is not open. See photo below.
- Fencings consists of barbwire fence in places on eastern and northern side. 6' high chain link is located on the southern side.
- There is no guard on site.
- All people accessing the site have to check in at the scale house. This is noted on a sign along main access road.

Comment: Locations of 3 gate closures.

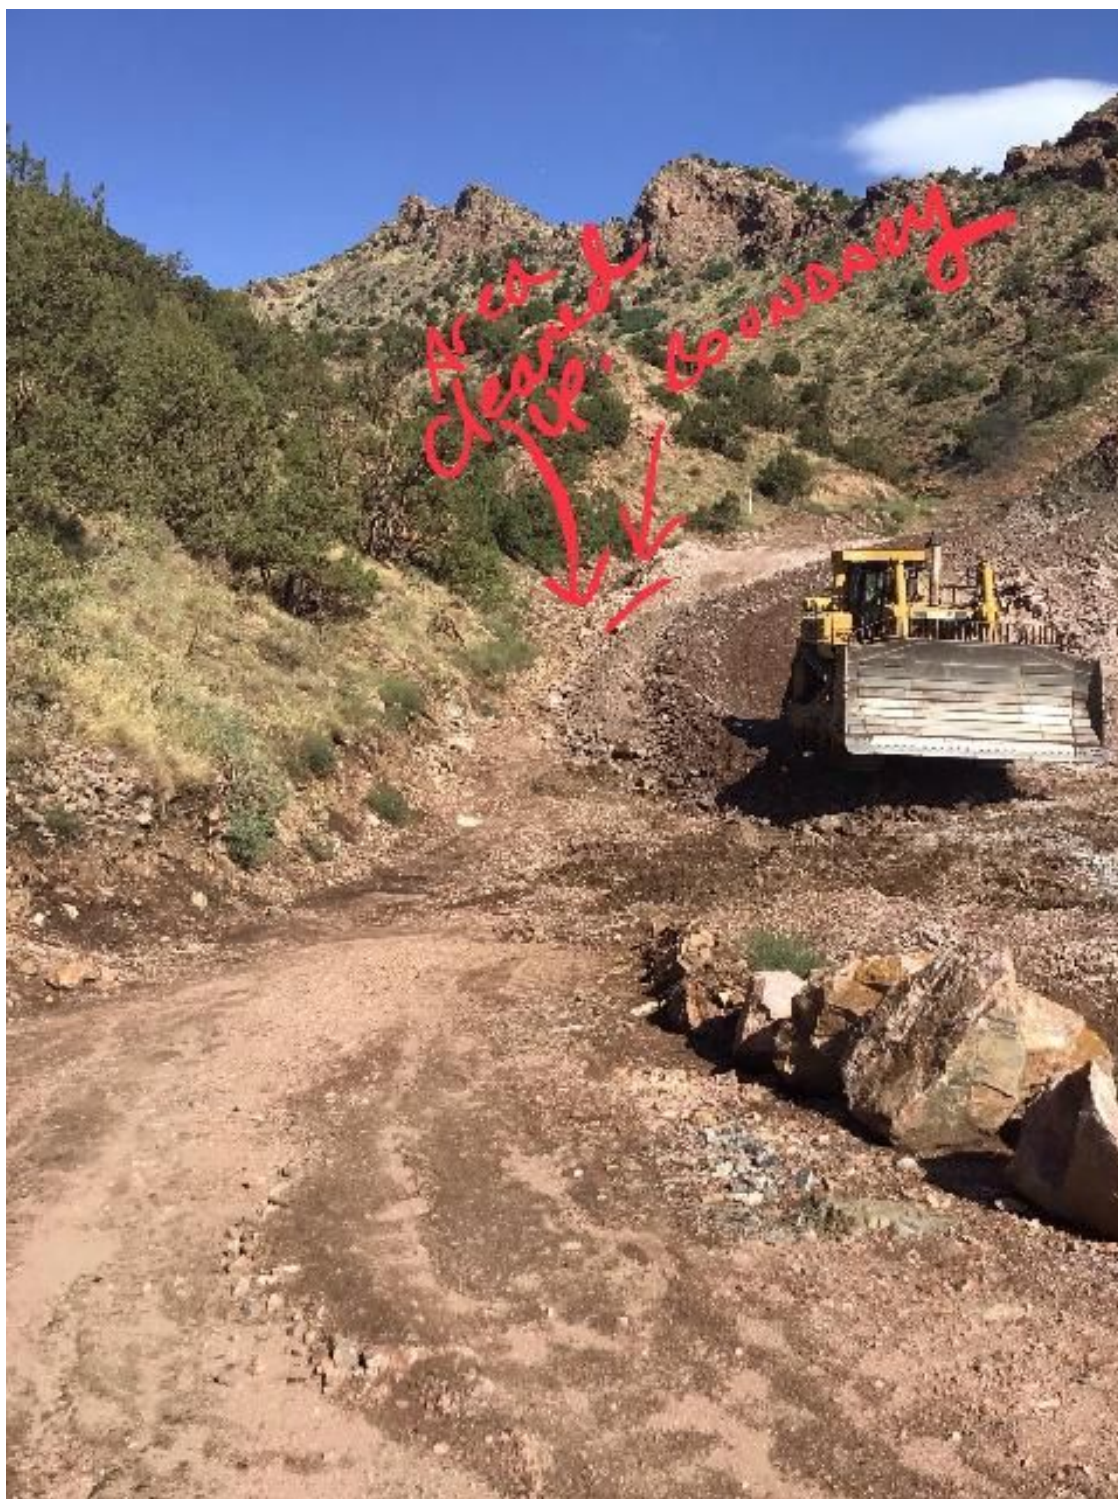
Image 7:

- **2.a. No visual inspection conducted of anything except the 5860 bench in Phase 2 area. When area was blasted, there was no backdrop to stop the rock. Due to the adjacent location of the drainage, some of the rock went over the backside into this area. All was cleaned up and no disturbance of the ground occurred. RESOLVED.**
- 2.b. All ponds cleaned out and check dams added to all the southern structures and features.
- 2.d. Going to deal with weeds in the spring. Too late this year.

Comment: Western boundary with overburden after blast.

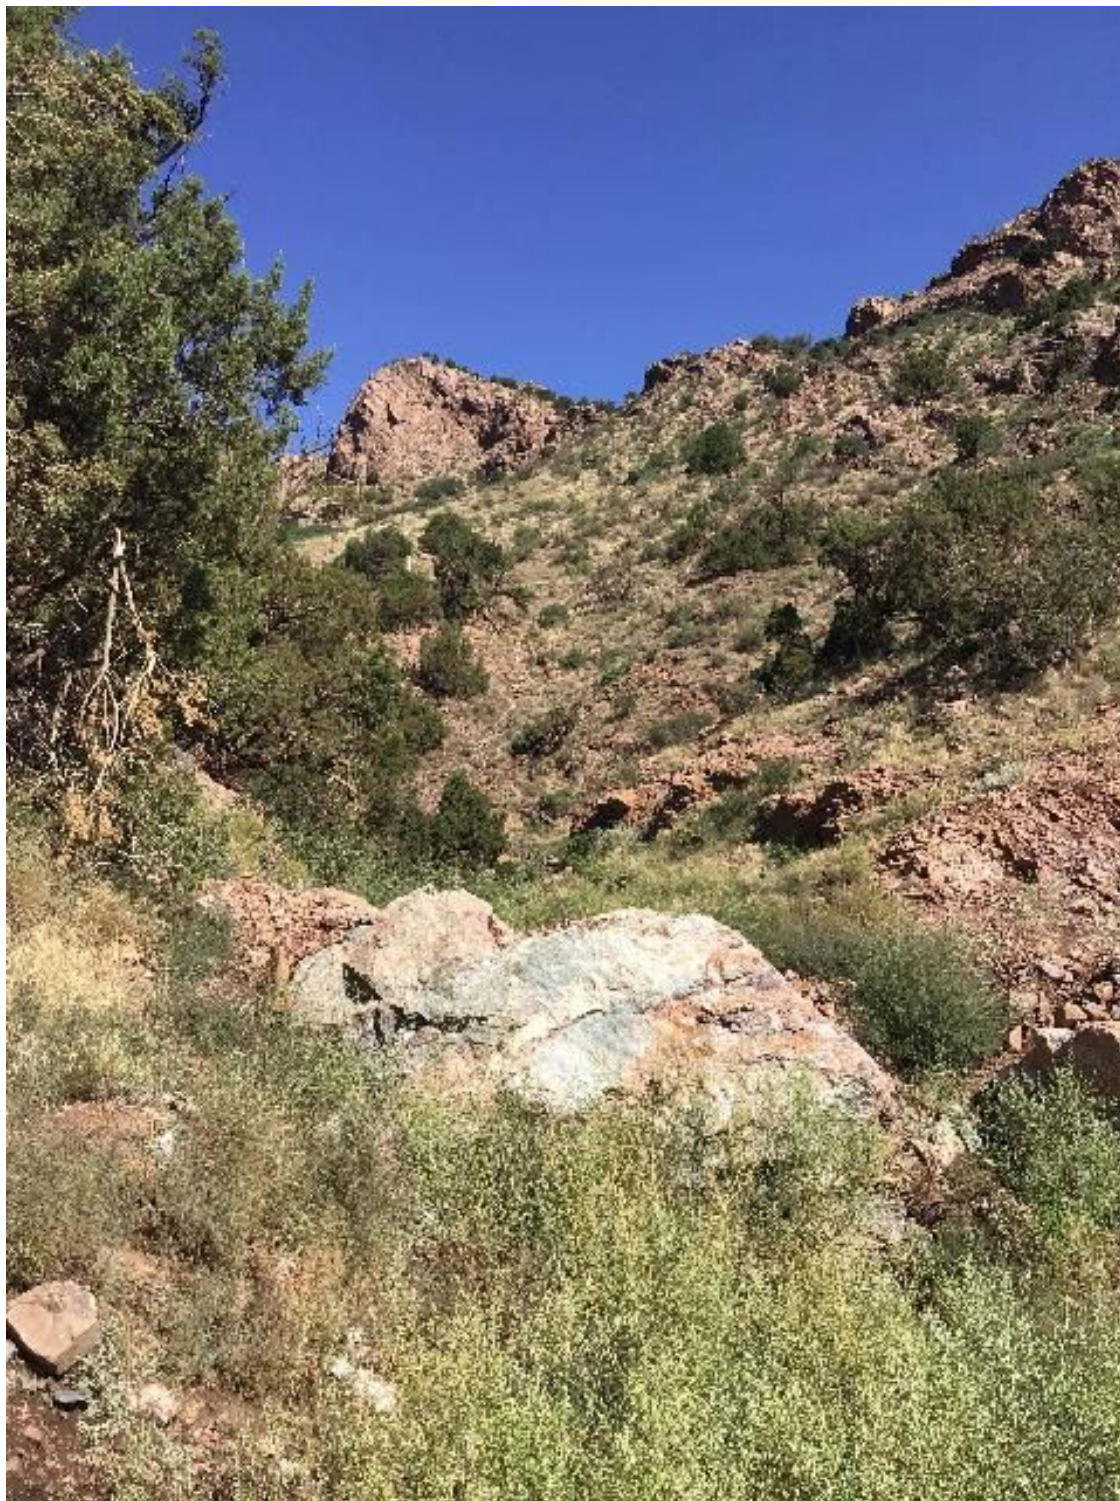
Image 8:

Comment: Natural drainage to west.

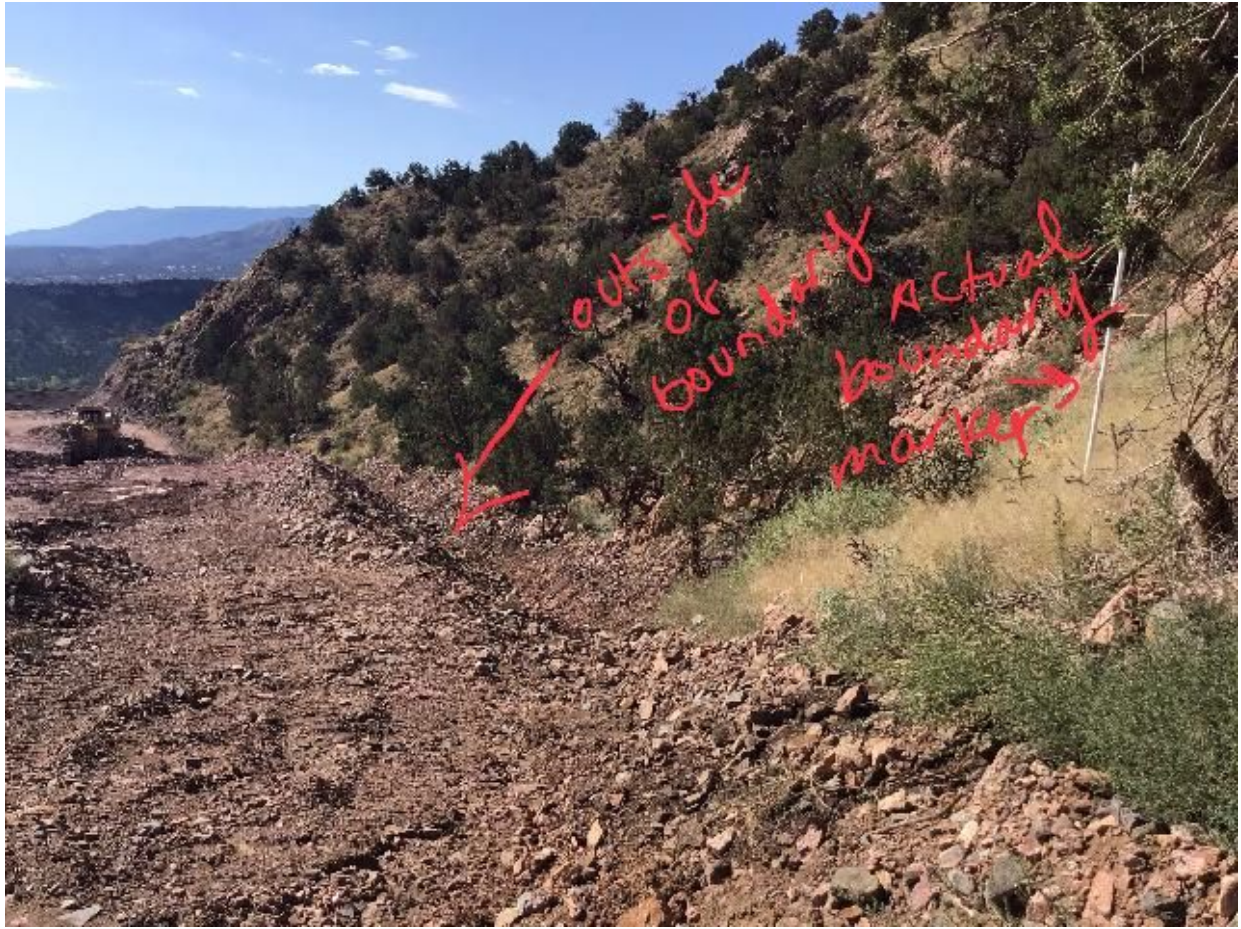
Image 9:

Comment: Looking east on newly disturbed drainage area outside of boundary.
