MINERALS PROGRAM INSPECTION REPORT
PHONE: (303) 866-3567

MINE NAME: Horton Gravel Pit	MINE/PROSPECTING ID#: M-1985-135	MINERAL: Sand and gravel	COUNTY: Larimer
INSPECTION TYPE: Monitoring	INSPECTOR(S): Amy Eschberger, Rob Zuber	INSP. DATE: February 13, 2020	INSP. TIME: 12:30
OPERATOR: Larimer County	OPERATOR REPRESENTATIVE: Justin Hersh	TYPE OF OPERATION: 112c - Construction Regular Operation

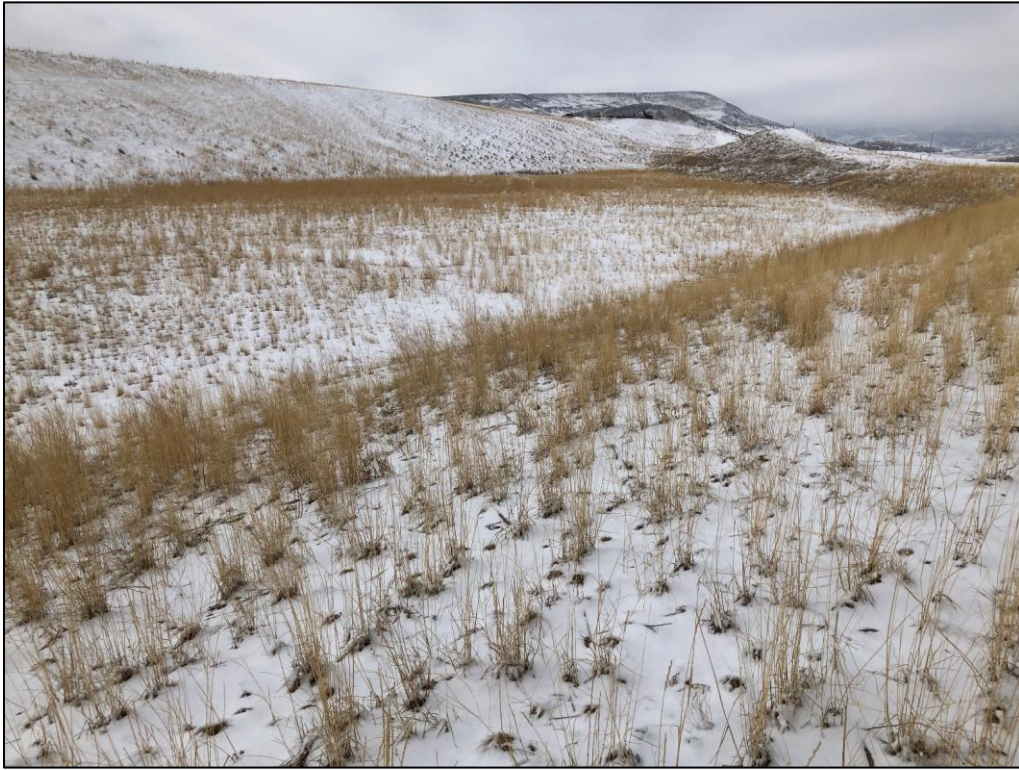
Photo 1. View looking southwest across western portion of pit, showing slopes stable with good grass cover. No ponded water was observed in pit during inspection.

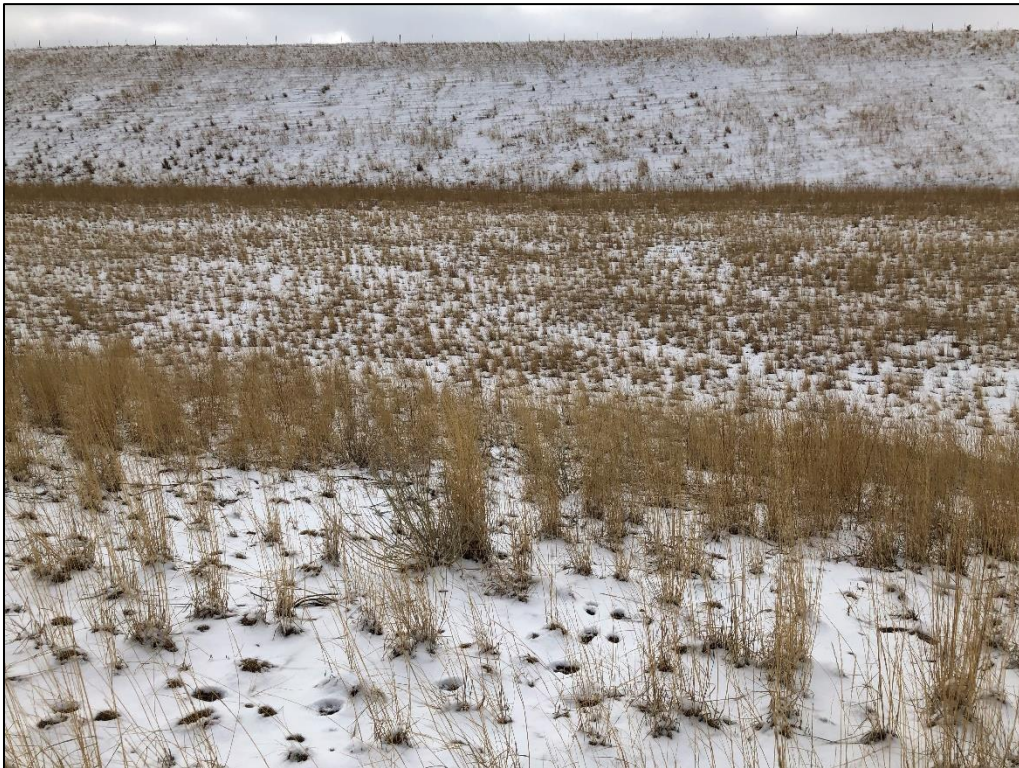
Photo 2. View looking south across central portion of pit, showing slopes stable with good grass cover. No ponded water was observed in pit during inspection.

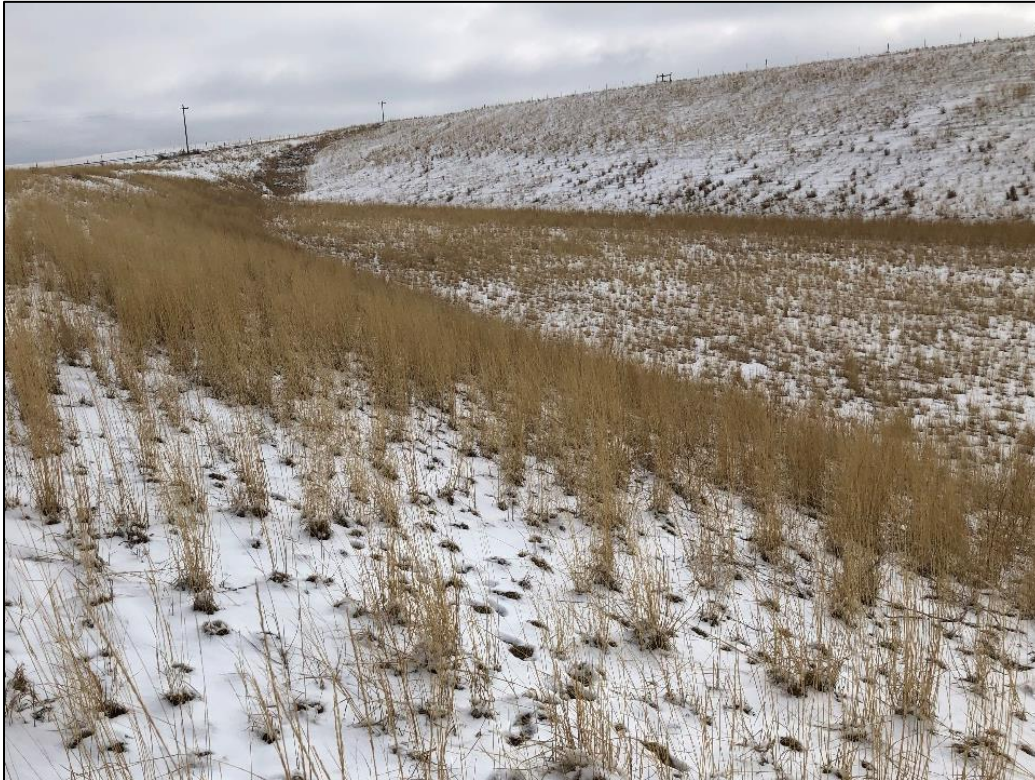
Photo 3. View looking southeast across eastern portion of pit, showing slopes stable with good grass cover. No ponded water was observed in pit during inspection.

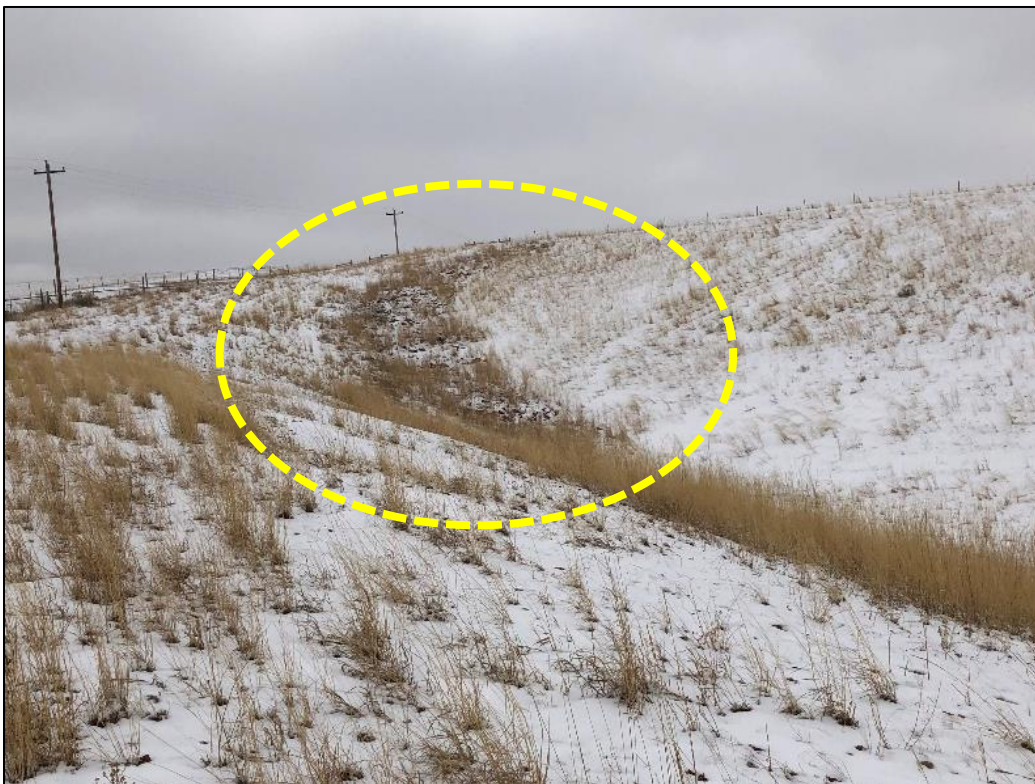
In its last inspection report (for September 12, 2012), the Division noted the presence of erosion gullies and ruts on the southern pit slope. The Division also noted ponded water in the eastern portion of the pit. Since that time, the operator repaired the erosion damage, reseeded those areas, and installed riprap lined channels at the northwestern and southeastern edges of the pit. The operator has also installed a buried culvert through the northern pit slope, which drains the pit to the irrigation ditch located north of the pit. According to the operator, a discharge permit has been obtained from the CDPHE, WQCD for this discharge. No ponded water was observed in the pit during the inspection.

The stormwater management structures installed at the site are not included in the approved mining plan or portrayed on the approved mining plan map (see enclosed mining plan map). Therefore, a problem is cited in this report (see pages 1 and 2) pursuant to Rules 6.4.3 and 6.4.4, requiring the operator to submit a Technical Revision (see enclosed form) to update the mining plan and mining plan map to address the stormwater management structures installed at the site. These structures are also not included in the approved reclamation plan or portrayed on the approved reclamation plan map (see enclosed reclamation plan map). Therefore, a separate problem is cited in this report (see page 2) pursuant to Rules 6.4.5 and 6.4.6, requiring the operator to submit, in the same Technical Revision, an updated reclamation plan and reclamation plan map that address the stormwater management structures installed at the site.

Photo 4. Closer view of eastern corner of pit where riprap lined channel was installed (circled). This channel was mostly obscured by snow cover.

CORRECTIVE ACTIONS: By the corrective action date, the operator shall submit a Technical Revision, with the required \$216 fee, to update the current approved mining plan and mining plan map to reflect existing and proposed activities at the site, particularly to address the stormwater management structures, new access road, and county staging area constructed at the site.

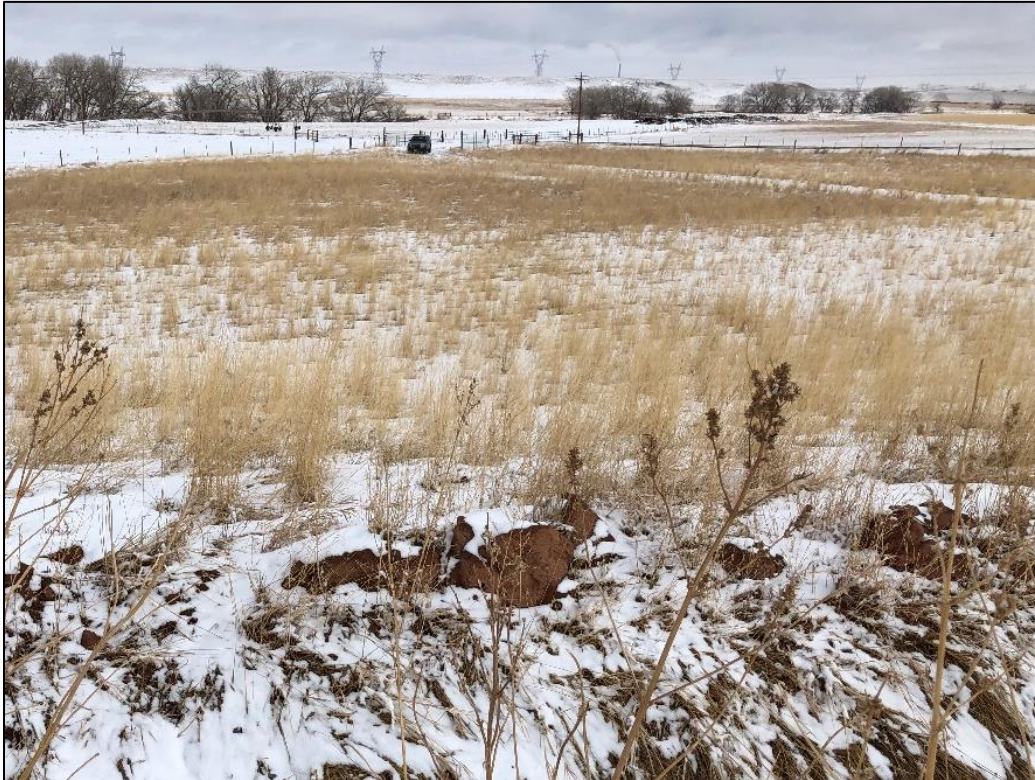
Photo 5. View looking northeast (from irrigation ditch) at reclaimed northeastern portion of permit area (near main site entrance) which was utilized for material stockpiling.

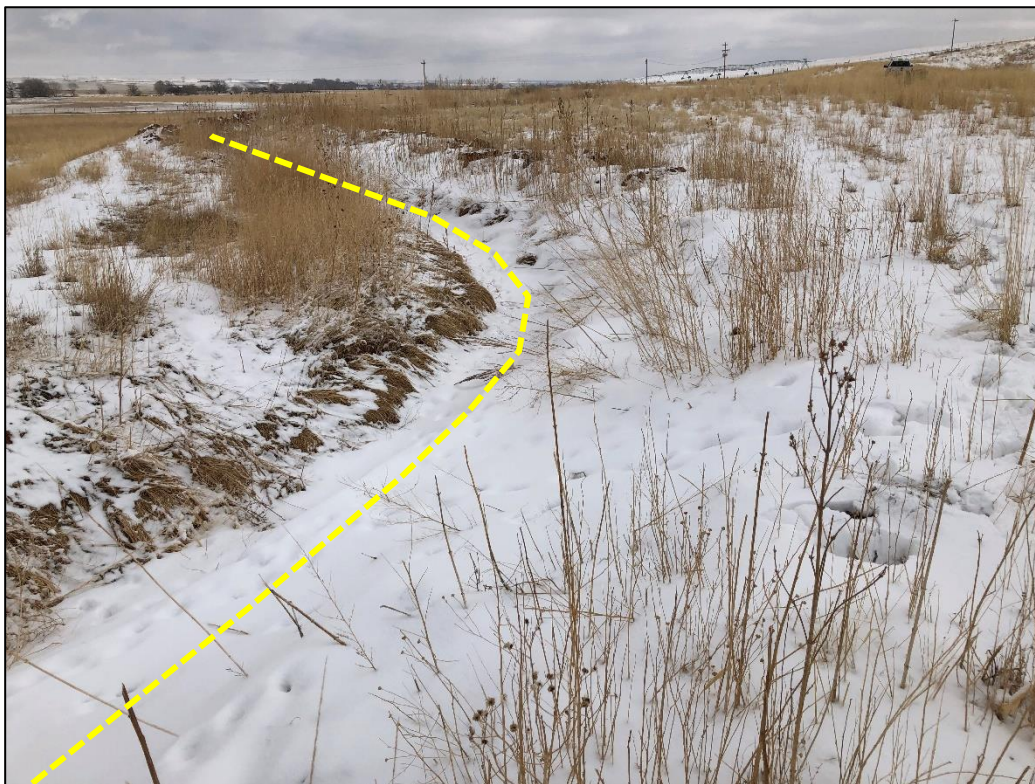
Photo 6. View looking southeast across irrigation ditch which crosses northeastern portion of permit area. Approximate center line of ditch delineated.

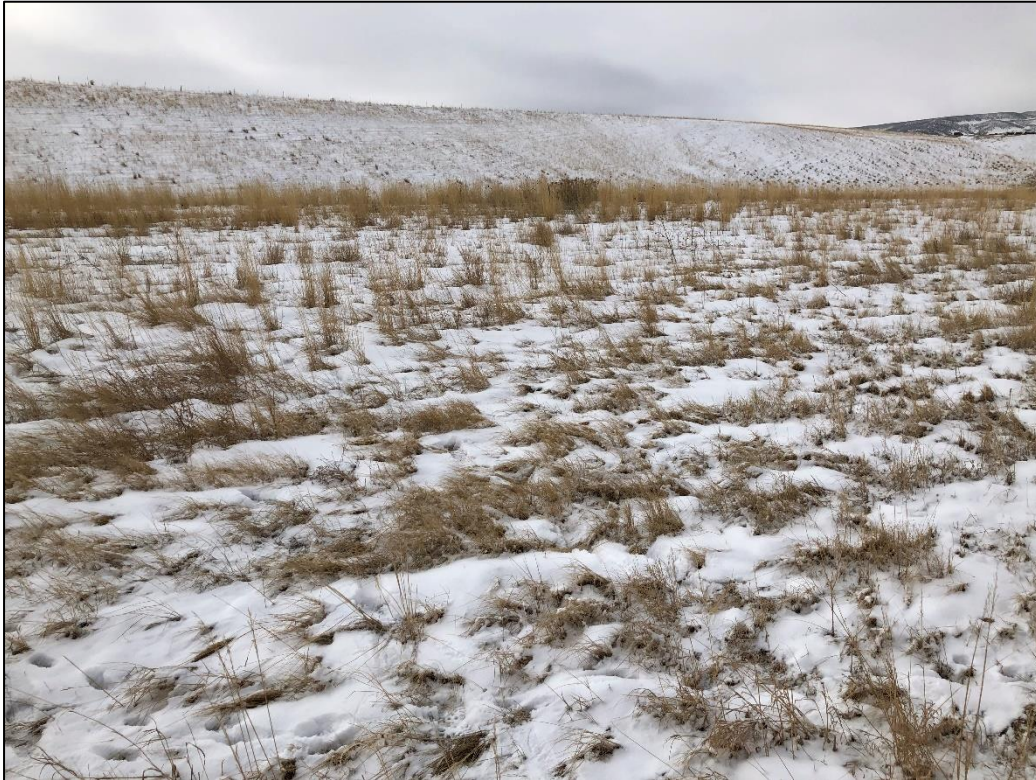
Photo 7. View looking southwest across reclaimed land between pit and irrigation ditch.

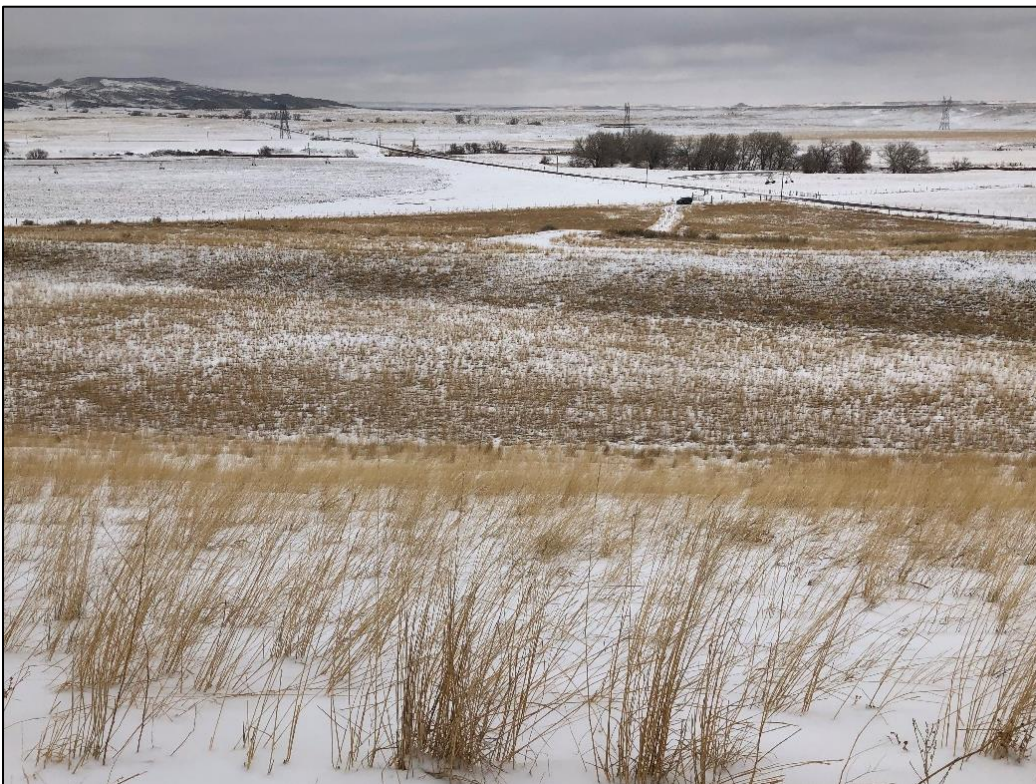
Photo 8. View looking northeast across reclaimed pit area in eastern half of site from top of southern pit wall.

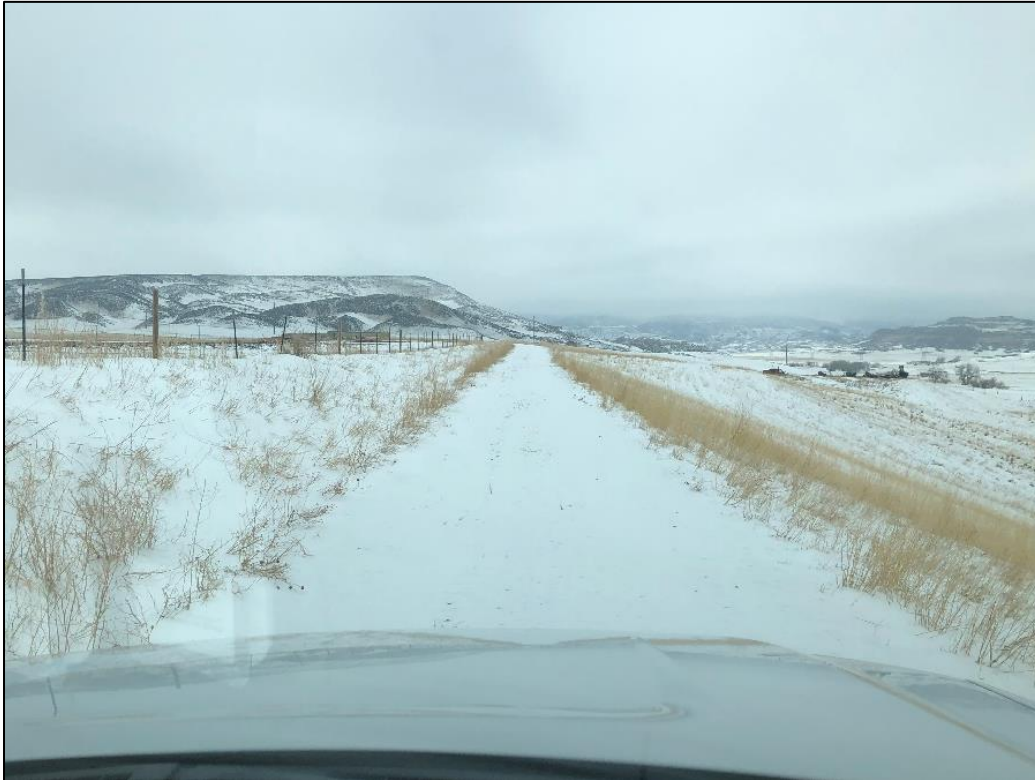
The operator has constructed a new (gated) entrance to the site at the southeastern corner of the permit area. The new access road runs along the southern edge of the permit area to a small (approximately 0.75 acre) gravel area being used by the county for storing road and bridge equipment (e.g., culverts, concrete beams). The Division estimates the new access road to be approximately 1,840 feet in length. According to the aerial imagery available in Google Earth, these new features were constructed at the site between 2014 and 2016. The approved permit does not include the additional access road or the equipment storage area. Therefore, the operator will need to provide updated mining and reclamation plans to address the new access road and equipment storage area. These features will also need to be portrayed on the updated mining and reclamation plan maps. These items can be included in the same Technical Revision required for the problems cited above. If the operator wishes to continue using a portion of the site for equipment storage after reclamation, this should be addressed in the updated reclamation plan and reclamation plan map. Also, any haul roads proposed to remain after reclamation should be portrayed on the updated reclamation plan map.

Photo 9. View looking northwest across new haul road constructed along southern edge of permit area to access county staging area. Barbed wire fence (at left) marks southern permit boundary.

mining plan), portray these features on the updated mining plan map, and if these features will remain for reclamation, portray them on the updated reclamation plan map. If these features will be reclaimed, describe how they will be reclaimed in the updated reclamation plan.

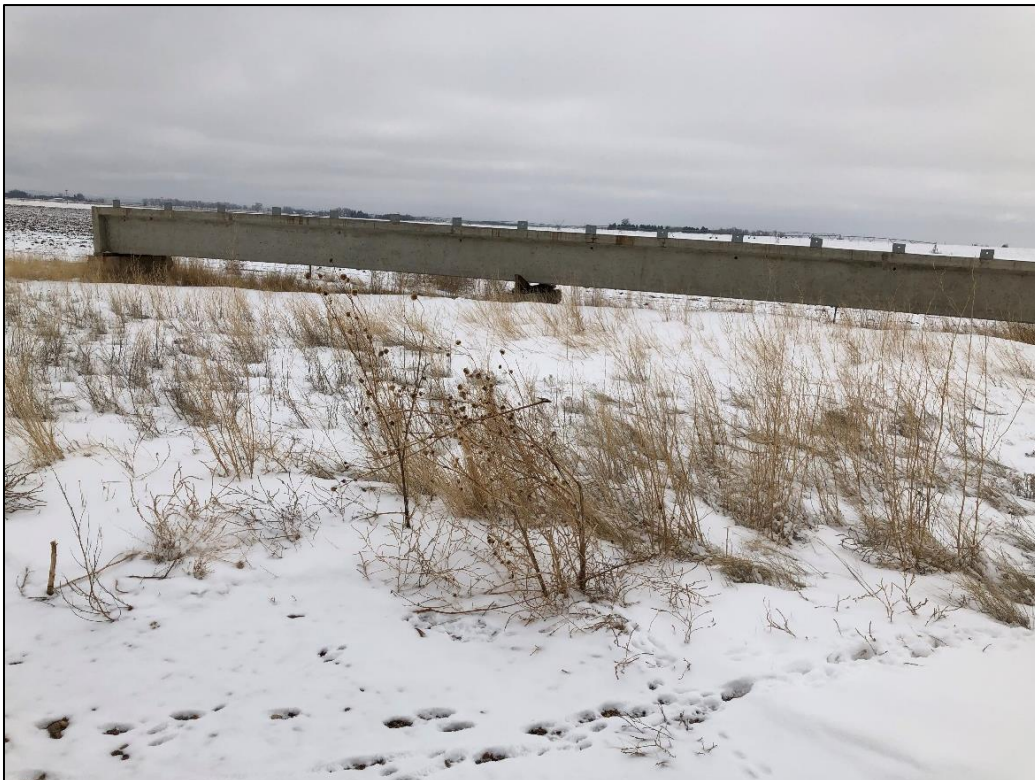
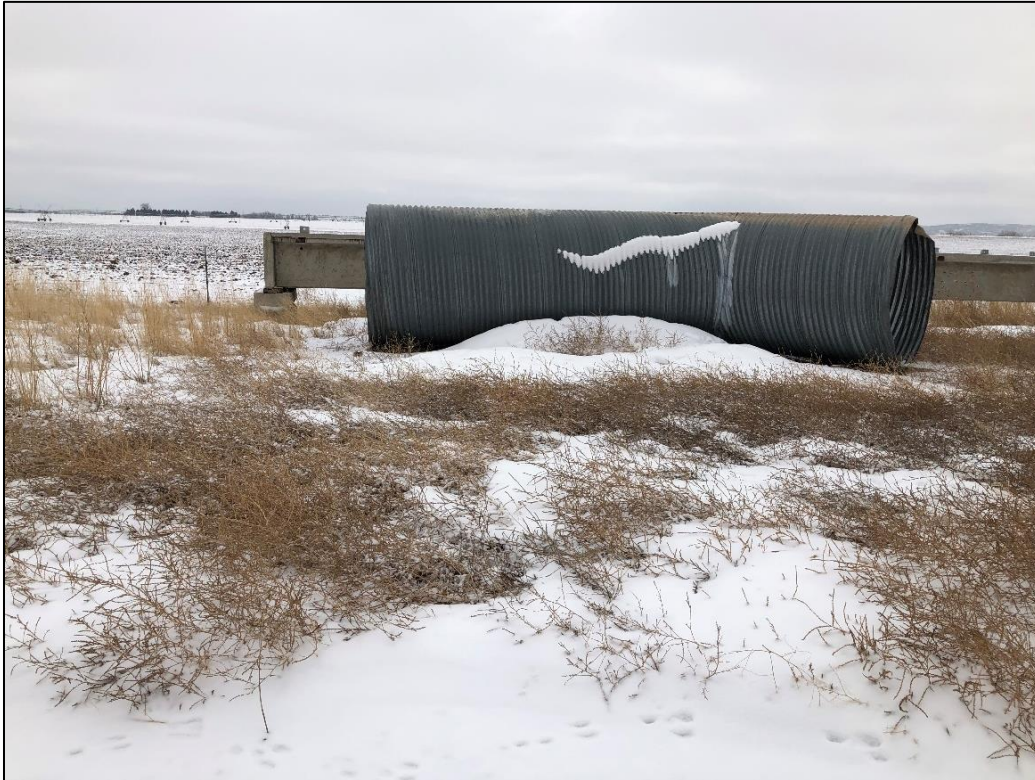
Photo 10. View looking south across small gravel staging area constructed at south-central edge of permit area for road and bridge equipment storage.

Photo 11. View looking south across small gravel staging area constructed at south-central edge of permit area for road and bridge equipment storage.

- c. Describe the county staging area constructed at the site (in the updated mining plan), portray this area on the updated mining plan map, and if this feature will continue to be used by the county after reclamation, portray this feature on the updated reclamation plan map. If this feature will be reclaimed, describe how it will be reclaimed in the updated reclamation plan.

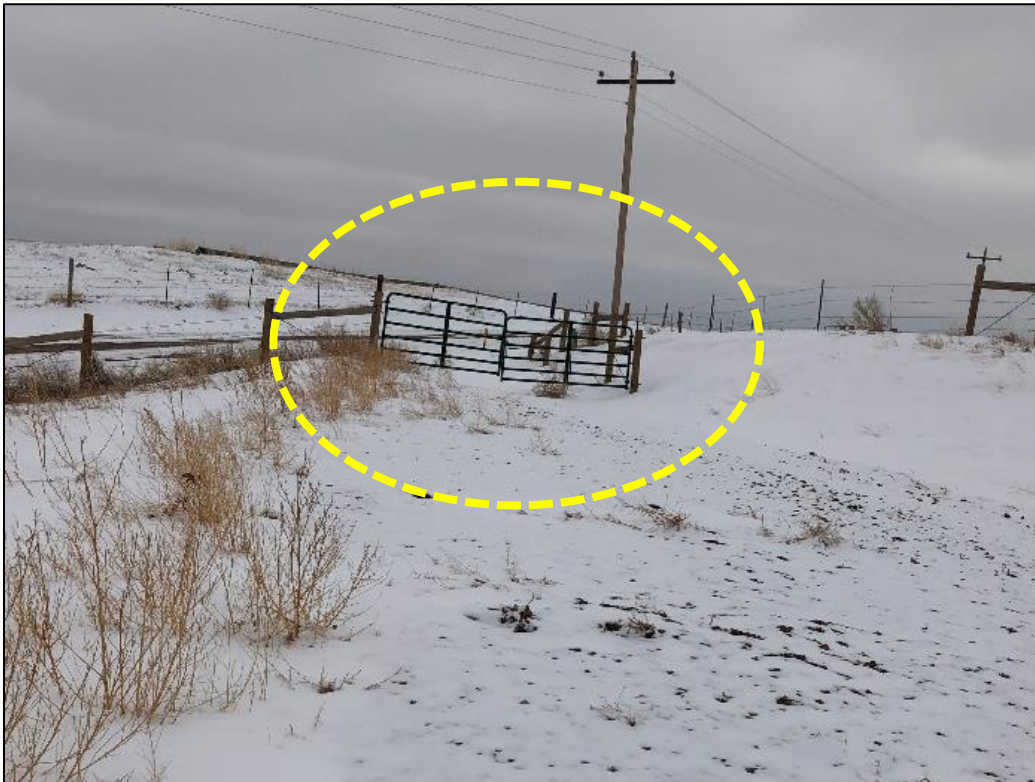
Photo 12. View looking southeast at new gated access constructed at southeastern corner of permit area.

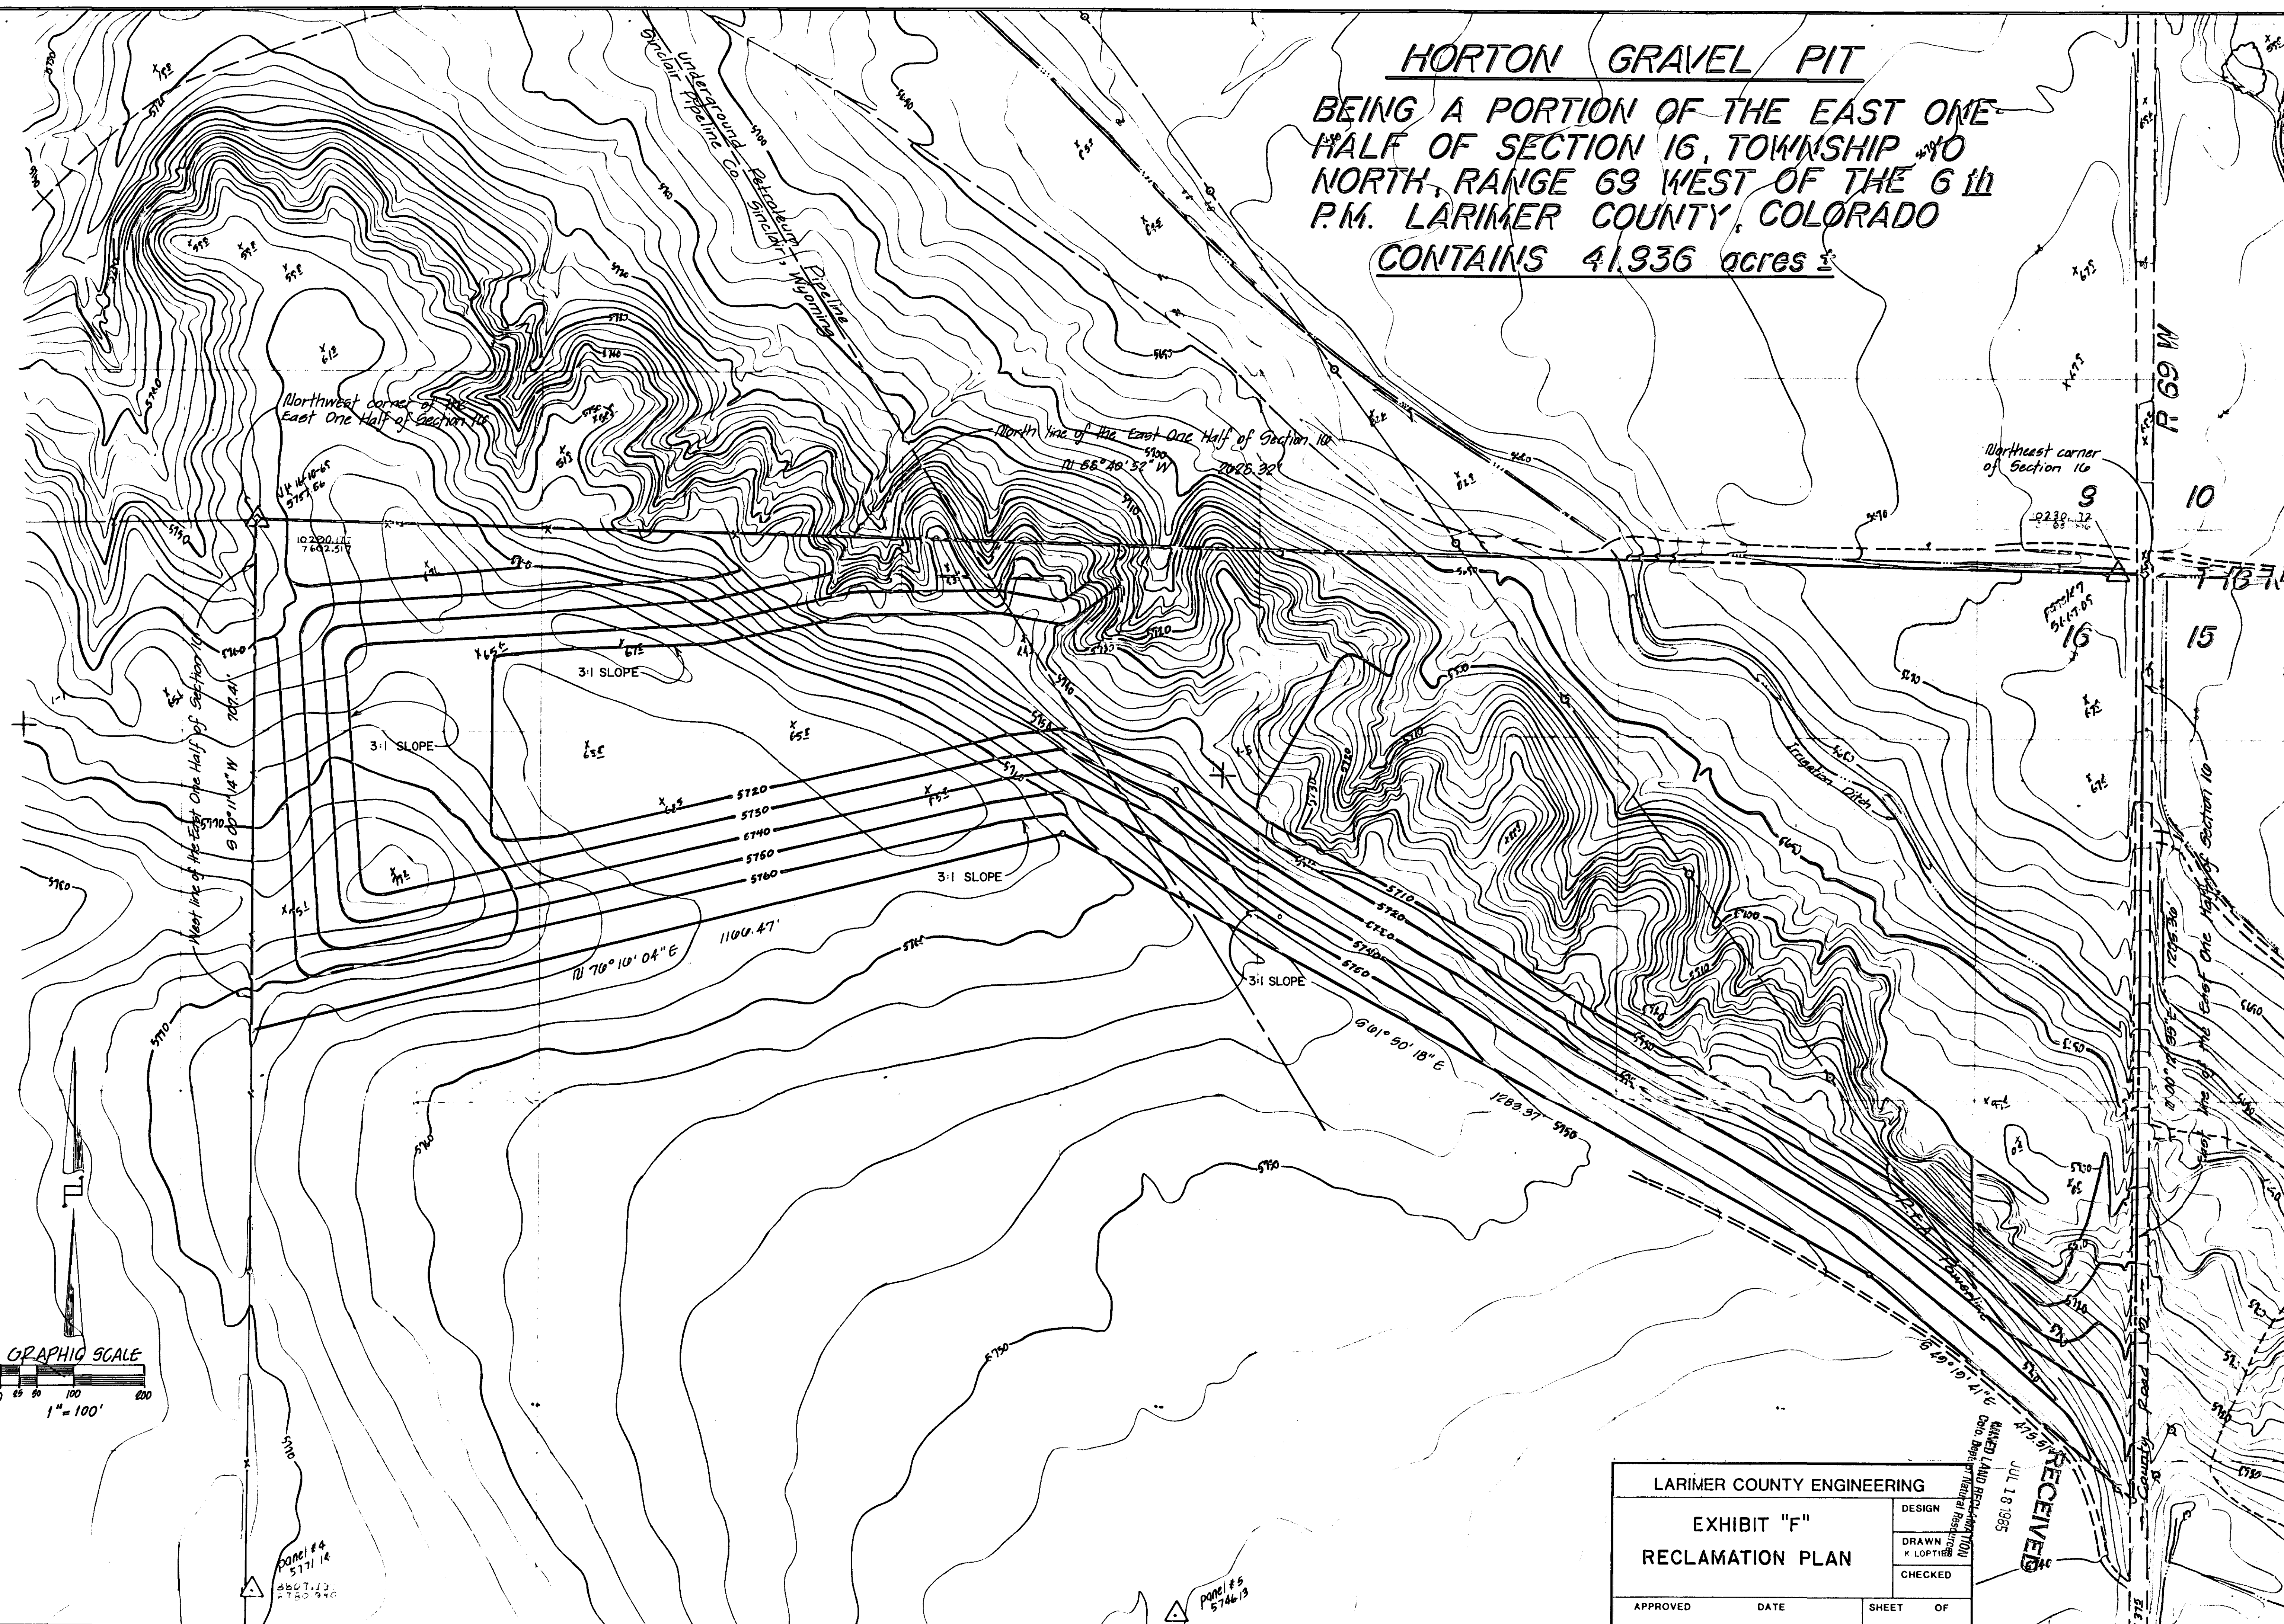
LARIMER COUNTY ENGINEERING	
EXHIBIT "F"	
RECLAMATION PLAN	
DESIGN	DRAWN
CHECKED	DATE
APPROVED	SHEET OF

PROBLEM: The current reclamation plan and reclamation plan map need to be updated pursuant to Rules 6.4.5 and 6.4.6. The operator must describe how reclamation will be achieved on all affected land. Specifically, the operator has installed stormwater management structures (riprap lined channels, buried culvert), a new access road, and a county staging area, which are not included in the approved reclamation plan or portrayed on the approved reclamation plan map.

CORRECTIVE ACTIONS: By the corrective action date, the operator shall submit a Technical Revision, with the required \$216 fee (can be same revision submitted for problem cited above), to update the current approved reclamation plan and reclamation plan map to reflect existing and proposed activities at the site, particularly to address the stormwater management structures, new access road, and county staging area constructed at the site. Any of these features proposed to remain for reclamation shall be portrayed on the updated reclamation plan map.
