**RE: Colowyo Coal Mine
Permit No. C-1981-019
Fill Monitoring Certifications
First Quarter 2020**

South Taylor Fill Inspection Certification

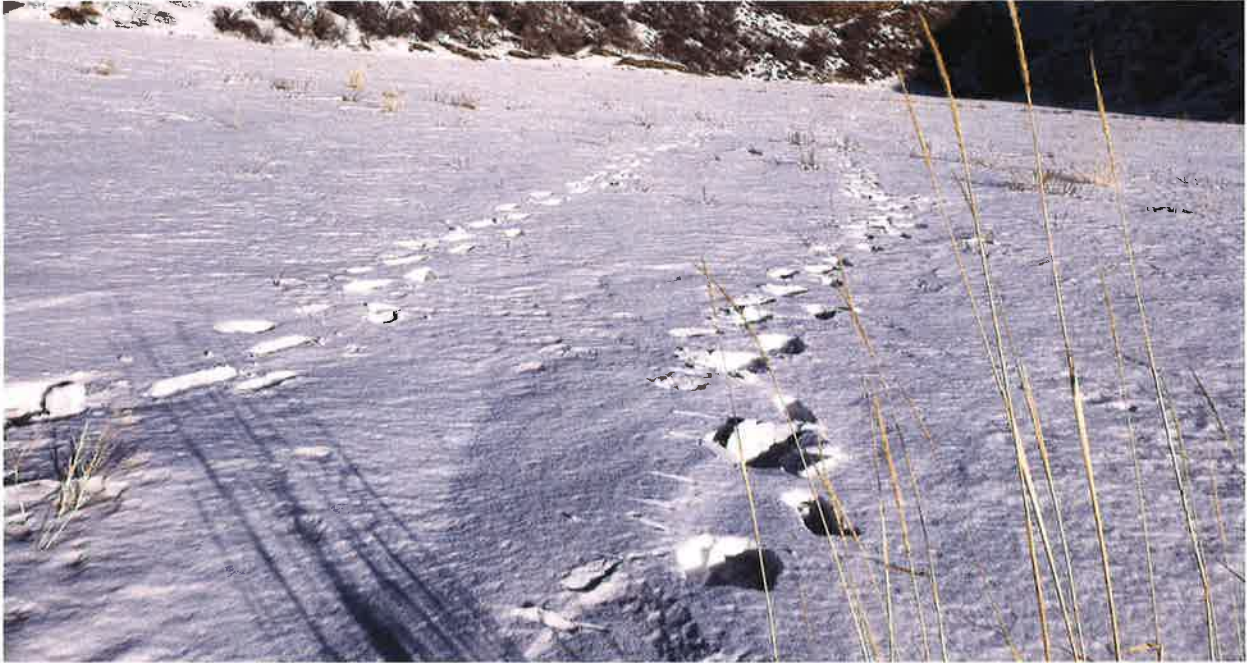
03-05-20 - West Taylor fill looking northwest from monitoring well location

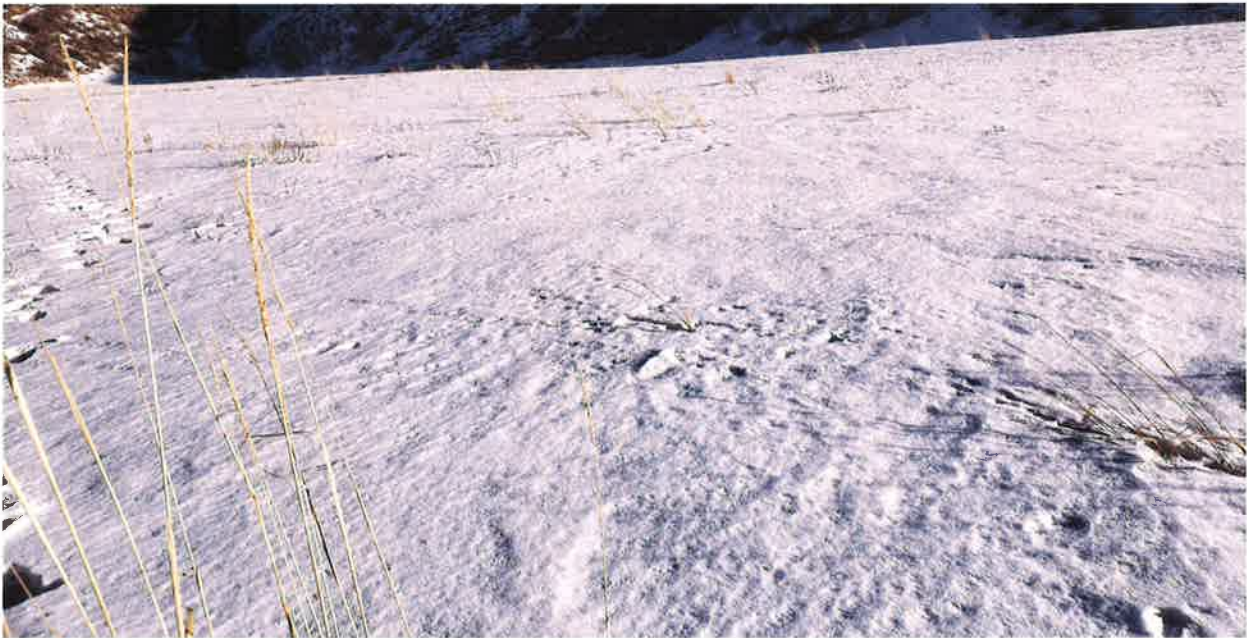
03-05-20 - West Taylor fill looking northeast from monitoring well location

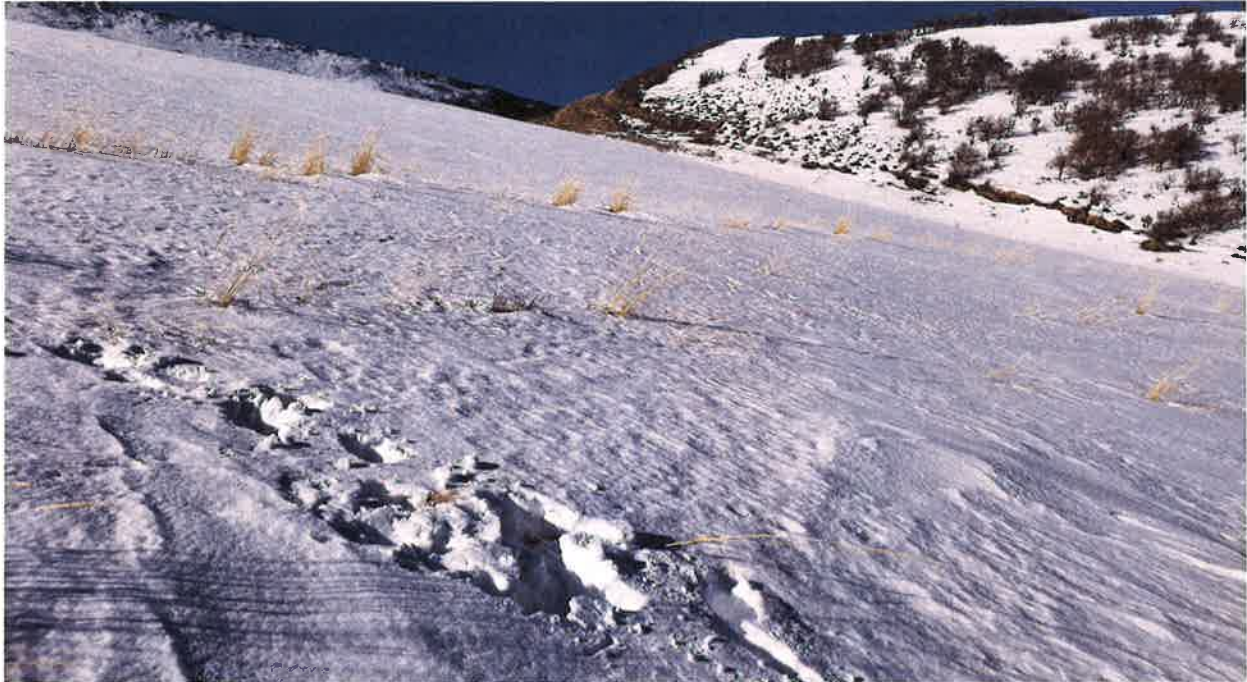
03-05-20 - West Taylor Fill West Flank from monitoring well location

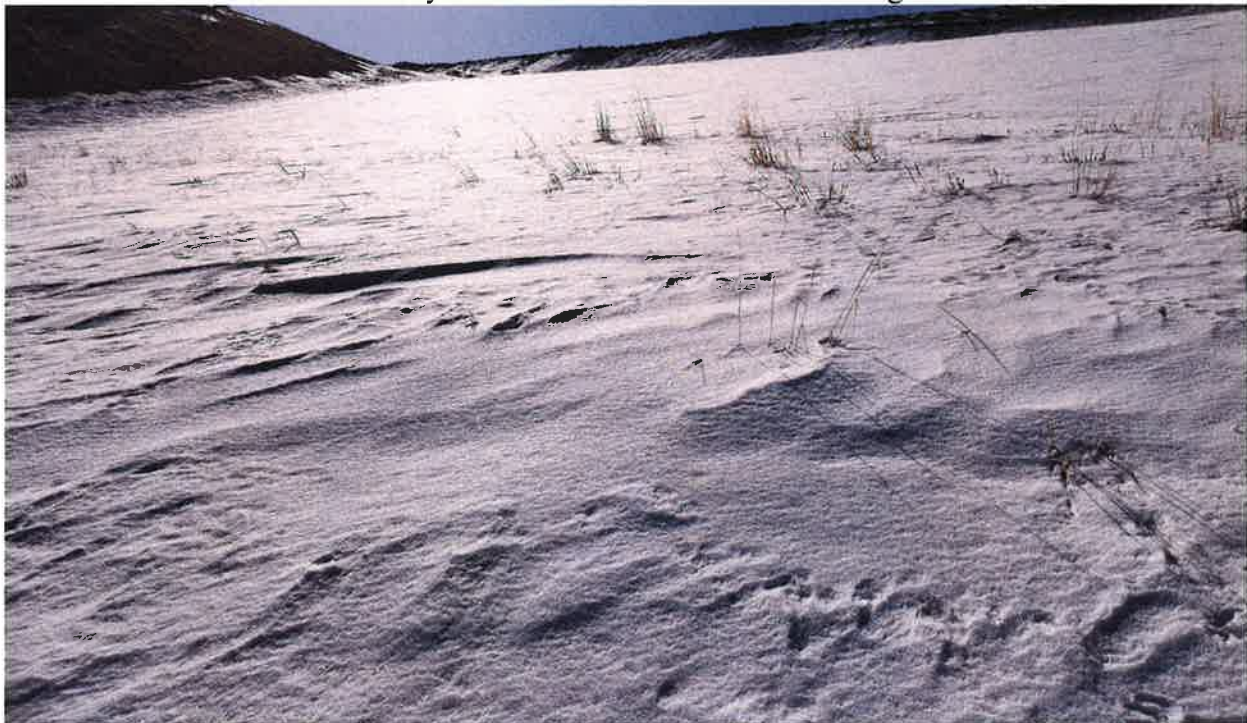
03-05-20 - West Taylor Fill East Flank from monitoring well location

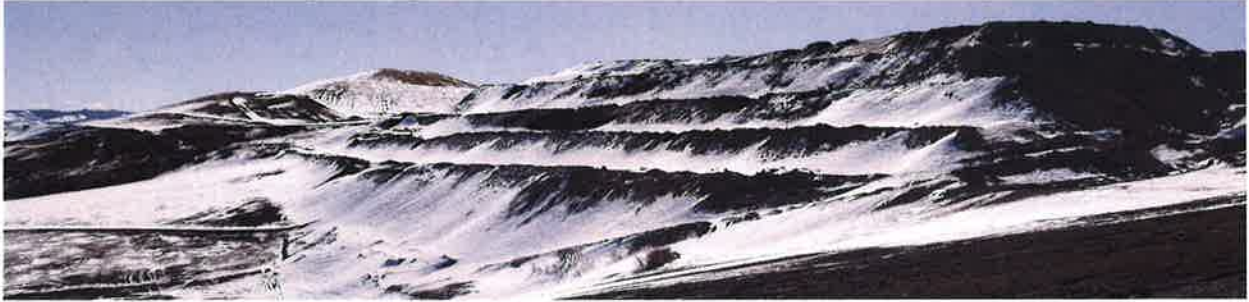
East Taylor Fill with C-C' Underdrain Area: No activity other than rock crusher operations have taken place within the East Taylor fill during this quarter.

No structural weakness, signs of instability, or other hazards were noted at the time of inspection.

03-05-20 - East Taylor Fill looking east from the west ridgeline
