**MINERALS PROGRAM INSPECTION REPORT**  
**PHONE: (303) 866-3567**

<b>MINE NAME:</b> Boyer Pit	<b>MINE/PROSPECTING ID#:</b> M-2002-122	<b>MINERAL:</b> Sand and gravel	<b>COUNTY:</b> Custer
<b>INSPECTION TYPE:</b> Monitoring	<b>INSPECTOR(S):</b> Timothy Cazier	<b>INSP. DATE:</b> June 19, 2019	<b>INSP. TIME:</b> 08:30
<b>OPERATOR:</b> Seifert Construction dba Seifert Enterprises, LLC	<b>OPERATOR REPRESENTATIVE:</b> Kent Beach	<b>TYPE OF OPERATION:</b> 112c - Construction Regular Operation

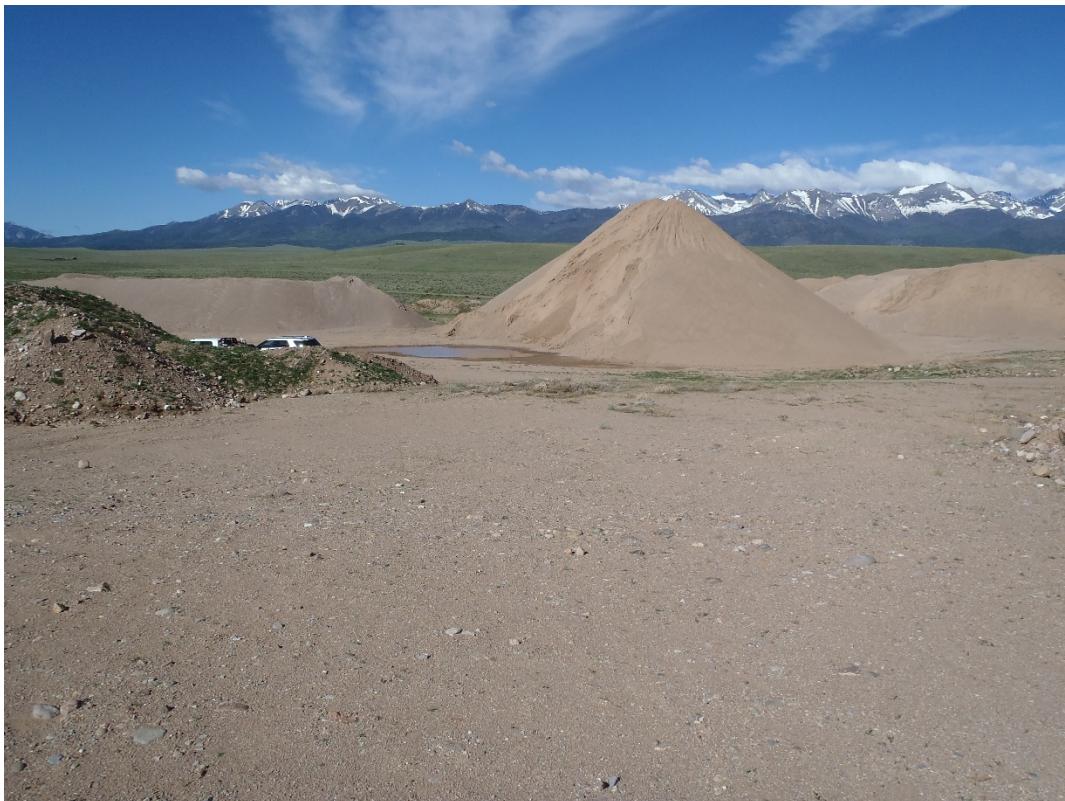
Excess Spoil and Dev. Waste: Crusher fines (squeegee) piles were observed in the pit bottom (see **Photo 1**).

Hydrologic Balance: Some standing water was observed in the pit (see **Photo 1**), assumed to be from recent storm events. No exposed groundwater was observed.

Photo 1. Crusher fines and standing water from recent rain (south of CR 105, looking south).

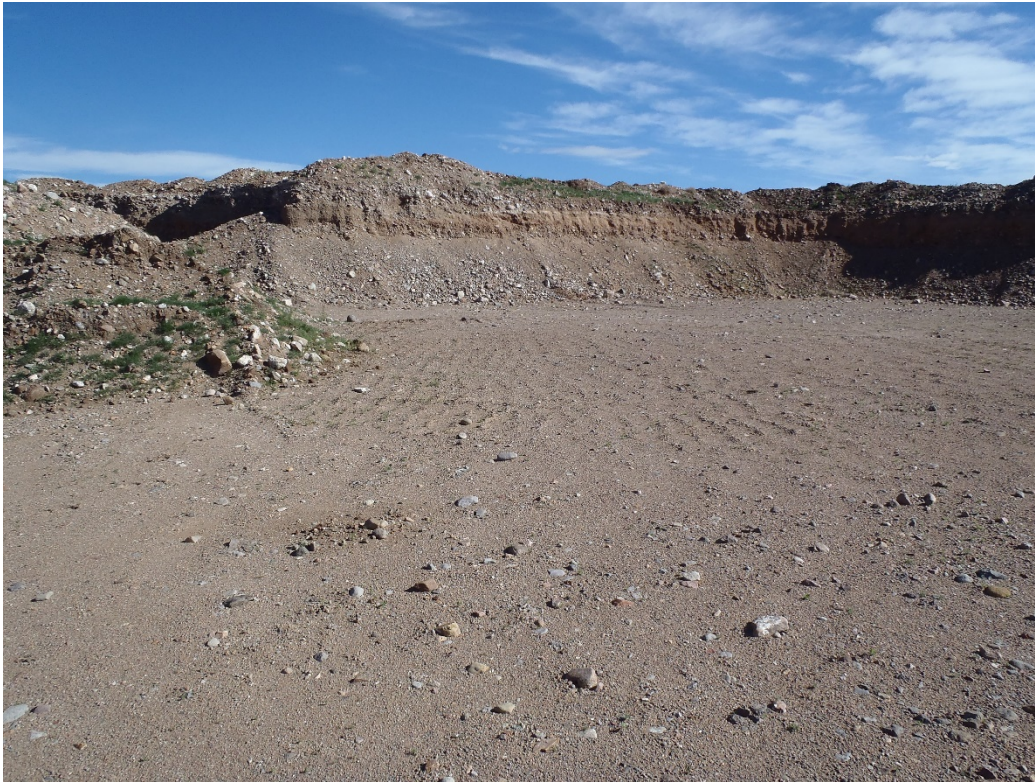
Gen. Compliance with Mine Plan: Mining is essentially complete on the northwest end of the operation (north and west of CR 105 and Phase 1 on the original application Exhibit C). Mr. Beach stated the increasing thickness of the overburden towards the northeast (Phase 9) makes it uneconomical to continue mining in that direction. The maximum allowed disturbed area is 13 acres. Google Earth was used to measure the historical cumulative disturbed area, which was estimated to be approximately 30 acres, based on 2017 imagery. However, a significant portion of the northwest part of the permit has been reclaimed and may be enough to bring the affected area down to the approved 13 acres if a release request is submitted. [The DRMS recommends Seifert Construction submit an acreage reduction request for the reclaimed area so an assessment can be made as to whether the permit and/or financial warranty need to be adjusted for the current disturbance.](#) Highwalls were estimated to vary between 8 and 12 feet in height and appeared stable (see **Photos 2 and 3**).

Topsoil: Mr. Beach indicated topsoil was being pushed back prior to mining and stockpiled above the highwall (see **Photo 2**).

Photo 2. Highwall south of CR 105 (looking north).

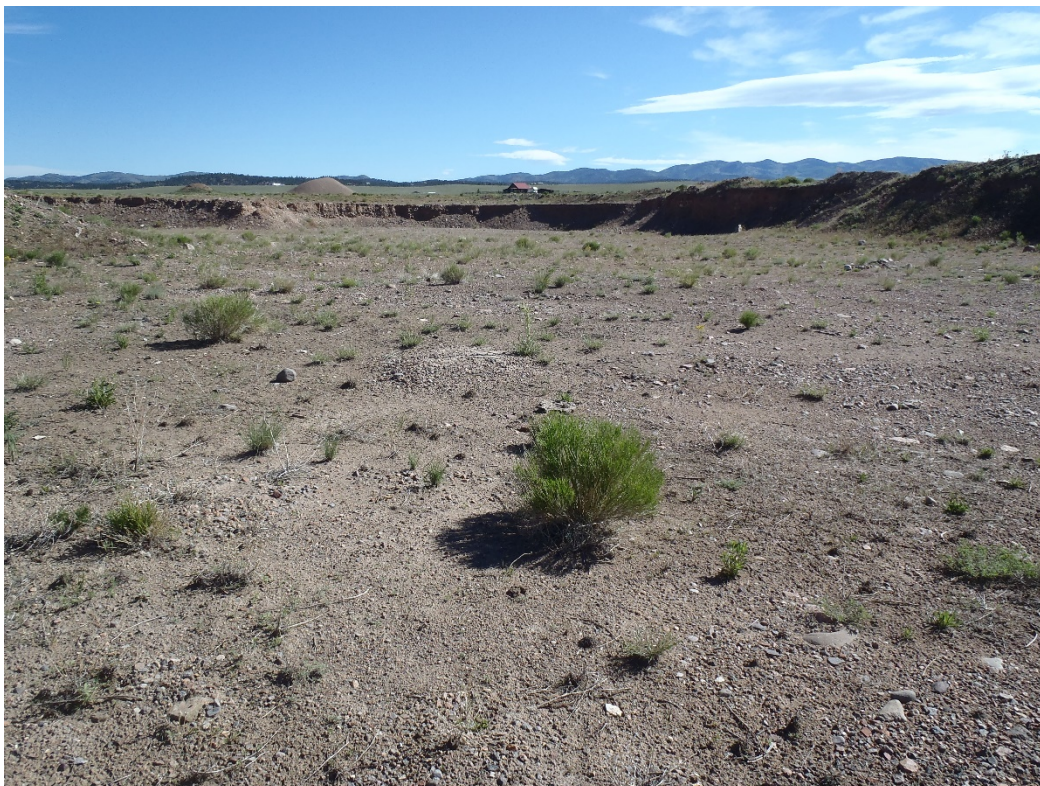
Photo 3. Highwall north of CR 105 (looking east).

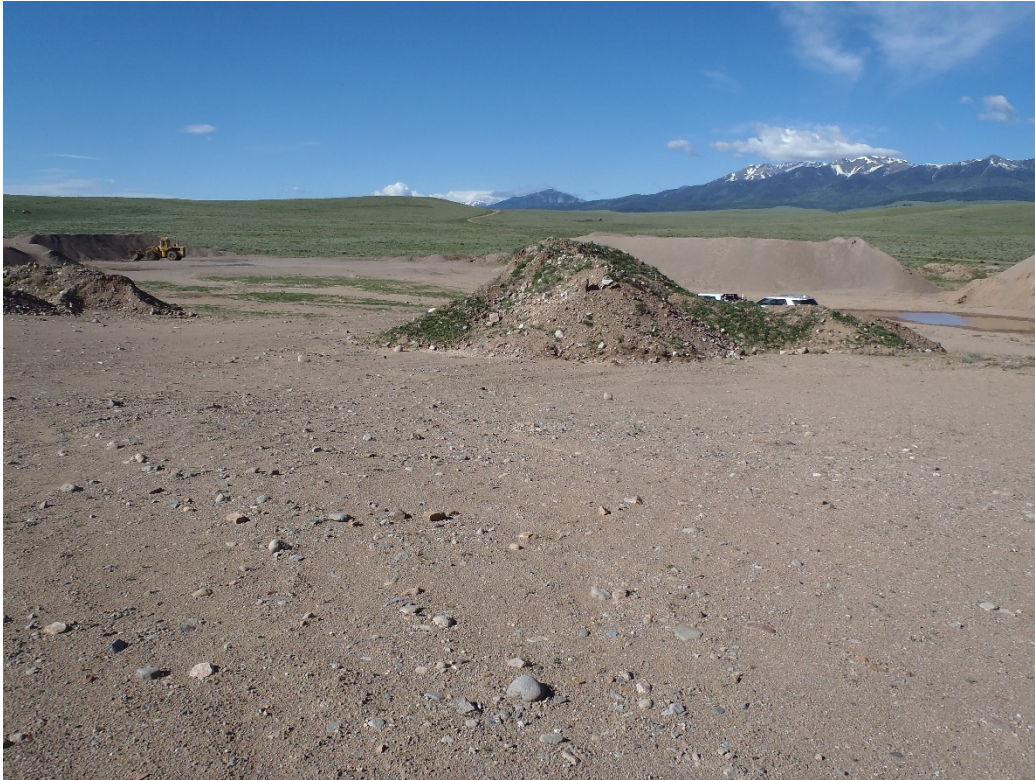
Processing Waste: Reject and squeegee material stockpiles were observed on the pit floor (see **Photo 4**).

Photo 4. Reject and squeegee material stockpiles observed on the pit floor (looking south).

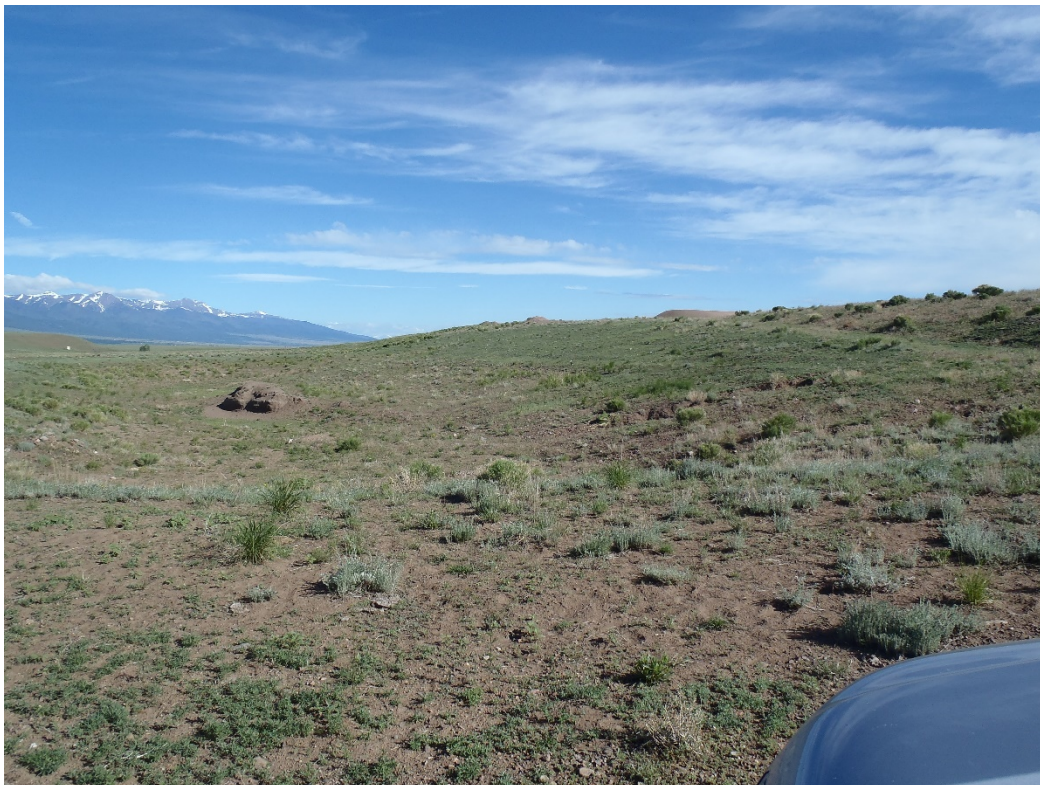
Reclamation Success: Reclamation was in progress in the northwest portion of the permit area where grading topsoiling and seeding had been completed (see **Photo 5**). Mr. Beach indicated additional reclamation work in this area was being delayed as the land had recently been sold to the Navajo Nation and updated agreements were in process.

Photo 5. Northwest portion of permit area where reclamation had been completed (looking north).

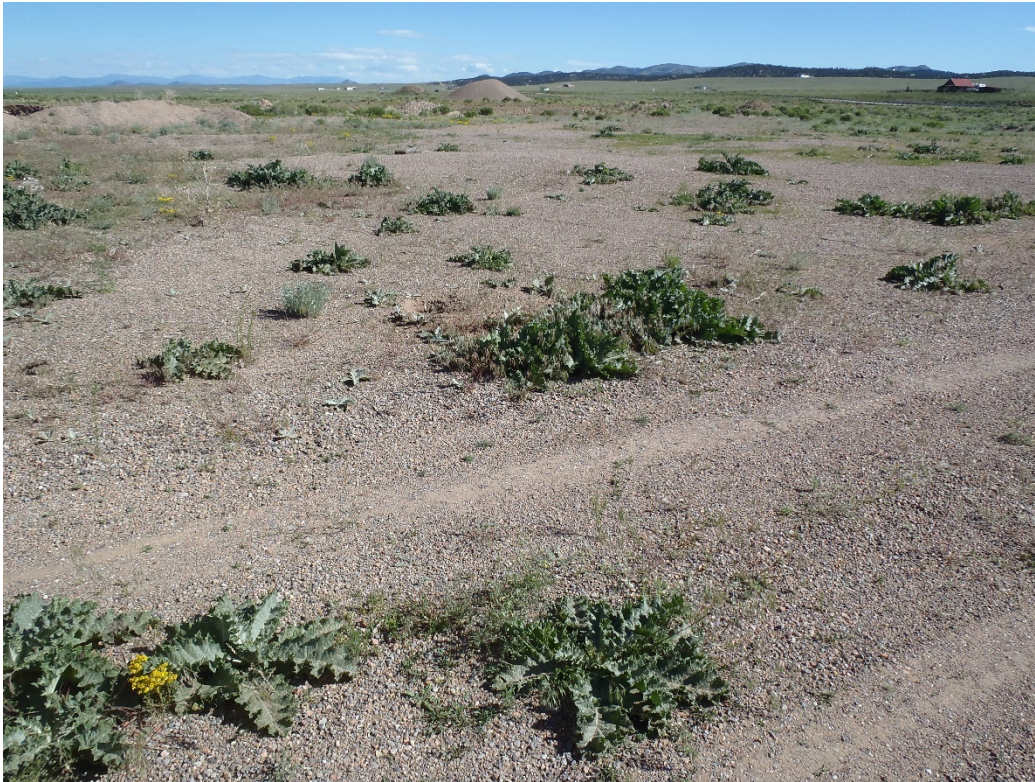
**PROBLEM/POSSIBLE VIOLATION:** Problem: There are state-listed noxious weeds (Scotch Thistle) present on site. This is a problem for failure to employ weed control methods for state listed noxious weed species within the permitted area, and to reduce the spread of weeds to nearby areas as required by Section 3.1.10 (6) of the rule.

Revegetation: Several scotch thistle plants (see **Photo 6**) were observed northwest of CR 105. **The presence of this List B species is cited as a Problem on page 1 of this report.** No noxious weeds were observed on the

Photo 6. Scotch thistle north of CR 105 (looking east).

**CORRECTIVE ACTIONS:** Implement approved weed control plan and provide proof to the Division that this has been done. If a weed control plan is not already in place, the operator shall develop a weed control and management plan in accordance with Section 3.1.10 (6) of the Rule. This plan should be developed in consultation with the county extension agency, or weed control district office and should include specific control measures to be applied, a schedule for when control measures will be applied and a post-treatment monitoring plan. This weed control plan shall be submitted to the Division as a Technical Revision to the approved plan with the appropriate Technical Revision fee of \$216.00 by the corrective action date.

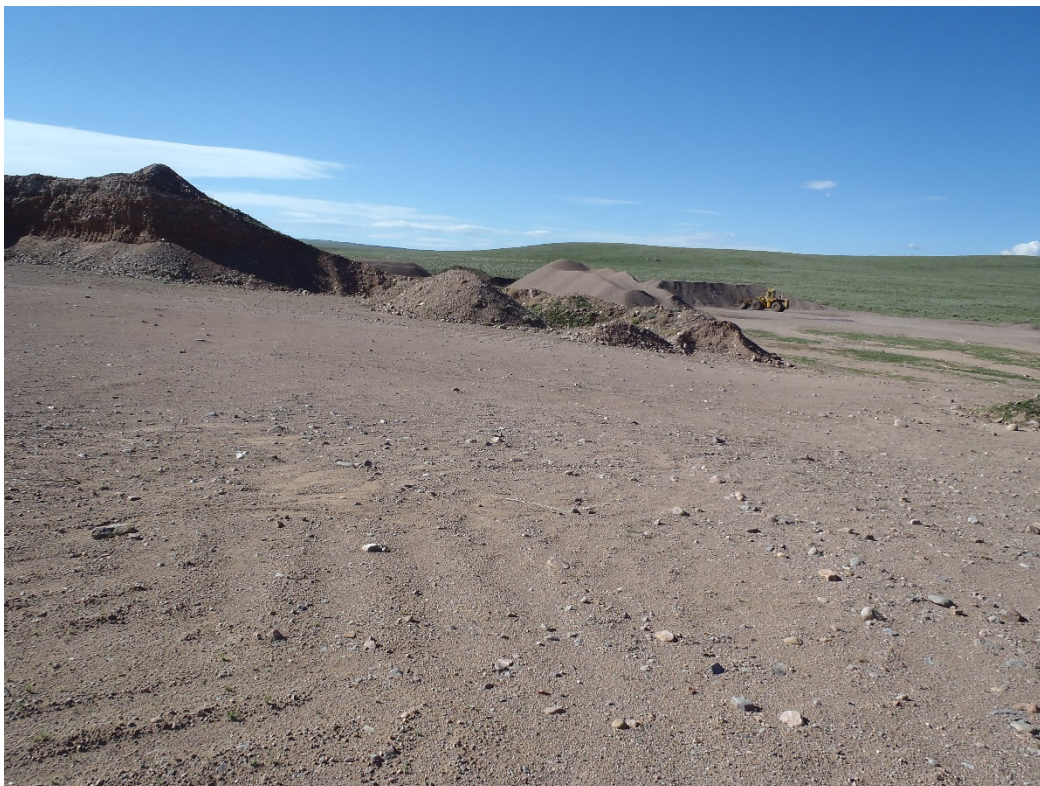
Support Facilities On-site: A loader was observed on site (see **Photo 7**).

Photo 7. Loader south of CR 105 (looking SE).

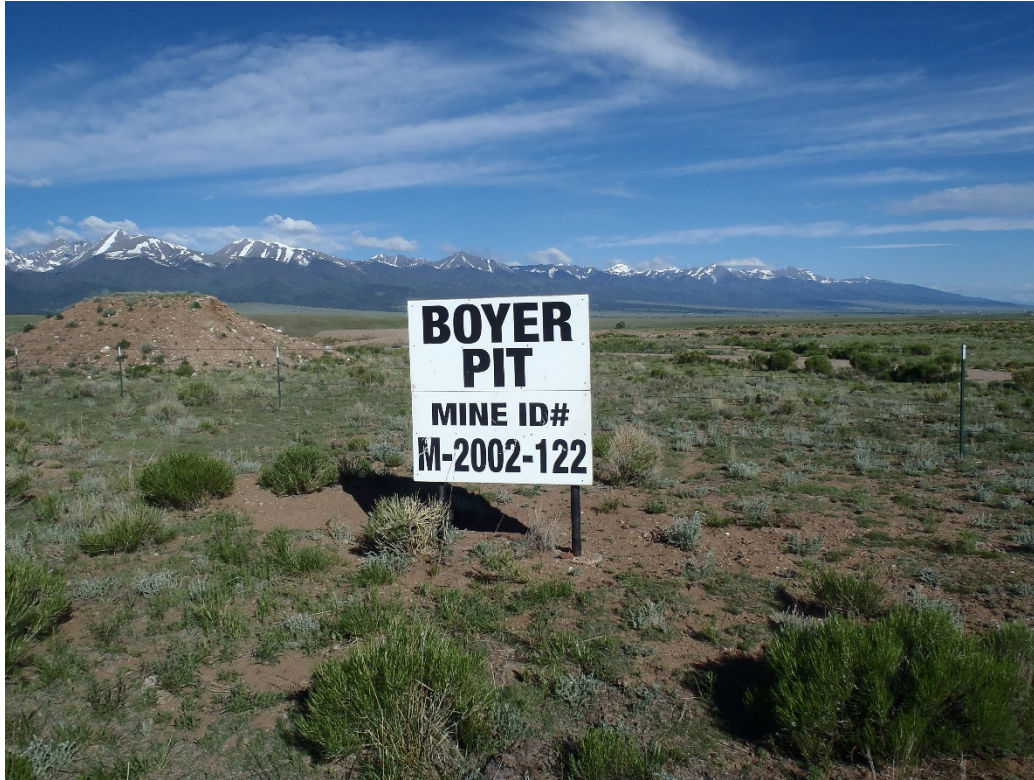
Signs and Markers: The permit sign was properly posted (see **Photo 8**) and boundary markers were observed to delineate the permit boundary (see **Photo 9**). Mr Beach indicated the ag ditch is used on the SW side.

Photo 8. Permit sign off CR 105 (looking NW).

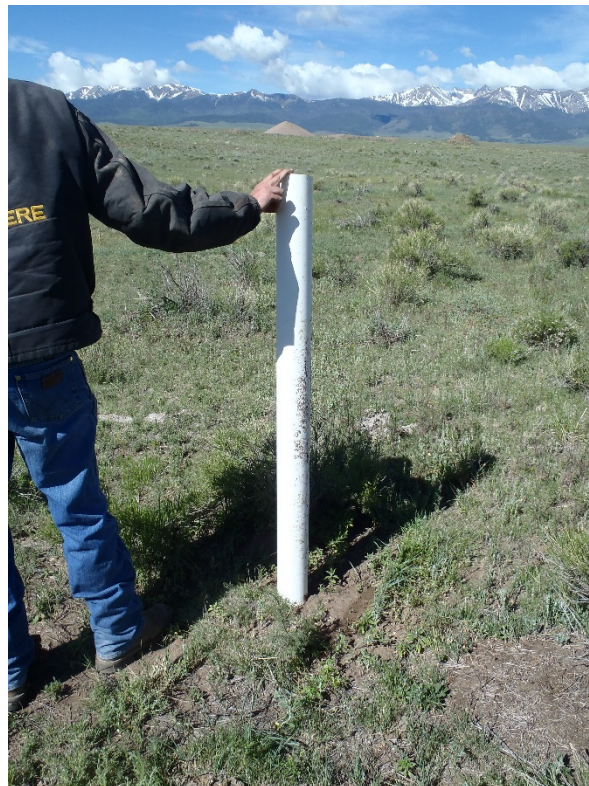
Photo 9. Typical permit boundary marker (NE corner).
