COLORADO
Division of Reclamation,
Mining and Safety
Department of Natural Resources

Permit Number: C-1981-041 Mine Name: Roadside Portals Operator: Snowcap Coal Company, Inc. Operator Address: MS Tonya Hammond P.O. Box 1430 Palisade, CO 81526	County: Mesa Operation Type: Underground Permit Status: Active Ownership: Private
	Operator Representative Present: Tonya Hammond
Operator Representative Signature: (Field Issuance Only)

Inspection Start Date: March 11, 2020 Inspection Start Time: 14:35 Inspection End Date: March 11, 2020 Inspection End Time: 15:00		Inspection Type: Coal Complete Inspection Inspection Reason: Normal I&E Program Weather: Cloudy	
Joint Inspection Agency: None		Joint Inspection Contacts: None	
Post Inspection Agency: None		Post Inspection Contacts: None	
Inspector(s): Clayton Wein	Inspector's Signature: <i>Clayton Wein</i>		Signature Date: 3/18/2020

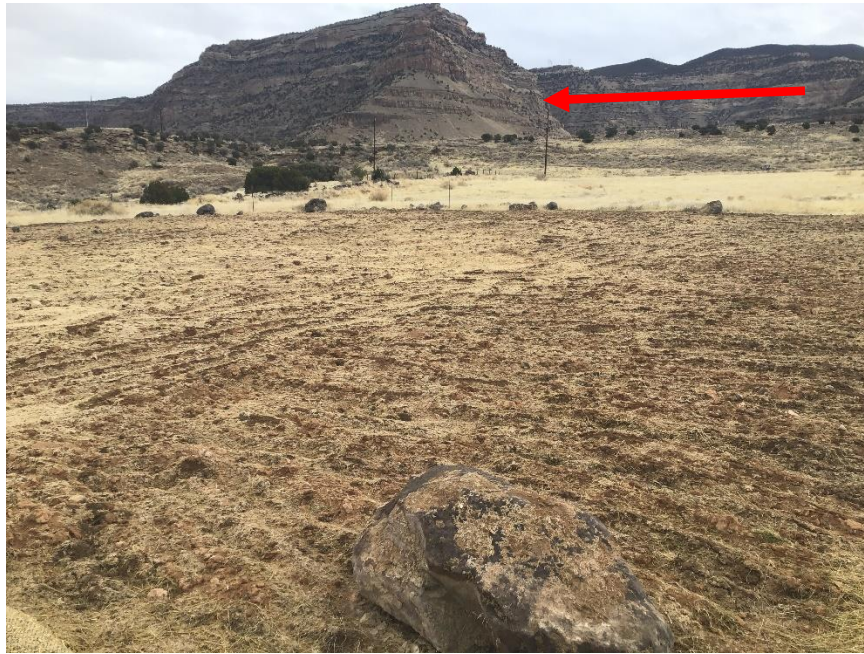
The remaining disturbance of 0.4 acres at the site are associated with the repair work outlined in Technical Revision No. 69. The repairs at the site were completed in October of 2019. The site was then backfilled, graded and topsoiled. Reseeding of the site was completed shortly after the grading work was conducted. The reclamation work at the site ended in November of 2019. The site was stable with no erosional issues (Photos 1 and 2). Vegetation at the reclaimed site has not started to grow yet. The sediment logs placed around the perimeter of the disturbance were intact and in good condition. There were no indications of off-site impacts. The area remained in its grading to the approximate original contours. No settling of the surface was identified. The disturbance boundary markers remained in place and were easy to locate.

Photo 1: The eastern portion of the 0.4 acres of disturbance at the mine site.

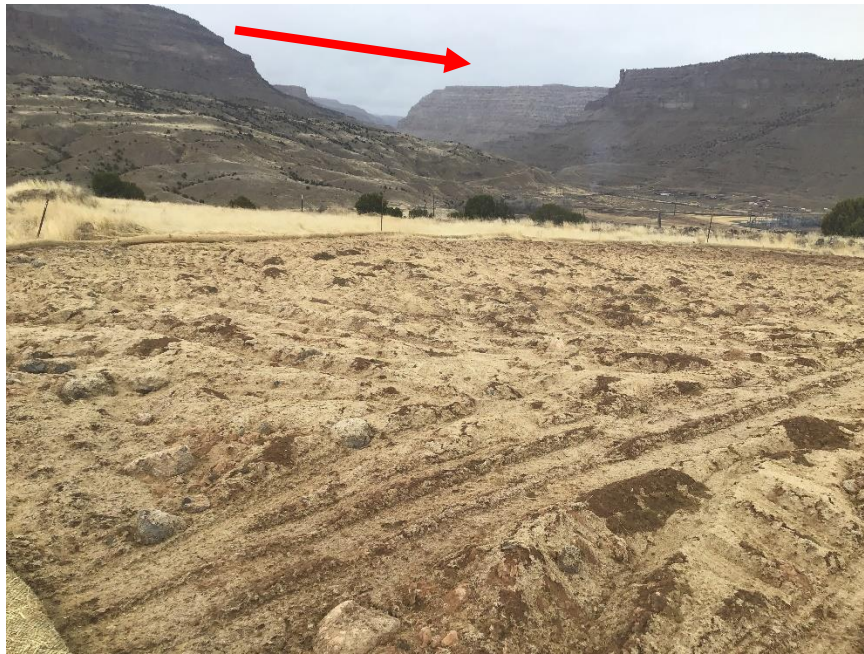
Photo 2: The western portion of the 0.4 acres of disturbance at the mine site.

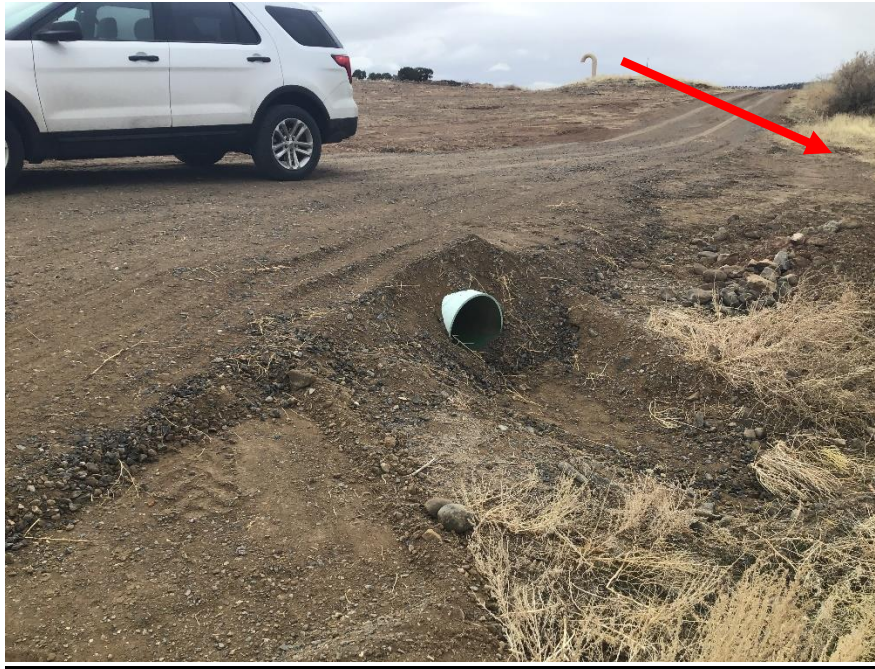
by the landowner on the road to the south of the North Decline. There were no erosional features identified. During recent Division inspections, it was noted that the land owner had cut a ditch through the access road to the south of the reclaimed A Substation. During the inspection, the ditch had been replaced by an 18 inch pvc culvert and the road had been returned to its original configuration (Photo 3). The liability for the A Substation was released with SL-11.

Photo 3: The photo above was taken as a follow up to previous Division inspections. The culvert shown above replaced a ditch noted in previous inspections located adjacent to the A Substation.
