COLORADO
Division of Reclamation,
Mining and Safety
Department of Natural Resources

Permit Number: C-2010-088 Mine Name: Fruita Loadout Operator: CAM-Colorado, LLC Operator Address: Ronald Hull 424 Lewis Hargett Circle Suite 250 Lexington, KY 40503	County: Mesa Operation Type: Loadout Permit Status: Temporary Cessation Ownership: Private
	Operator Representative Present: None
Operator Representative Signature: (Field Issuance Only)

Inspection Start Date: March 12, 2020 Inspection Start Time: 15:35 Inspection End Date: March 12, 2020 Inspection End Time: 16:05		Inspection Type: Coal Complete Inspection Inspection Reason: Normal I&E Program Weather: Clear	
Joint Inspection Agency: None		Joint Inspection Contacts: None	
Post Inspection Agency: None		Post Inspection Contacts: None	
Inspector(s): Clayton Wein	Inspector's Signature: <i>Clayton Wein</i>		Signature Date: 3/18/2020

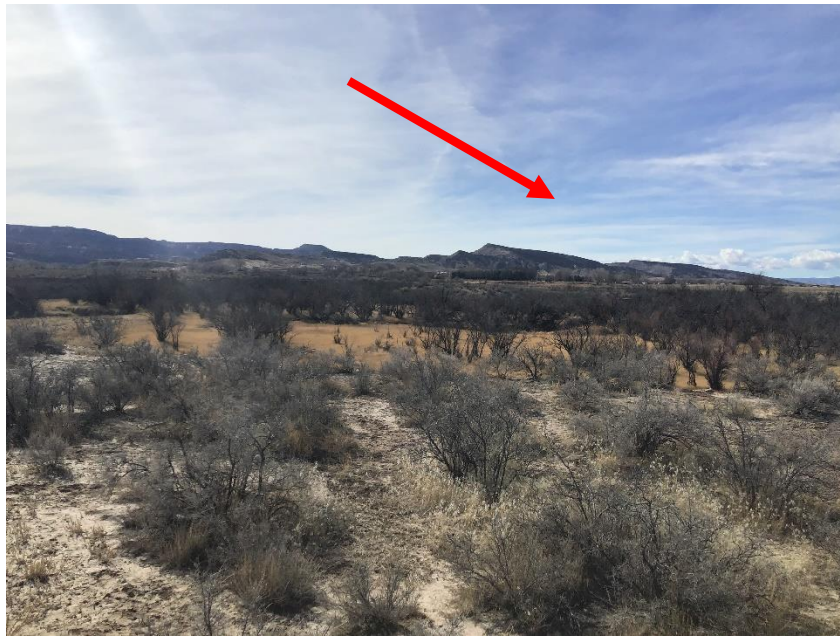
There has been no activity at the mine site since the previous Division Inspection (Photos 1 and 2). The site has been inactive since the permit was issued to the permittee. No disturbances have been created at the site.

Photo 1: The west-central portion of the permit area.

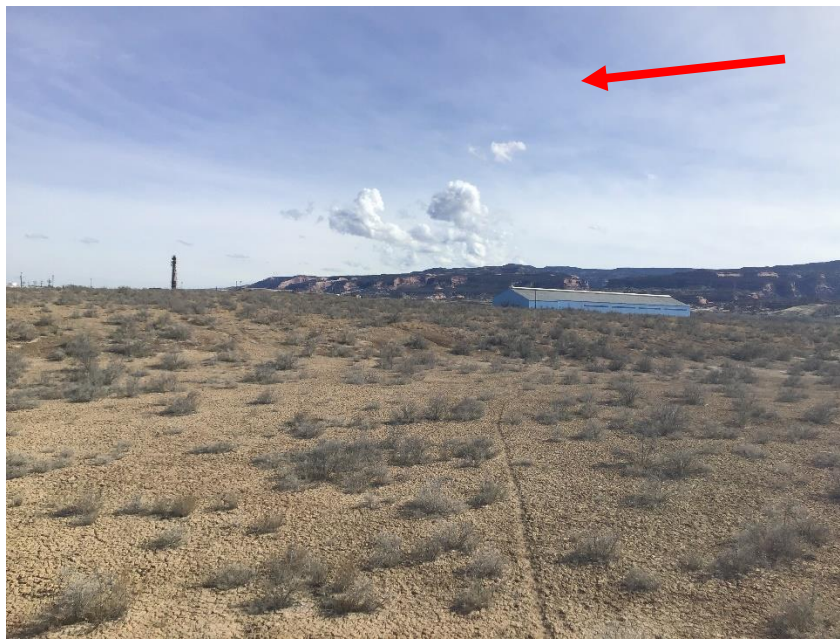
Photo 2: The east-central portion of the permit area.

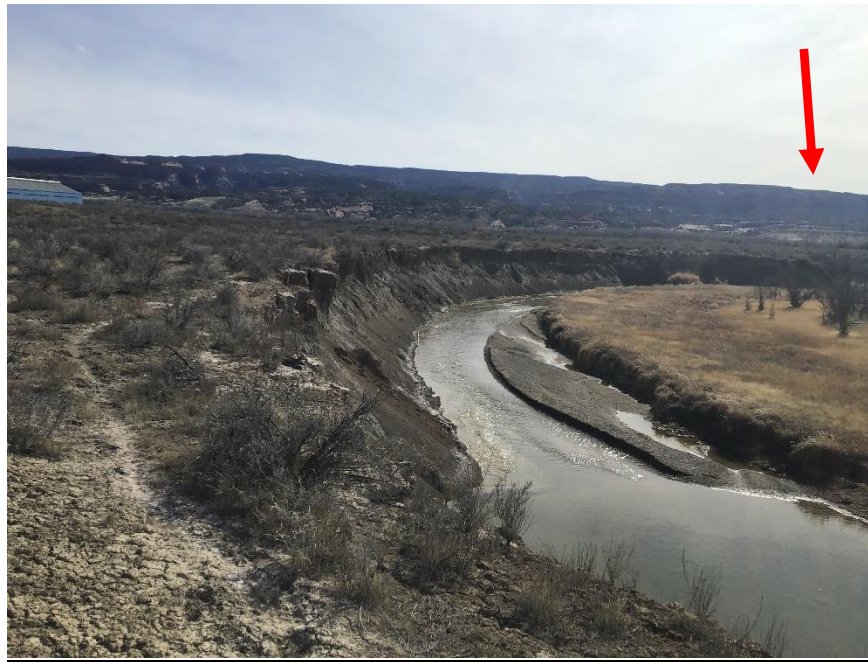
At the time of the inspection Reed Wash was flowing (Photo 3). The level of the water was low, typical for this time of year. The site was stable and there were no erosional features identified.

Photo 3: Reed Wash located in the western portion of the permit area.

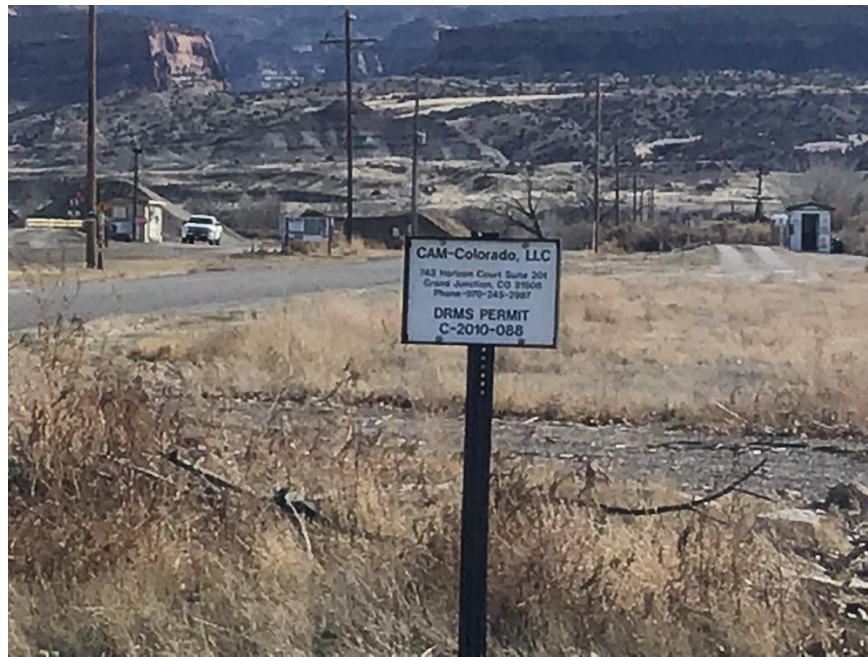
The mine identification sign was displayed to the left of the entrance to the site (Photo 4). The signs were located in a position that had an unobstructed view from the entrance. The sign was in good condition. Information displayed on the sign was up to date and included the required information about the permit, the

Photo 4: The permit identification sign.
