**COLORADO**  
Division of Reclamation,  
Mining and Safety  
Department of Natural Resources

| <b>Permit Number:</b> C-2010-089<br><b>Mine Name:</b> New Horizon North Mine<br><b>Operator:</b> Elk Ridge Mining and Reclamation, LLC<br><b>Operator Address:</b><br>Mr Tony Tennyson<br>5731 State Highway 13<br>Meeker, CO 81641 | <b>County:</b> Montrose<br><b>Operation Type:</b> Surface<br><b>Permit Status:</b> Active<br><b>Ownership:</b> Private |

| <b>Inspection Start Date:</b> March 10, 2020<br><b>Inspection Start Time:</b> 13:25<br><b>Inspection End Date:</b> March 10, 2020<br><b>Inspection End Time:</b> 14:00 | | <b>Inspection Type:</b> Coal Partial Inspection<br><b>Inspection Reason:</b> Normal I&E Program<br><b>Weather:</b> Cloudy | |

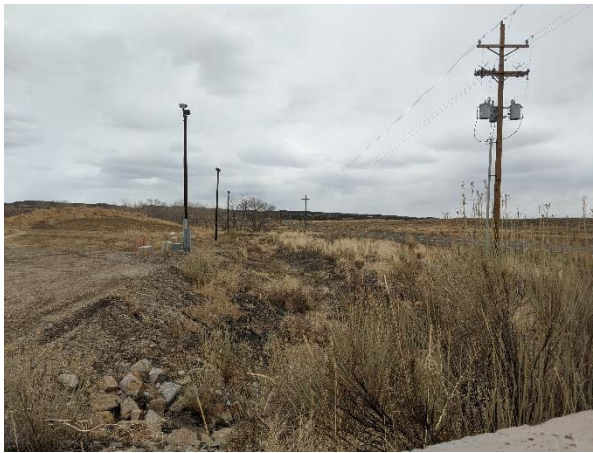
The Ditches throughout the mine site were in good repair. No large flows have coursed through the ditches over the winter months. No maintenance is required at this time on the ponds or ditches.

Photo 1: Ditch 1 looking east

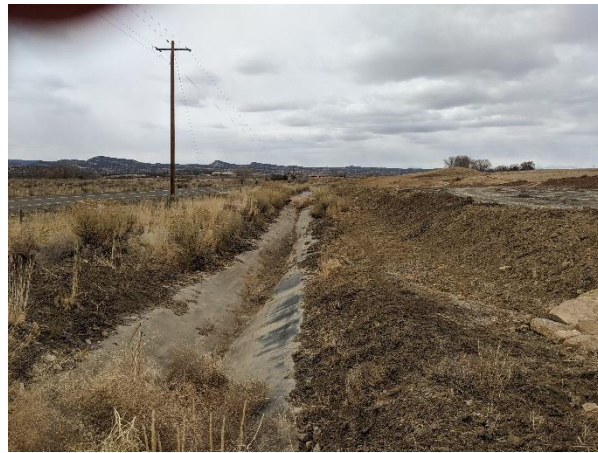
Photo 2: Ditch 1 looking west

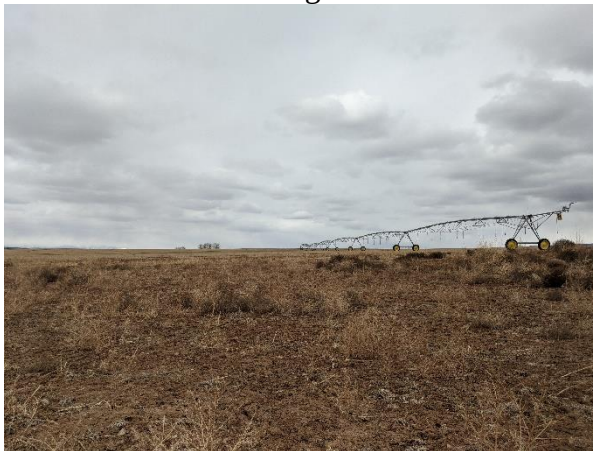
Photo 3: Irrigated pasture, looking NW, still dormant

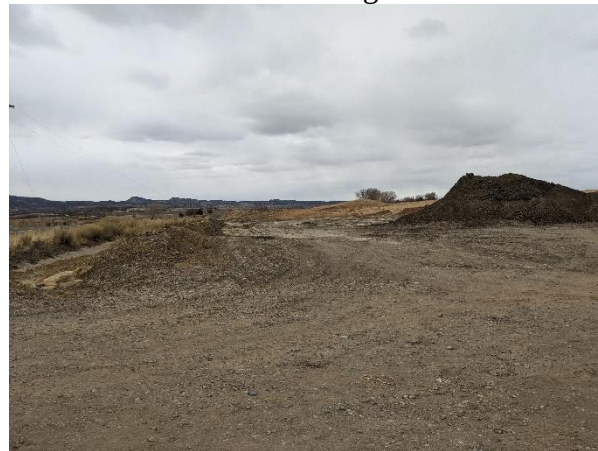
Frank noted that the landowner had completed filling the irrigation sprinkler wheel tracks with gravel in preparation for this irrigation season. Gravel has been pushed up from the pad area into a pile. Additional gravel remains on a portion of the pad. ERMIR will continue to salvage the gravel for use by the landowner. This material will be stored on the east side of the pad/facilities area. Once the remaining gravel is scraped up, the operator will rip the pad prior to replacing bench 1 material, replacing topsoil and grading to the final contours. Frank anticipated that this activity would later in the year, tentatively late May or June. This date may be adjusted as necessary.

Photo 4: facilities area pad with gravel pushed into a pile.

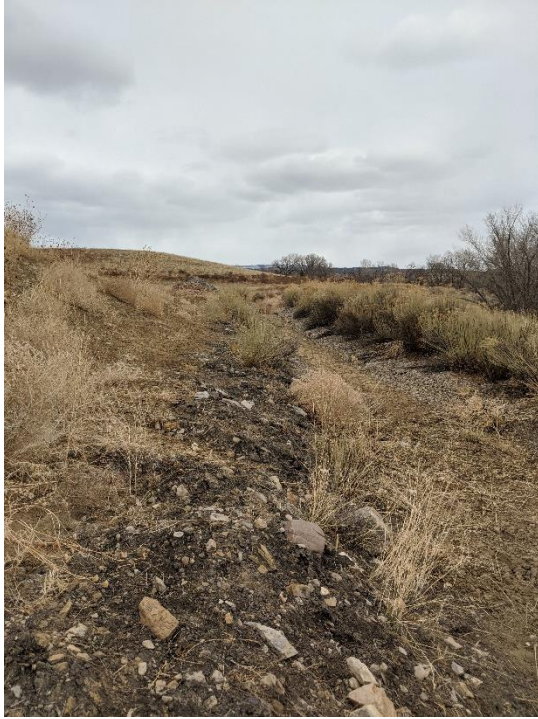
Photo 5: east ditch looking east

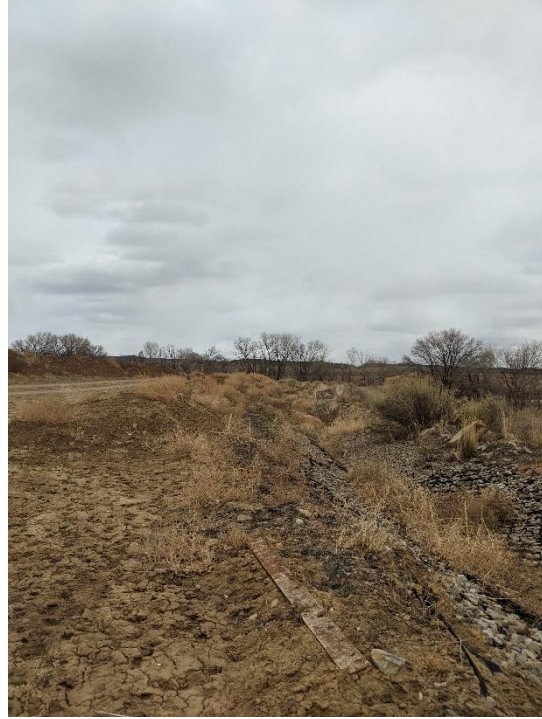
Photo 6: East ditch

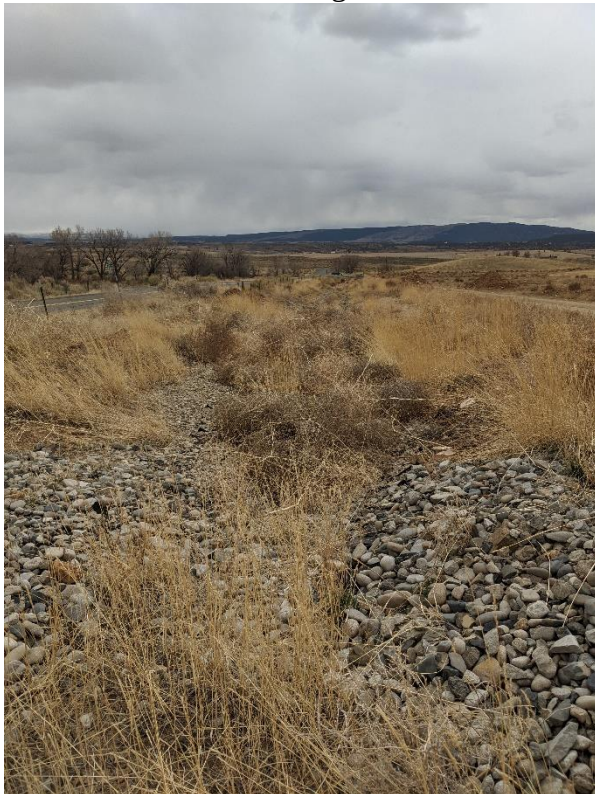
Photo 7: East ditch on east side of mine, looking south
