**PERMIT INFORMATION**

**INSPECTION INFORMATION**

**COMMENTS**

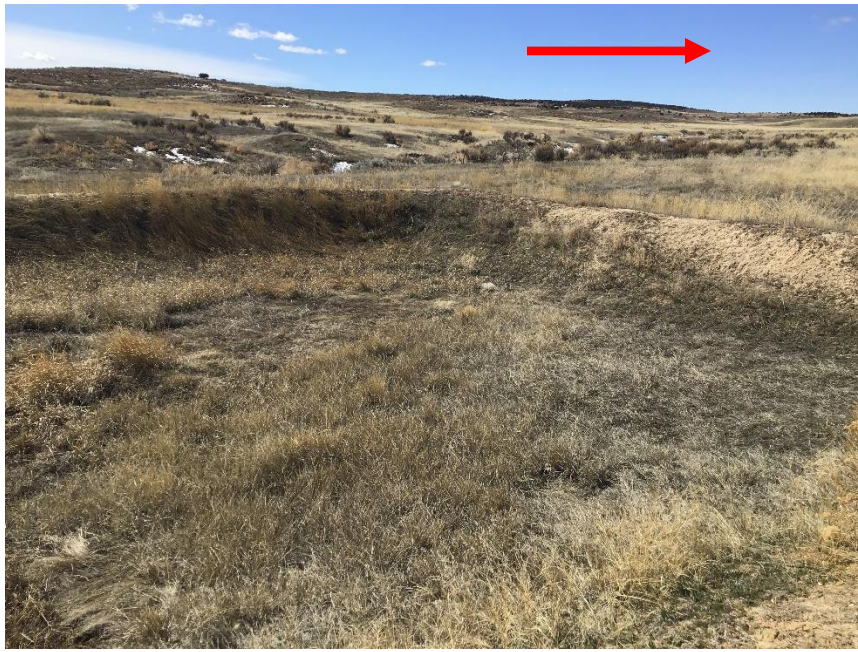
There is one pond, RR-1, and a sump, RS-1 (Photo 1), located on the south side of the train loadout. The pond was receiving a small amount of water from the culvert inlet during the inspection. The inlets to the pond were in good condition. There was a small puddle of water impounded in the pond. No discharge was occurring. The outlets for the pond were stable and clear of obstructions. The embankment for the pond was vegetated and stable. There were no erosional features. The sump was dry. The outlet for the sump was stable and clear of obstructions. The embankments for the sump were stable with vegetation. There were no indications of erosion. A ditch leading from the loadout to the RR-1 Pond was dry. The ditch was clear of obstructions and stable. The embankments of the ditch are vegetated and there were no erosional features.

**Photo 1: The RS-1 Sump.**

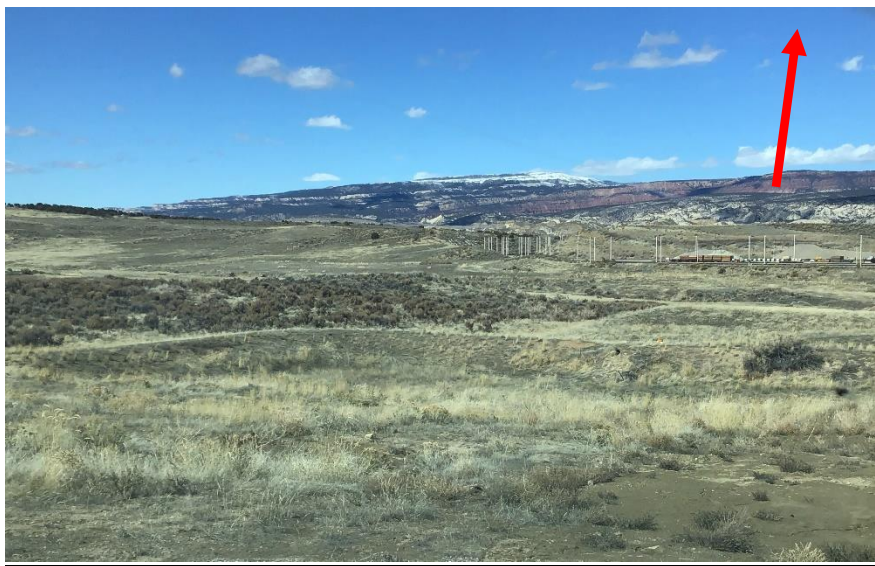
was dry at the time of the inspection (Photo 2). The outlets were in good repair. The pond's embankments were vegetated and stable. There were no erosional concerns.

**Photo 2: The SS-2 Pond.**

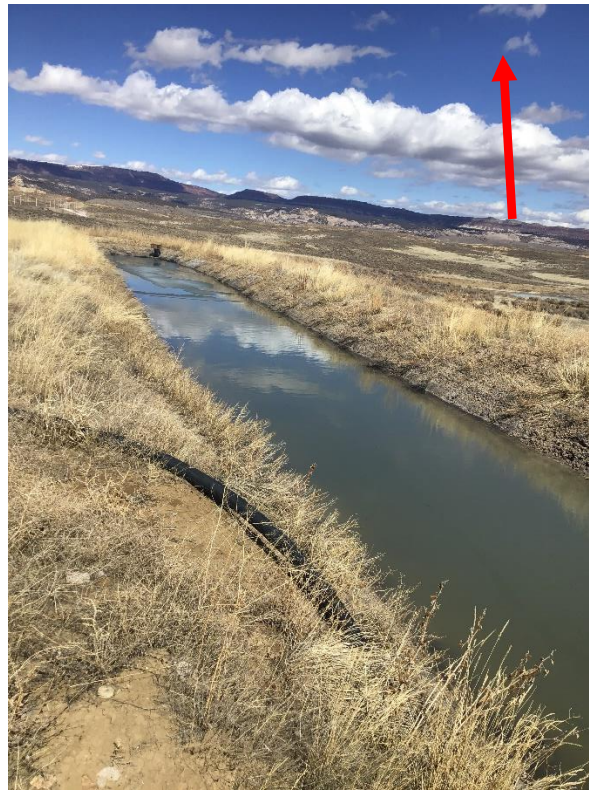
The B Seam Dewatering System No. 2 is located to the southeast of the Slot Storage. The system is composed of three cells, of which only the first two cells were being used. The system was not pumping water into the first cell at the time of the inspection. Only the first cell was impounding water (Photo 3), there was no discharge to the second cell. The embankments of the cells were stable with vegetation. There were no indications of erosion. The outlets were clear of debris.

**Photo 3:** The Upper cell of the B Seam Dewatering System No. 2.

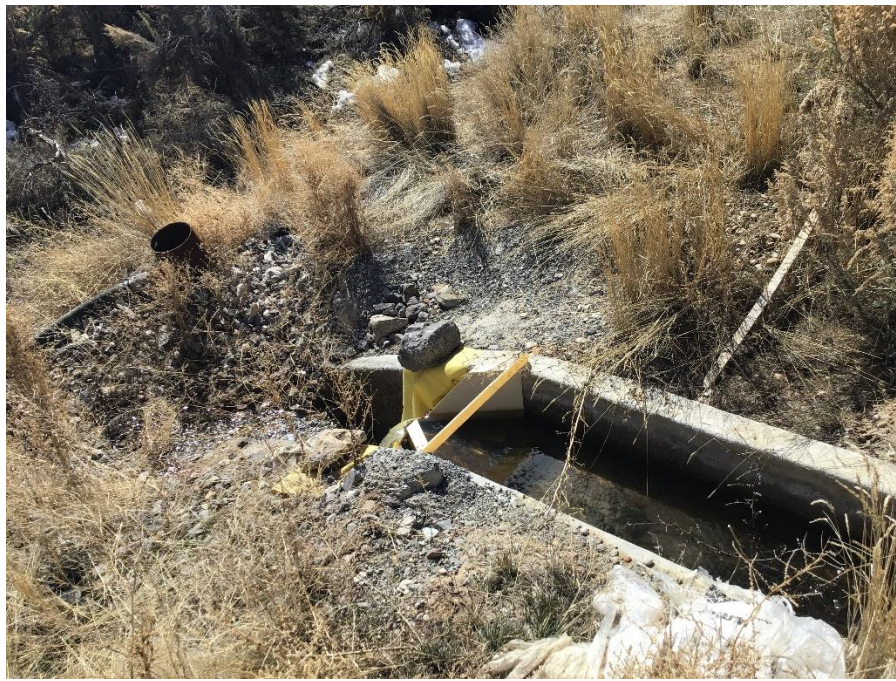
The B Seam Dewatering System No. 1 was inactive. All cells of the dewatering system were impounding water. The last Chance Pond was discharging water to Red Wash (Photo 4). The Outlet of the pond was in good repair. The embankments of the system were vegetated and stable. There were no erosional features observed.

**Photo 4:** The outlet of the Last Chance Pond at the B Seam Dewatering System No. 1.

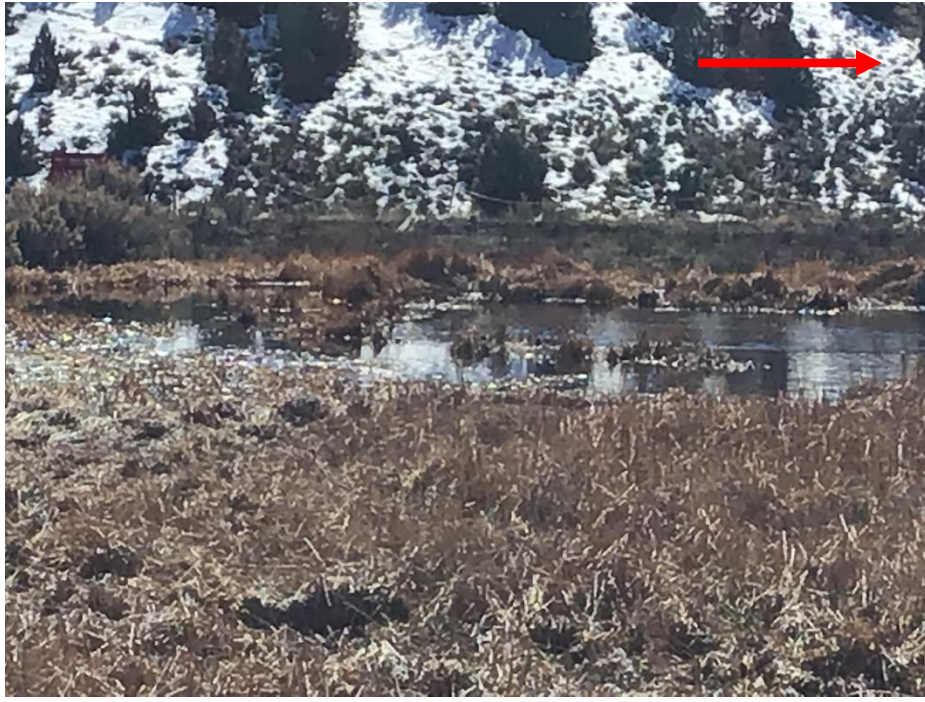
Three ponds are located at the portals/main facilities area. The DP-1 Pond is located on the south side of the main facilities area. The pond was receiving runoff from melted snow during the inspection. The pond was partially frozen (Photo 5). The outlet to the pond was unobstructed. The embankment was vegetated and stable. There were no erosional concerns identified. The PP-1 Pond is located on the Prep Plant bench north of the DP-1 Pond. The pond was impounding water. There was no discharge from the pond. The embankments were vegetated and stable. No erosional features were noted. The PP-2 Pond is located on the upper bench and to the west of the PP-1 Pond. The pond was holding water and mostly frozen (Photo 6). There was no discharge from the pond. The embankment was stable and vegetated. There were no erosional features.

**Photo 5:** The DP-1 Pond.

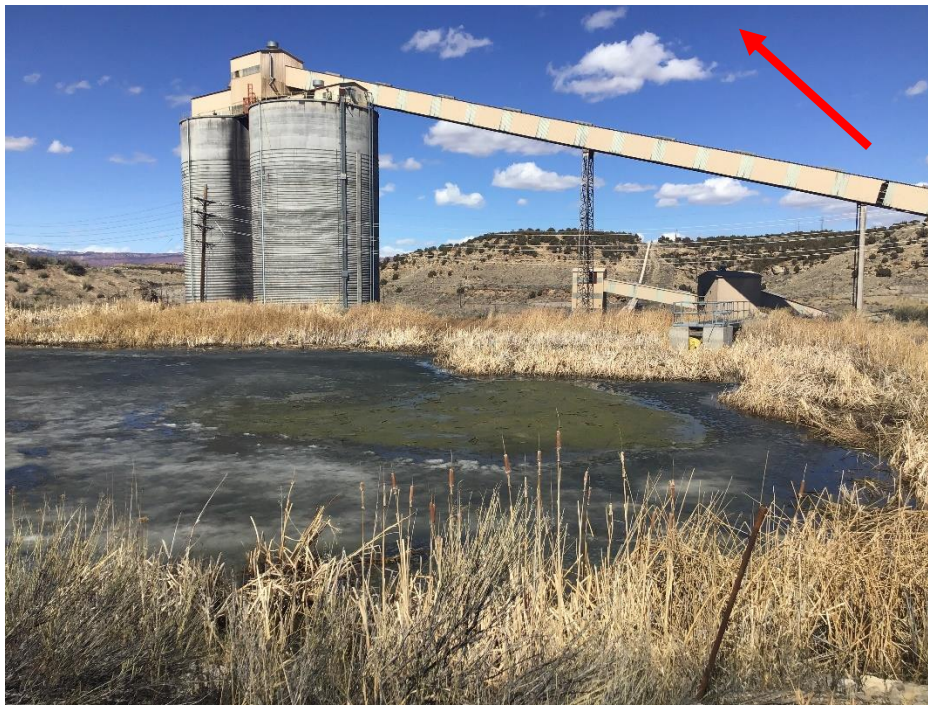
**Photo 6:** The PP-2 Pond on the upper bench of the Main Facilities Area.

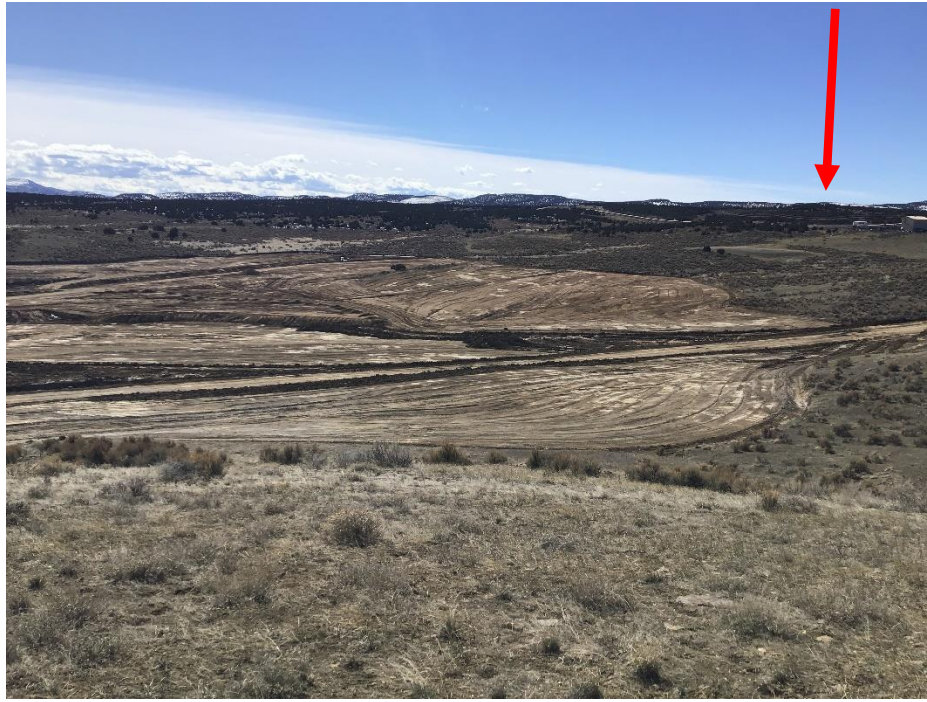
Work on the RP-A Refuse area was not occurring during the inspection due to the soft and damp ground conditions. The area was stable and there were no indications of erosion (Photo 7). No off-site impacts were observed.

**Photo 7:** An overview of the RP-A Refuse Area construction.

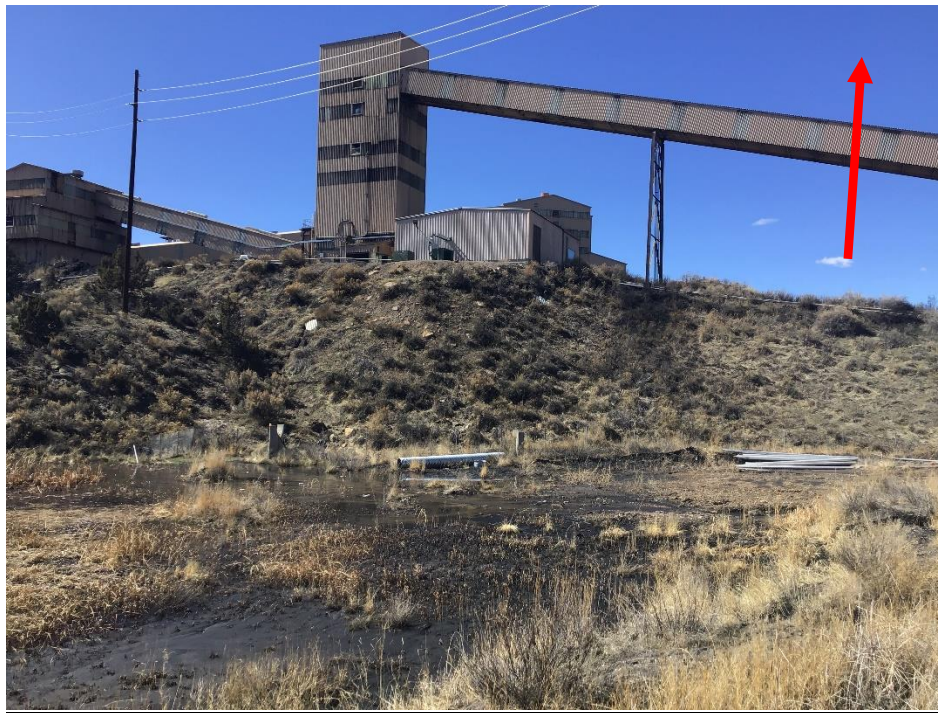
The Main Facilities are consists of three benches. The lower bench contains the mine office, shop and portals. This bench was stable and well kept. Water from runoff was being directed to the DP-1 Pond. There were no off-site impacts observed. The middle bench is dedicated to the prep plant. This bench was observed to be stable with no erosional concerns. Water from runoff was being properly directed to the DP-1 Pond. The ditches on the bench have partially filled with sediment. Conversations with the operator's representative has assured the Division that the ditches are included on the items for spring maintenance. The slopes of the bench were vegetated and stable (Photo 8). There were no erosional features observed. The upper bench has an equipment laydown area, power substation and the PP-2 Pond. The bench was maintained and stable. The berms were vegetated with no erosional concerns. The safety fence surrounding the substation was in good condition. The slopes of the bench were stable and vegetated. There were no erosional concerns.

**Photo 8:** The slopes of the middle bench at the Main Facilities Area.
