COLORADO
Division of Reclamation,
Mining and Safety
Department of Natural Resources

Permit Number: C-1982-056 Mine Name: Foidel Creek Mine Operator: Twentymile Coal, LLC Operator Address: Ms Miranda Kawcak 29515 Routt County Road No. 27 Oak Creek, CO 80467	County: Routt Operation Type: Underground Permit Status: Active Ownership: Private
	Operator Representative Present: None
Operator Representative Signature: (Field Issuance Only)

Inspection Start Date: March 16, 2020 Inspection Start Time: 10:00 Inspection End Date: March 16, 2020 Inspection End Time: 10:00		Inspection Type: Aerial Inspection Inspection Reason: Normal I&E Program Weather: Clear	
Joint Inspection Agency: None		Joint Inspection Contacts: 	
Post Inspection Agency: None		Post Inspection Contacts: 	
Inspector(s): Tabetha Lynch Brock Bowles		Inspector's Signature:

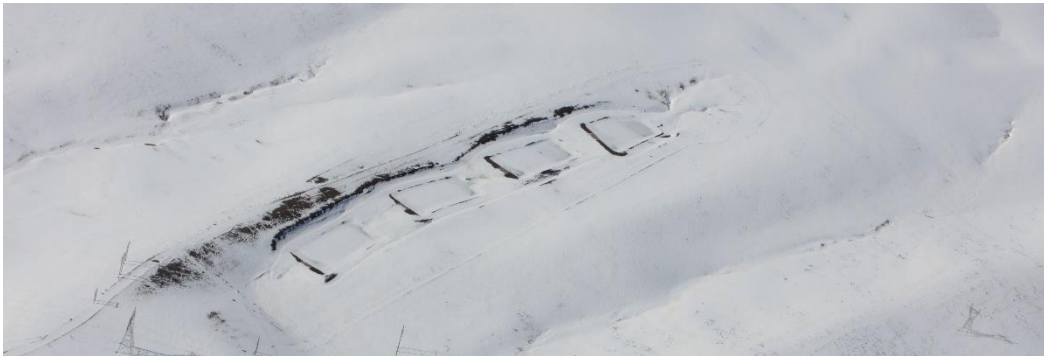
The site appears mostly snow covered with ice on most of the ponds. Passive treatment ponds near 6MN shown below.

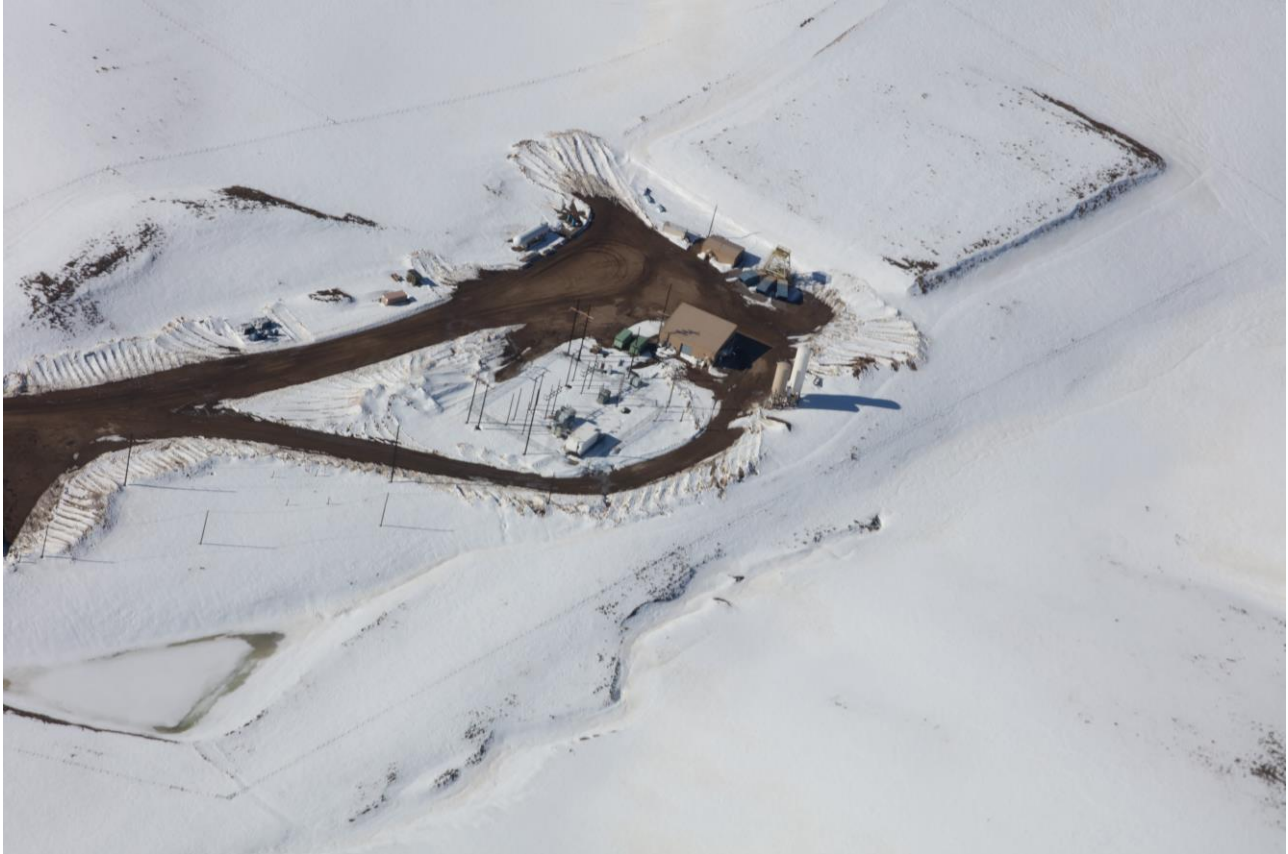
It appears snow removal activities may negatively impact drainage at the site. Shown in the photo above, at the 6MN pad snow appears to have been pushed into the pad perimeter ditch. This will likely impact the proper function of that ditch. Please evaluate snow removal practices and ensure it is not causing off-site impacts. This area will be further evaluated at the next on ground inspection.

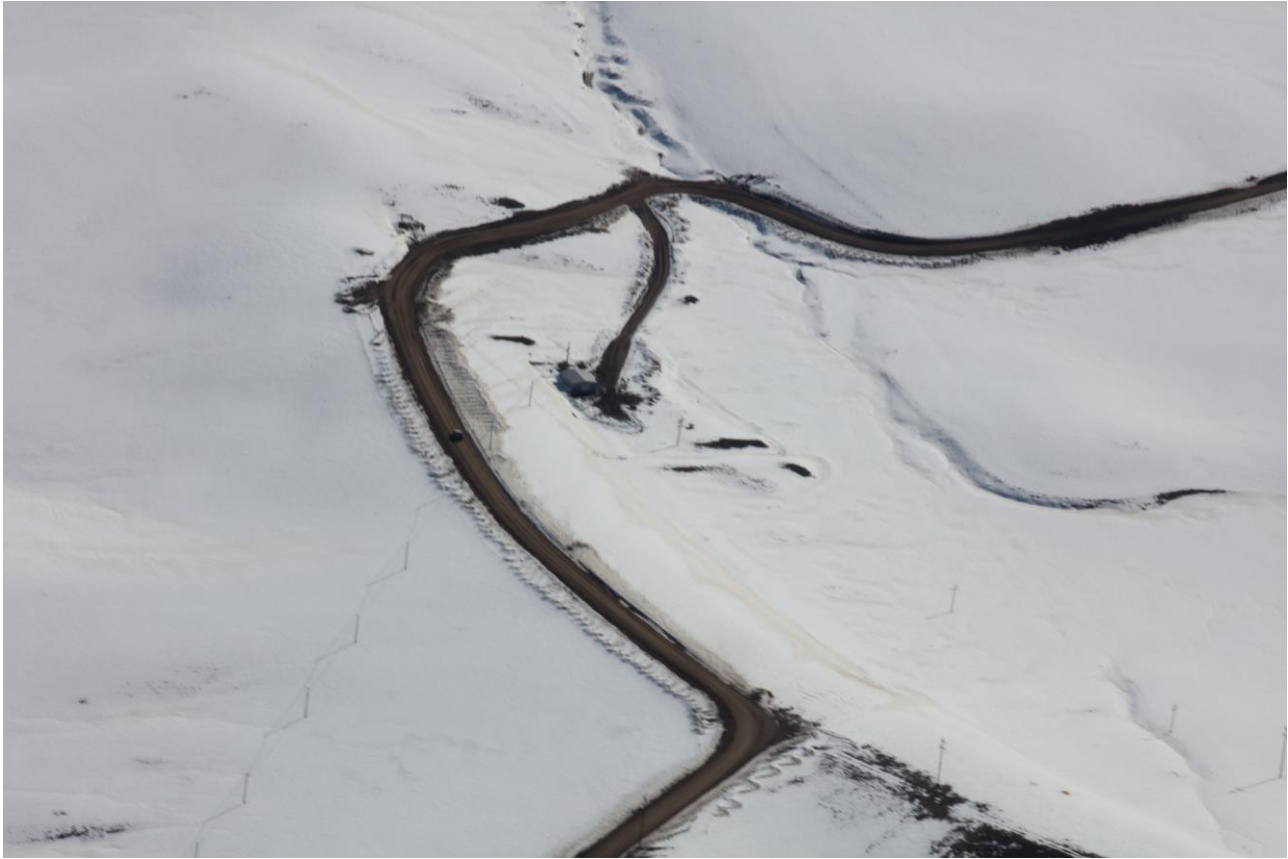
It appears some topsoil piles along the 6MN road maybe have been impacted by snow removal activities. This will be further assessed once snow has melted and during an on-site inspection.
