**PERMIT INFORMATION**

<b>Permit Number:</b> C-1981-008 <b>Mine Name:</b> New Horizon Mine <b>Operator:</b> Elk Ridge Mining and Reclamation, LLC <b>Operator Address:</b> Mr Tony Tennyson 5731 State Highway 13 Meeker, CO 81641	<b>County:</b> Montrose <b>Operation Type:</b> Surface <b>Permit Status:</b> Active <b>Ownership:</b> Private
	<b>Operator Representative Present:</b>  Frank Ferris
<b>Operator Representative Signature:</b> (Field Issuance Only)

**INSPECTION INFORMATION**

<b>Inspection Start Date:</b> March 10, 2020 <b>Inspection Start Time:</b> 14:00 <b>Inspection End Date:</b> March 10, 2020 <b>Inspection End Time:</b> 15:00		<b>Inspection Type:</b> Coal Partial Inspection <b>Inspection Reason:</b> Normal I&E Program <b>Weather:</b> Cloudy	
<b>Joint Inspection Agency:</b>  None		<b>Joint Inspection Contacts:</b>	
<b>Post Inspection Agency:</b>  None		<b>Post Inspection Contacts:</b>	
<b>Inspector(s):</b>  Janet Binns	<b>Inspector's Signature:</b>

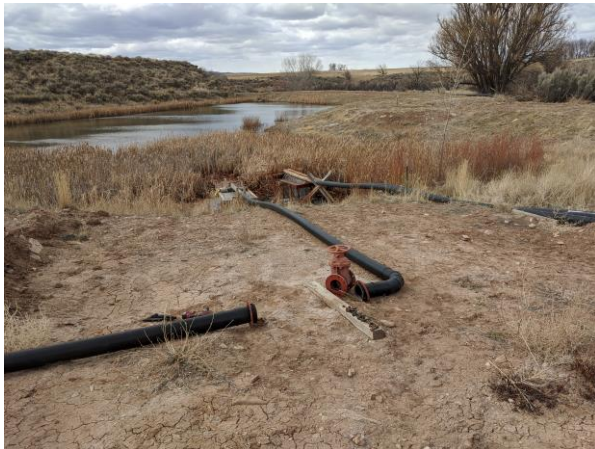
ERMUR is installing a flow meter in the CC ditch line to Pond 13. Spoil spring pipe flow meters were reading 137 and 19.7 at the time of the inspection. Pond 13 was discharging 0.26 on the staff gauge at the flume. Discharge was clear. Receiving stream in Tuttle Draw was clear as well.

Photo 1: installing flow meter at Pond 13

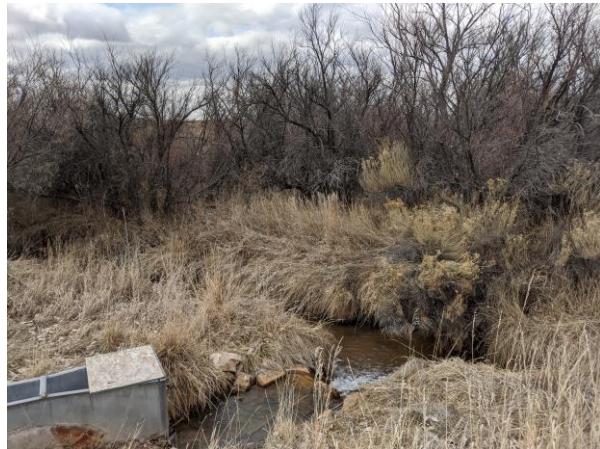
Photo 2: Pond 13 discharge into Tuttle draw
