**MINERALS PROGRAM INSPECTION REPORT**  
**PHONE: (303) 866-3567**

<b>MINE NAME:</b> #2 Verhoeff Pit	<b>MINE/PROSPECTING ID#:</b> M-2008-013	<b>MINERAL:</b> Sand and gravel	<b>COUNTY:</b> Bent
<b>INSPECTION TYPE:</b> Monitoring	<b>INSPECTOR(S):</b> Daniel Cunningham	<b>INSP. DATE:</b> March 10, 2020	<b>INSP. TIME:</b> 13:00
<b>OPERATOR:</b> Riverside Aggregates, LLC	<b>OPERATOR REPRESENTATIVE:</b> None	<b>TYPE OF OPERATION:</b> 110c - Construction Limited Impact	
<b>REASON FOR INSPECTION:</b> Normal I&E Program	<b>BOND CALCULATION TYPE:</b> Complete Bond	<b>BOND AMOUNT:</b> \$10,254.00	
<b>DATE OF COMPLAINT:</b> NA	<b>POST INSP. CONTACTS:</b> None	<b>JOINT INSP. AGENCY:</b> None	
<b>WEATHER:</b> Clear	<b>INSPECTOR'S SIGNATURE:</b>

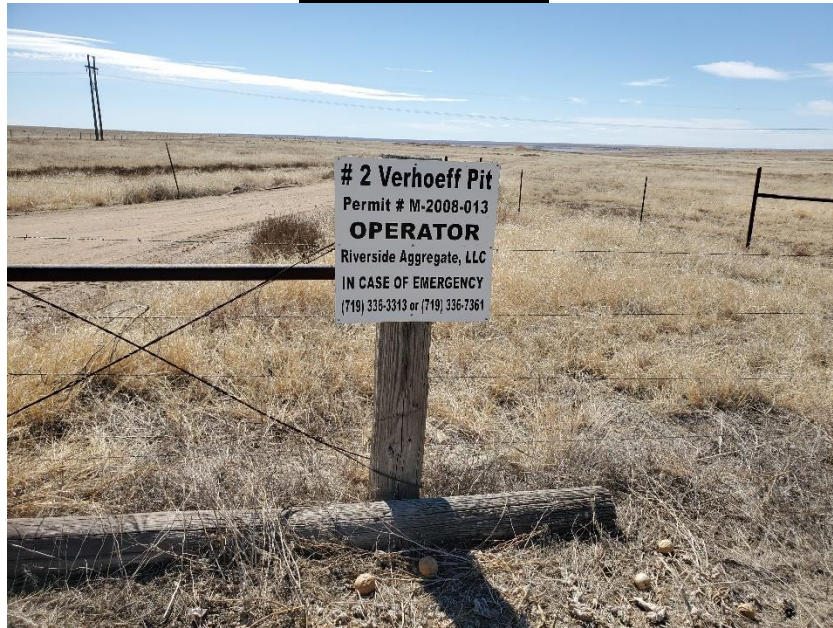
The site identification sign was posted at the mine site entrance and boundary markers were seen around the permitted area. There was no standing water noted during the inspection.

Photo 1: Permit Sign

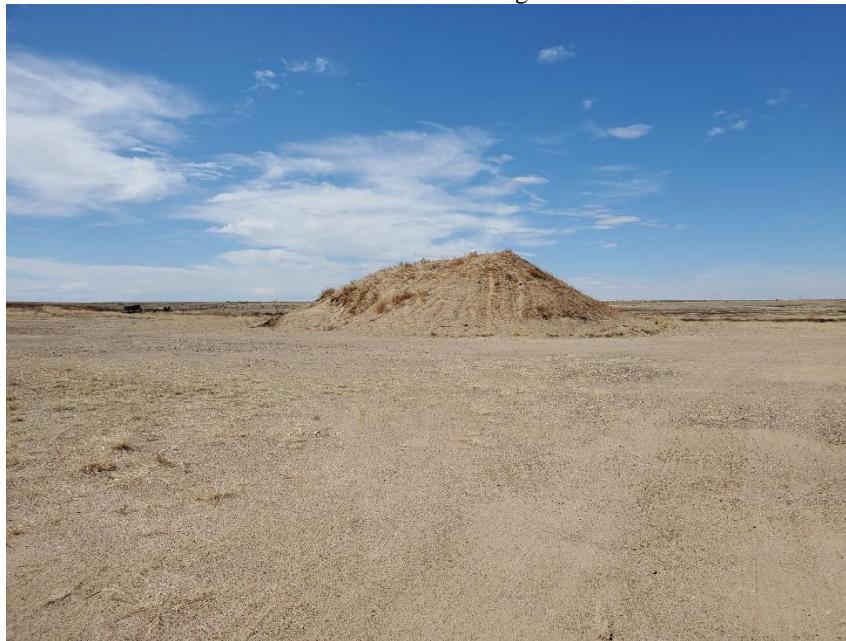
Photo 2: Stockpile

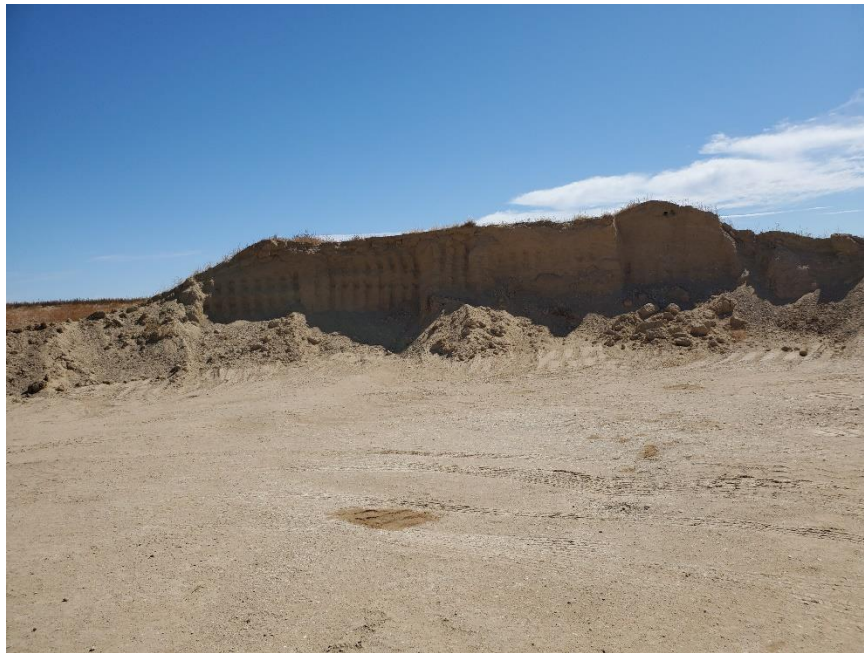
Several stockpiles were seen throughout the permitted area. The topsoil was stable with good vegetation established and stored in the eastern side of the pit. A fifteen foot highwall was seen along the southern border of the permitted area. There appeared to be recent excavation work done along the eastern section of the permit.

Photo 4: Southern Highwall
