MINERALS PROGRAM INSPECTION REPORT
PHONE: (303) 866-3567

MINE NAME: Cresson Project	MINE/PROSPECTING ID#: M-1980-244	MINERAL: Gold	COUNTY: Teller
INSPECTION TYPE: Aerial Inspection	INSPECTOR(S): Timothy A. Cazier	INSP. DATE: September 10, 2019	INSP. TIME: 15:16
OPERATOR: Cripple Creek & Victor Gold Mining Company	OPERATOR REPRESENTATIVE: None	TYPE OF OPERATION: 112d-3 - Designated Mining Operation	
REASON FOR INSPECTION: Normal I&E Program	BOND CALCULATION TYPE: None	BOND AMOUNT: \$209,491,188.00	
DATE OF COMPLAINT: NA	POST INSP. CONTACTS: None	JOINT INSP. AGENCY: None	
WEATHER: Cloudy	INSPECTOR'S SIGNATURE:

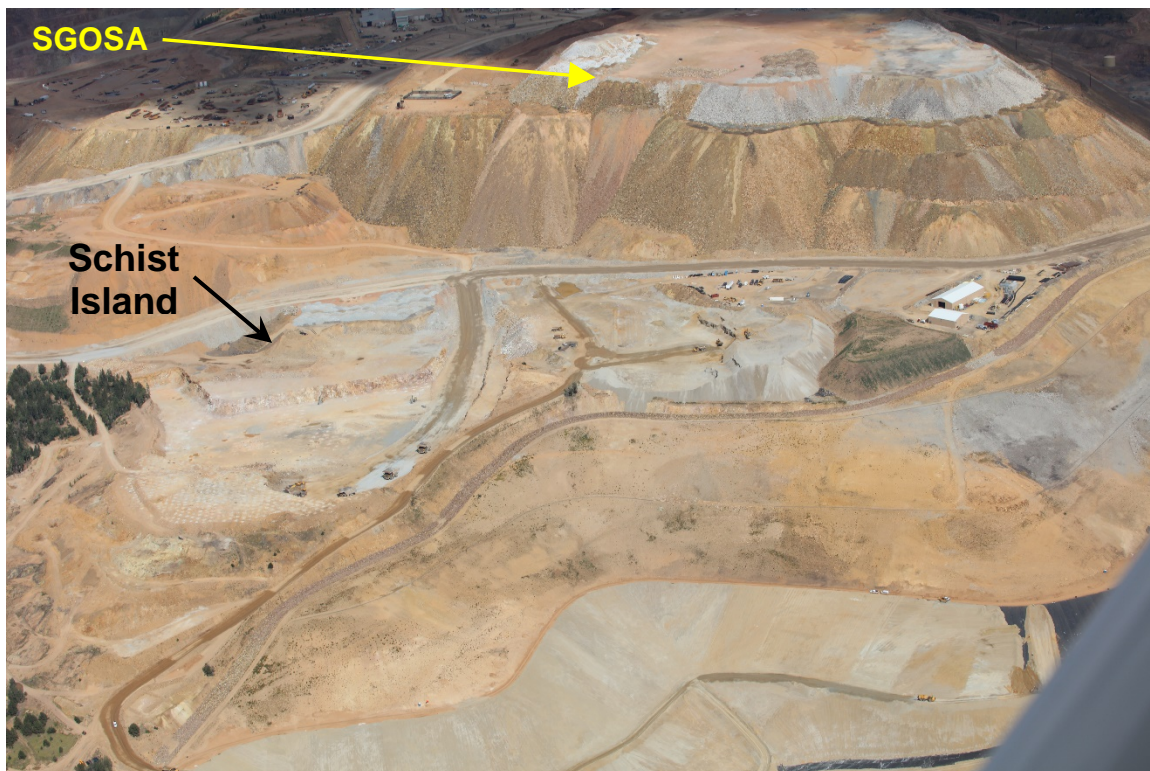
Photo 1. North Cresson pit – Schist Island Pit (Looking east).

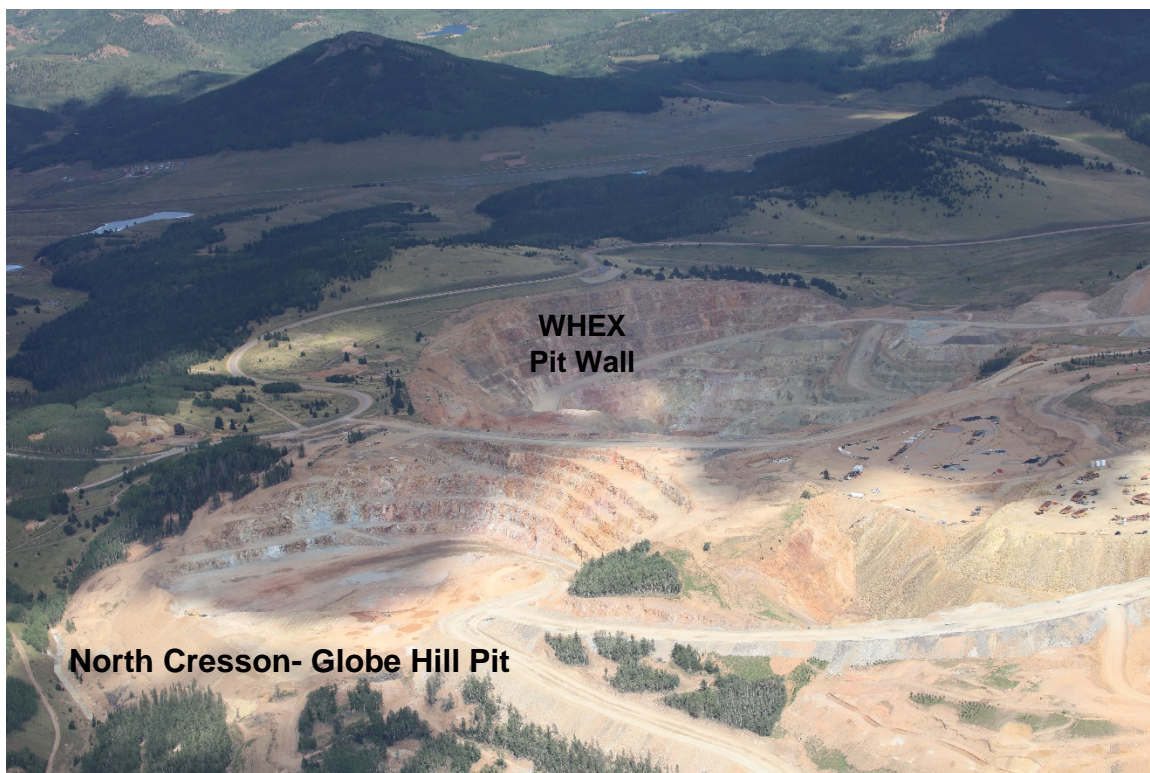
Photo 2. North Cresson (looking east).

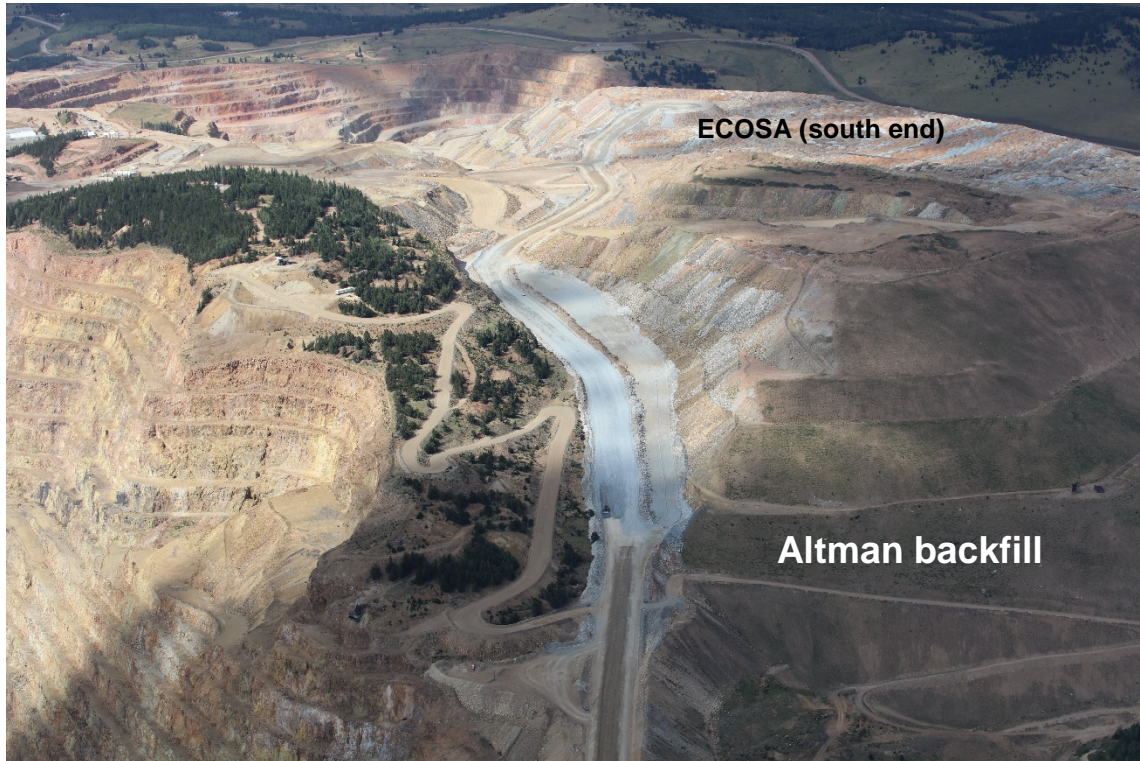
Photo 3. East Cresson OSA, south end (looking north).

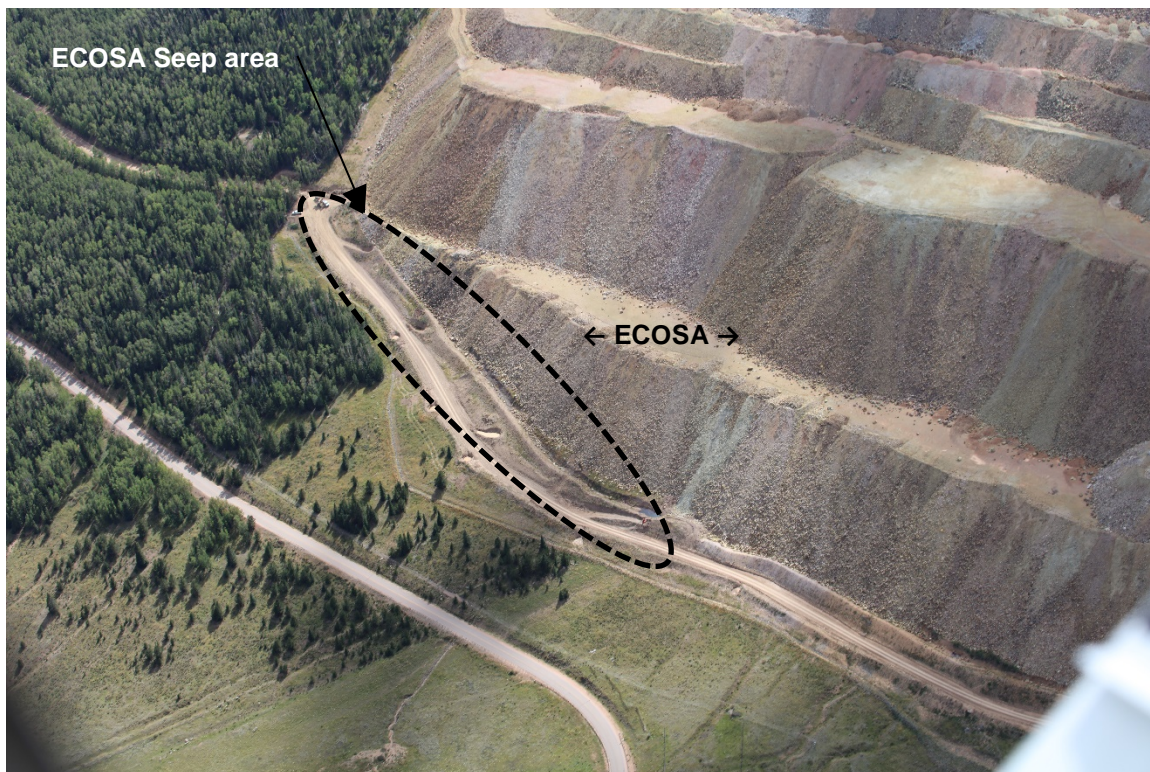
Photo 4. East Cresson OSA Toe, south end (looking south).

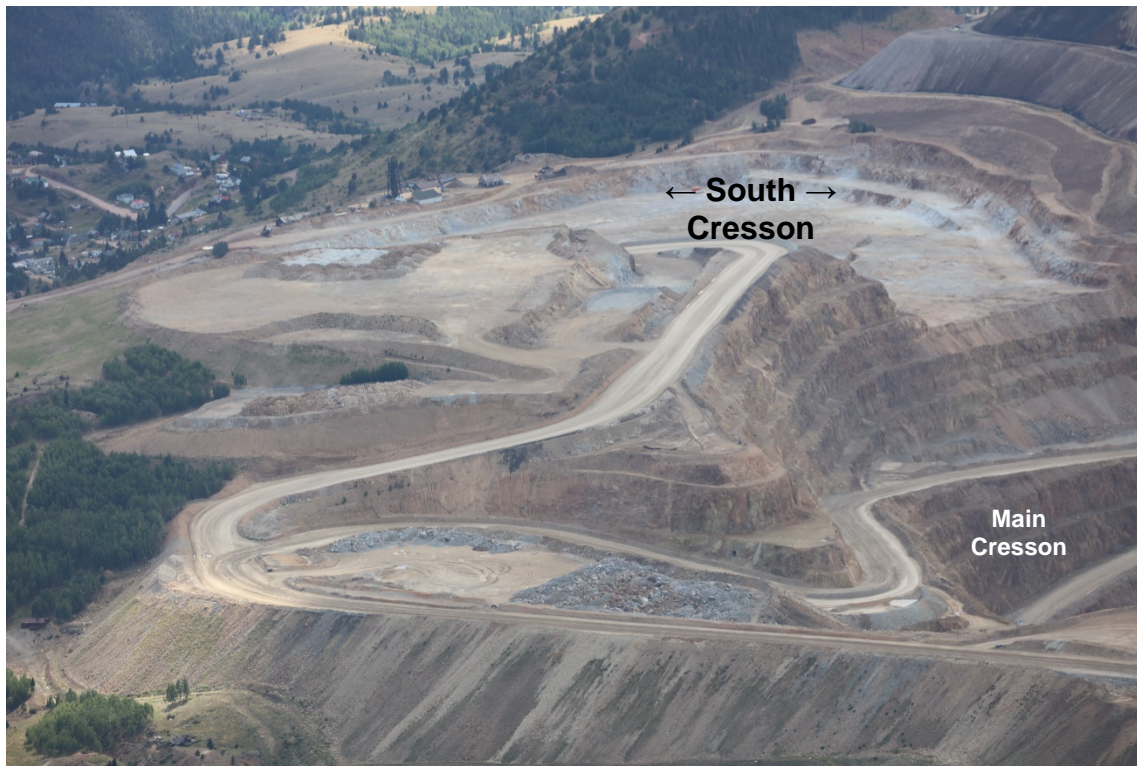
Photo 5. South Cresson Pit (looking SW).

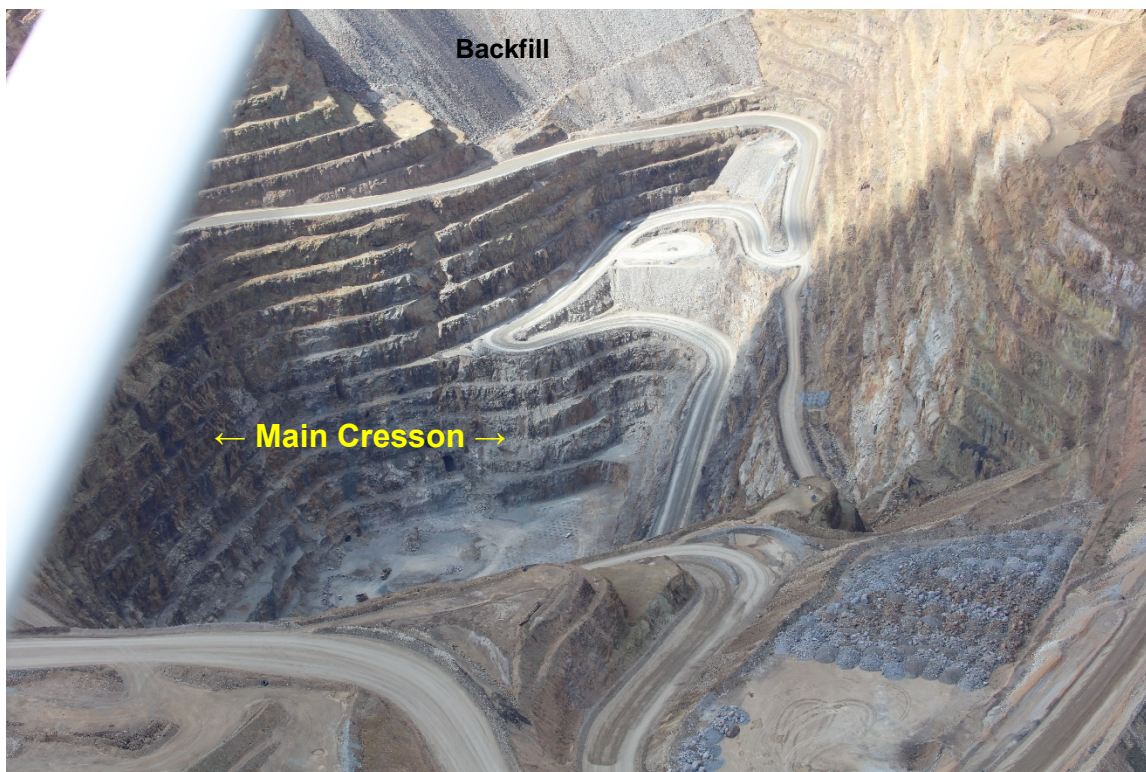
Photo 6. Main Cresson Pit (looking north)

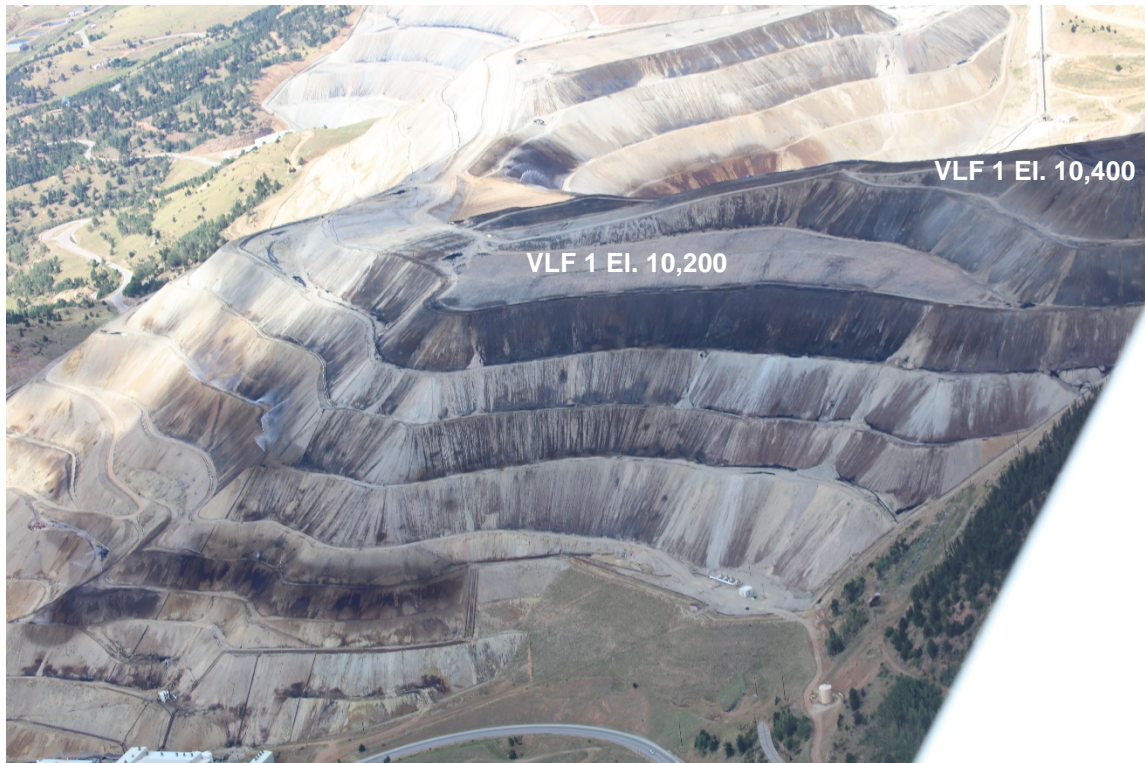
Photo 7. VLF 1/Arequa Gulch VLF (looking north); No visible ponding on VLF 1.

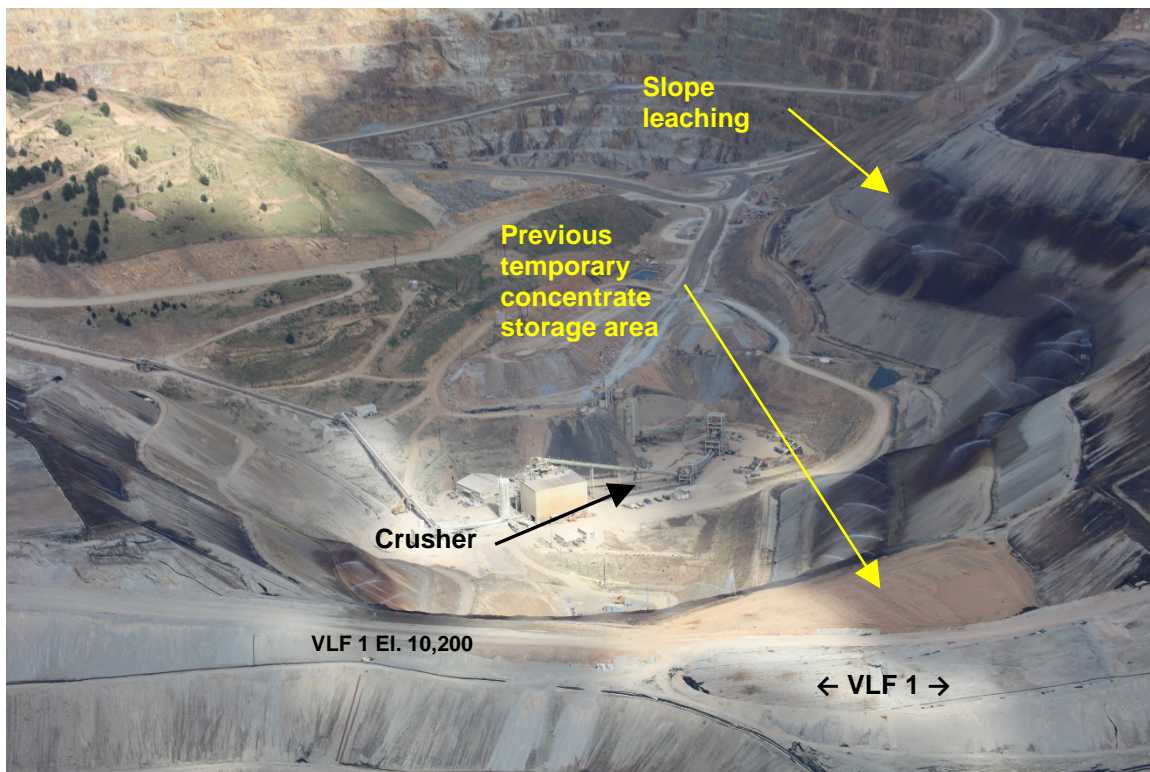
Photo 8. VLF 1/Arequa Gulch VLF (looking NE); No visible ponding on VLF 1.

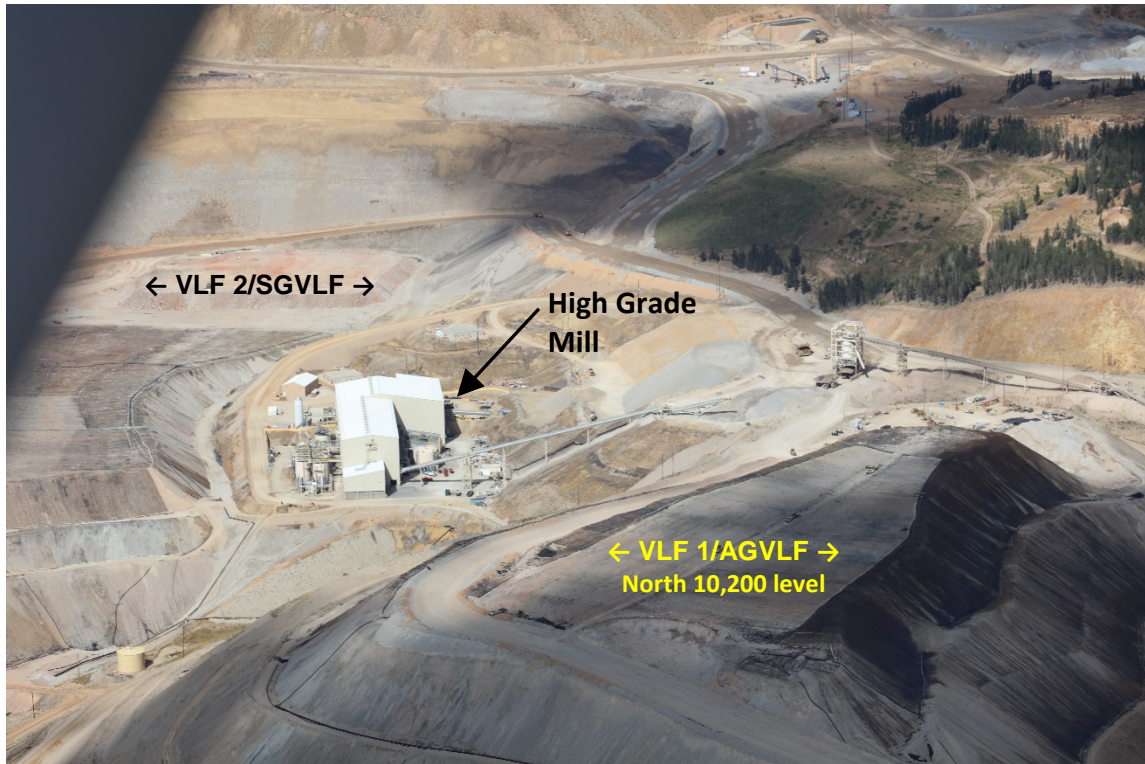
Photo 9. High Grade Mill and VLFs (Looking NNE; no visible solution ponding).

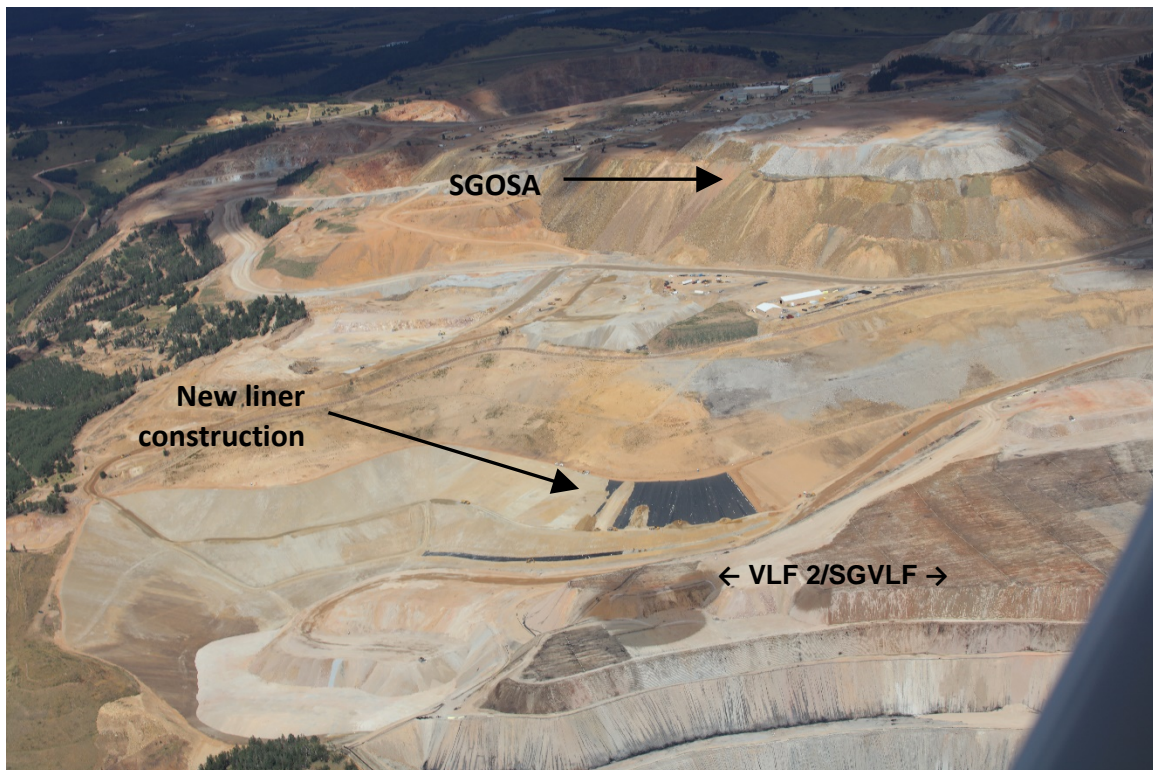
Photo 10. VLF 2/Squaw Gulch VLF (looking ENE).

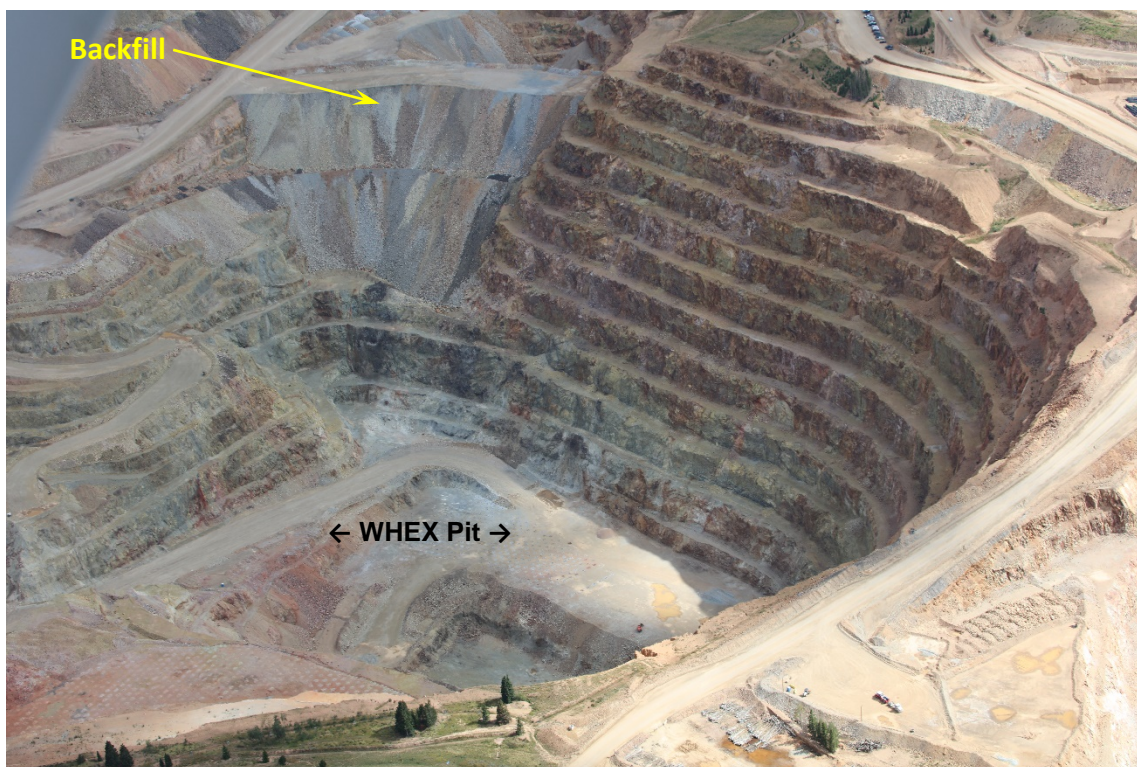
Photo 11	WHEX pit	Looking south	<i>Backfill visible in upper left</i>
<u>Acronyms:</u> WHEX – Wildhorse Extension Pit VLF – valley leach facility OSA – overburden storage area

Photo 11. WHEX Pit (Looking south).
