### MINERALS PROGRAM INSPECTION REPORT PHONE: (303) 866-3567

<b>MINE NAME:</b> Cresson Project	<b>MINE/PROSPECTING ID#:</b> M-1980-244	<b>MINERAL:</b> Gold	<b>COUNTY:</b> Teller
<b>INSPECTION TYPE:</b> Aerial Inspection	<b>INSPECTOR(S):</b> Timothy Cazier	<b>INSP. DATE:</b> March 16, 2020	<b>INSP. TIME:</b> 11:39
<b>OPERATOR:</b> Cripple Creek & Victor Gold Mining Company	<b>OPERATOR REPRESENTATIVE:</b> None	<b>TYPE OF OPERATION:</b> 112d-3 - Designated Mining Operation

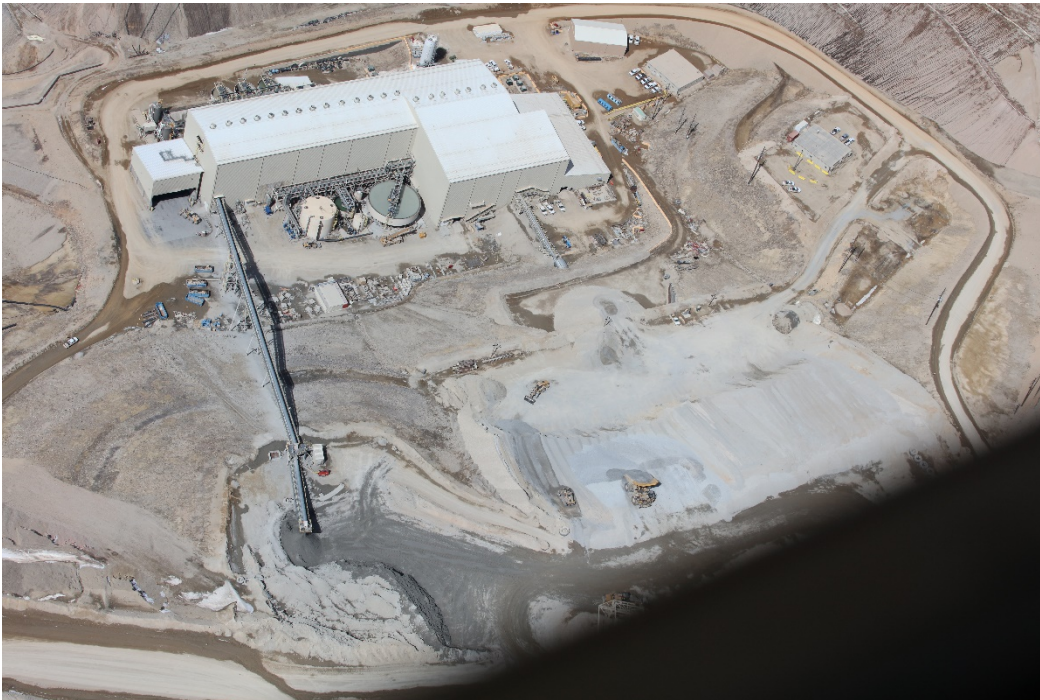
High Grade Mill: The purpose was to perform a visual inspection for leaks, spills and secondary containment problems. Both the east (see **Photo 1**) and west (see **Photo 2**) sides of the mill exterior were inspected with no observable impact on the secondary containment.

Photo 1. East side of High Grade Mill (looking NW).

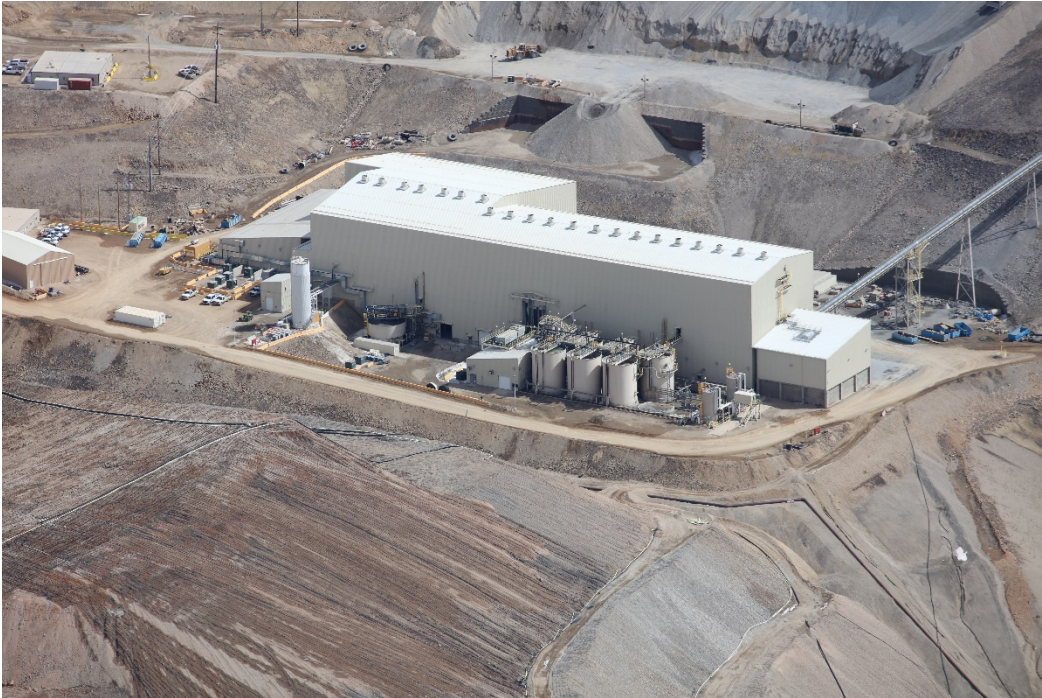
Photo 2. West side of High Grade Mill (looking east).

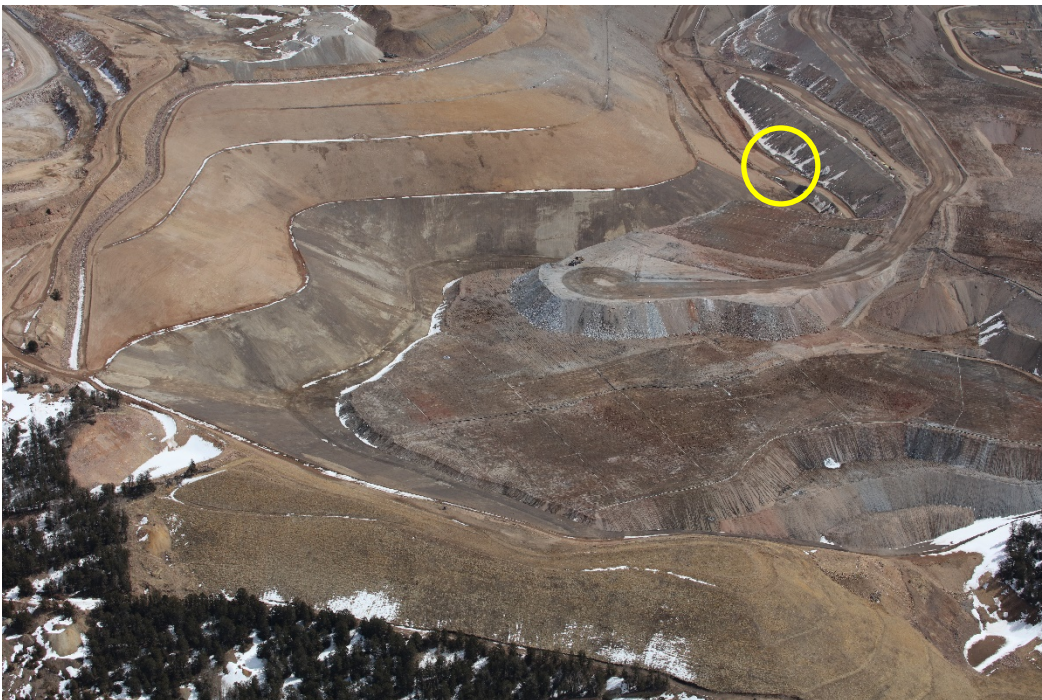
**PROBLEM/POSSIBLE VIOLATION:** Problem: Water ponding on VLF2 and Process solution ponding were observed in areas greater than the 3 ft x 3 ft on VLF1 as limited by the approved wildlife protection plan.

Squaw Gulch Valley Leach Facility (VLF 2): No ponded process solution was observed in the active leach areas on VLF 2. However, a pond area greater than the allowed 3 ft x 3 ft was observed on the old VLF2 haul road on the north side (see **Photo 3**). This may be meltwater and not process solution, but as it is a potential wildlife attractant and on the lined area of VLF2, therefore subject to the wildlife protection plan. **The VLF2 ponding is included in the cited Problem on Page 1 of this report.** The progression of ore stacking on the north side of VLF2 was observed to be in compliance with the stacking plan approved in TR-103 (see **Photo 4**). An overview of VLF2 is presented in **Photo 5**) for comparison with previous aerial inspection reports.

Photo 3. VLF2 – ponded water on old haul road (looking SE).

**CORRECTIVE ACTIONS:** Provide photographic documentation of eliminating the areas of ponded water and solution by the Corrective Action Due Date.

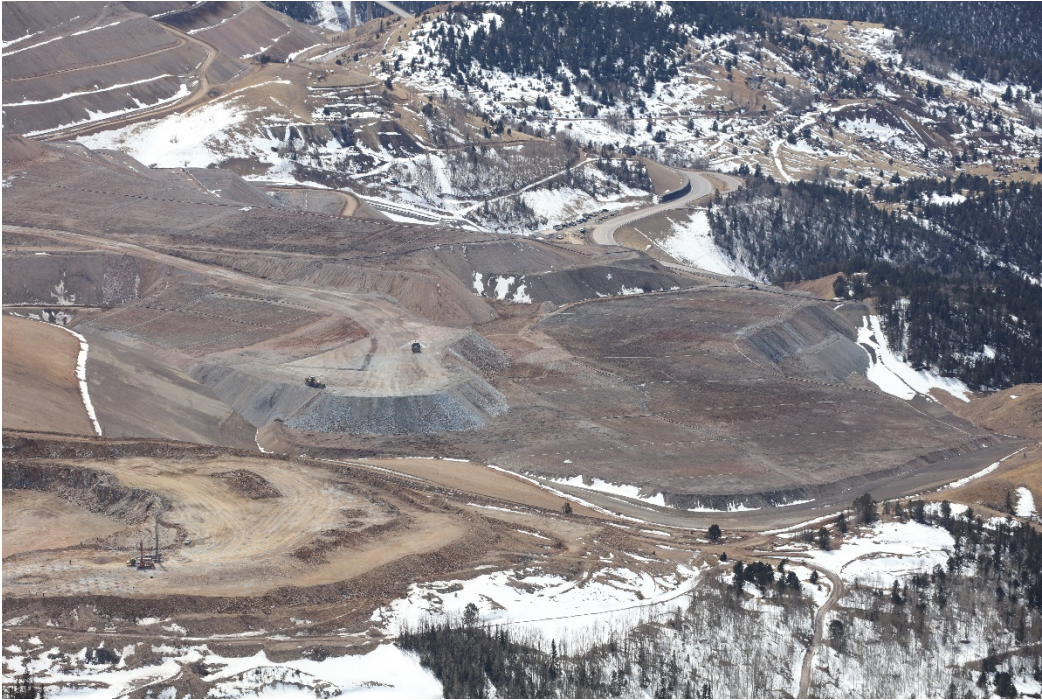
Photo 4. Ore stacking towards DCF protected liner on the north end of VLF2.

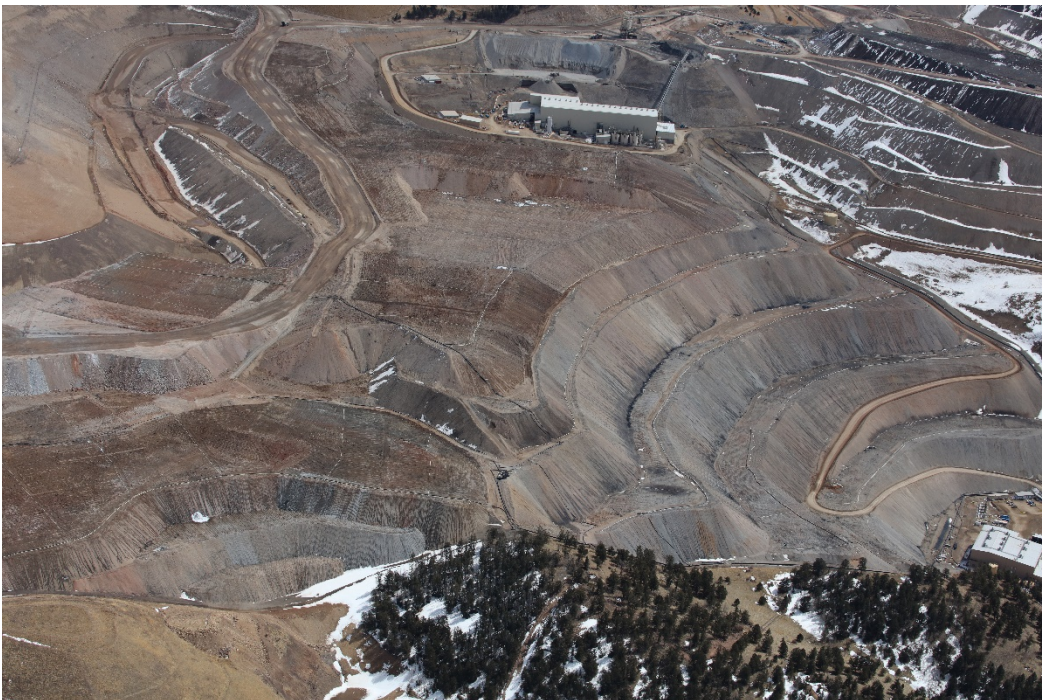
Photo 5. VLF2 Overview (looking SE).

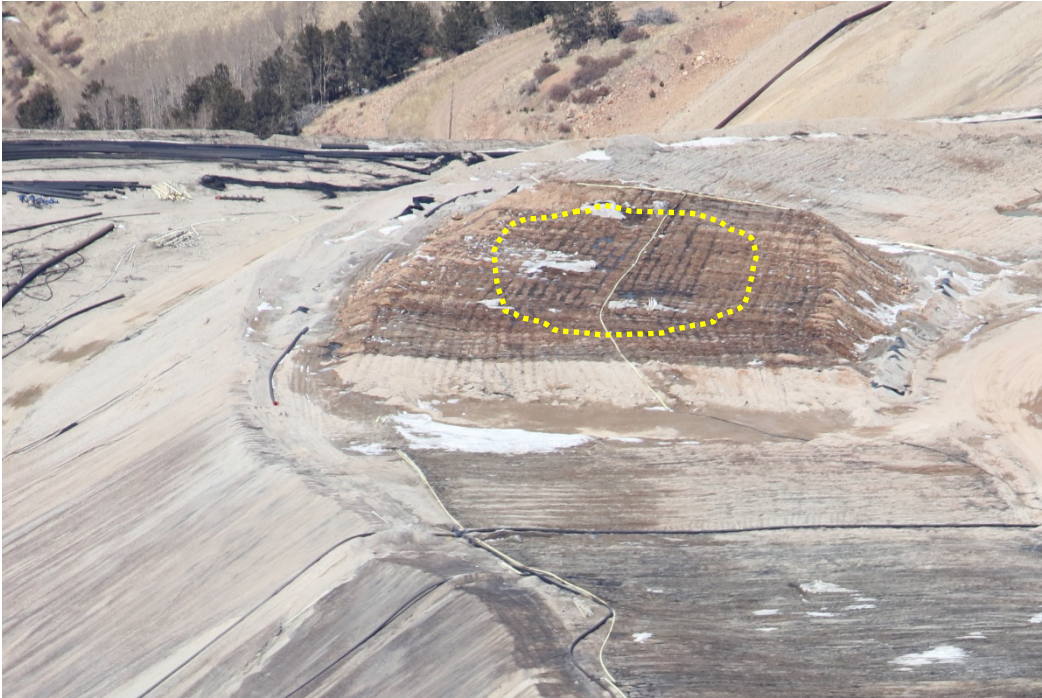
Arequa Gulch Valley Leach Facility (VLF1): Solution ponding was observed along the Leach Test Cell between the 10,200 and 10,400 levels (see **Photo 6**). Solution ponding was also observed on the northeast end of the 10,300 level (see **Photo 7**). Solution ponding was also observed on the 10,400 level (see **Photos 8 and 9**). Finally water ponding was observed in between the PSES tanks and the rinsed tanks at the base of the access road to the Phase 1 pumps (see **Photo 10**) which is over the liner and similar to the aforementioned haul road ponding in the north side of VLF2, is subject to the wildlife protection plan. *[Note: the Division received an email on the morning of March 23, 2020 from Mr. Justin Bills showing the pond near the PSES had about 75 percent coverage with bird balls. The Division's position is that full coverage is required].* **The VLF1 solution and water ponding is included in the cited Problem on Page 1 of this report.** An overview of VLF1 is presented in **Photo 11** for comparison with previous aerial inspection reports.

Photo 6. VLF1 Leach Test Cell ponded process solution observed.

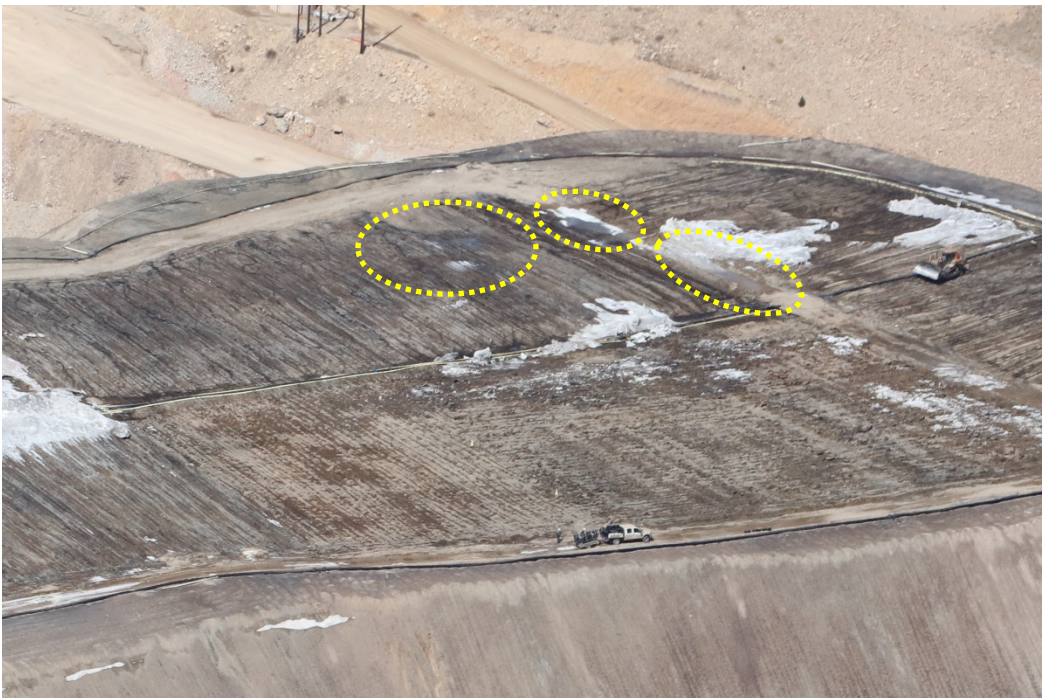
Photo 7. VLF 1 (NE end of 10,300 level) – ponded process solution observed (looking north).

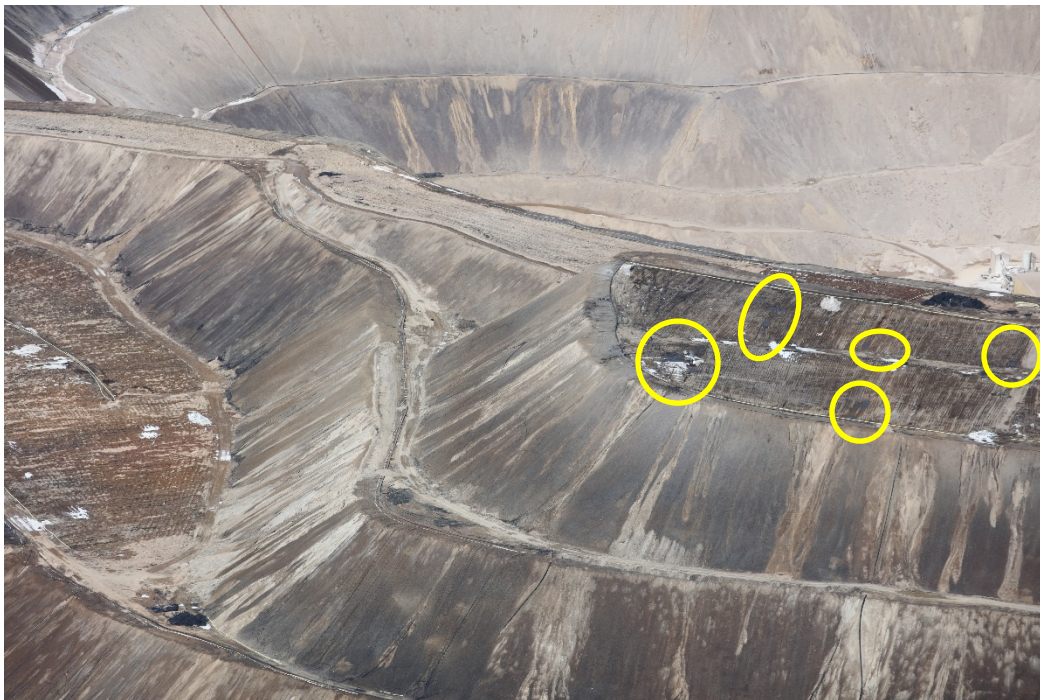
Photo 8. VLF 1 (west end of 10,400 level) – ponded process solution observed (looking NW).

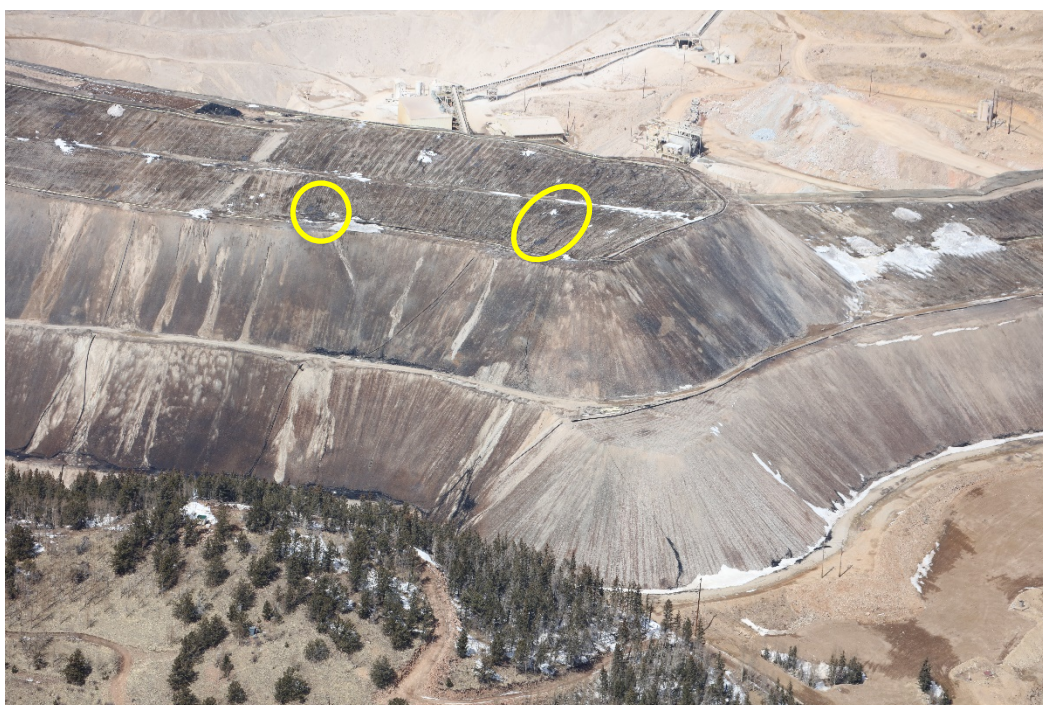
Photo 9. VLF 1 (east end of 10,400 level) – ponded process solution observed (looking NW).

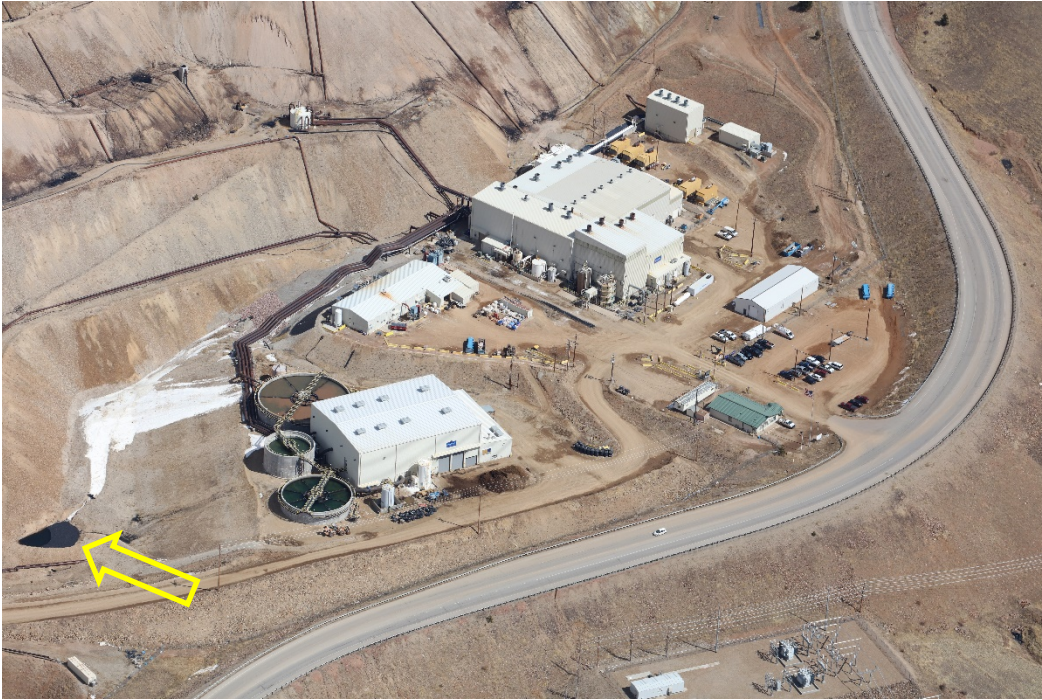
Photo 10. VLF 1 – ponded water NW of PSES tanks (looking NE).

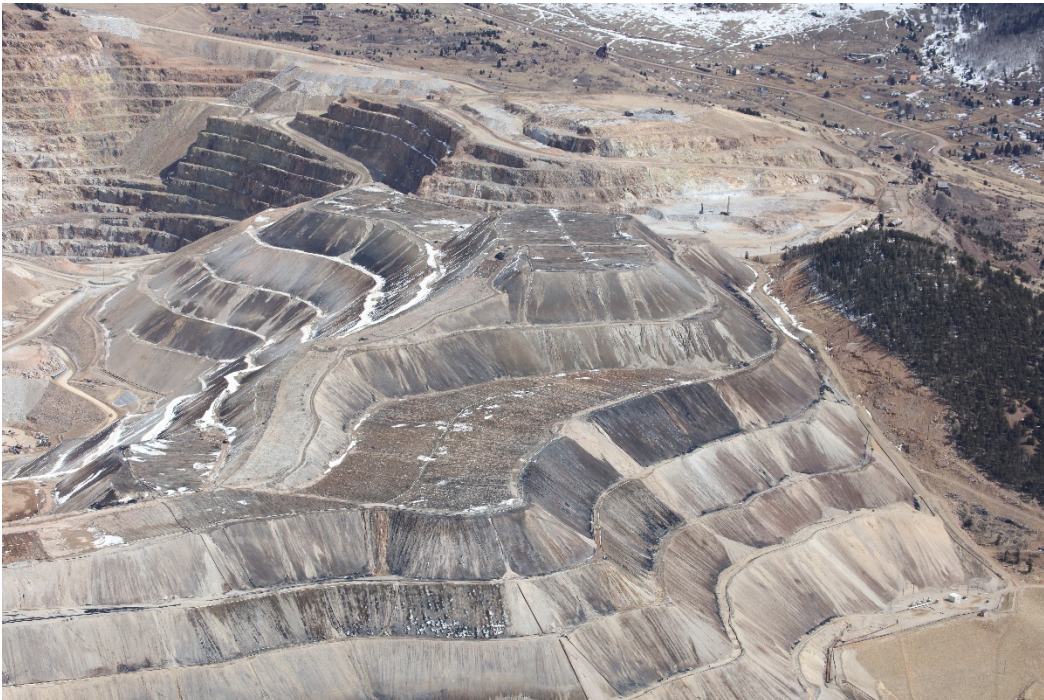
Photo 11. VLF 1 Overview (looking ENE).

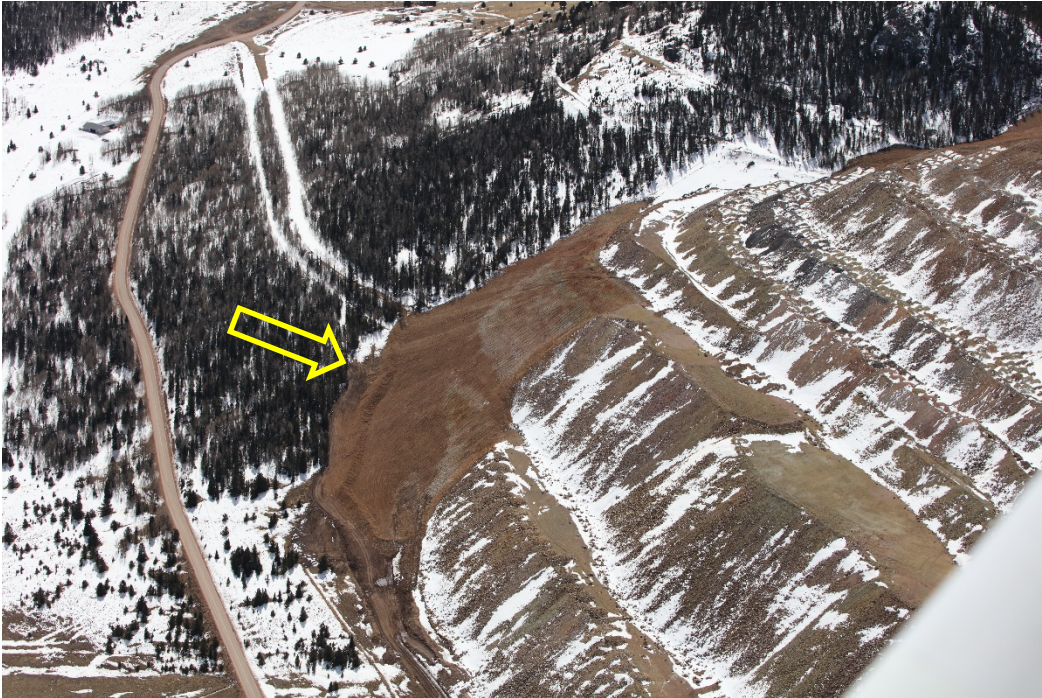
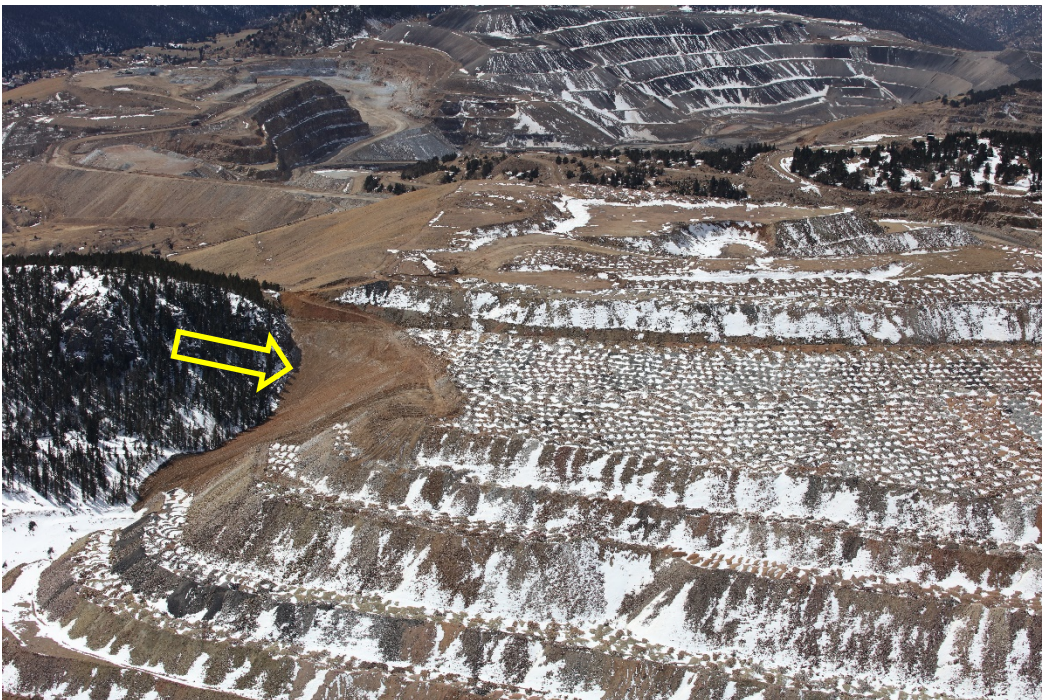
East Cresson Overburden Storage Area (ECOSA) Reclamation: Reclamation grading was observed on the south end of the ECOSA (see **Photos 12 and 13**).

Photo 12. South ECOSA reclamation (looking south).

Photo 13. South ECOSA reclamation (looking SW).

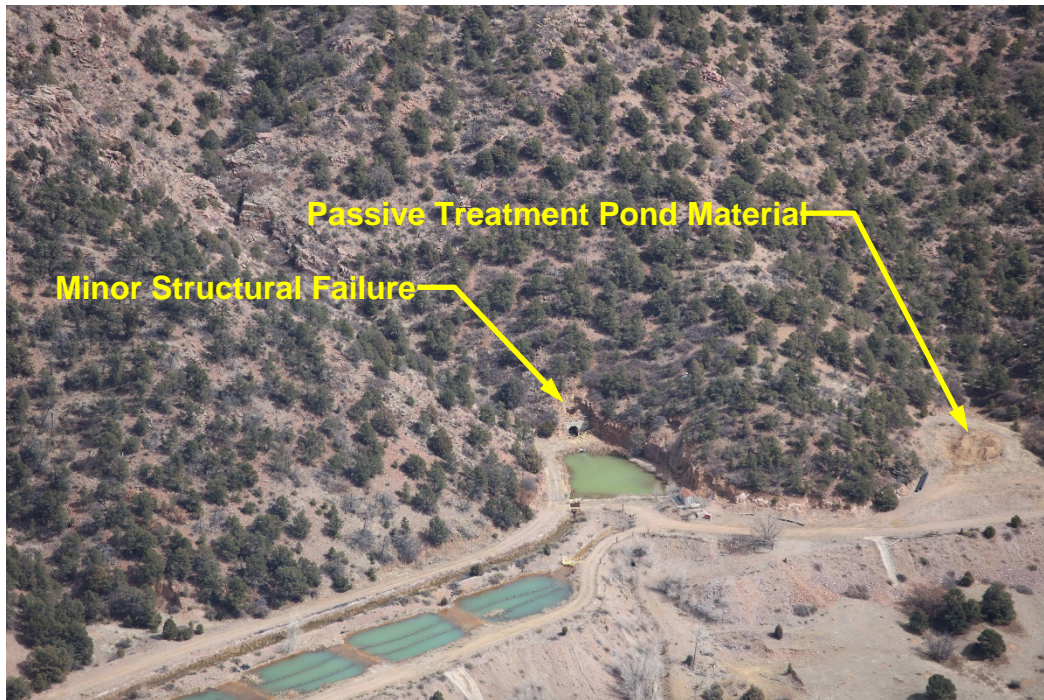
Carlton Tunnel: On March 10, 2020, the Division received notice from CC&V of a minor structural failure in the Carlton Tunnel. As such the Division included the area in this aerial inspection. The failure was too small to be

clearly observed in the aerial images taken (see **Photo 14**). A disturbed area was observed south of the tunnel opening. A telephone conversation with Mr. Justin Bills (CC&V) on March 19<sup>th</sup> confirmed the material in this disturbed area is what is removed from the five passive treatment ponds (see **Photo 15**) through which the discharge from the Carlton Tunnel flows, during regular maintenance. Records reviewed at this time are unclear as to whether or not this area is in the permit and affected area boundary. Mr. Bills agreed to research their records for clarification. The Division will follow up with this and visit the area as part of a future on-site inspection.

Photo 14. Carlton Tunnel outlet and Disturbed area to the south (looking east).

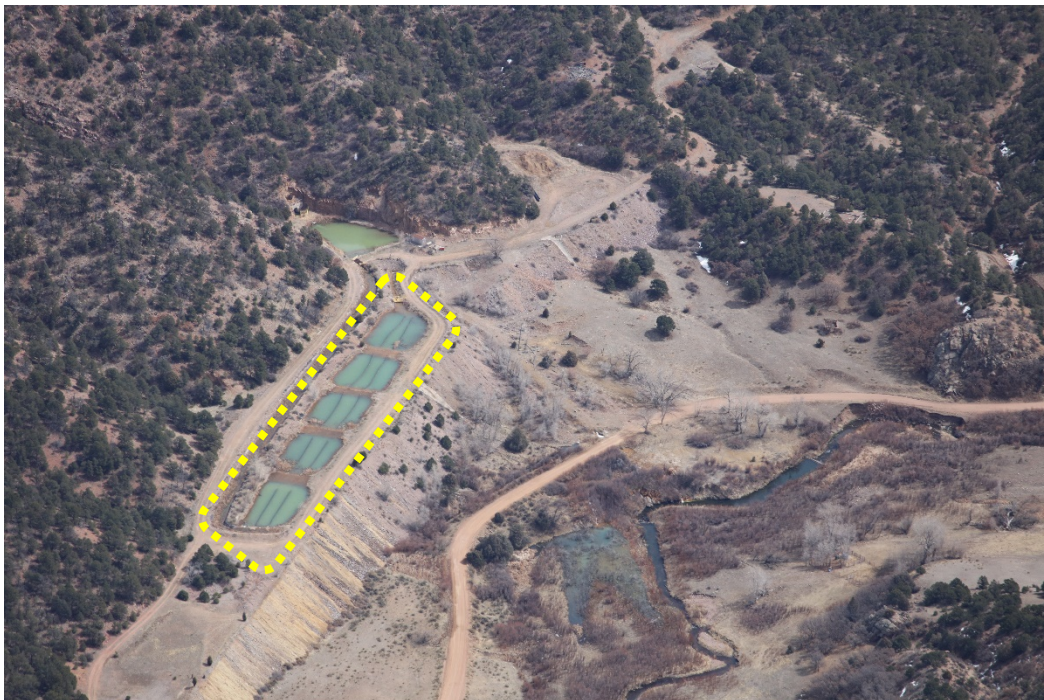
Photo 15. Carlton Tunnel Passive Treatment ponds (looking ESE).

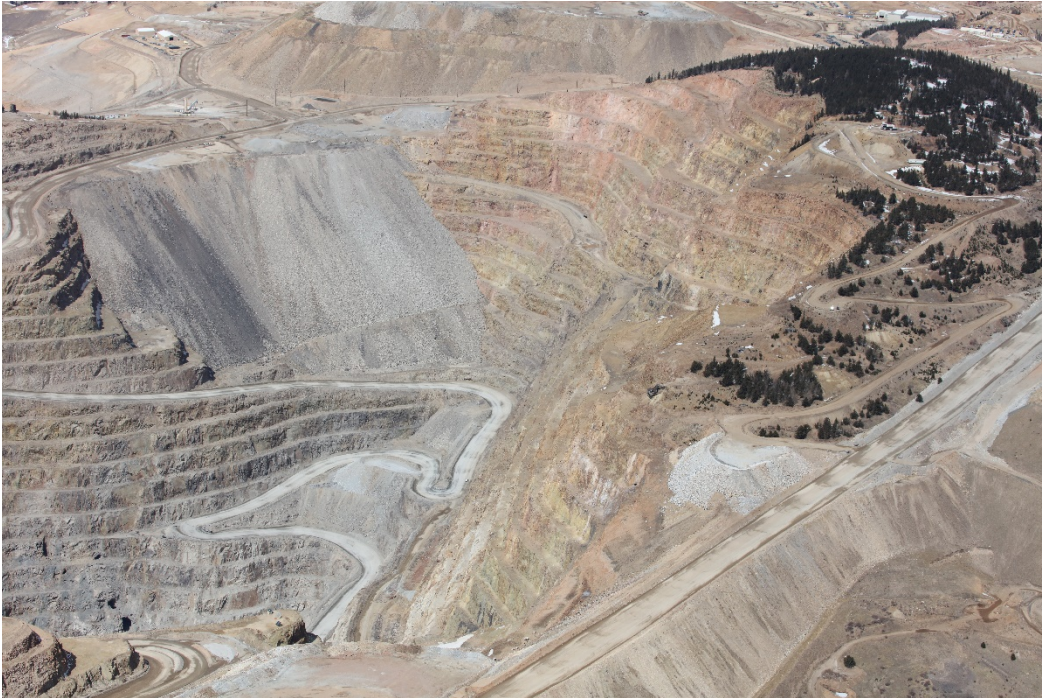
Aerial Pit views: Images of the Main Cresson (see **Photo 16**), South Cresson (see **Photo 17**), Schist Island (see **Photo 18**) and Globe Hill (see **Photo 19**) Pits are presented for comparison with previous aerial inspection reports.

Photo 16. Main Cresson Pit (looking NW).

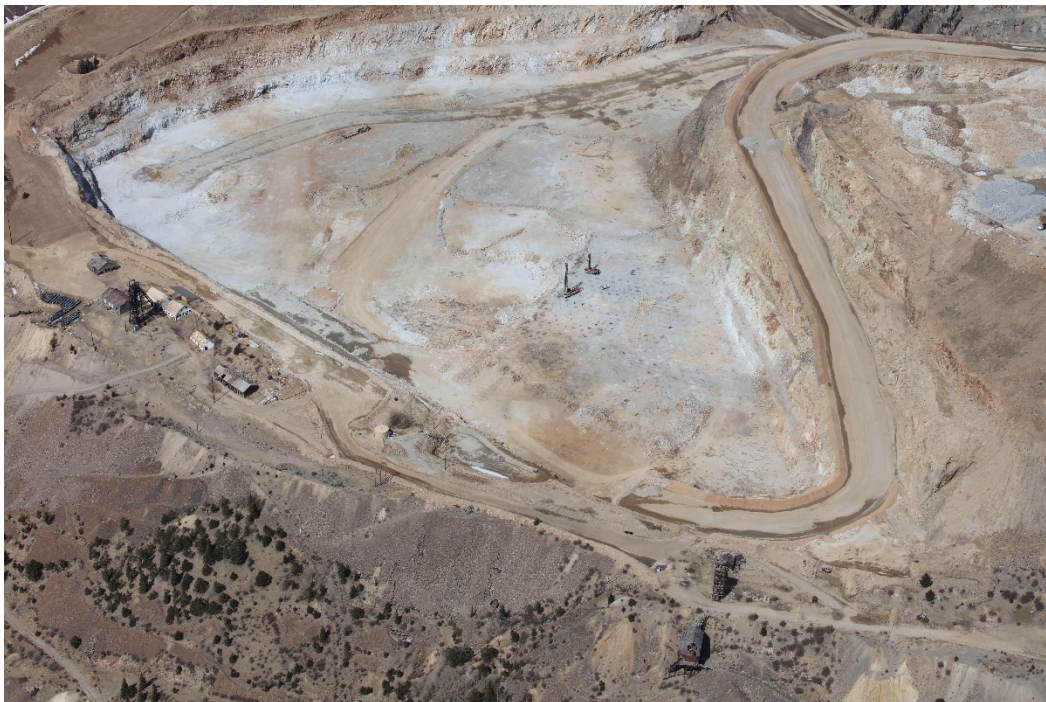
Photo 17. South Cresson Pit (looking NW).

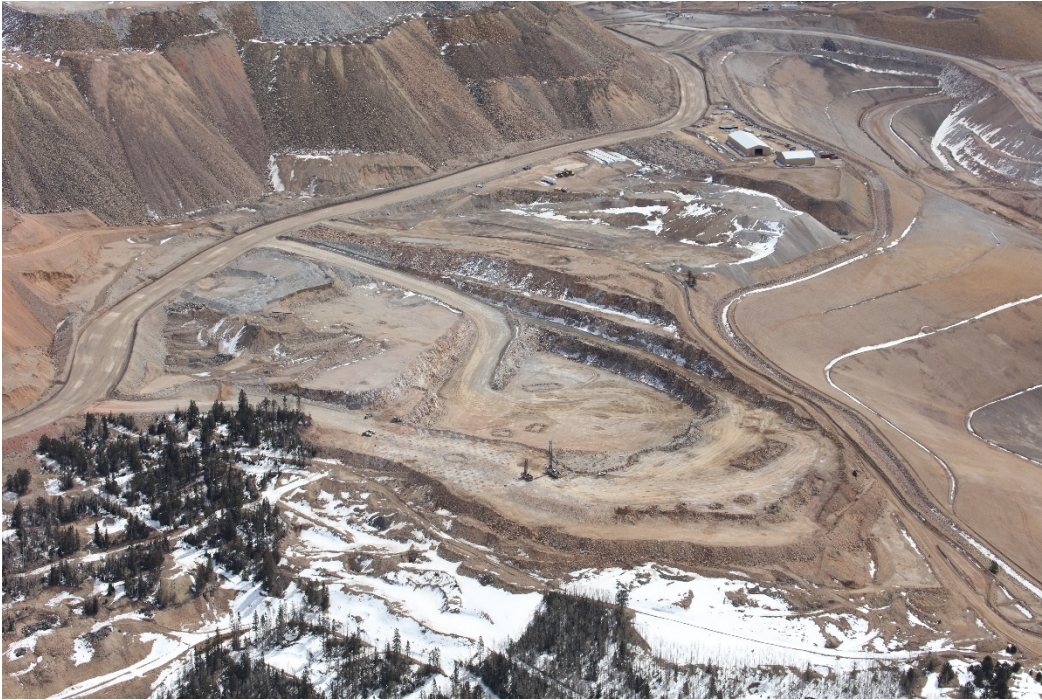
Photo 18. Schist Island Pit (looking SE).

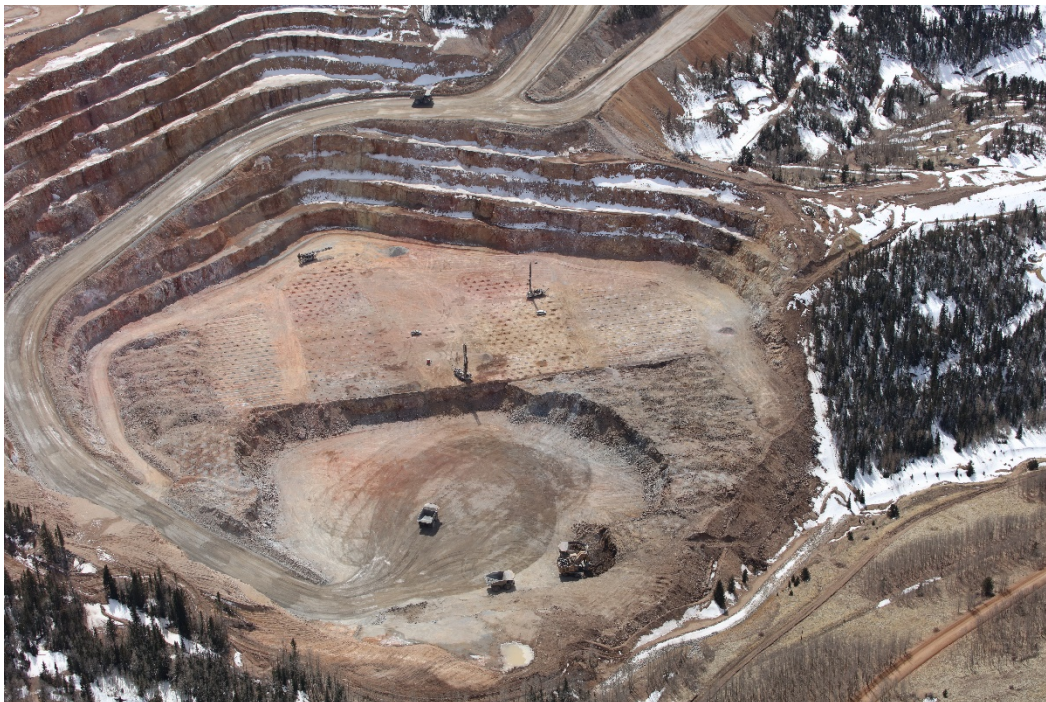
Photo 19. Globe Hill Pit (looking south).
