MINERALS PROGRAM INSPECTION REPORT
PHONE: (303) 866-3567

MINE NAME: Cresson Project	MINE/PROSPECTING ID#: M-1980-244	MINERAL: Gold	COUNTY: Teller
INSPECTION TYPE: Aerial Inspection	INSPECTOR(S): Timothy Cazier	INSP. DATE: November 12, 2019	INSP. TIME: 16:02
OPERATOR: Cripple Creek & Victor Gold Mining Company	OPERATOR REPRESENTATIVE: None	TYPE OF OPERATION: 112d-3 - Designated Mining Operation	
REASON FOR INSPECTION: Normal I&E Program	BOND CALCULATION TYPE: None	BOND AMOUNT: \$209,491,188.00	
DATE OF COMPLAINT: NA	POST INSP. CONTACTS: None	JOINT INSP. AGENCY: None	
WEATHER: Clear	INSPECTOR'S SIGNATURE:

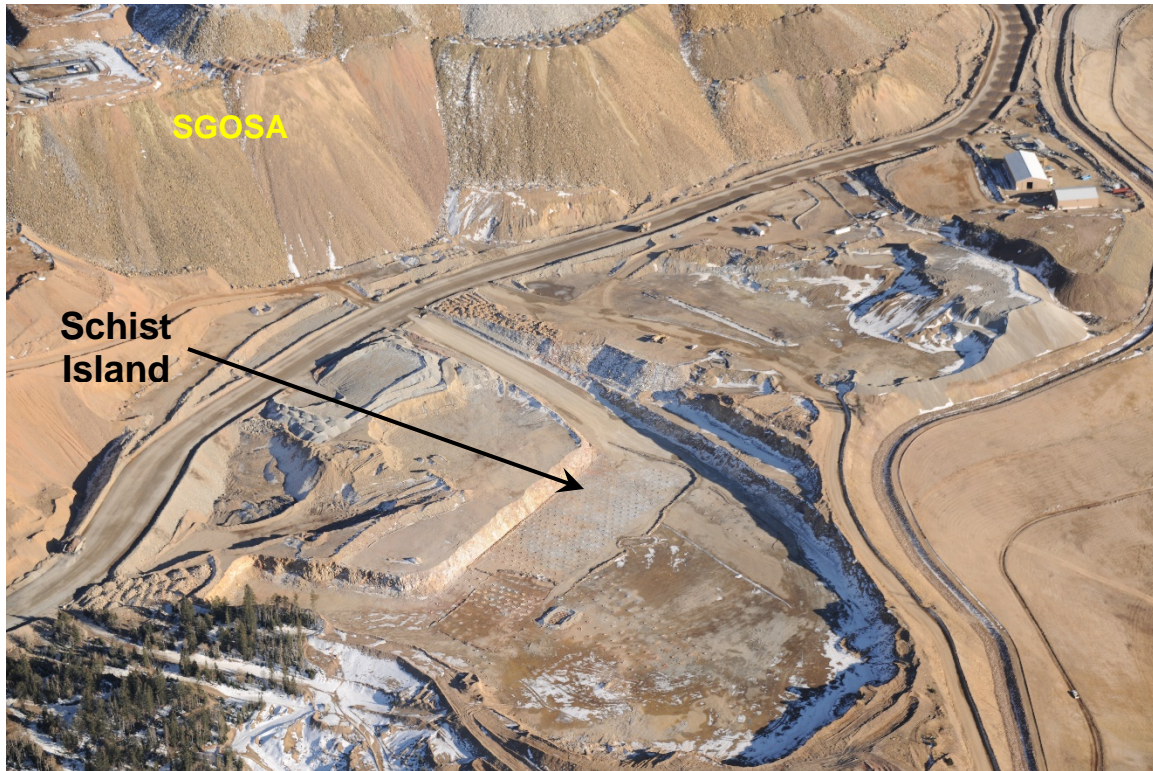
Photo 1. North Cresson pit – Schist Island Pit (Looking SE).

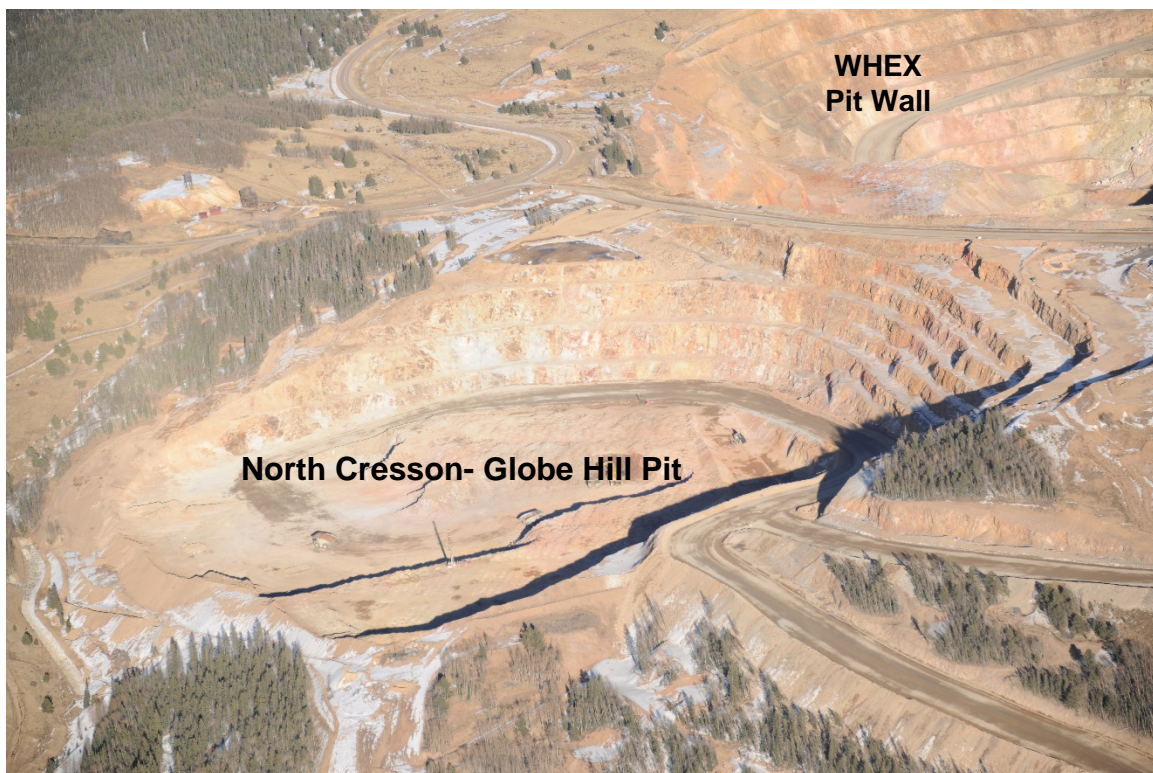
Photo 2. North Cresson – Globe Hill (looking NE).

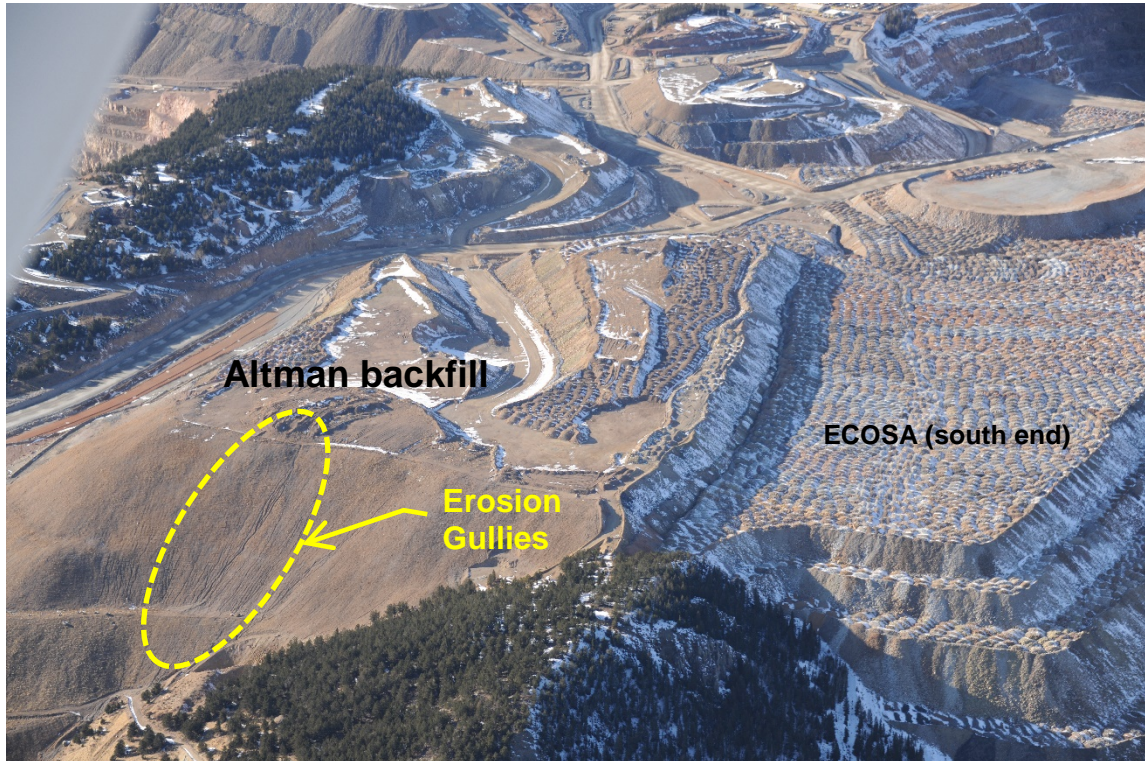
Photo 3. Altman Backfill/East Cresson OSA, south end (looking NW, note erosion gullies).

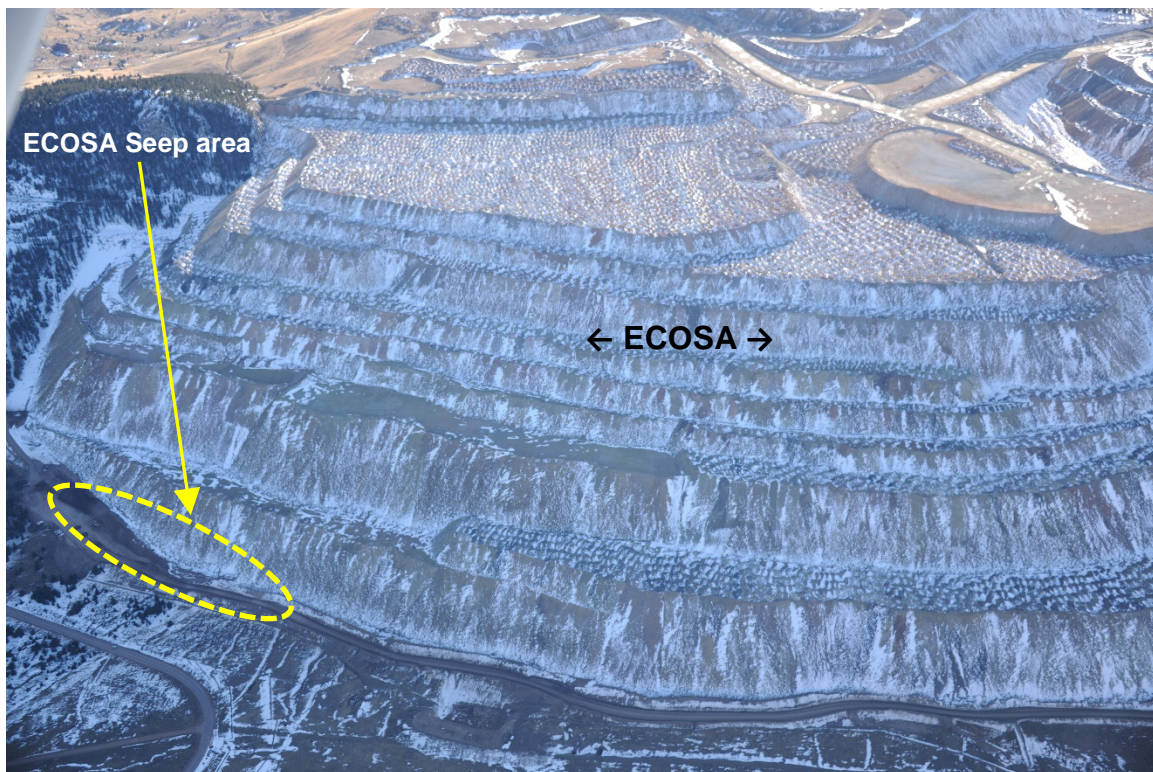
Photo 4. East Cresson OSA Toe, south end (looking SW).

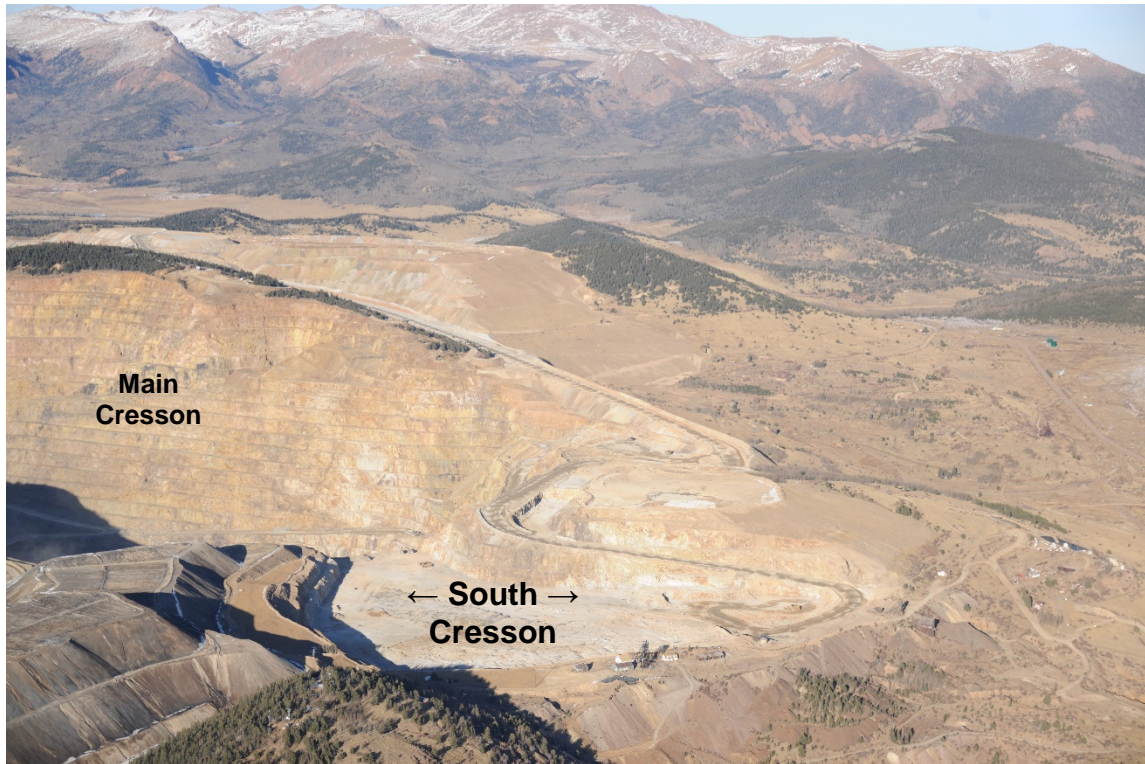
Photo 5. South Cresson Pit (looking NE).

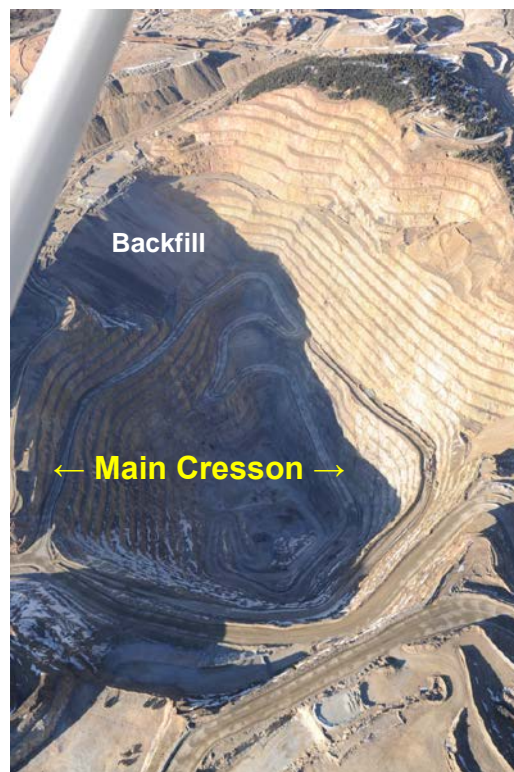
Photo 6. Main Cresson Pit (looking north)

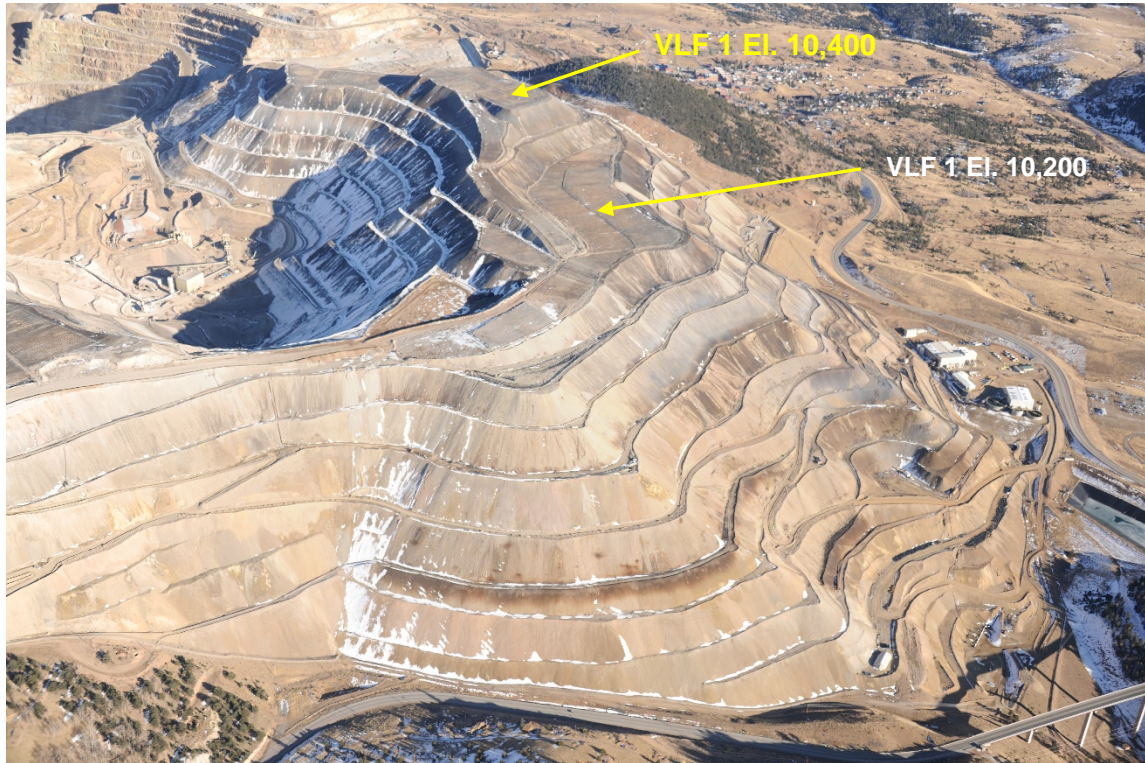
Photo 7. East end VLF 1/Arequa Gulch VLF (looking east); No visible ponding on VLF 1.

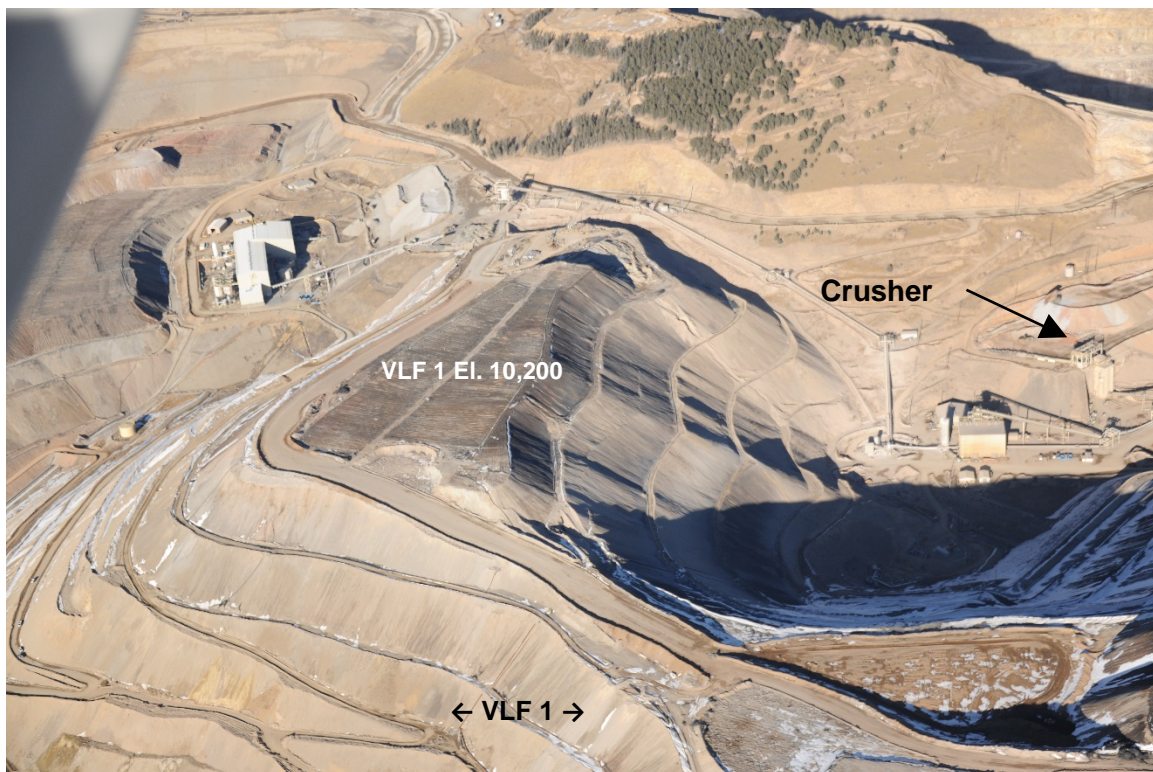
Photo 8. VLF 1/Arequa Gulch VLF (looking NE); No visible ponding on VLF 1.

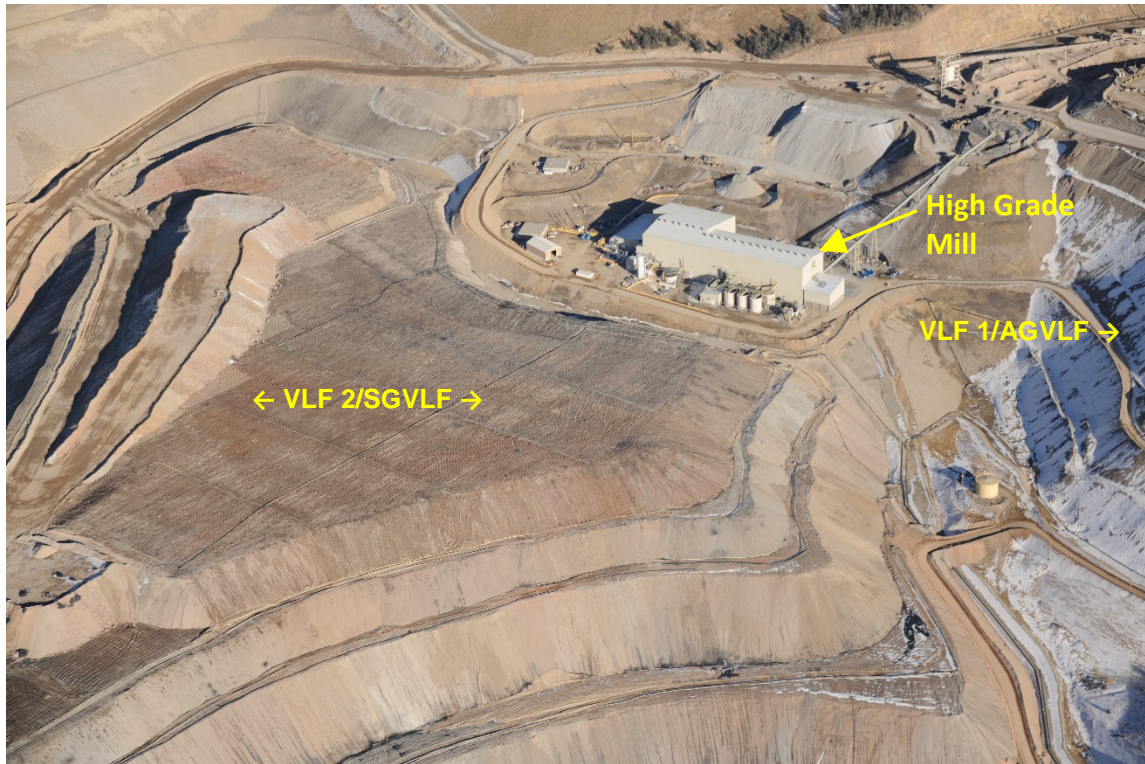
Photo 9. High Grade Mill and VLFs (Looking east; no visible solution ponding).

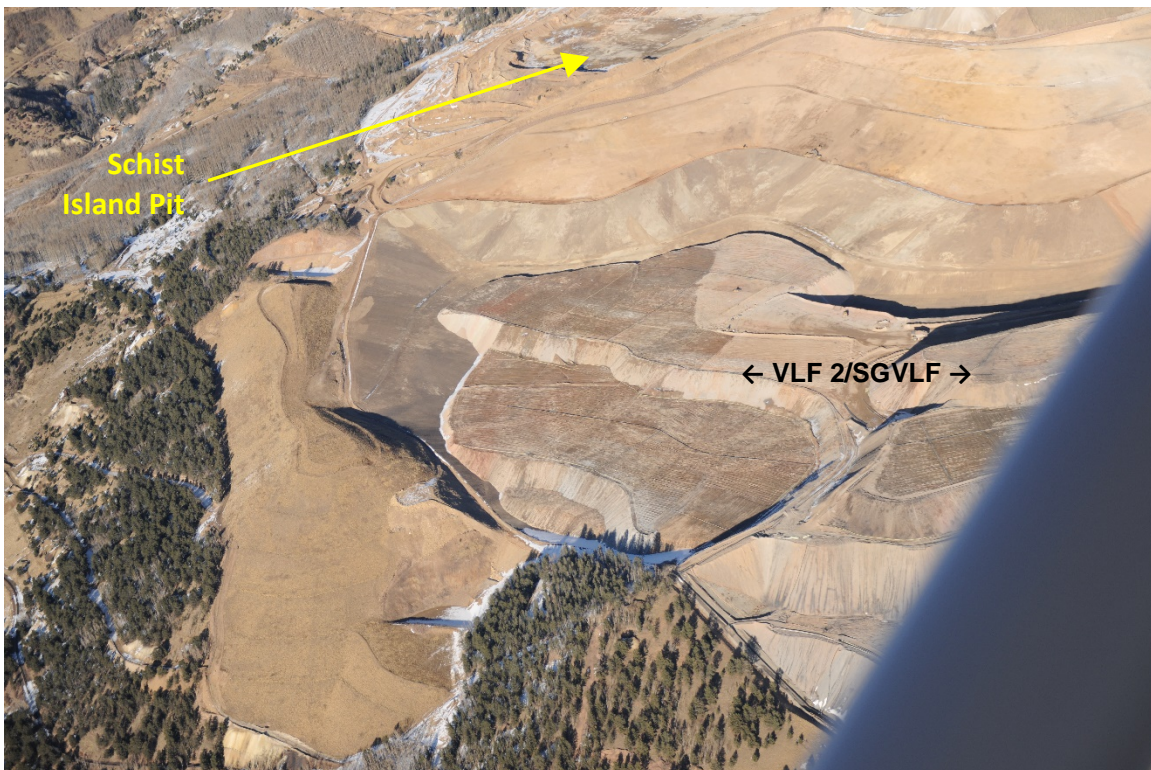
Photo 10. North VLF 2/Squaw Gulch VLF (looking NE).

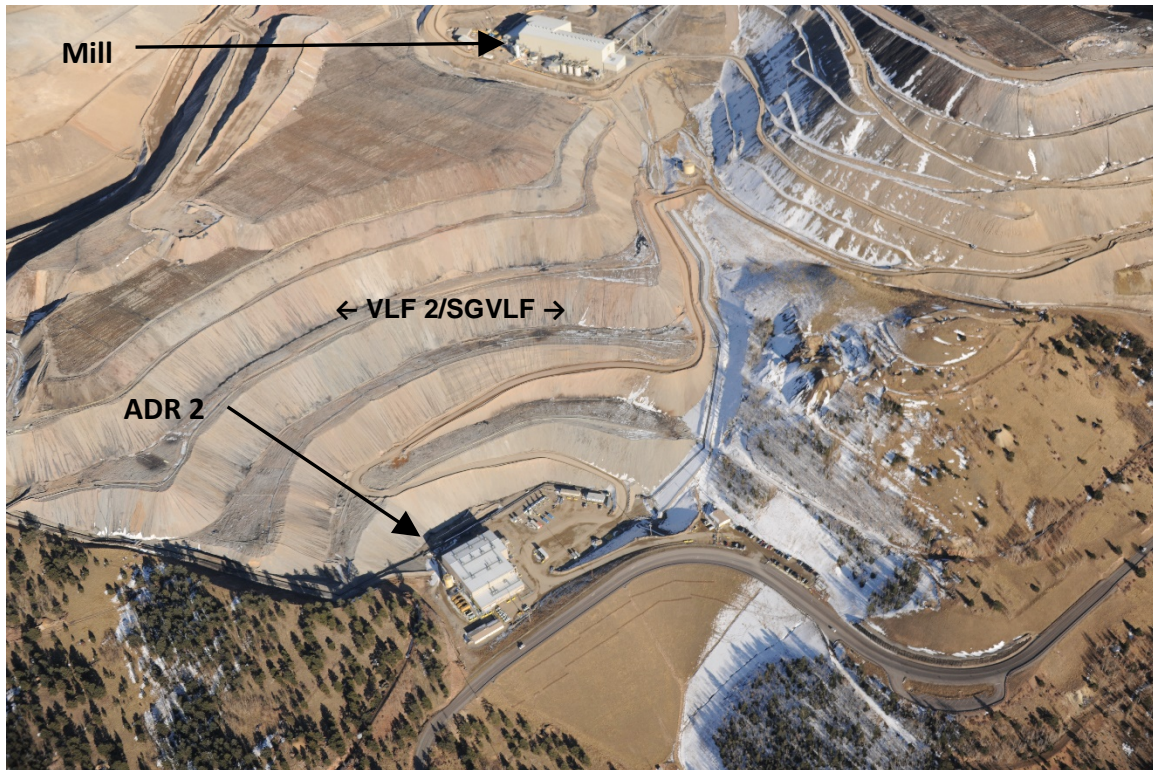
Photo 11. VLF 2/Squaw Gulch VLF (looking east).

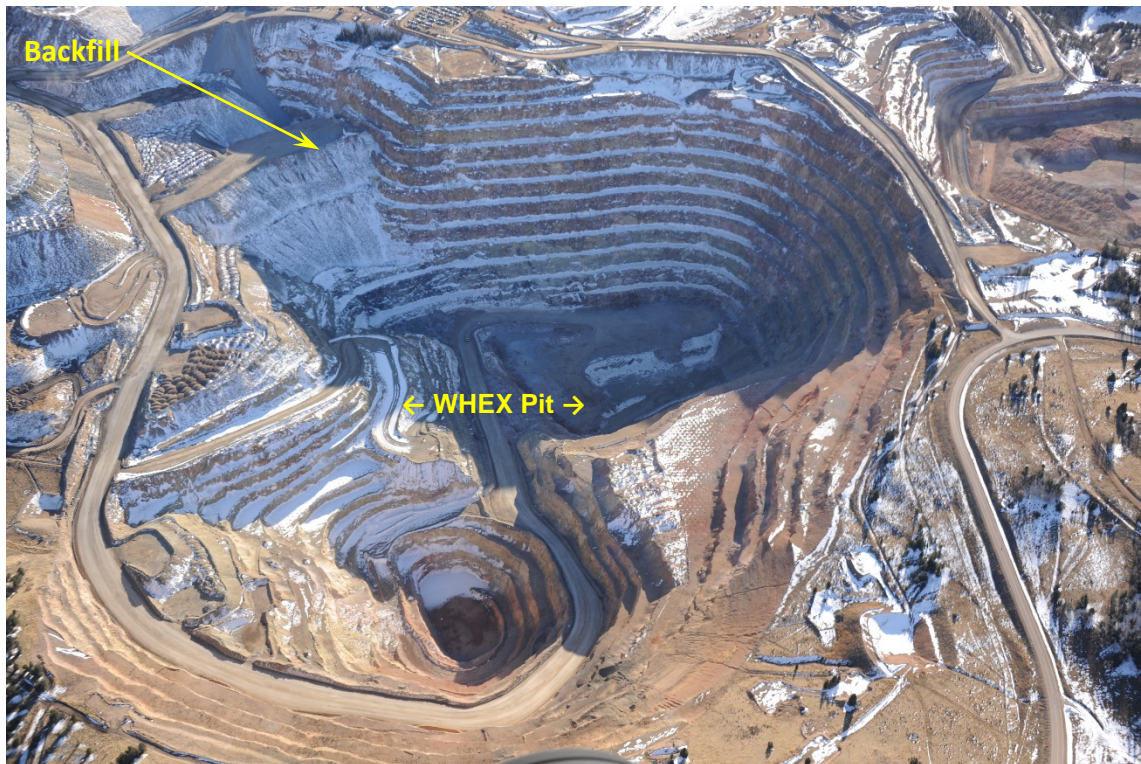
Photo 12. WHEX Pit (Looking SW).
