MINERALS PROGRAM INSPECTION REPORT
PHONE: (303) 866-3567

MINE NAME: Cresson Project	MINE/PROSPECTING ID#: M-1980-244	MINERAL: Gold	COUNTY: Teller
INSPECTION TYPE: Aerial Inspection	INSPECTOR(S): Timothy Cazier	INSP. DATE: January 24, 2020	INSP. TIME: 10:39
OPERATOR: Cripple Creek & Victor Gold Mining Company	OPERATOR REPRESENTATIVE: None	TYPE OF OPERATION: 112d-3 - Designated Mining Operation	
REASON FOR INSPECTION: Normal I&E Program	BOND CALCULATION TYPE: None	BOND AMOUNT: \$209,491,188.00	
DATE OF COMPLAINT: NA	POST INSP. CONTACTS: None	JOINT INSP. AGENCY: None	
WEATHER: Clear	INSPECTOR'S SIGNATURE:

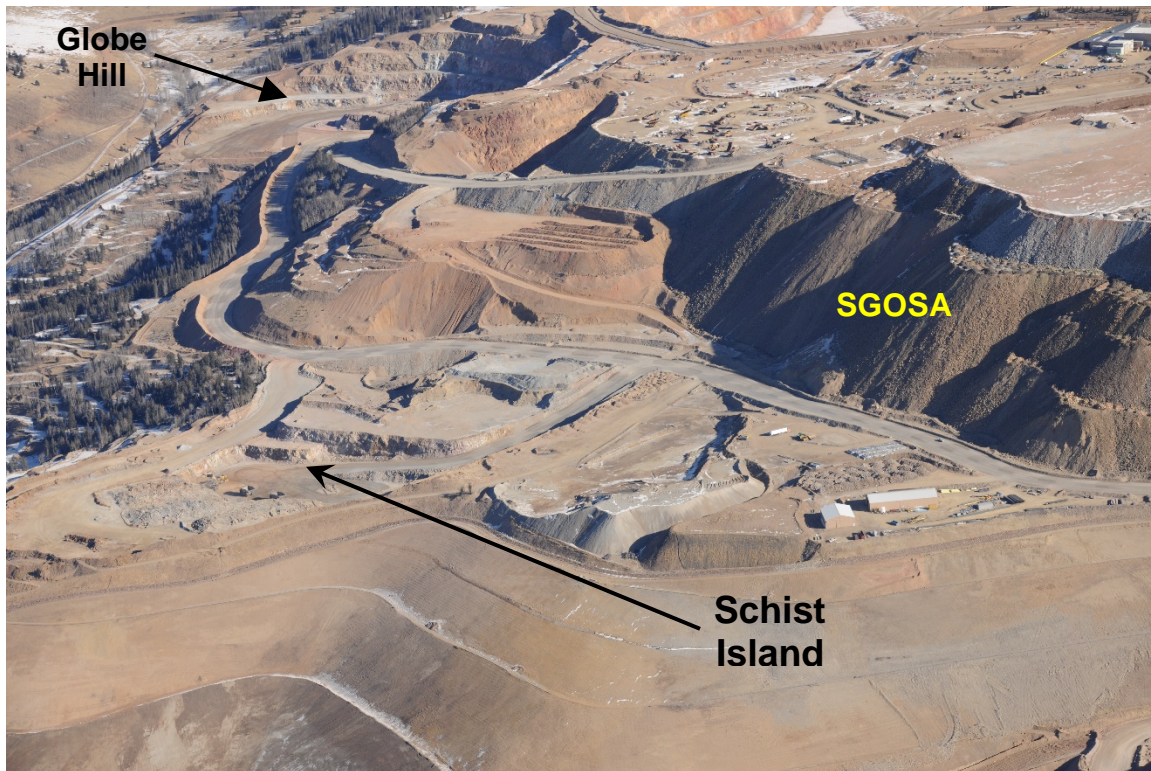
Photo 1. North Cresson pit – Schist Island Pit (Looking NNE).

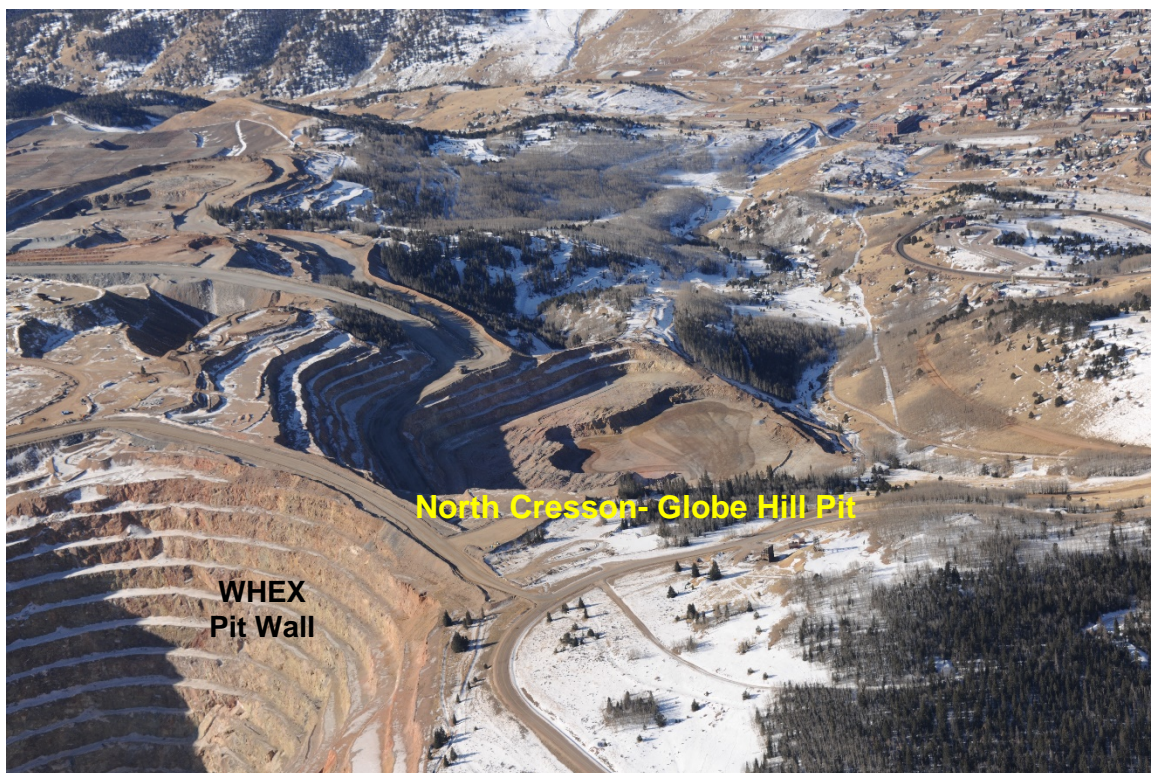
Photo 2. North Cresson – Globe Hill (looking SW).

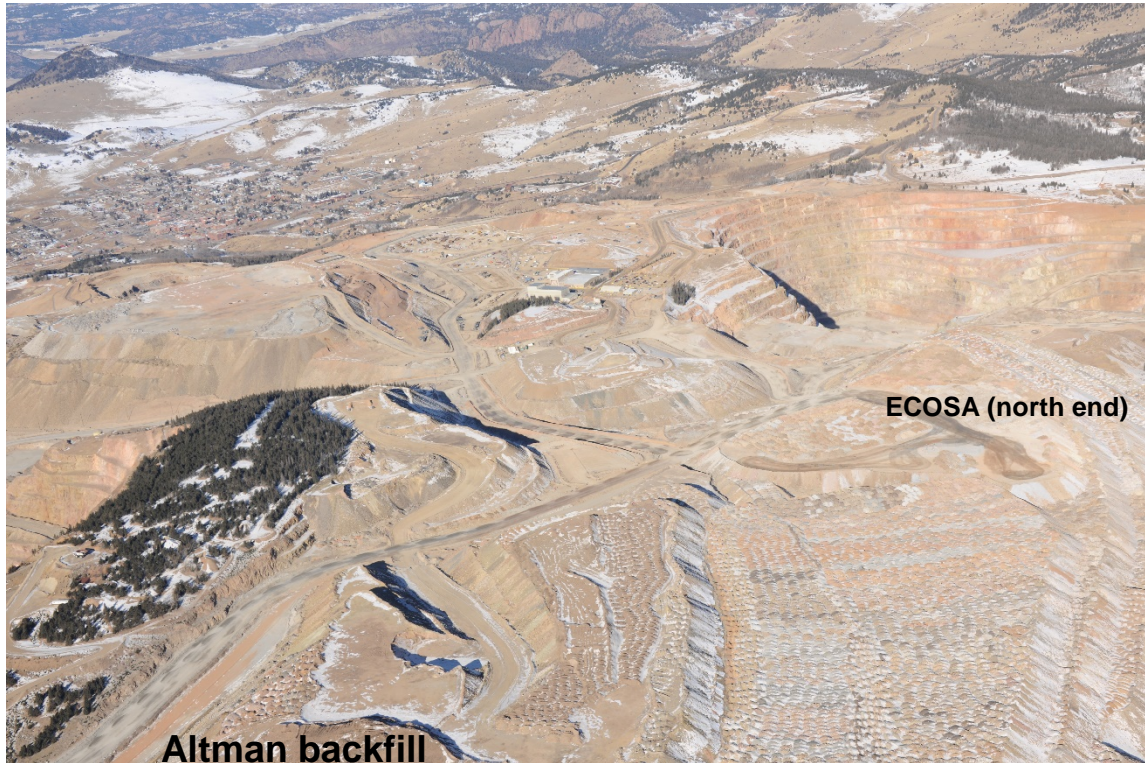
Photo 3. Altman Backfill/East Cresson OSA (looking NW).

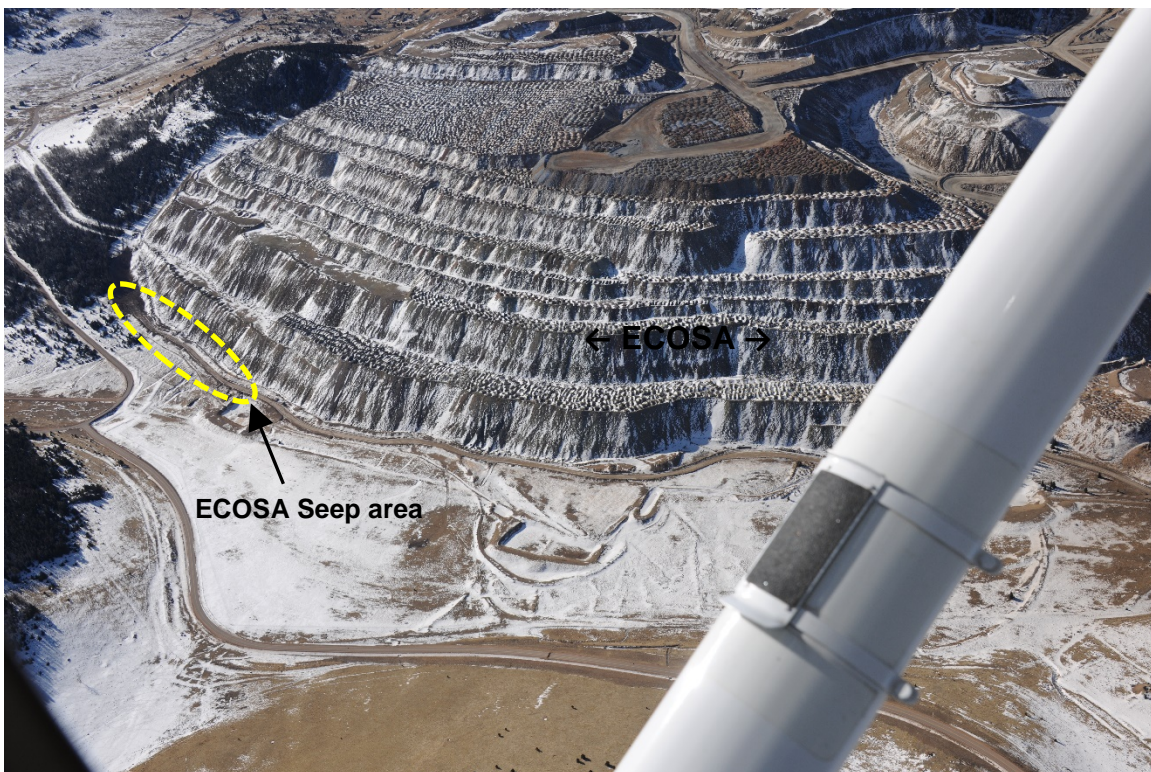
Photo 4. East Cresson OSA Toe (looking south).

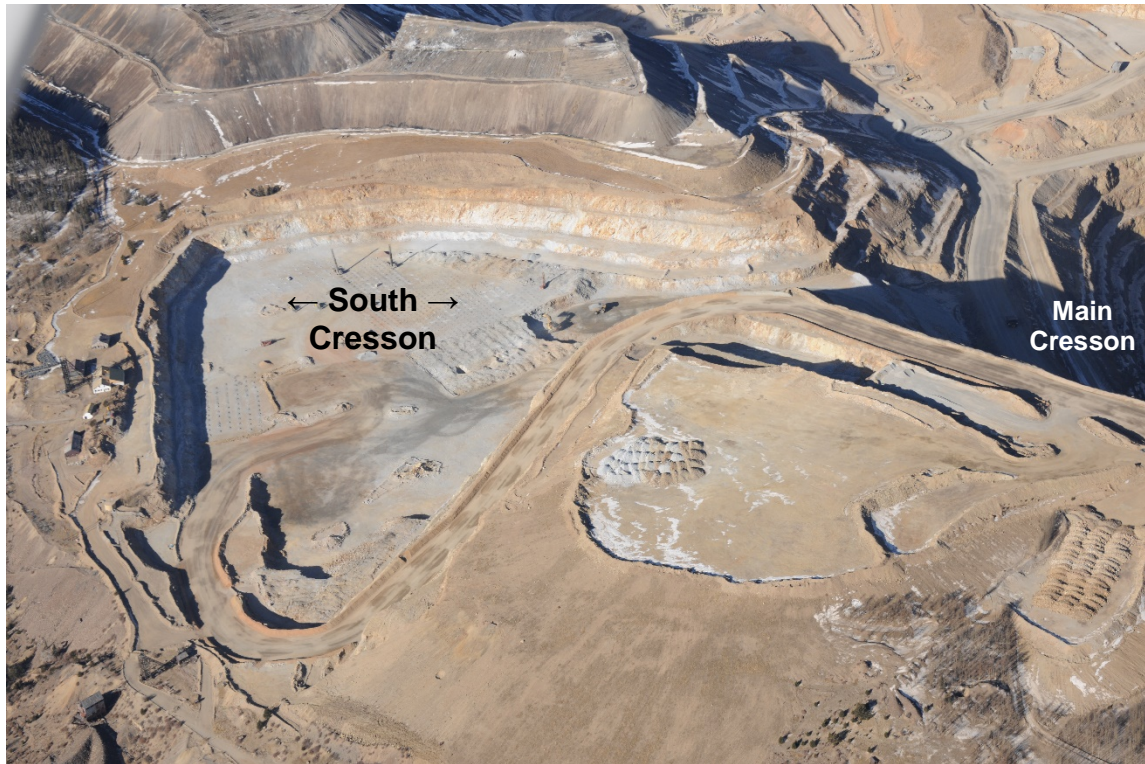
Photo 5. South Cresson Pit (looking west) .

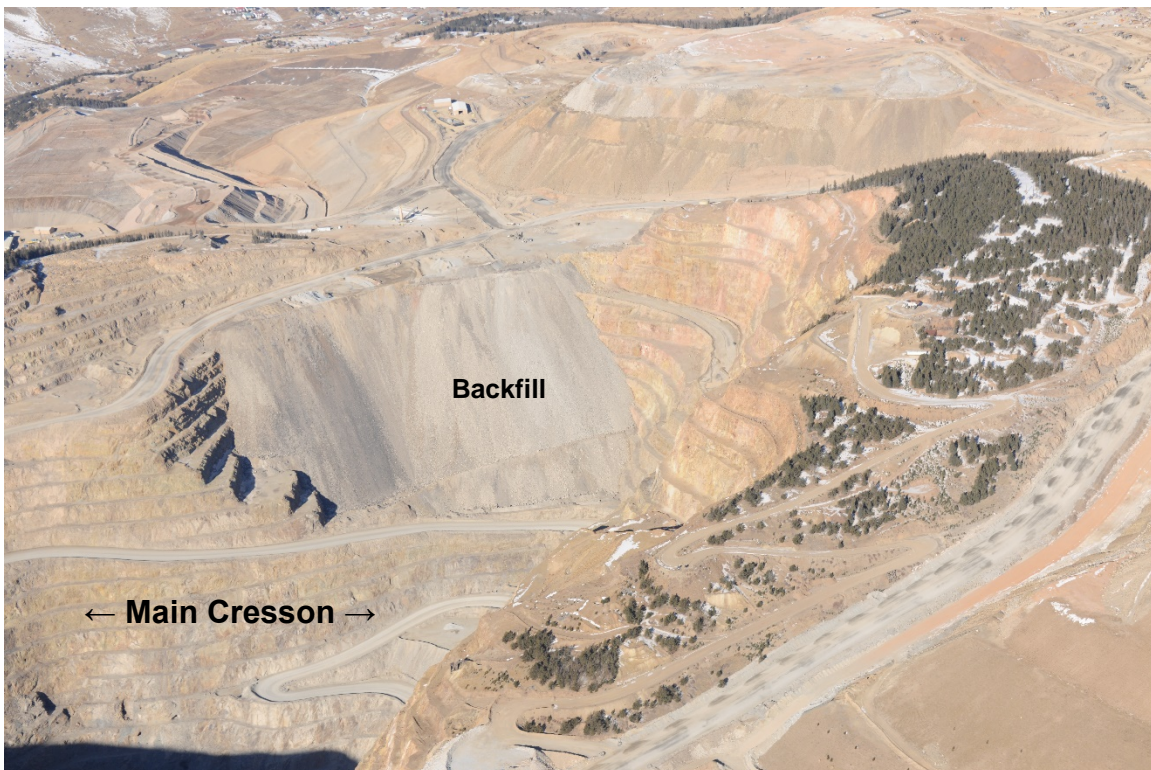
Photo 6. Main Cresson Pit (looking NW)

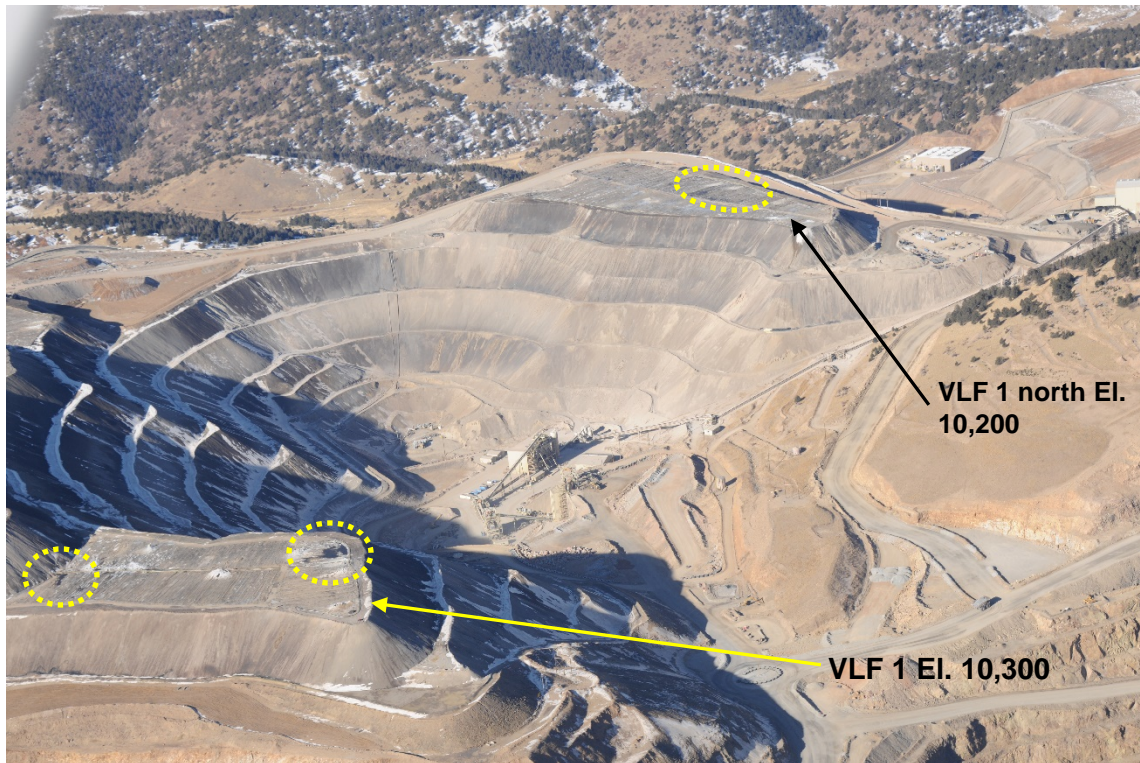
Photo 7. VLF 1/Arequa Gulch VLF (looking west); Possible ponding circled.

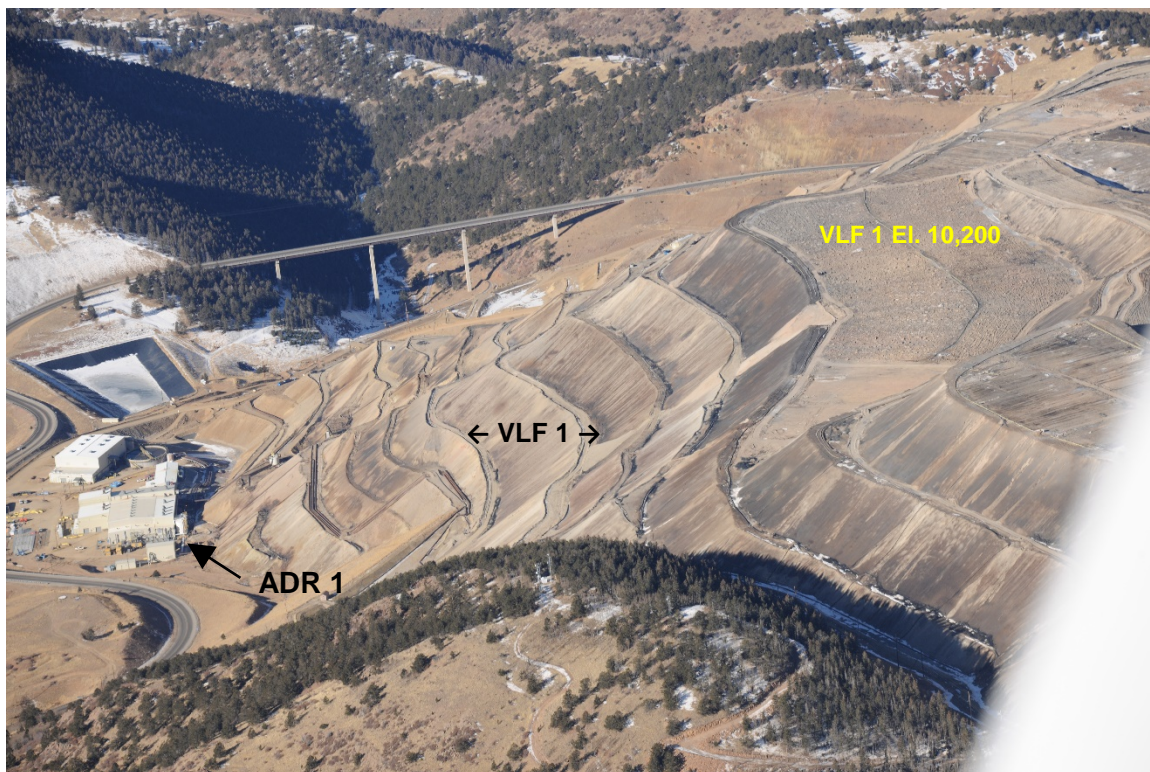
Photo 8. VLF 1/Arequa Gulch VLF (looking west); No visible ponding on South 10,200 level.

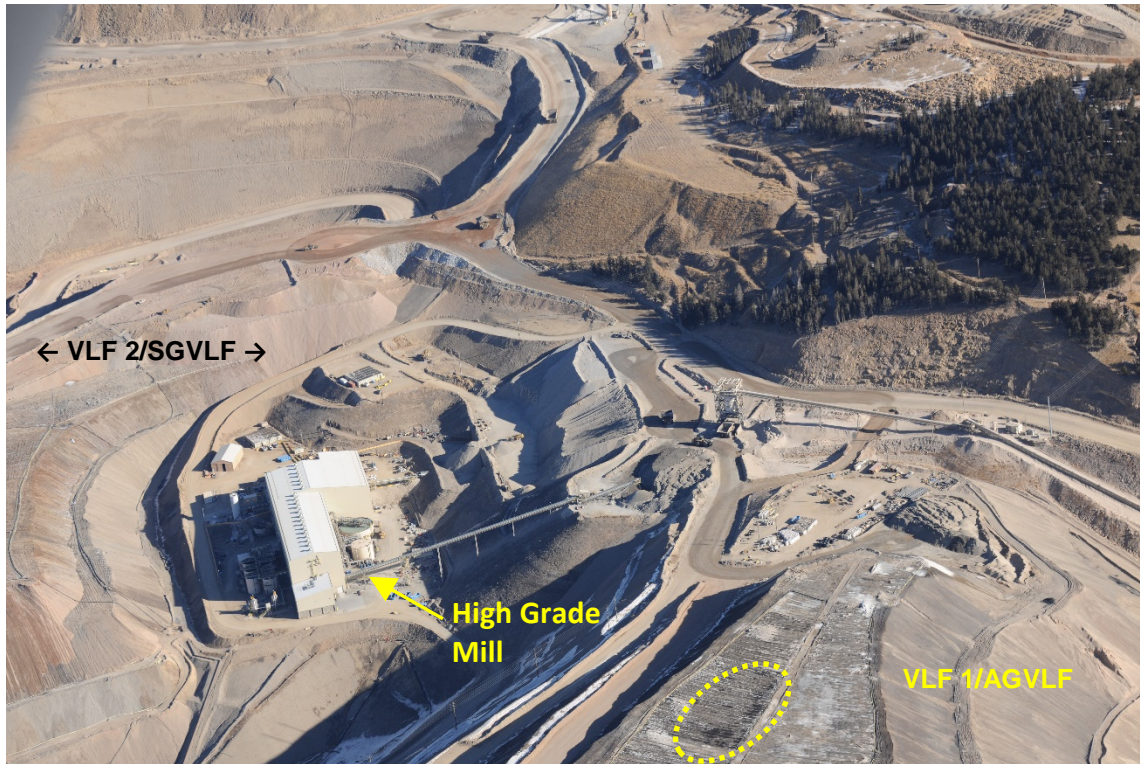
Photo 9. High Grade Mill and VLFs (Looking NE; Possible solution ponding circled).

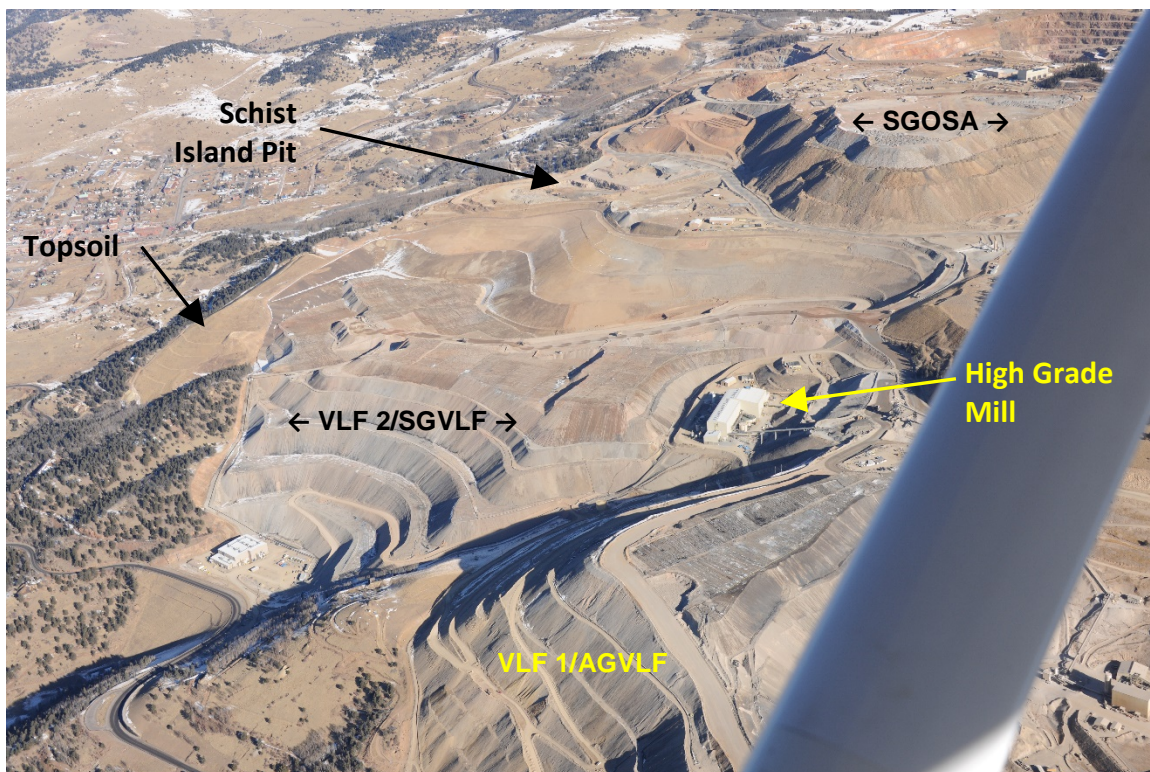
Photo 10. North VLF 2/Squaw Gulch VLF (looking north).

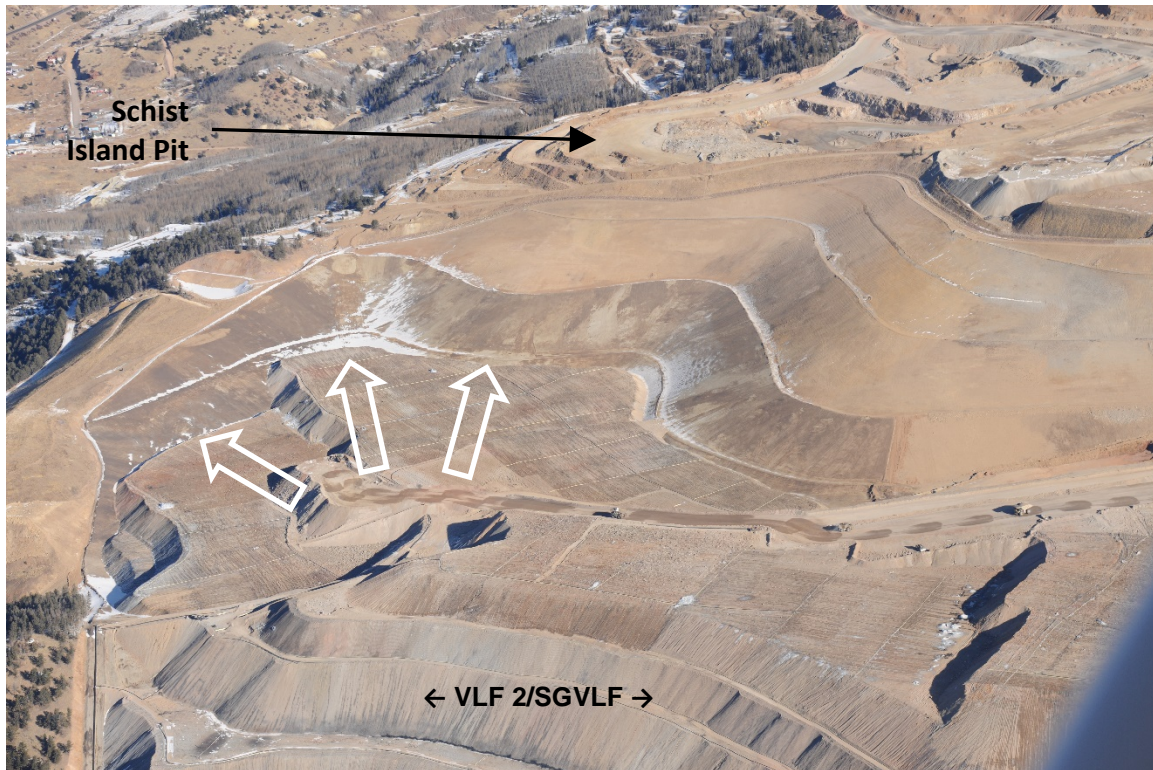
Photo 11	Squaw Gulch VLF (VLF 2) 2 of 2	Looking north	Schist Island beyond, topsoil stockpile on left (<i>note ore stacking appears in compliance</i>).
Photo 12	WHEX pit	Looking SW	Backfill visible on left, Globe Hill pit in upper right.
<u>Acronyms:</u> WHEX – Wildhorse Extension Pit VLF – valley leach facility		ADR – Adsorption, Desorption, Recovery OSA – overburden storage area SG – Squaw Gulch

Photo 11. VLF 2/Squaw Gulch VLF (looking north, arrows show ore stacking direction).

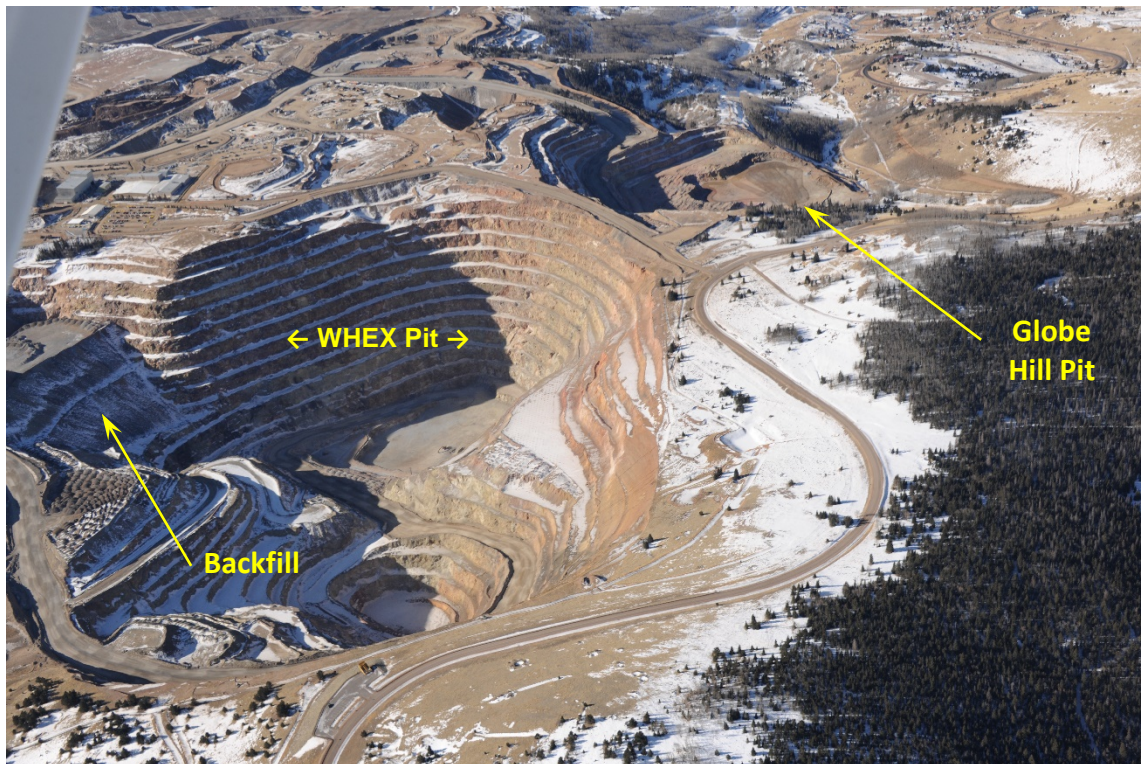
Photo 12. WHEX Pit (Looking SW).
