**MINERALS PROGRAM INSPECTION REPORT**  
**PHONE: (303) 866-3567**

<b>MINE NAME:</b> North River Gravel Pit Extension	<b>MINE/PROSPECTING ID#:</b> M-1999-007	<b>MINERAL:</b> Gravel	<b>COUNTY:</b> Rio Blanco
<b>INSPECTION TYPE:</b> Preoperation Inspection	<b>INSPECTOR(S):</b> Dustin Czaplá	<b>INSP. DATE:</b> February 26, 2020	<b>INSP. TIME:</b> 11:00
<b>OPERATOR:</b> George T. Weldon Construction, LLC	<b>OPERATOR REPRESENTATIVE:</b>	<b>TYPE OF OPERATION:</b> 112c - Construction Regular Operation	
<b>REASON FOR INSPECTION:</b> Preoperation Inspection	<b>BOND CALCULATION TYPE:</b> None	<b>BOND AMOUNT:</b> \$25,900.00	
<b>DATE OF COMPLAINT:</b> NA	<b>POST INSP. CONTACTS:</b> None	<b>JOINT INSP. AGENCY:</b> None	
<b>WEATHER:</b> Cloudy	<b>INSPECTOR'S SIGNATURE:</b>

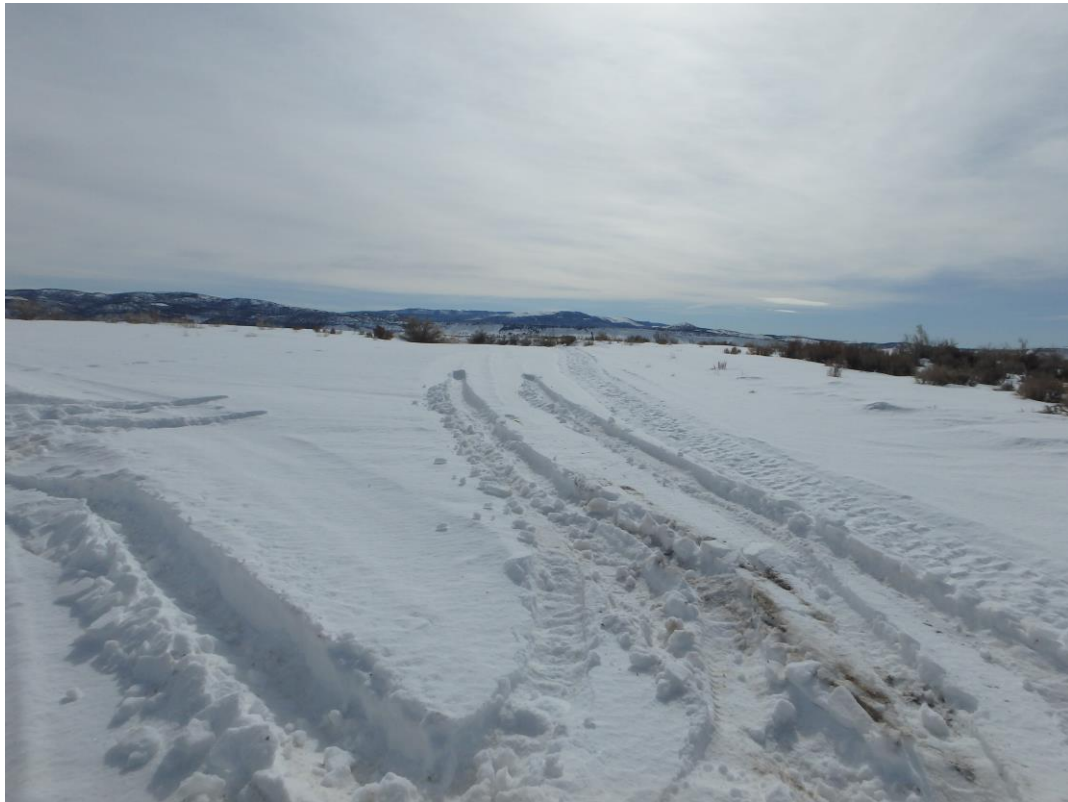
### **Access Road 2/26/2020:**

This inspection was conducted as part of the review process for the 112c conversion application (CN-1) that was submitted to the Division of Reclamation, Mining and Safety's (Division) on October 4, 2019. Pursuant to Rule 3.2 (7), 110c operations applying for 112c conversion shall be inspected after the application is filed and prior to Board consideration. On the date of this attempted inspection significant snow amount still covered the access road, preventing access to the site. Therefore, the inspector was unable to reach the site in order to conduct the required inspection. Another attempt to inspect the site will be made once the snow has cleared enough to allow access to the site.
