TRAPPER MINING INC.  
CRAIG, COLORADO

# **Horse Gulch Fill Quarterly Inspection Report**

**First Quarter 2020**

March 25, 2020

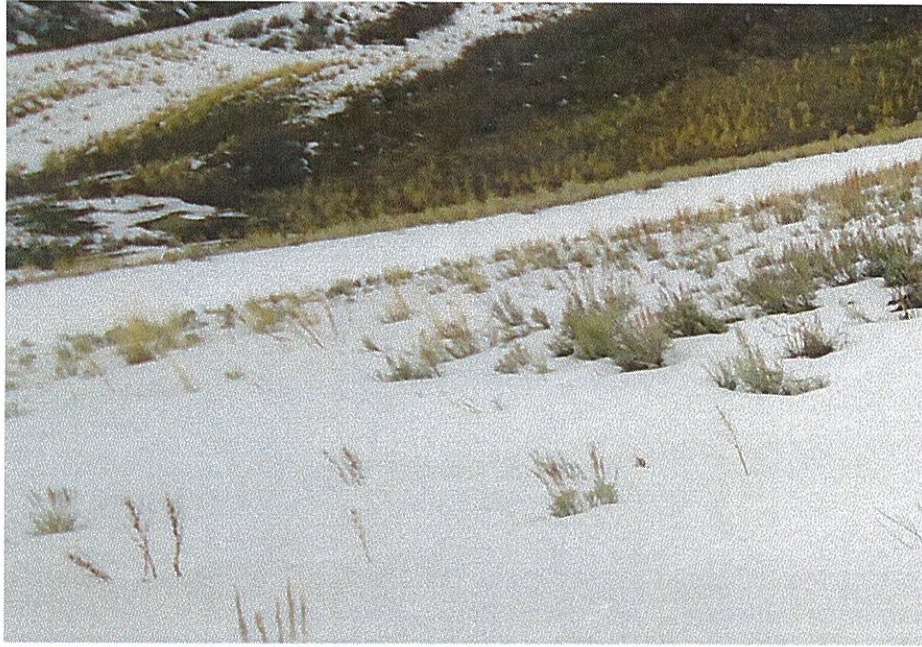
*Photograph 2: North Site above the 7350 Bench Elevation (3/23/2020)*

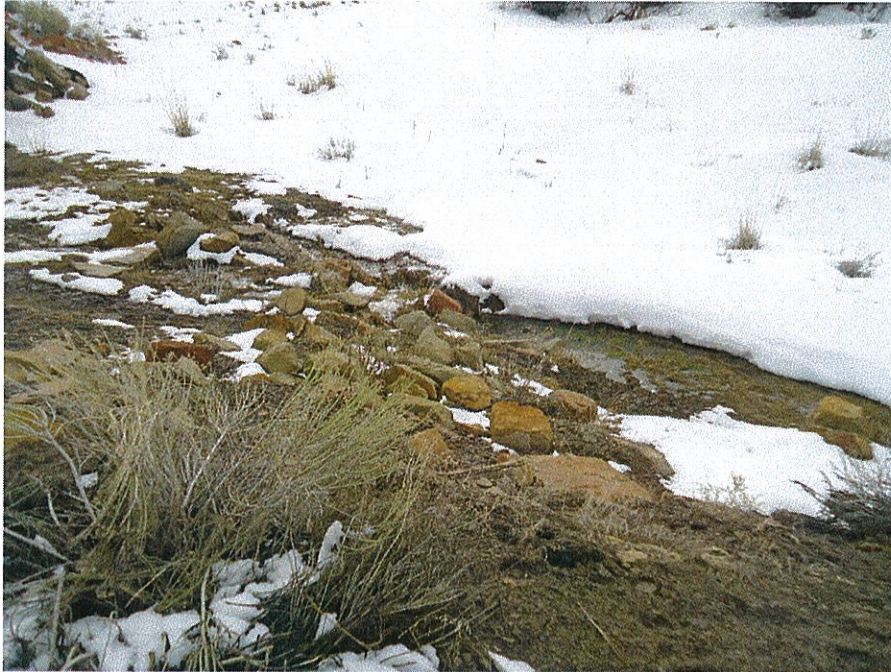
The underdrainage system was completed in the first quarter of 2010; additional work on this system is not anticipated. During the time of the inspection, there was approximately a tenth of a gallon per minute of water flow. (Photograph 3).

*Photograph 3: Water from the Underdrainage System (3/23/2020)*

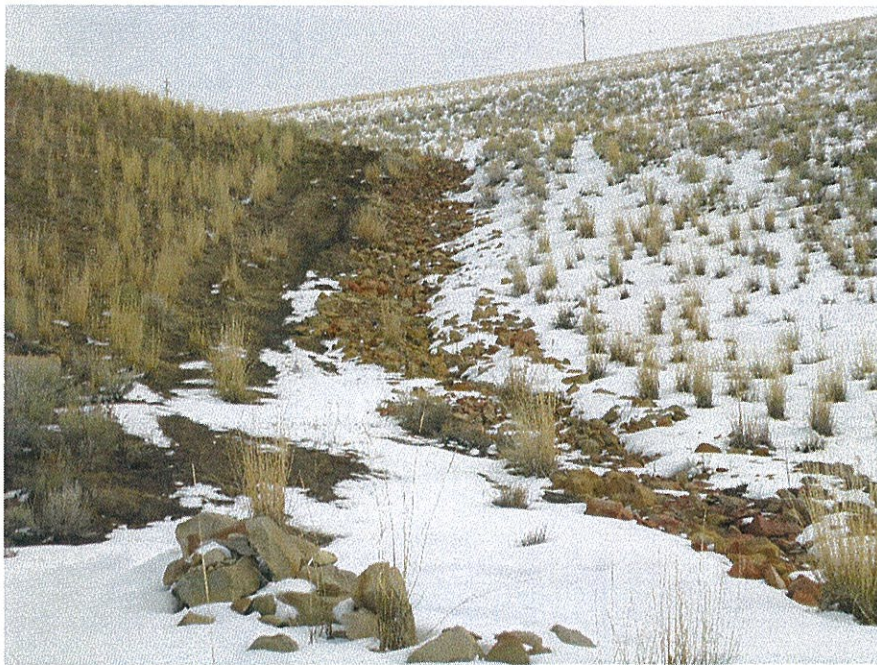
Both the north and south surface drains were inspected (Photographs 4 and 5). At the time of the inspection there was no water flow.

*Photograph 4: North Surface Drain Looking East (3/23/2020)*

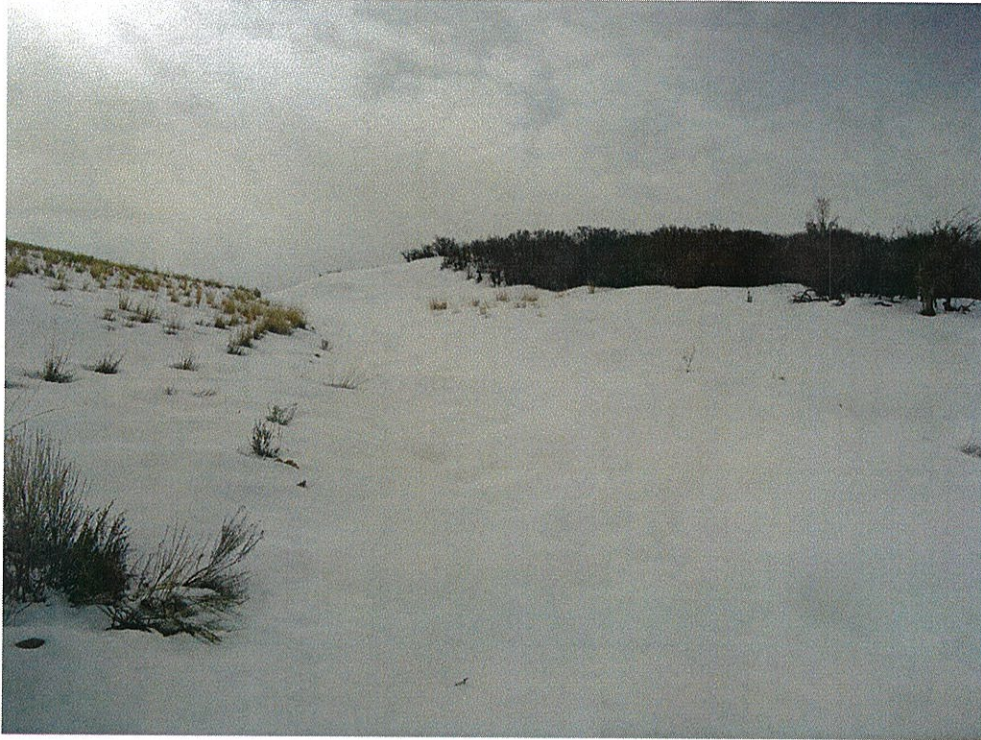
*Photograph 5: South Surface Drain Looking East (3/23/2020)*

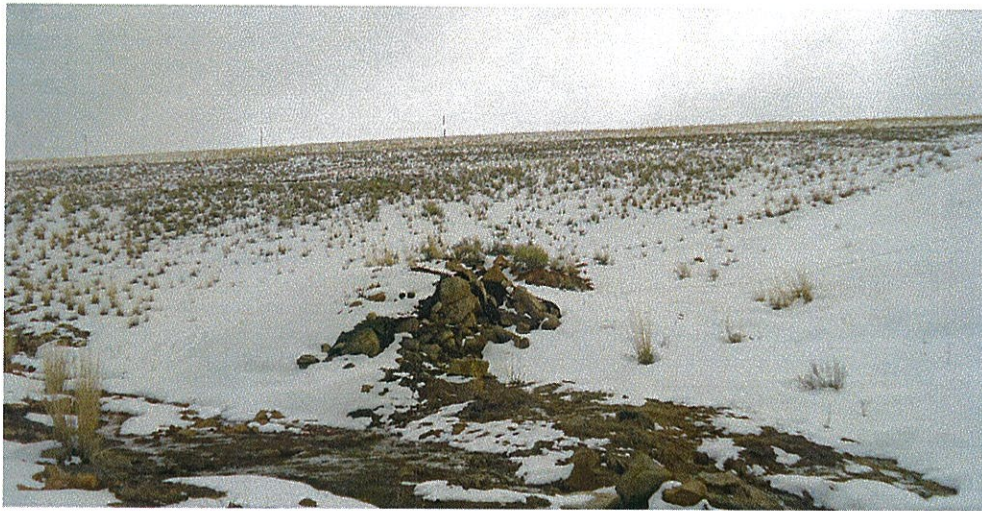
Photograph 6 depicts the west facing slope of the fill in the area where the slope of the fill is at 3H: 1V.

*Photograph 6: West Side Fill 3H: 1V Face Looking East (3/23/2020)*
