**NEW ELK MINE**  
**Permit No. C-1981-012**

**QUARTERLY COAL WASTE BANK INSPECTION REPORT**  
**March 5, 2020**

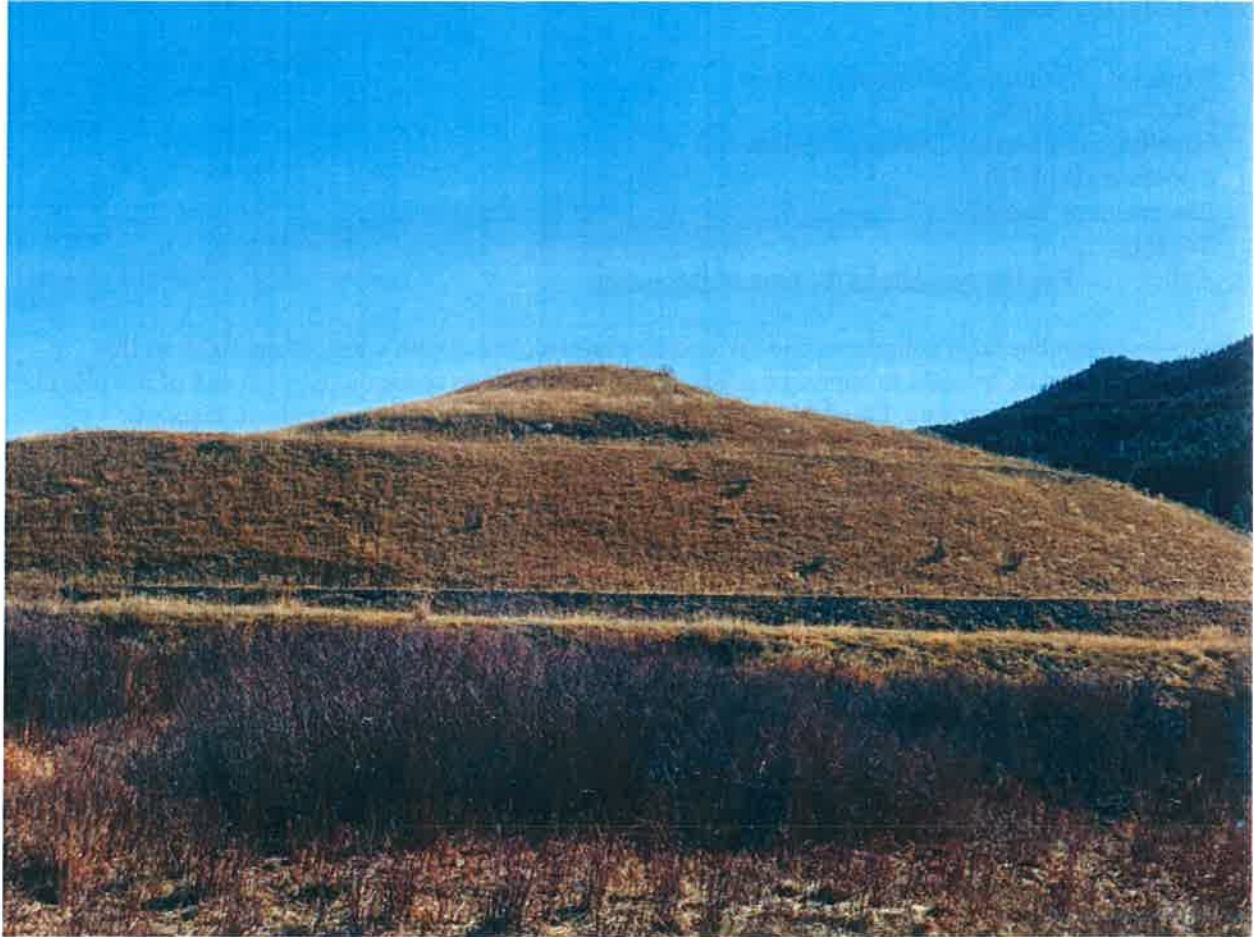
Overall the disposal area is in good condition.

**DWDA #1 – West Facing Slope**

None at this time.

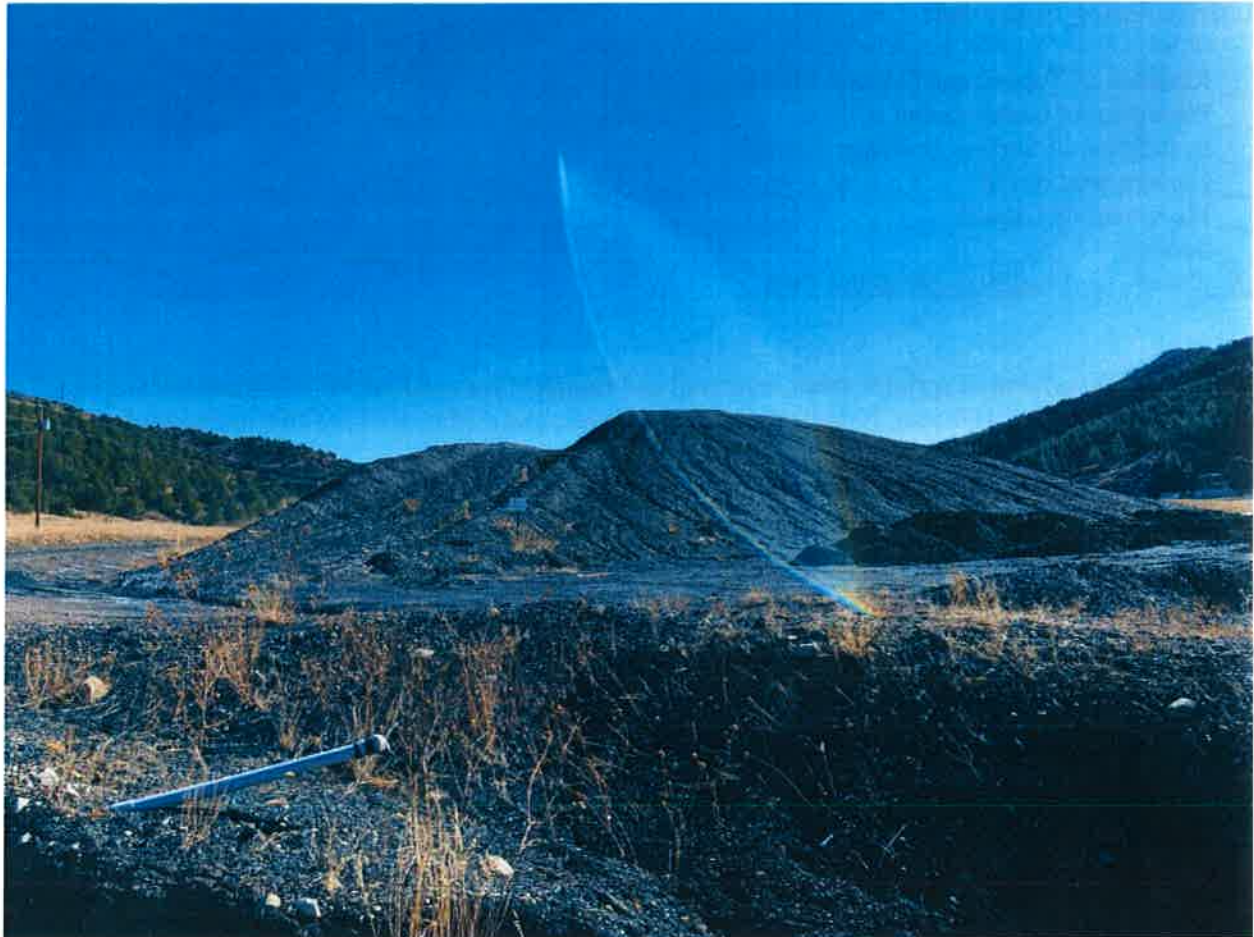
Surface and out slopes of the pile were inspected for visible signs of potential failure or instability. There was some surface erosion but not enough to make the area unstable. In all no signs of failure or instability were observed.

Overall the disposal area is in good condition.

**DWDA #2 – South and West Facing Slopes**

The Rills are being monitored and have not gotten any bigger and there is no sediment loading. Operator is evaluating either reclamation of the area or permitting alternative uses of the land north of the Purgatoire River and south of Highway 12.

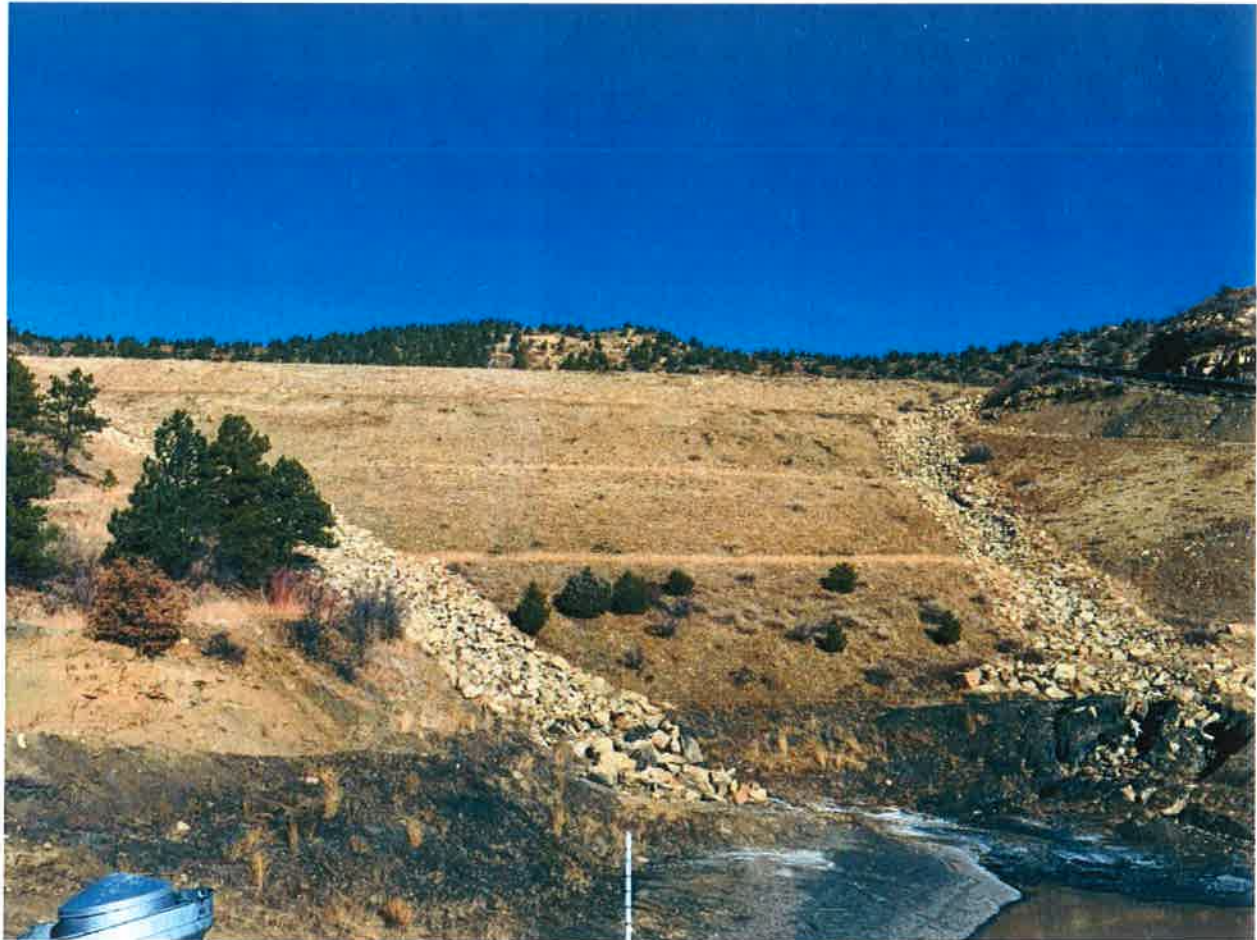
Overall the site is in good condition.

**Refuse Disposal Area – Reclaimed Benches and Armored Drainage**

None required at this time.
