QUARTERLY SEDIMENTATION POND INSPECTION REPORT

CDMR Rule 4.05.9(17)

Mine: New Elk
NPDES ID. No.: Pond #1
Inspection Period: First Quarter 2020
Inspection Date: 3/5/2020

QUARTERLY SEDIMENTATION POND INSPECTION REPORT
New Elk Mine- March 5, 2020

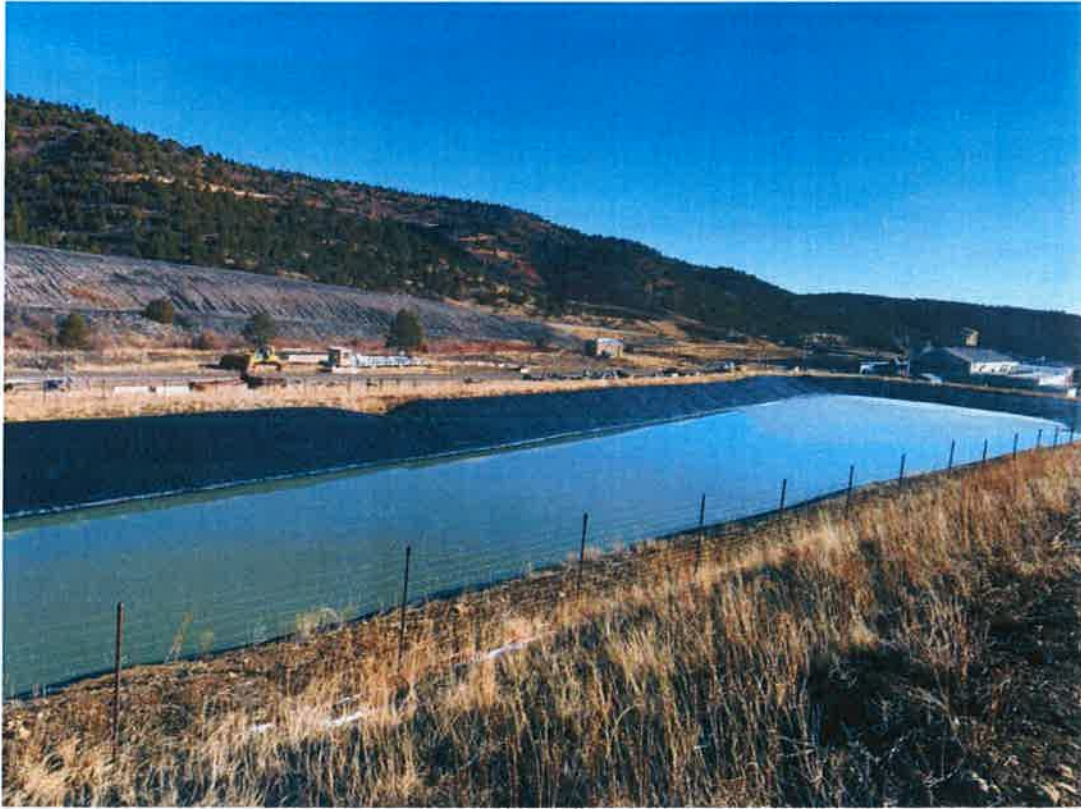
Pond 1

Pond liner is in good working condition at time of inspection. Pond was holding water at time of

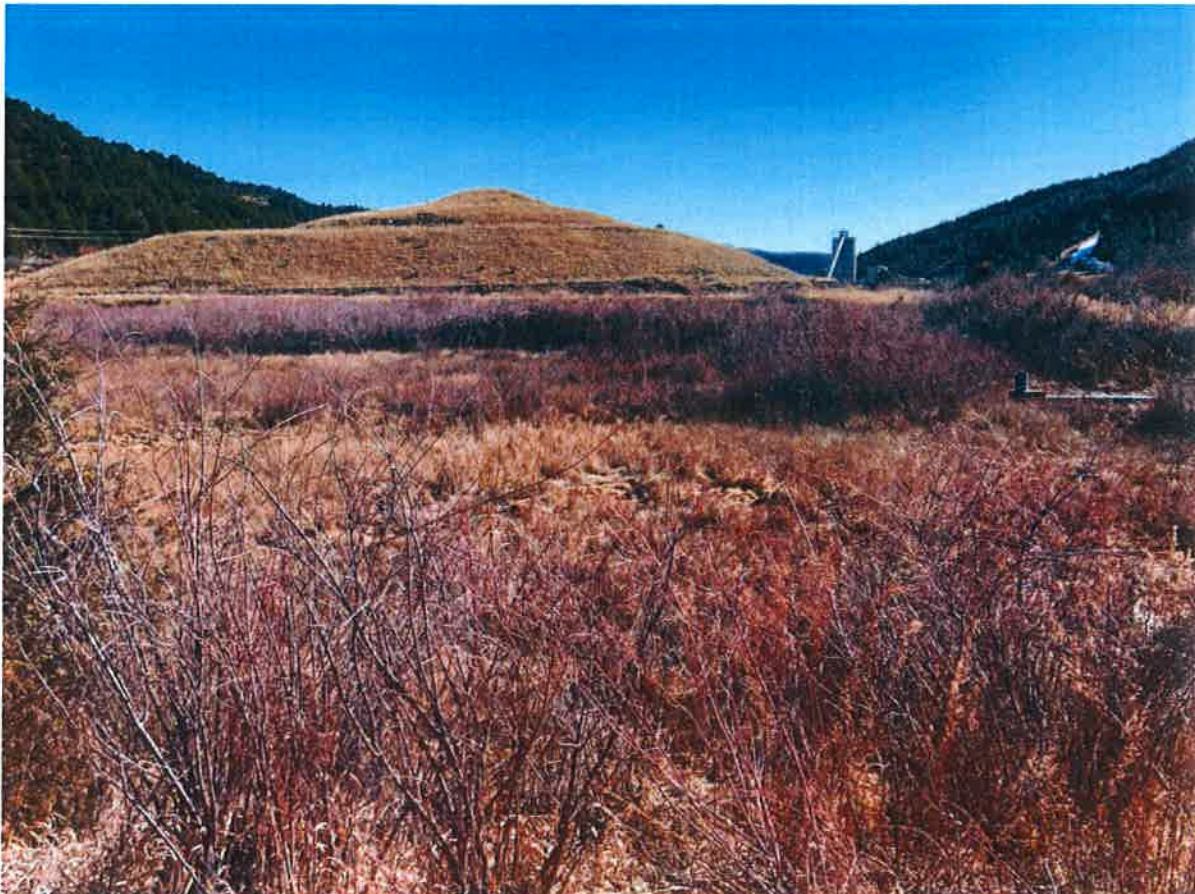
Pond 4

Pond is holding a little amount water but is not close to discharging.

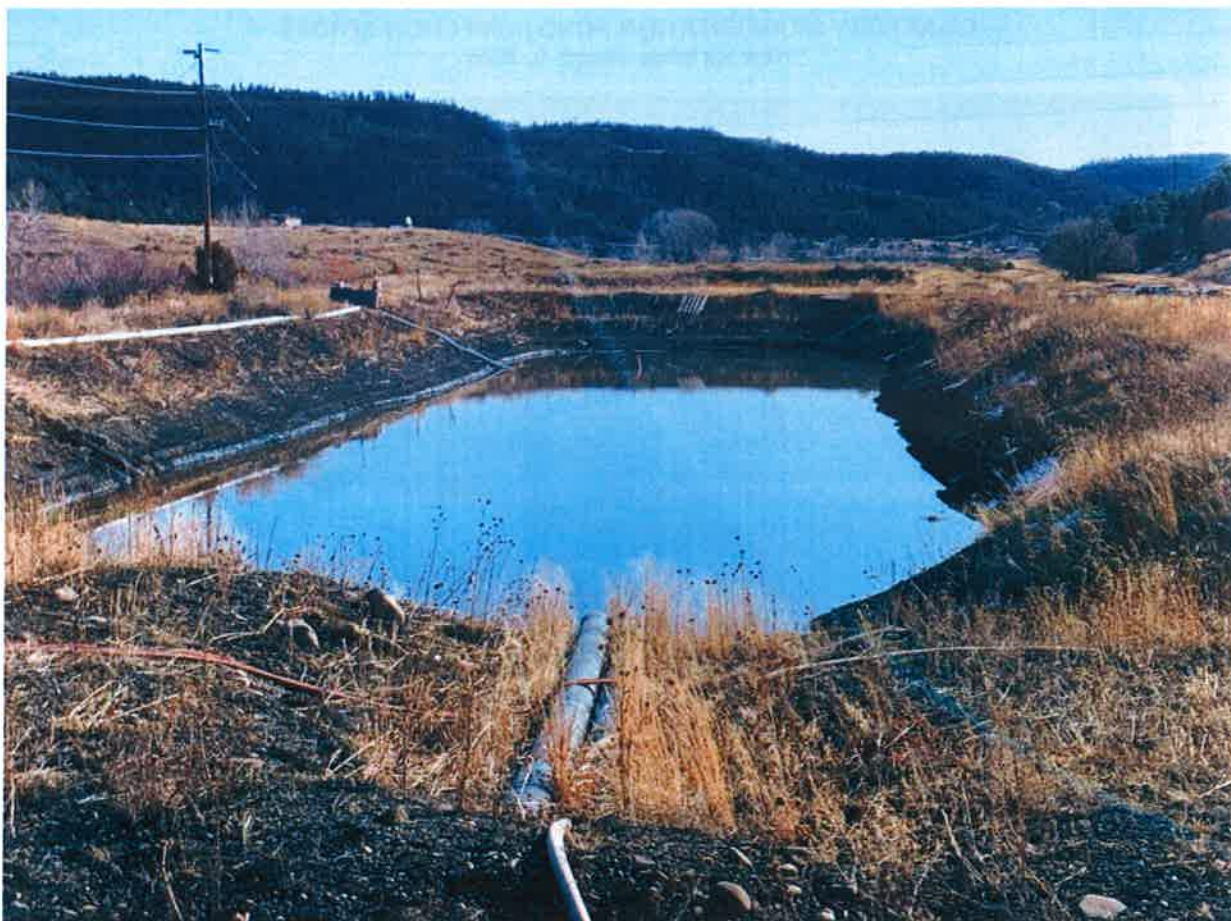
Pond 6

Pond is holding water, not close to full.

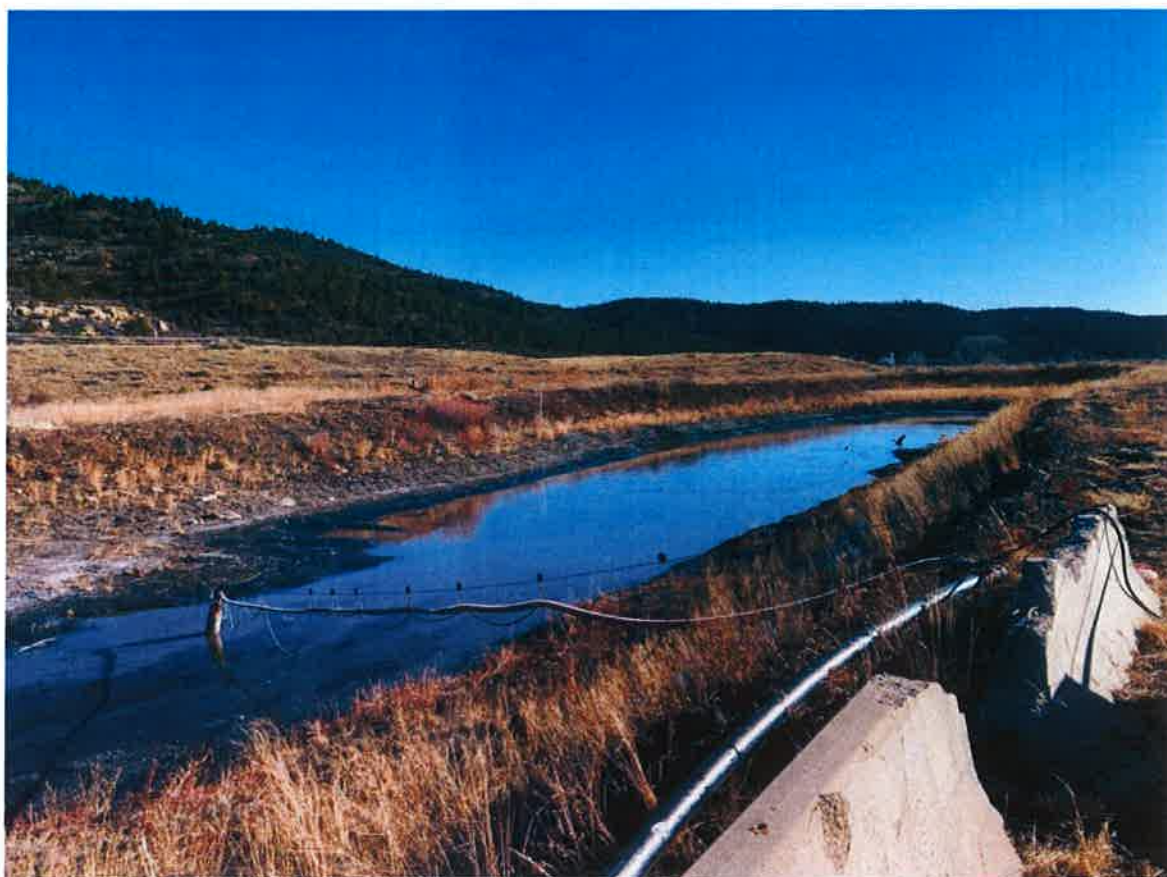
Pond 7

Pond is holding somewater, not near the max water level. Holding about 6 inches of sediment.

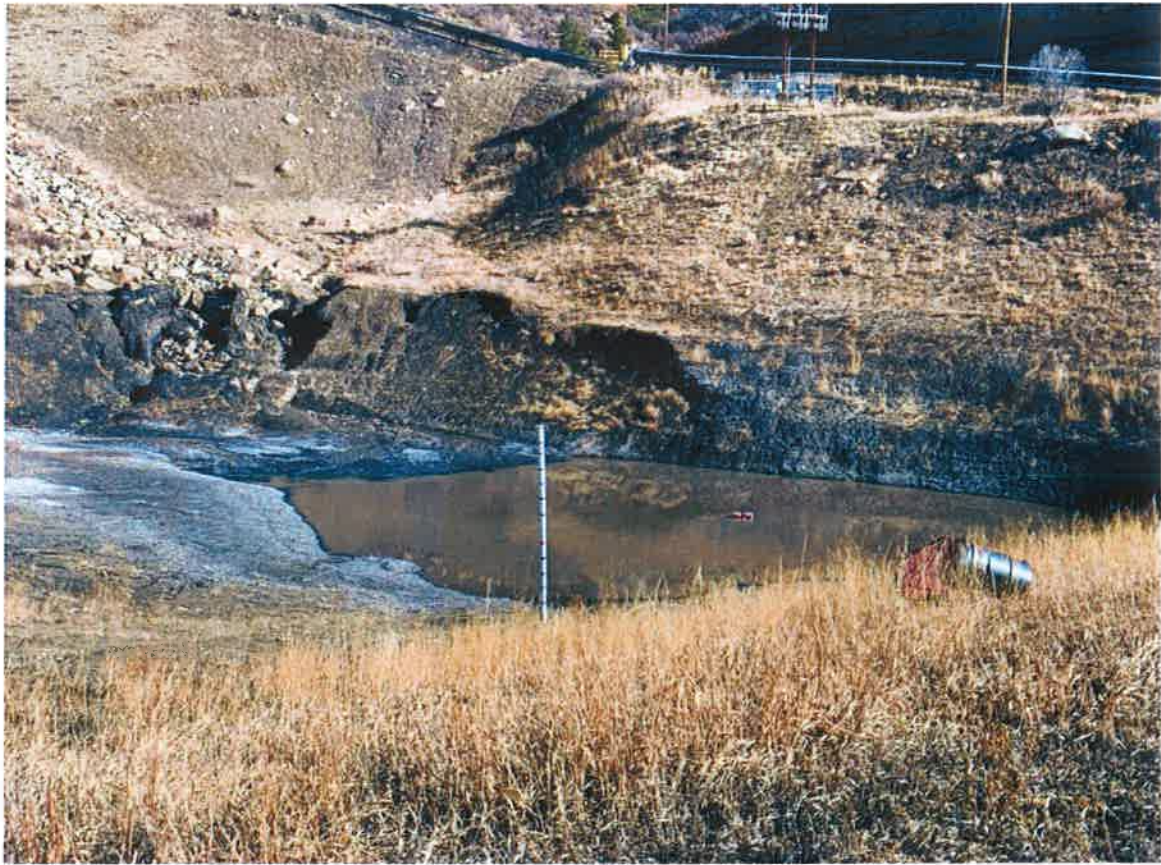
Pond 8

Pond is holding water, not near the decant level. No new sediment has been deposited.

Very little sediment in the pond.

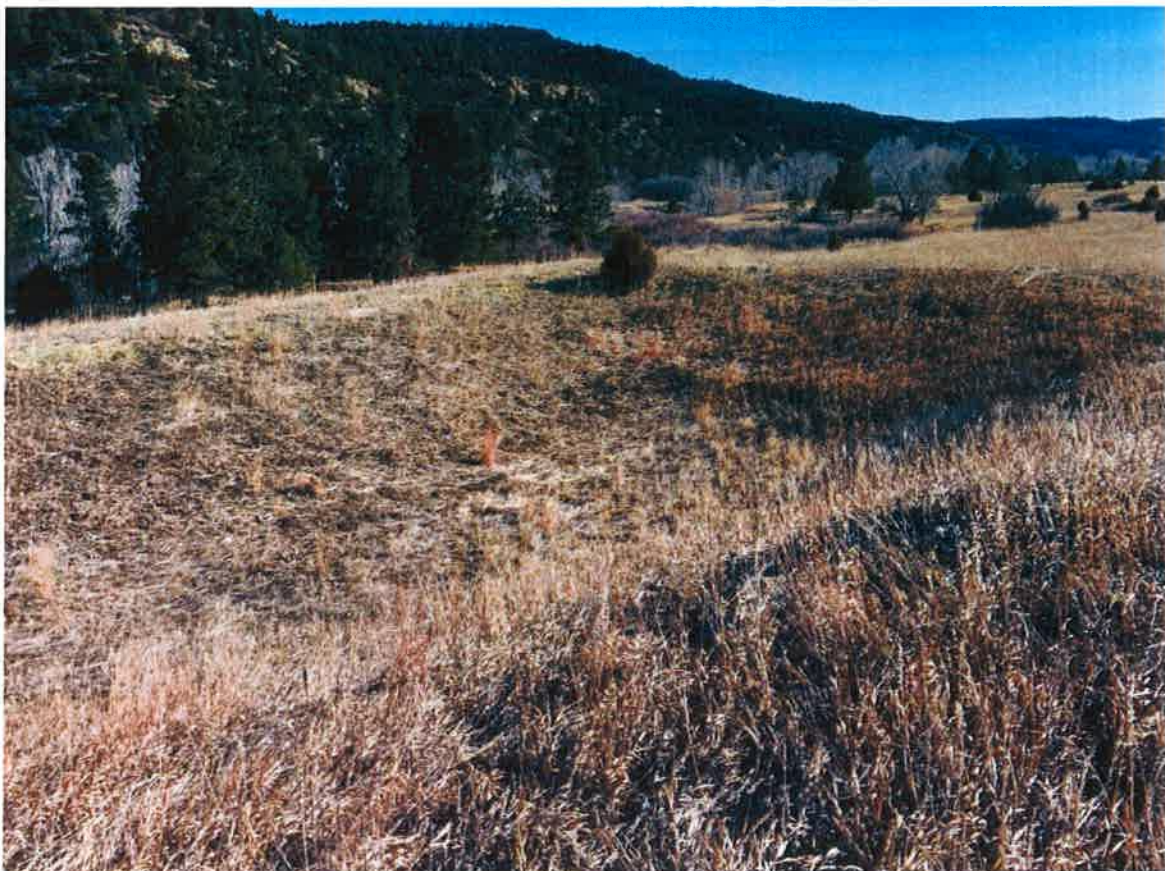
Containment Area #1

Containment area has little water, water is frozen.

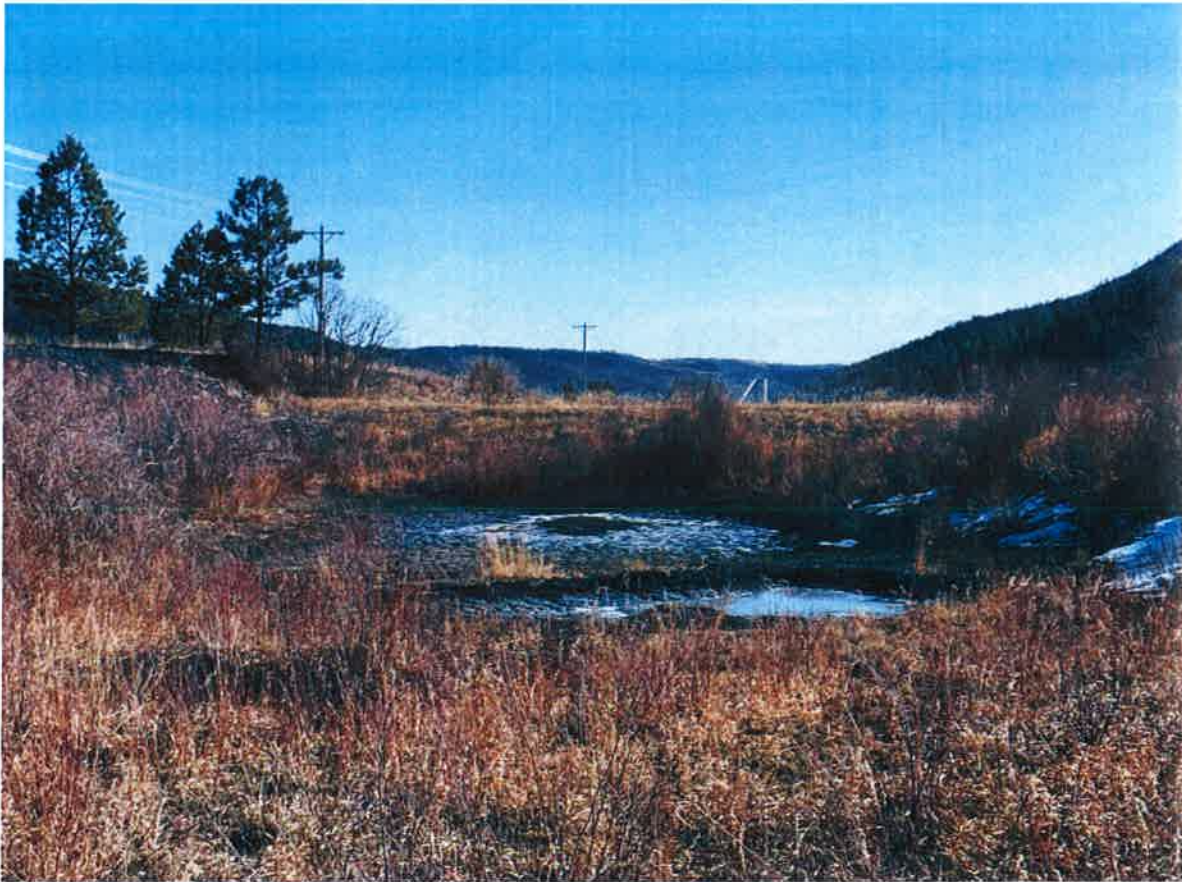
Containment Area #2

Containment is empty.

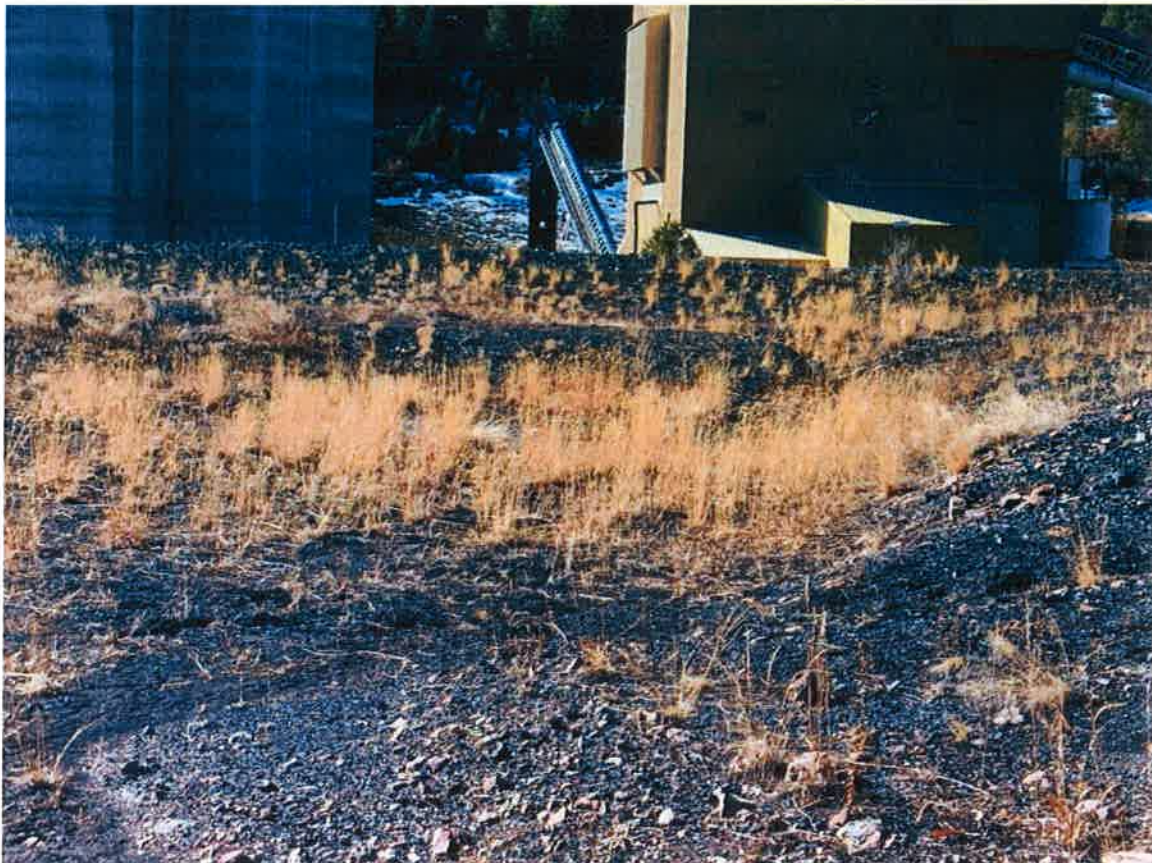
Containment Area #3

Containment Area is dry.

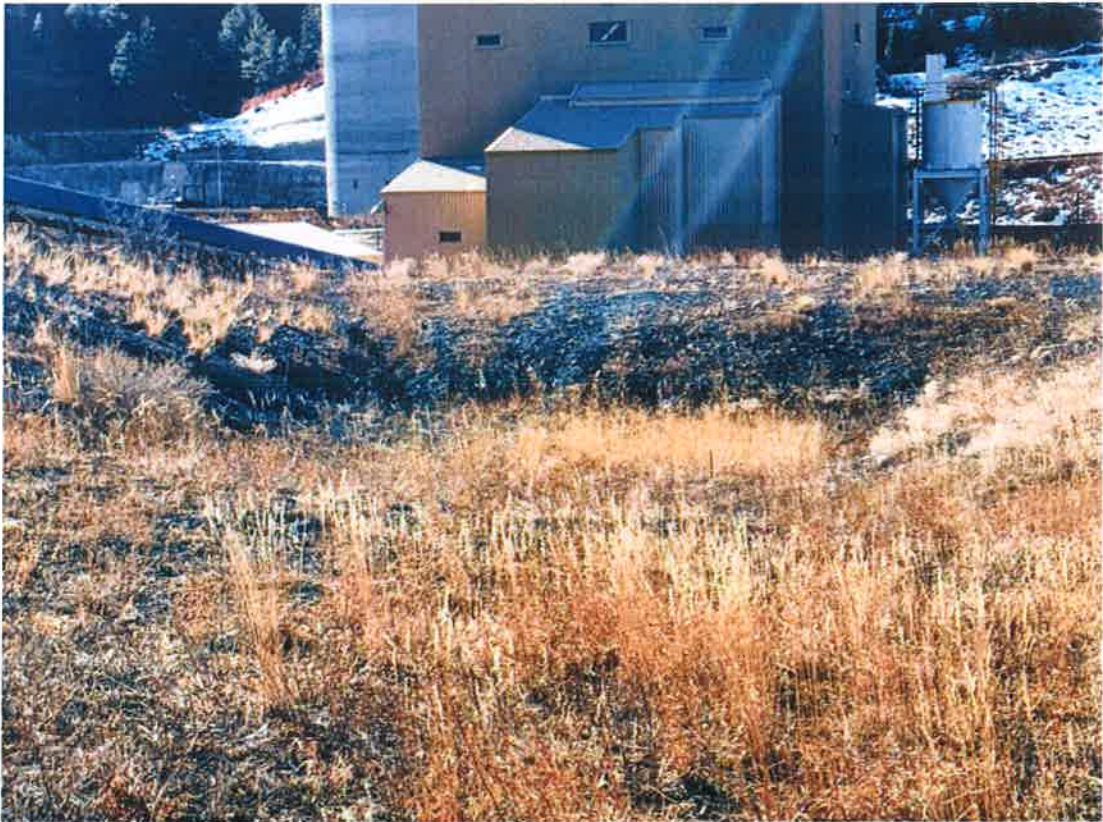
Containment Area #4

Containment Area is dry.

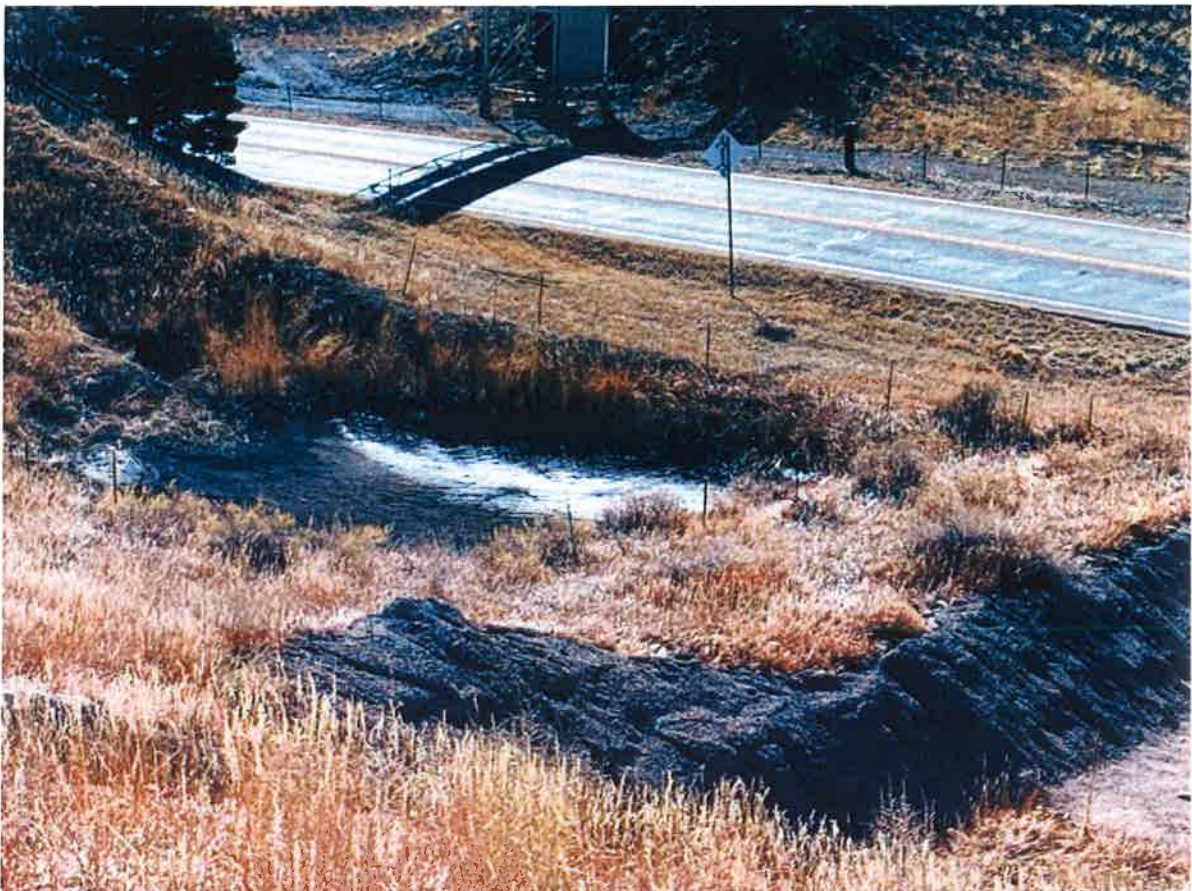
Containment Area #5

Containment Area is empty. Sediment will be cleaned from containment within 2 months.
