QUARTERLY SEDIMENTATION POND INSPECTION REPORT

Mine: Lorencito

Inspection Period: First Quarter 2020

QUARTERLY SEDIMENTATION POND INSPECTION REPORT
Lorencito Canyon Mine- March 5, 2020

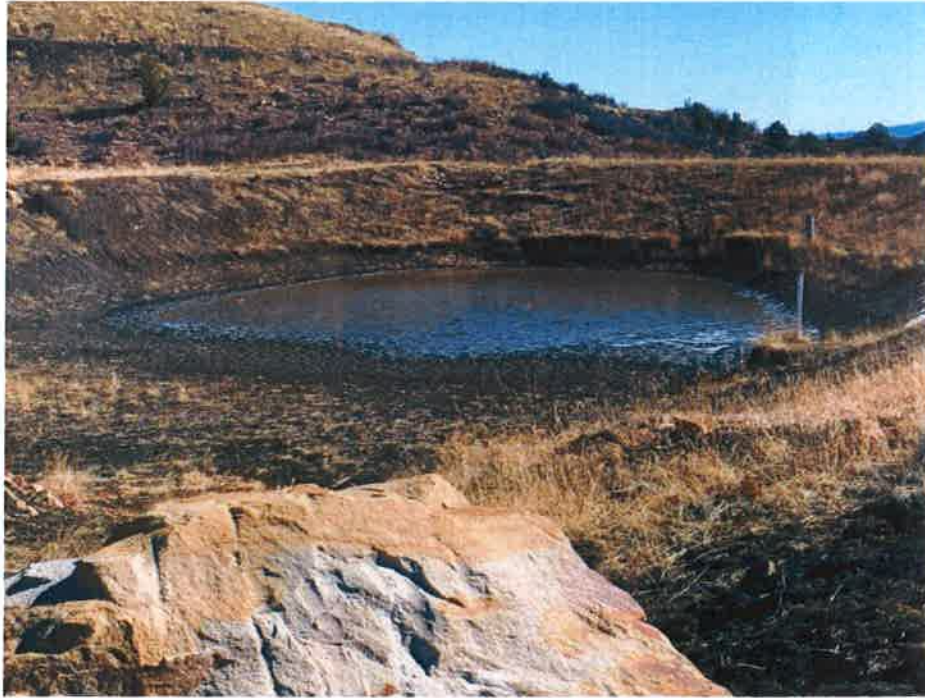
Pond 6

Pond is holding water. Water level is well below the decant.

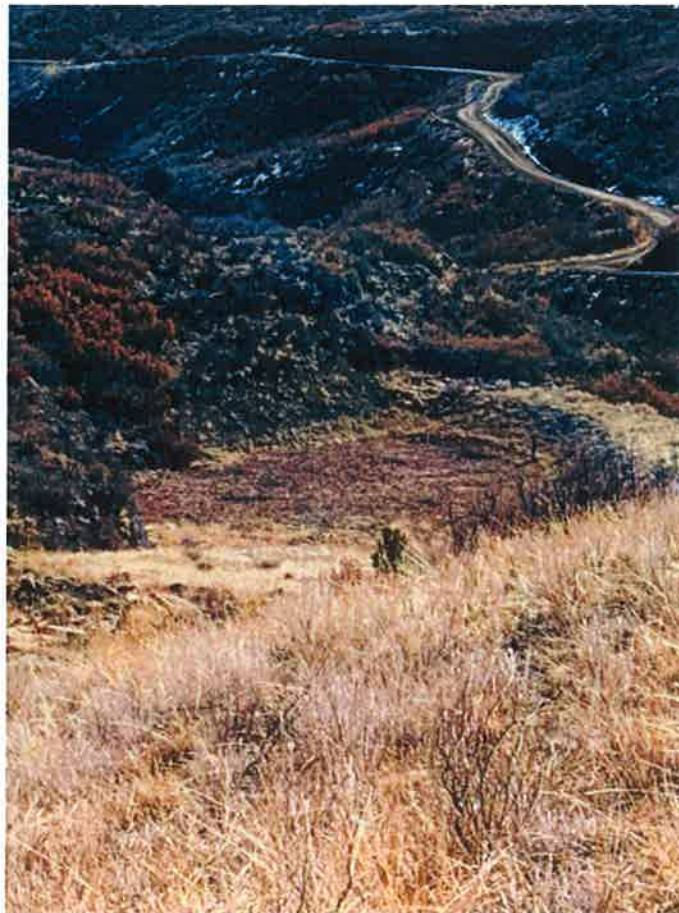
Pond 7

Pond empty at time of inspection. _____

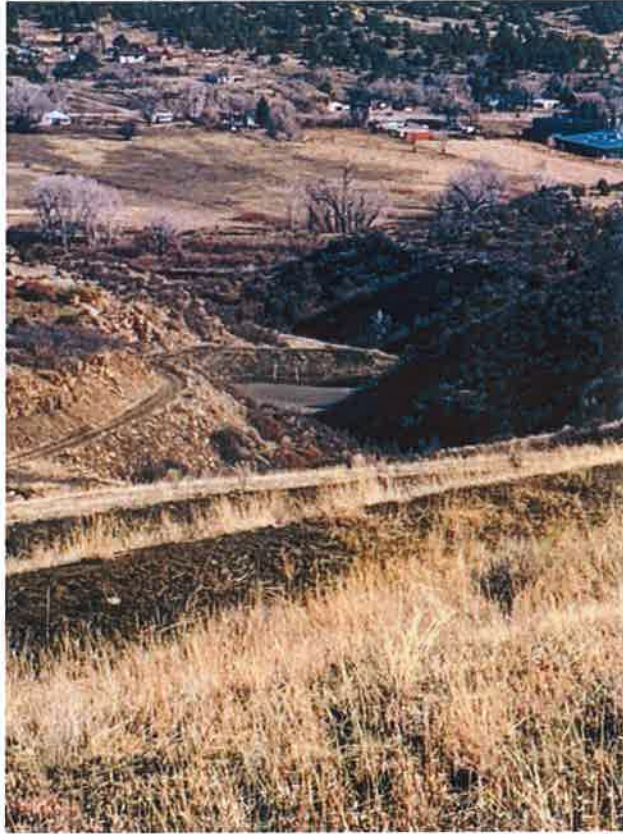
Pond 8

Pond empty at time of inspection.

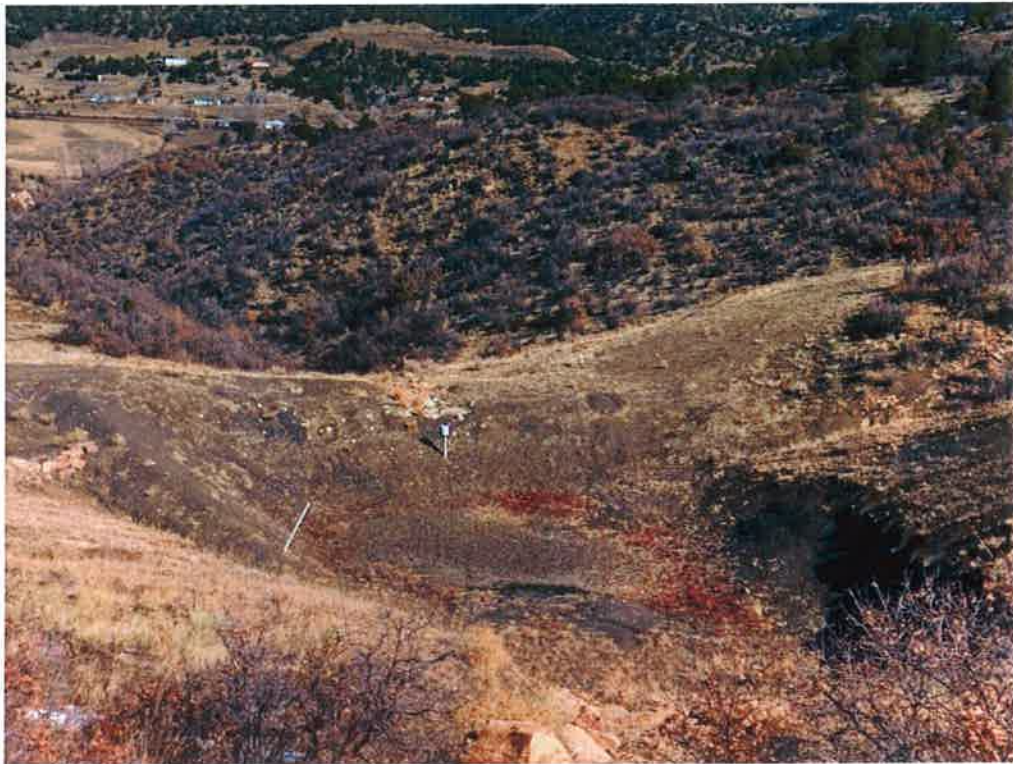
Pond 9

Pond empty at time of inspection.

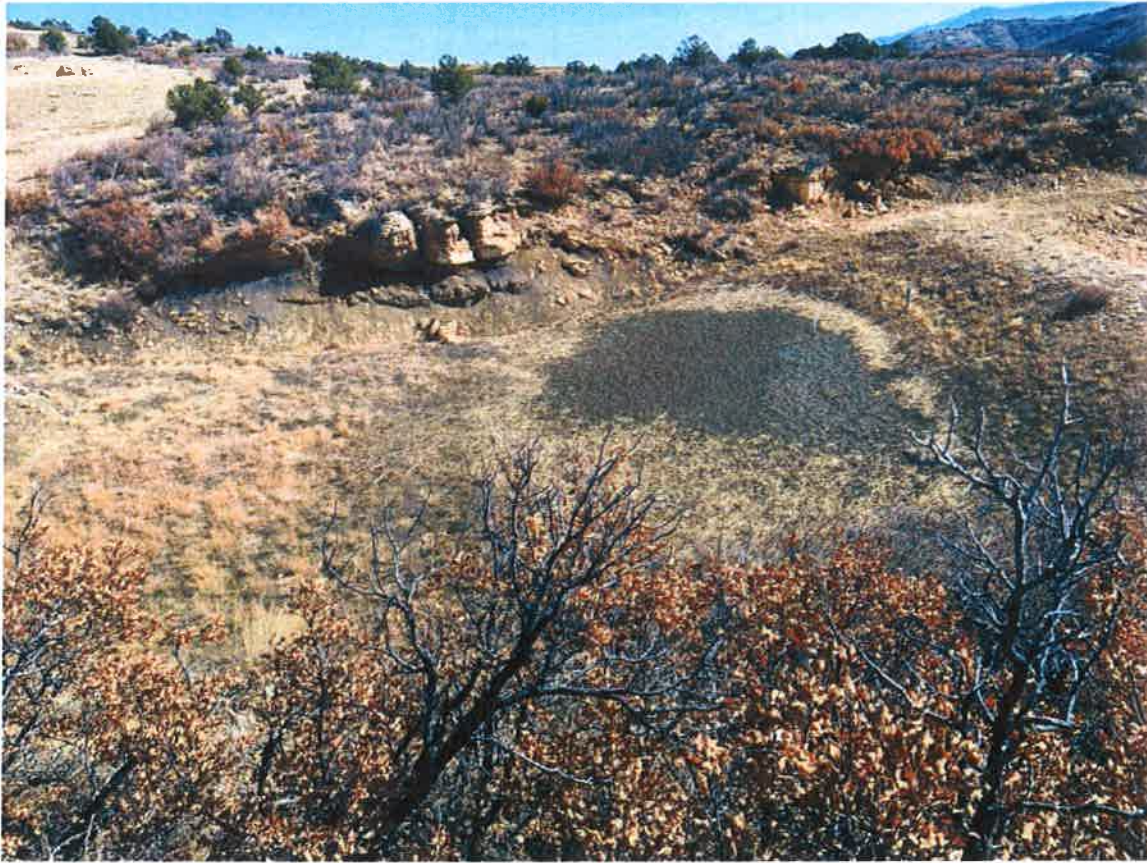
Pond 9a

Pond was not holding water at time of inspection.
