**LORENCITO CANYON MINE**  
**Permit No. C-1996-084**

**INSPECTION OF EXCESS SPOIL-FILLS 7, 8, & 9**  
**March 5, 2020**

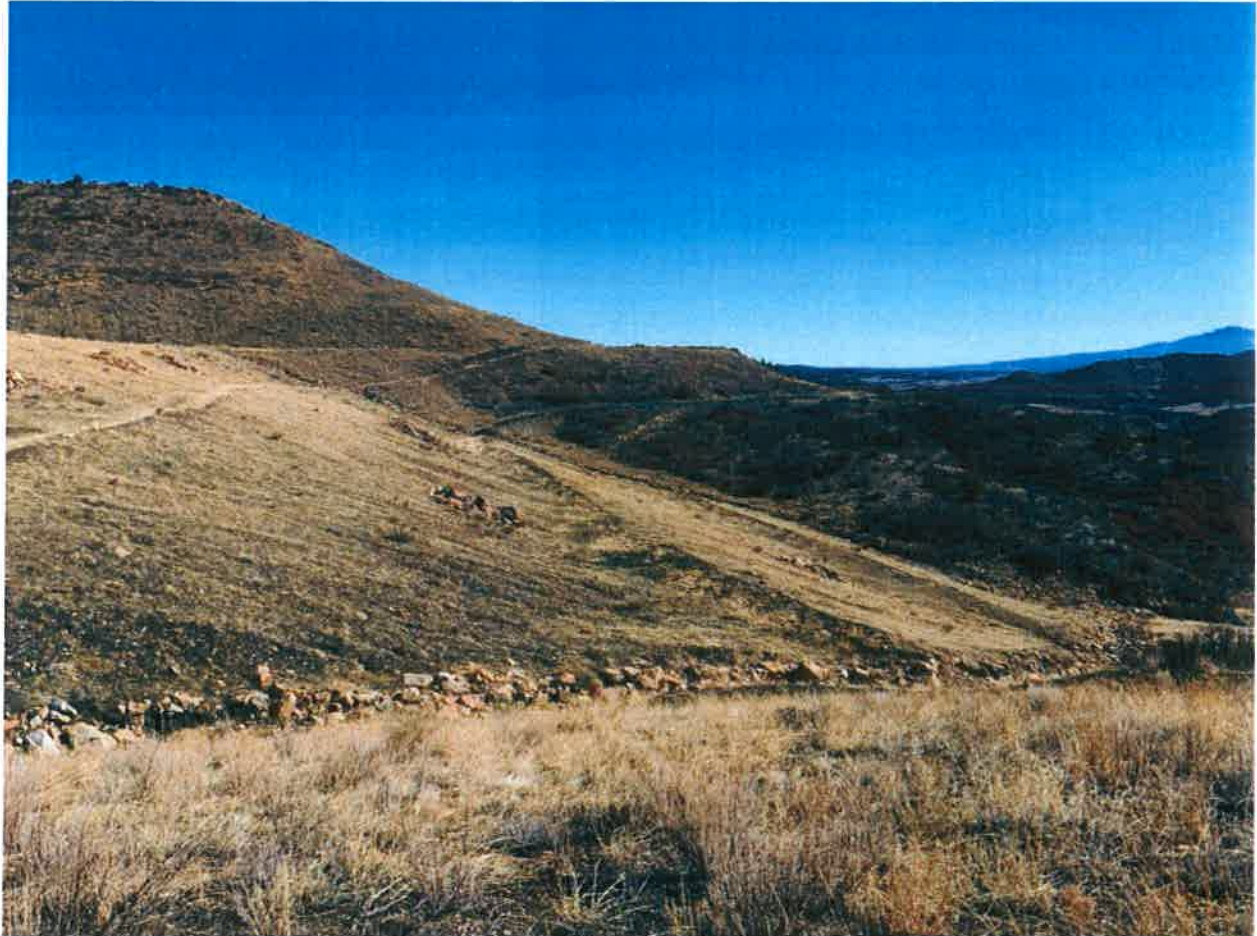
**Fill #7**

The entire excess spoil fill facility was examined for signs of failure and instability such as tension cracks, ground movement, springs and seeps, and standing water. There was no indication of potential instability at time of inspection.

Overall the site is in good condition. The vegetation on the fill is encouraging.

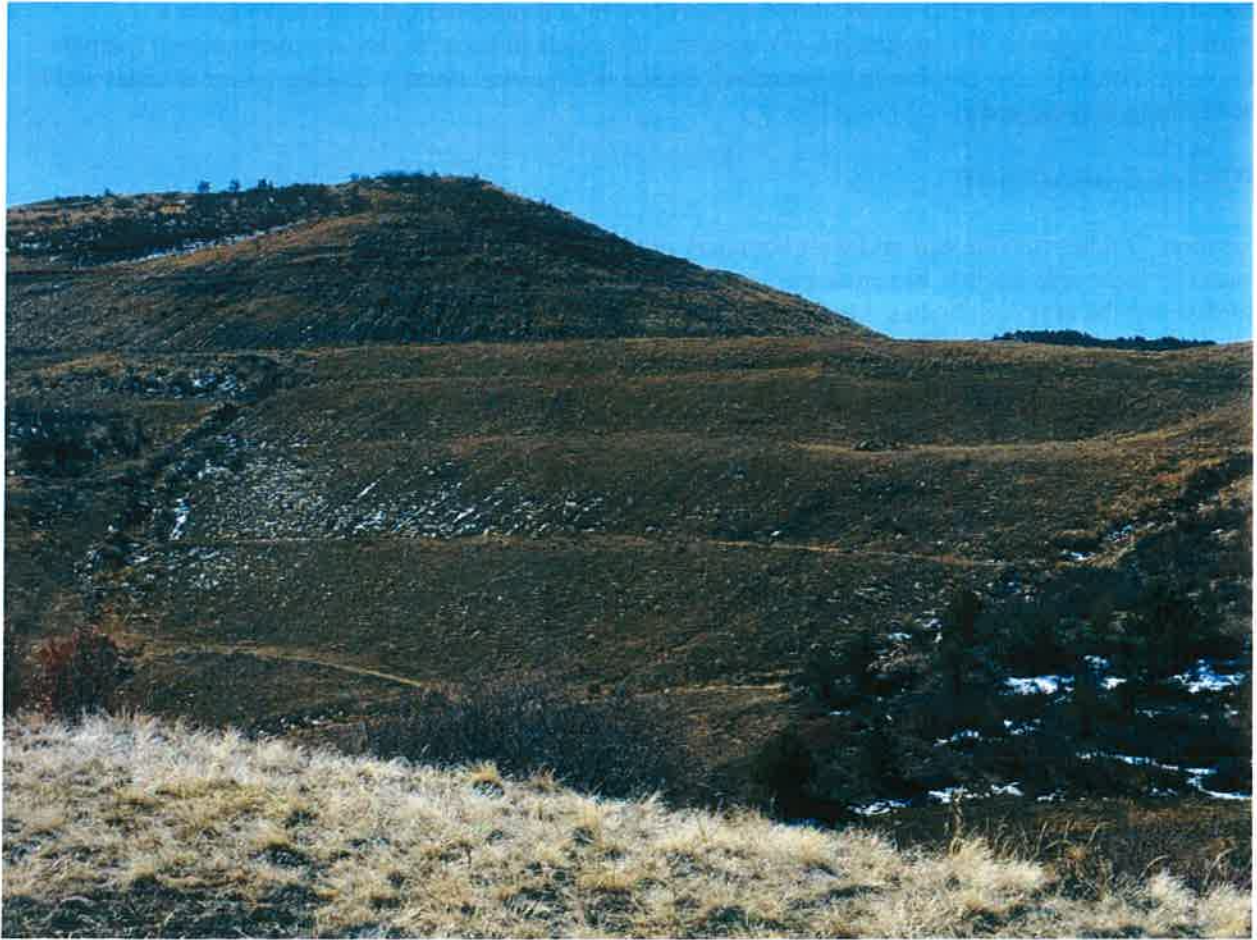
**Fill #8**

The entire excess spoil fill facility was examined for signs of failure and instability such as tension cracks, ground movement, springs and seeps, and standing water. There was no indication of potential instability at time of inspection.

Overall the site is in good condition. Vegetation is very good on the fill.

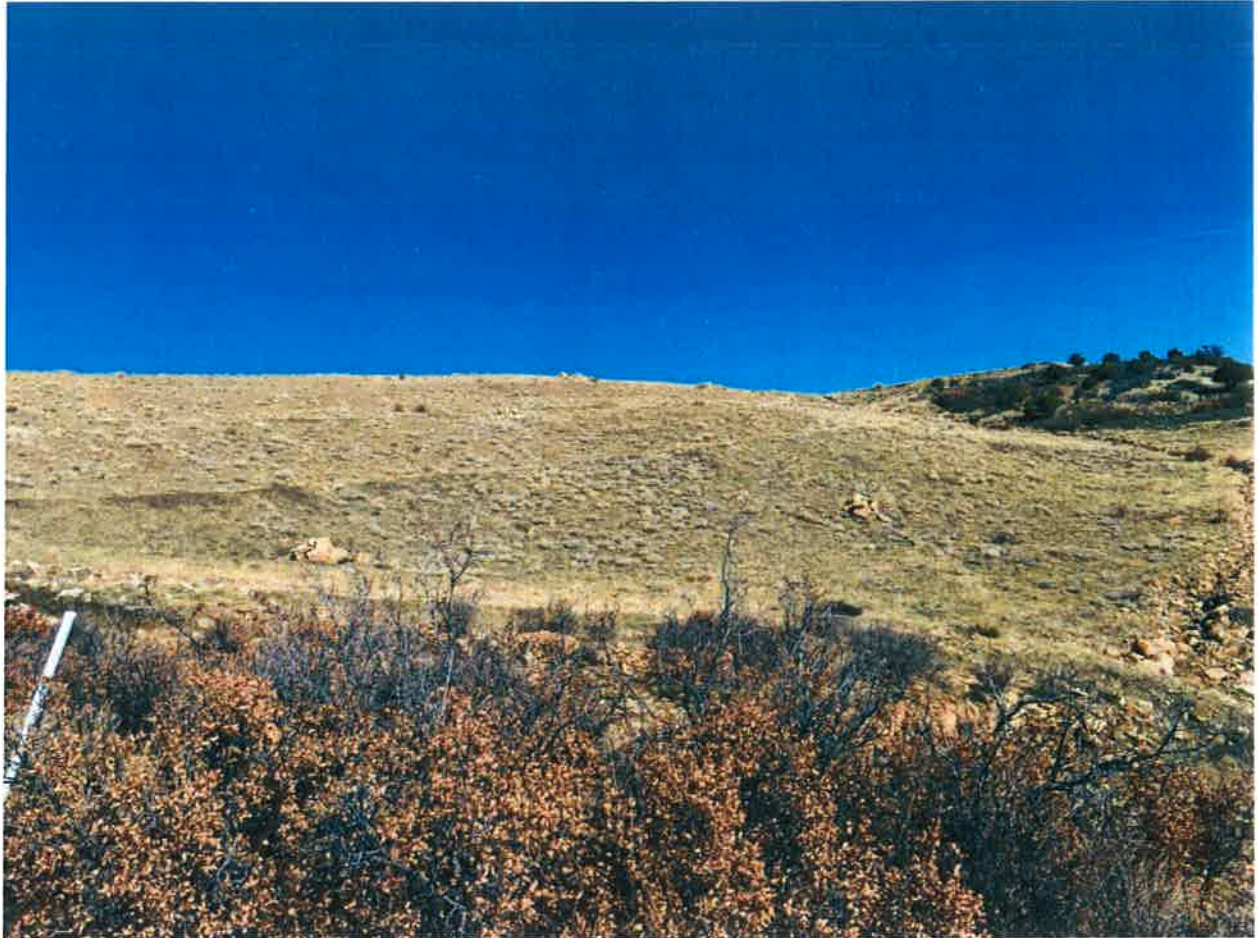
**Fill #9**

The entire excess spoil fill facility was examined for signs of failure and instability such as tension cracks, ground movement, springs and seeps, and standing water. There was no indication of potential instability at time of inspection.

Overall the site is in good condition.
