Re: King I Mine, C-1981-035

Stoner Engineering: Quarterly Inspection: Refuse Pile

1st Quarter 2020

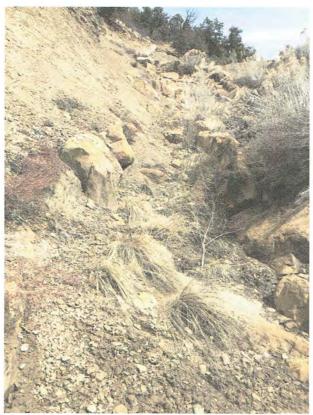
The south treated water ditch (Reach 10) was found to be in generally good condition. The portion of the Reach 10 channel identified in the previous report requiring maintenance has been addressed. The middle portion of Reach 1 (at the base of the steep slopes) has experienced some sedimentation due to sluffing of the soils from the adjacent steep slopes and is need of cleaning (see Pic. 1). The face of the embankment appeared to be in good condition as there were no signs of excessive erosion, instability or weakness (see Pic. 2). All the waste material located on the top of the pile has been placed in the embankment waste pile.

Pic. 1 –Reach 1 middle channel section sedimentation.

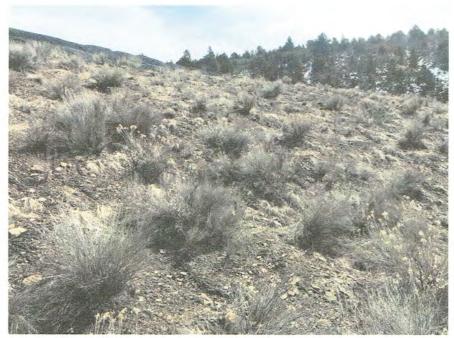
Pic. 2 – Face of waste pile in good condition.

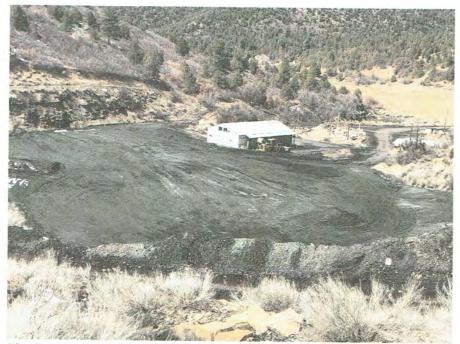
Waste material continues to be hauled to and dumped at the base of the existing waste pile/embankment where it is collected and being placed in accordance with TR-27 (see Pic. 3). The slope of the top of the existing pile is currently in excess of that defined in the Waste Bank Design produced by Don May, 1997. Specifically, the cross slope from north to south across the top of the waste pile embankment. The excess slope does not pose any danger to the stability of the existing waste pile though some localized erosion may occur during/after localized storm events.

Pic. 3 – Waste material being installed placed below existing waste embankment pile.
