Re: King I Mine, C-1981-035
Stoner Engineering: Quarterly Inspection: Water Quality Improvements
1st Quarter 2020

Date: March 27, 2020

Re: King Coal I – Quarterly Water Quality Improvements Inspection

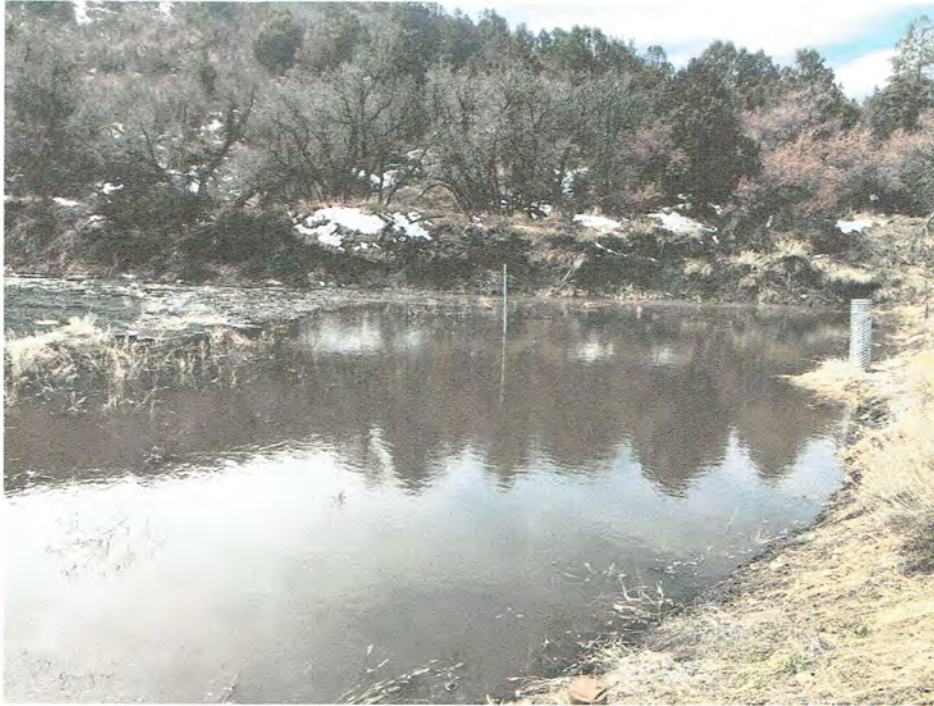
Both ponds contained runoff as a result of the recent snow at the time of the inspection (see Pic. 1). The ponds both appeared to generally be in good condition. The sedimentation gages show the ponds are not yet it need of cleaning. The ponds should continue to be monitored after storm events to ensure that excess sediment does not reduce the required storage capacity available for storm water runoff.

Pic. 1 – West pond.

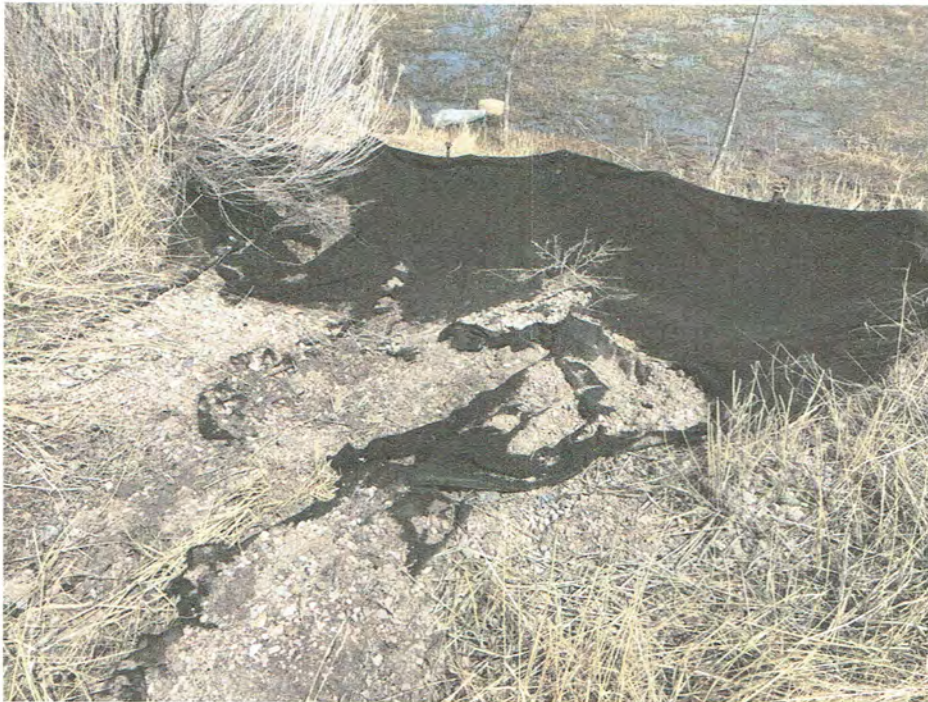
The sedimentation traps at the entrance to the site are generally in good condition. The sedimentation trap located along the north side of the driveway is in need of some repairs (see Pic. 2). The section of Reach 10 where runoff was escaping from the channel section and causing erosion along the side of the channel has been repaired.

Pic. 2 – East sediment trap along driveway.

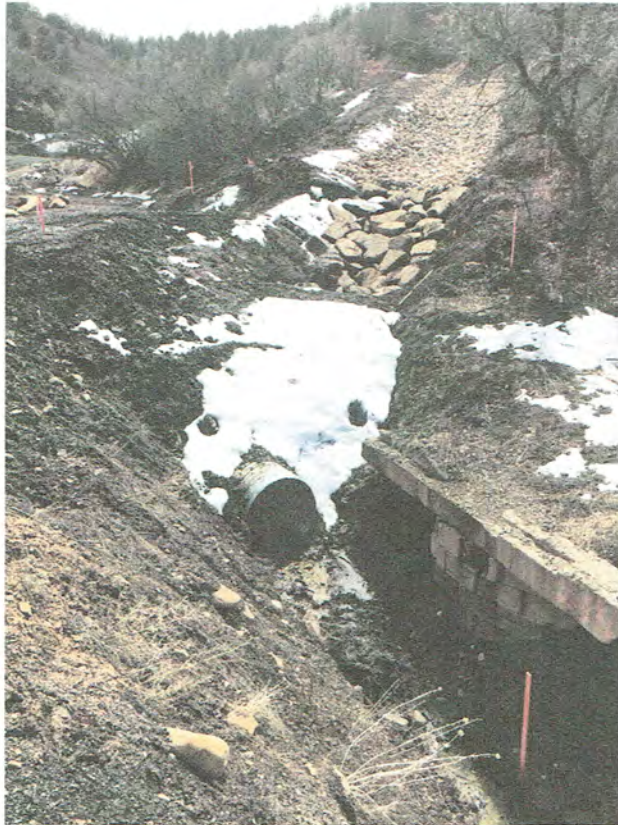
The new culvert for Reach 8 for the new haul road has been installed. Reach 3 has been rerouted around the west side of the property around TR-27 construction and connected to Reach 5 just above the east retaining pond (see Pic. 3, 4 and 5). The erosion control measures around the area inlet/foundation drain at the end of Reach 7 have been improved to prevent excessive sedimentation (see Pic. 6).

Pic. 3 – New culvert under new haul road location.

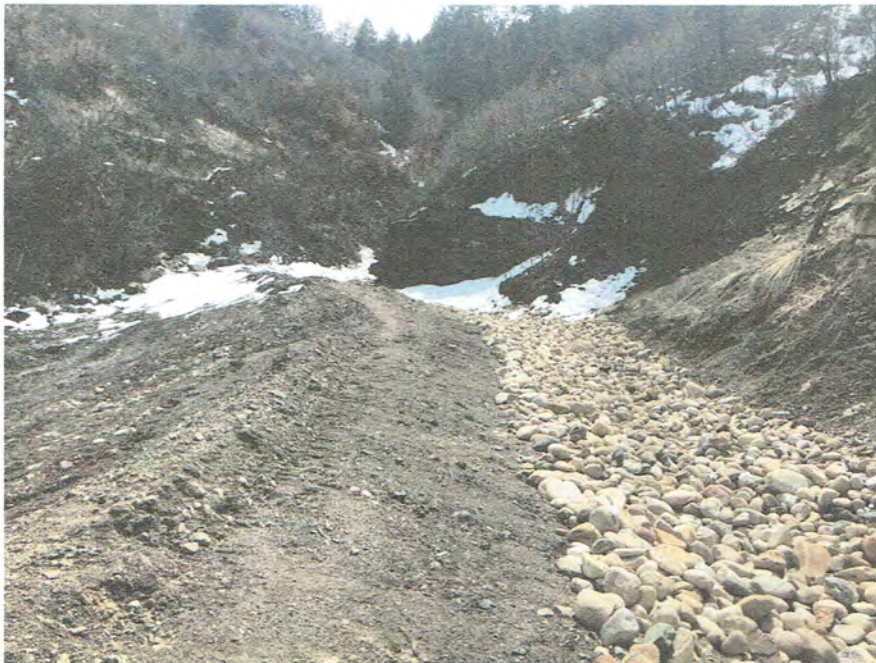
Pic. 4 – Reach 3 channel relocation along west side of property.

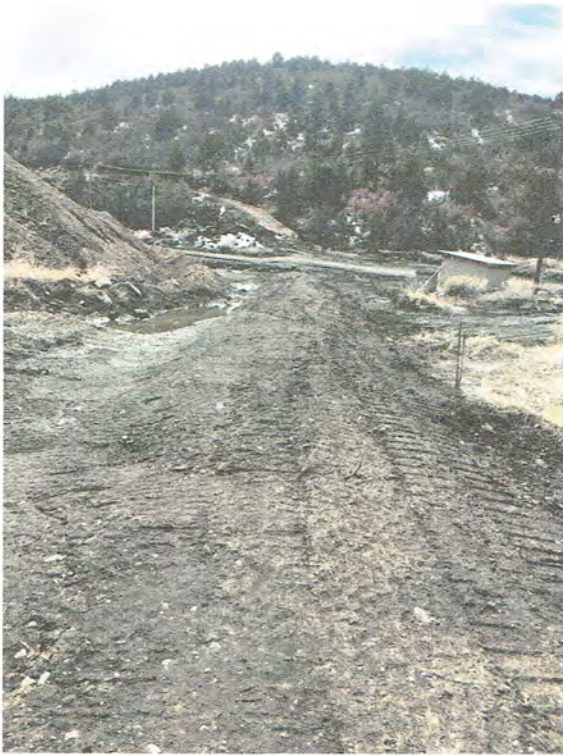
Pic. 5 – New Reach 3 culvert connecting to Reach 5.

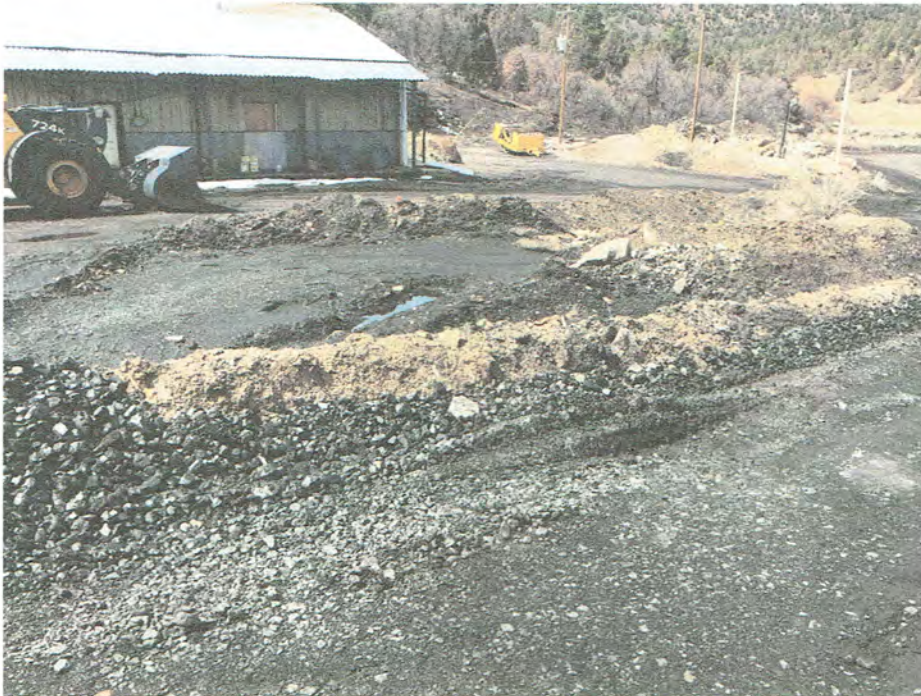
Pic. 6 – Improvements preventing excess sedimentation at Reach 7/foundation drain.
