MINERALS PROGRAM INSPECTION REPORT
PHONE: (303) 866-3567

MINE NAME: Climax Mine	MINE/PROSPECTING ID#: M-1977-493	MINERAL: Molybdenum	COUNTY: Summit
INSPECTION TYPE: Aerial Inspection	INSPECTOR(S): Dustin Czapla	INSP. DATE: March 16, 2020	INSP. TIME: 12:00
OPERATOR: Climax Molybdenum Company	OPERATOR REPRESENTATIVE:	TYPE OF OPERATION: 112d-3 - Designated Mining Operation	
REASON FOR INSPECTION: Normal I&E Program	BOND CALCULATION TYPE:	BOND AMOUNT: \$91,011,850.00	
DATE OF COMPLAINT: NA	POST INSP. CONTACTS: None	JOINT INSP. AGENCY: None	
WEATHER: Clear	INSPECTOR'S SIGNATURE:

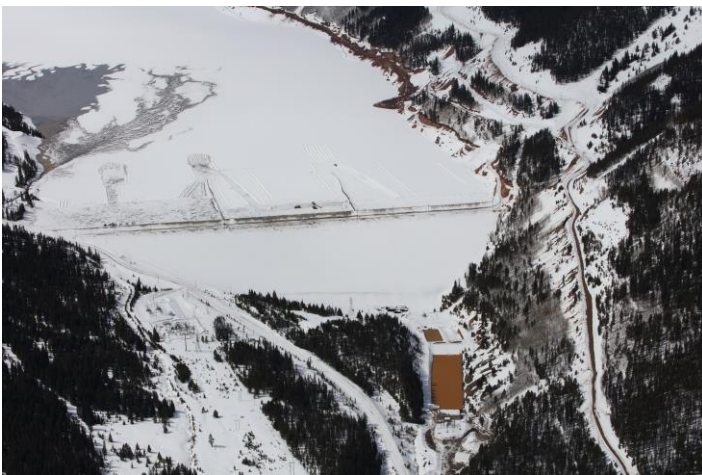
The Mayflower TSF and 5 Dam, Tenmile TSF and 3 Dam, Robinson TSF and 1 and 2 Dams were observed. The site was under significant snow cover during this inspection. No staining or discoloration were noted at any of the TSF dams. No abnormal conditions were noted. TSF's appear to be functioning within the established design criteria.

Mayflower TSF, 5 Dam

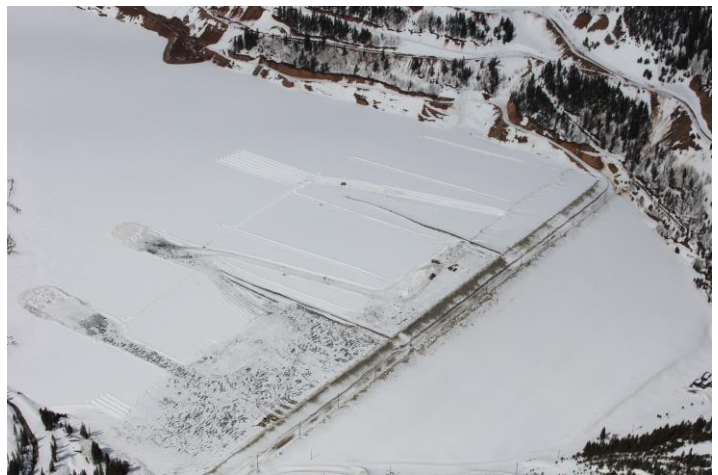
Mayflower TSF, 5 Dam

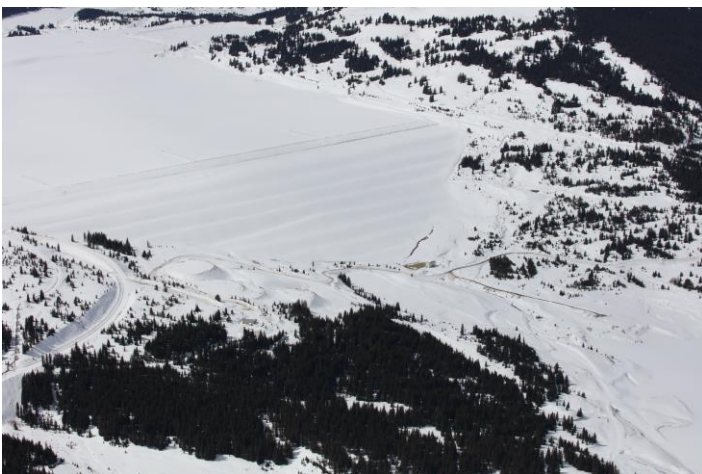
Tenmile TSF, 3 Dam

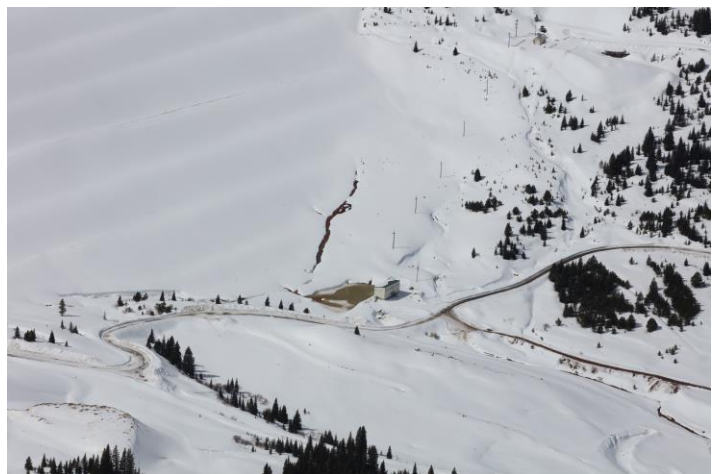
Tenmile TSF, 3 Dam

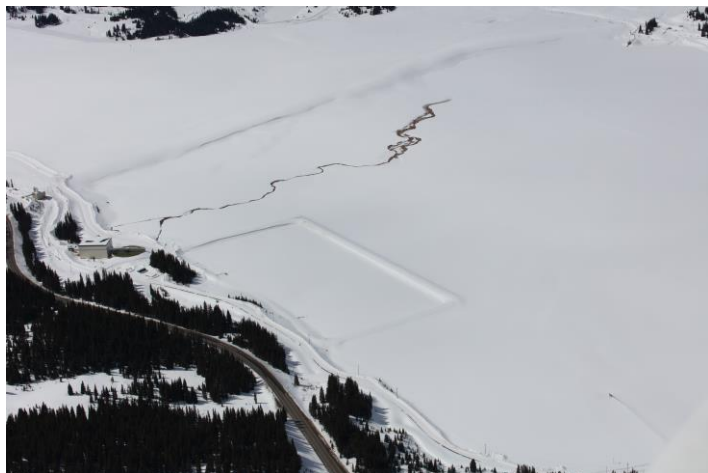
SDP, Robinson Pond, 2 Dam

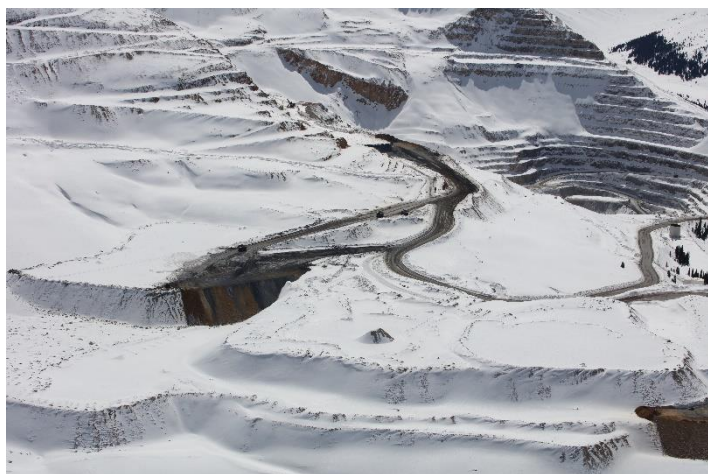
The McNulty and North 40 OSF's were observed. Deposition was occurring on the McNulty OSF during this inspection. The current OSF operating plan was drafted by Golder Associates in December 2016. The plan was submitted to the Division as part of TR-25. Golder states that snow accumulations of up to 2-3 feet on OSF faces do not significantly impact operation of large OSFs, however larger accumulations greater than 3 feet can become trapped as a continuous layer and form a weak layer or saturate finer grained layers as melting occurs. Therefore Golder recommended that waste rock only be deposited on slopes with less than 3 feet of snow accumulation. This inspection confirmed that Climax is limiting waste rock deposition to slopes with little to no snow accumulation, and therefore appears to be in compliance with Golder recommendations for winter time OSF operations.

McNulty OSF

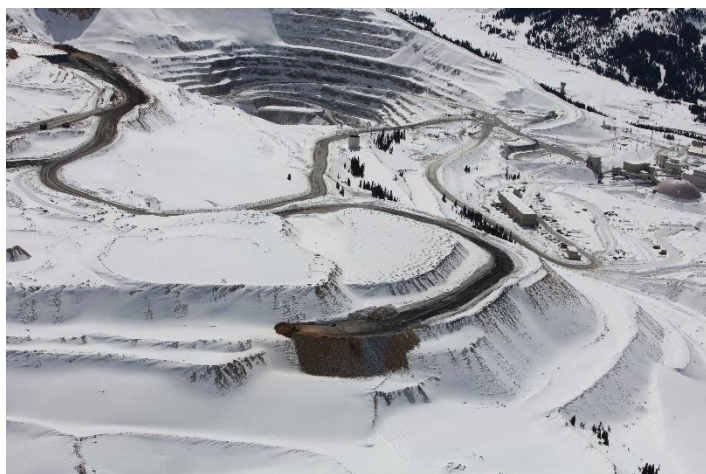
McNulty OSF
