**MINERALS PROGRAM INSPECTION REPORT**  
**PHONE: (303) 866-3567**

<b>MINE NAME:</b> Bradford Mesa Quarry	<b>MINE/PROSPECTING ID#:</b> M-2019-046	<b>MINERAL:</b> Gravel	<b>COUNTY:</b> Huerfano
<b>INSPECTION TYPE:</b> Preoperation Inspection	<b>INSPECTOR(S):</b> Patrick Lennberg	<b>INSP. DATE:</b> November 25, 2019	<b>INSP. TIME:</b> 12:00
<b>OPERATOR:</b> Southway Construction Company, Inc.	<b>OPERATOR REPRESENTATIVE:</b> Katie Todt, Ben Miller, Paul Bottini	<b>TYPE OF OPERATION:</b> 112c - Construction Regular Operation	
<b>REASON FOR INSPECTION:</b> Preoperation Inspection	<b>BOND CALCULATION TYPE:</b> None	<b>BOND AMOUNT:</b> No Bond Held	
<b>DATE OF COMPLAINT:</b> NA	<b>POST INSP. CONTACTS:</b> None	<b>JOINT INSP. AGENCY:</b> County	
<b>WEATHER:</b> Cloudy	<b>INSPECTOR'S SIGNATURE:</b>

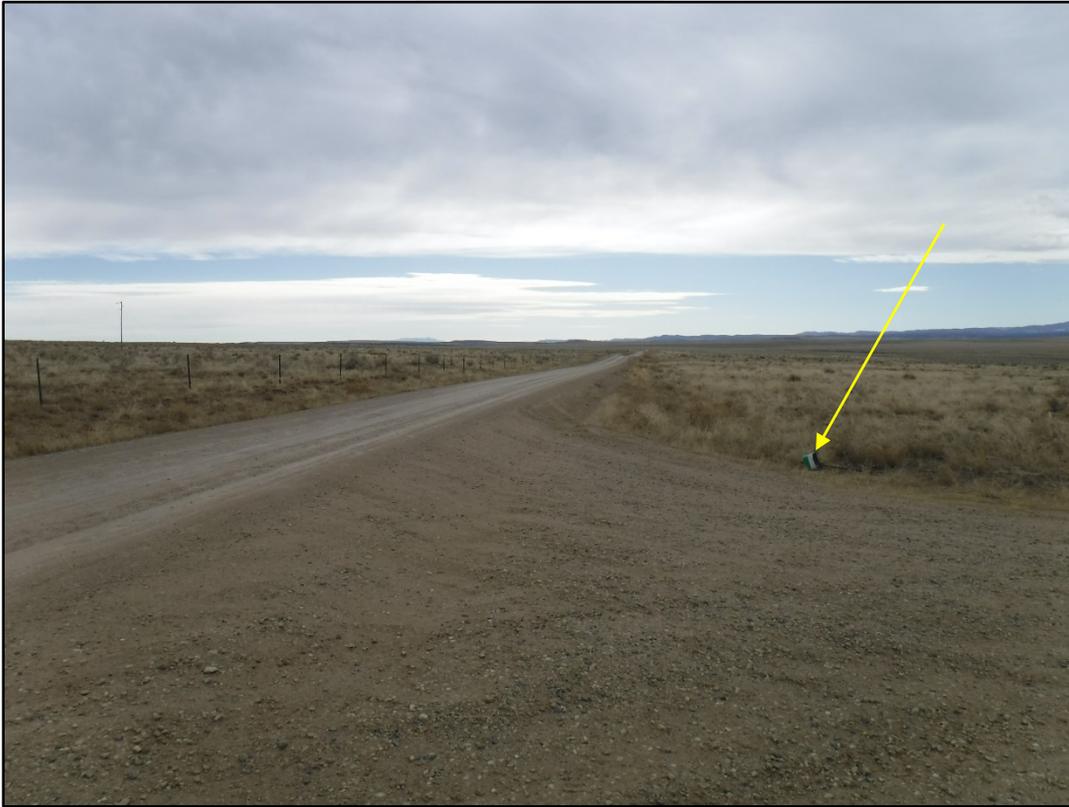
The permit notice was not posted at the mine entrance along County Road 120 there was a tee-post that appeared to have the notice sign attached to it. The Permittee has supplied a photo of the Notice sign as it was originally installed at the original permit boundary before the 3.2 mile haul road was included into the permit boundary. The permit area is currently rangeland that is characterized by native grasses and cacti with some yucca. The area is actively being used for grazing for cattle. The landowner has a numerous stock tanks for watering cattle. The stock tanks are refreshed through a series of water pipelines and solar powered pump stations located throughout the permit area. Structures observed during the inspection were accurately depicted on the maps within the permit application. To the north of the permit area is the Bradford Reservoir which was dry at the time of the inspection. The Permittee stated that the reservoir went dry when the irrigation ditches that supplied water where disrupted during highway construction to the west.

**Photo 1:** Looking south at the junction of CR 120 and the haul road entrance, yellow arrow indicated tee-post that held notice sign that subsequently fell down

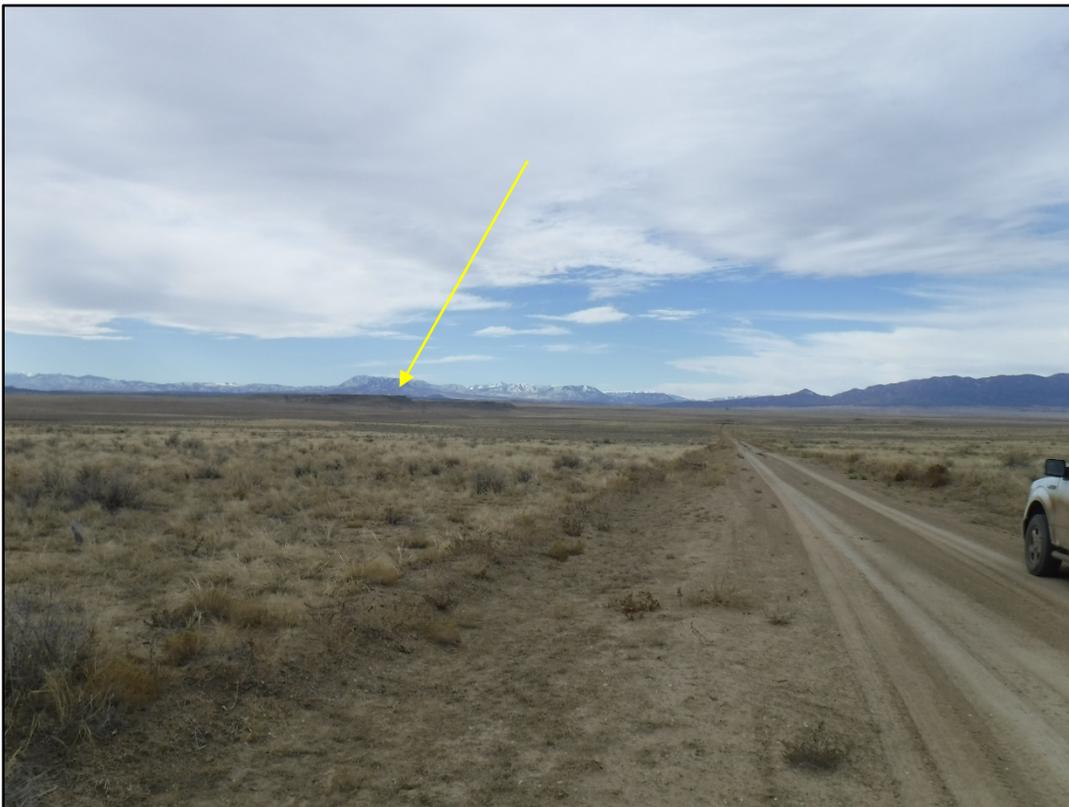
**Photo 2:** Looking west along the haul road leading to mine area, indicated by yellow arrow

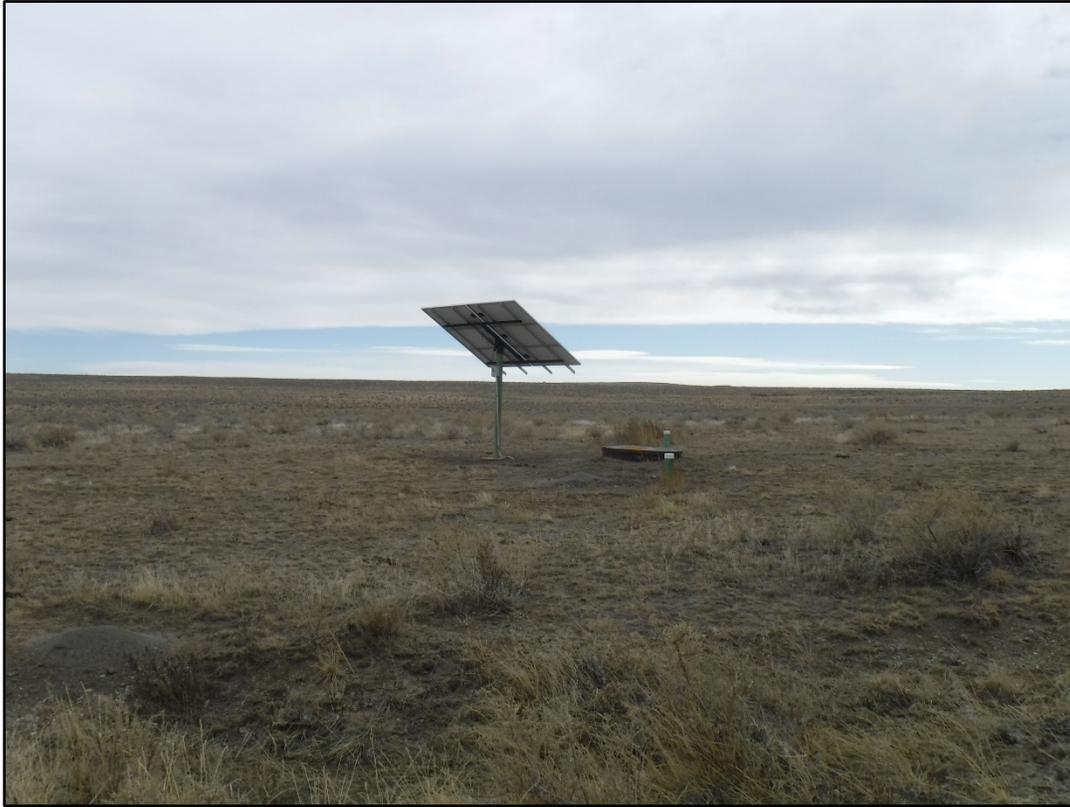
**Photo 3:** Solar powered booster station for cattle tanks

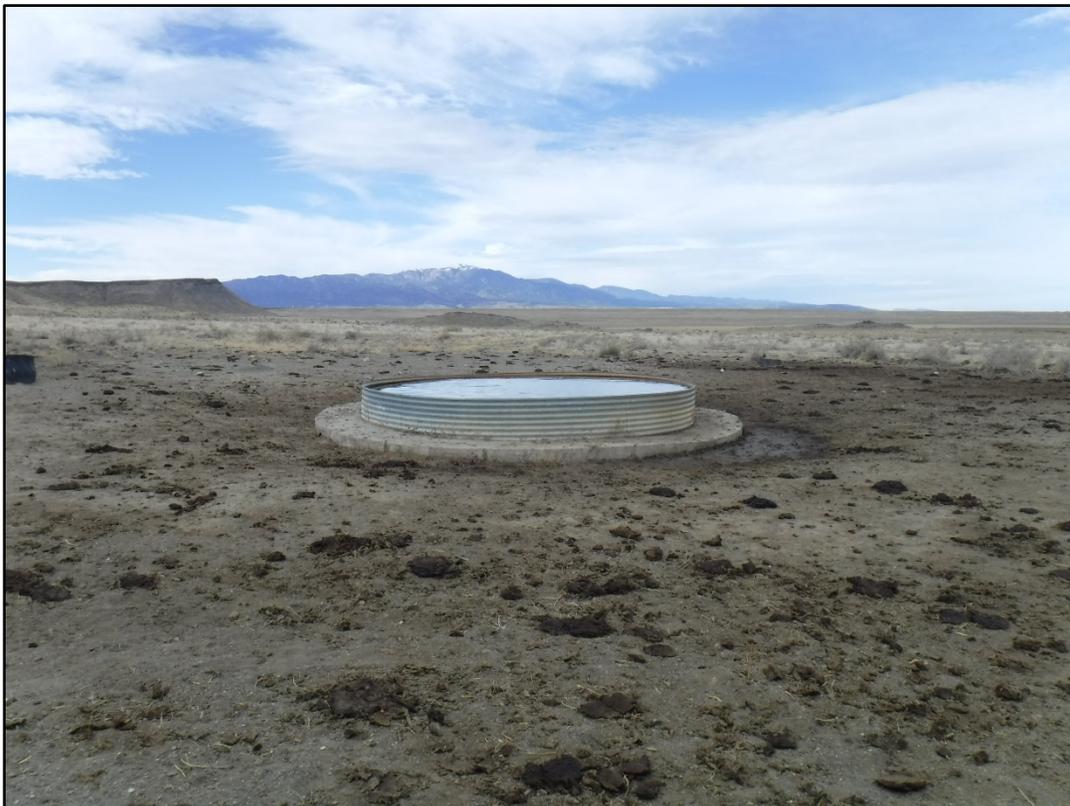
**Photo 4:** Cattle tank

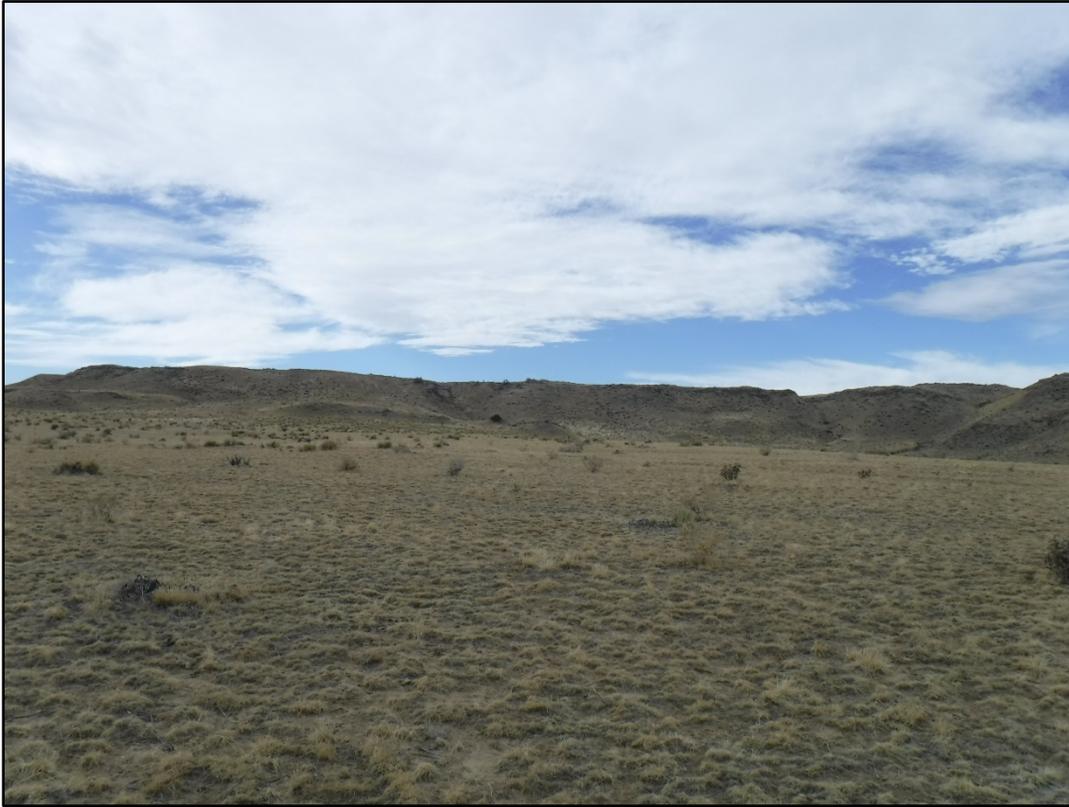
**Photo 5:** Approximate location of dump area located on the southeastern side of mining area

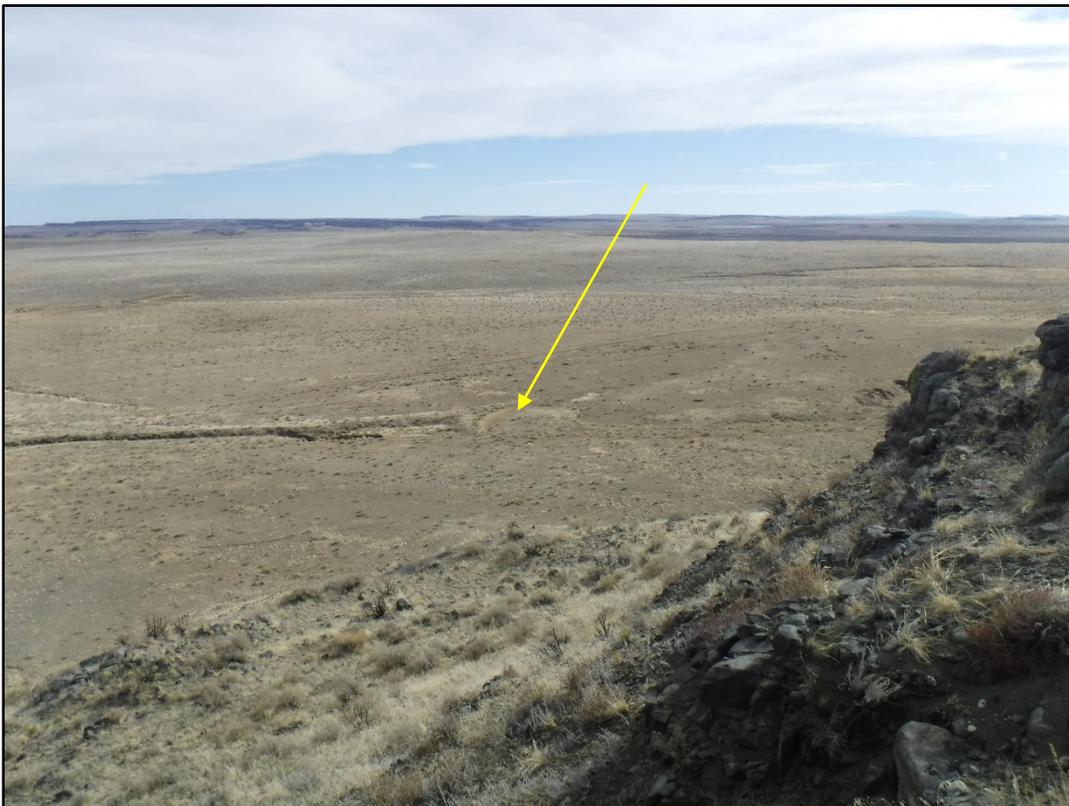
**Photo 6:** Looking southeast from the mesa top, arrow indicates the approximate location of dump sediment control structure

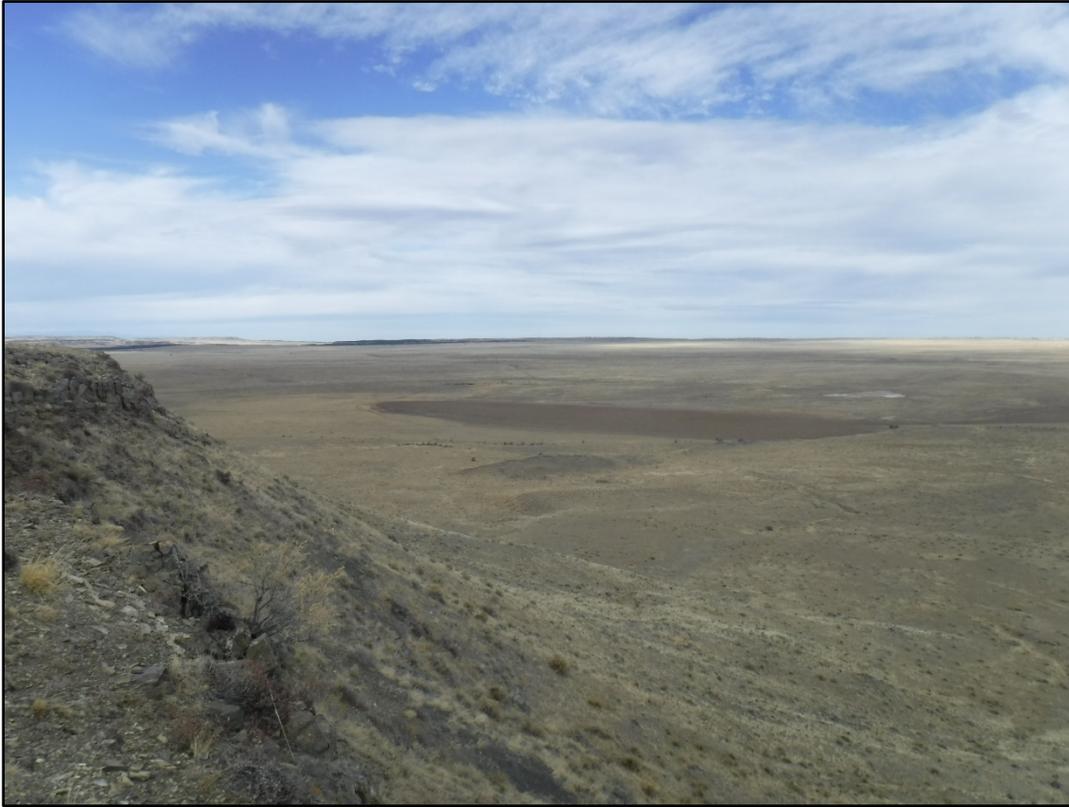
**Photo 7:** Looking north from the mesa top at the Bradford Reservoir

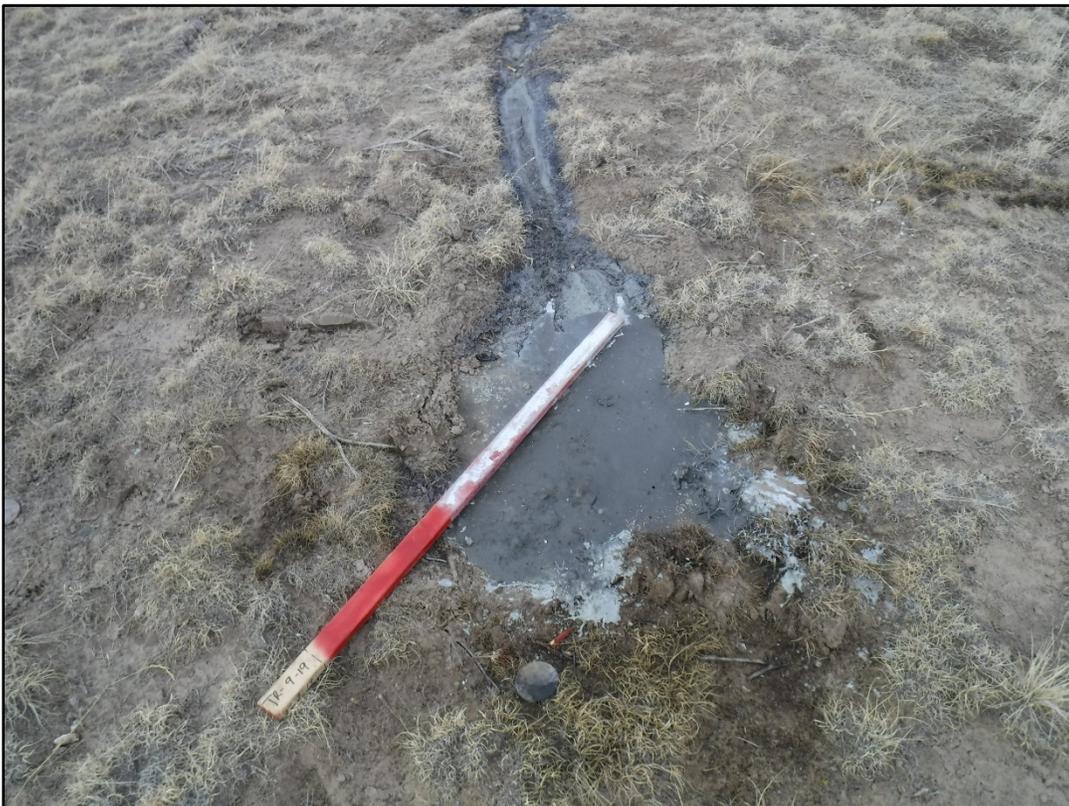
**Photo 8:** Borehole advanced as part of P2019-012

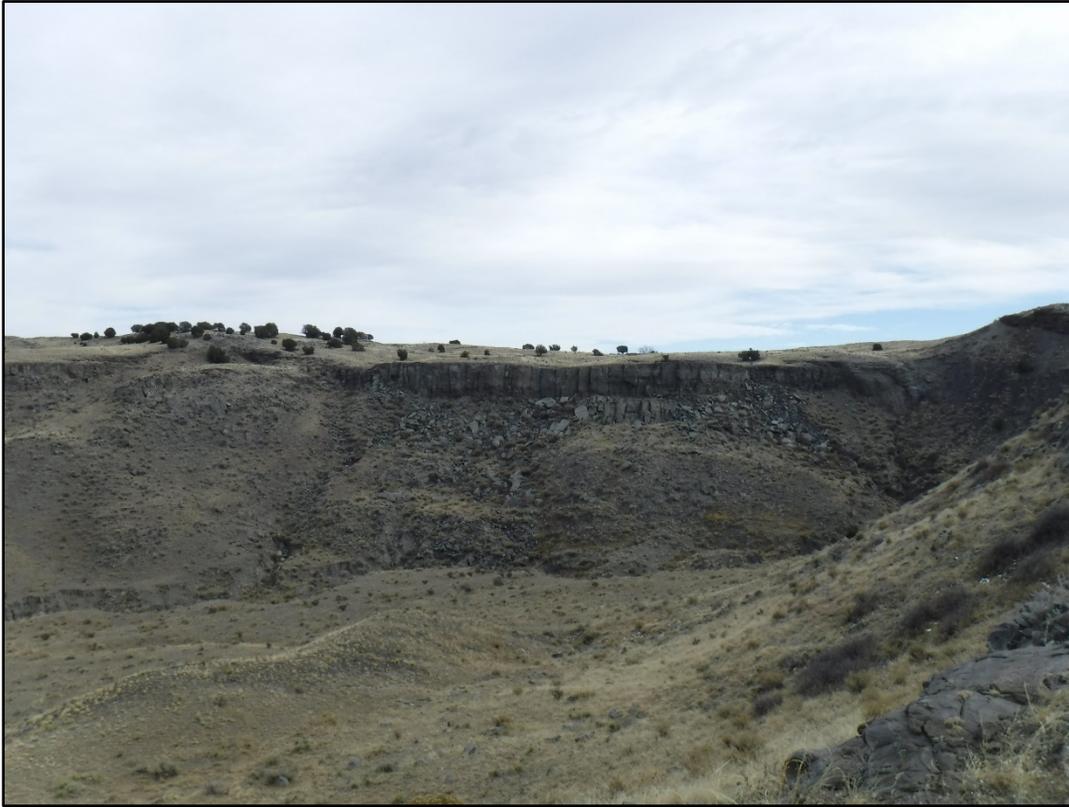
**Photo 9:** Looking at a cross-section view of the substance to be mined

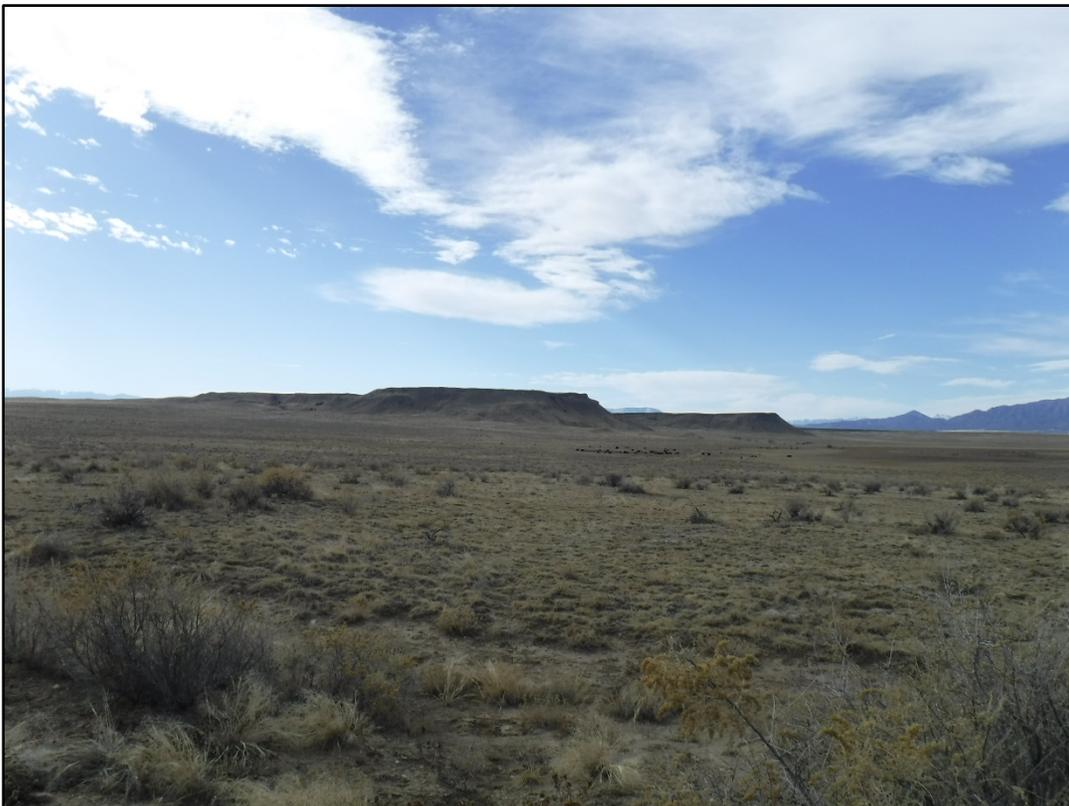
**Photo 10:** Looking south back towards the mesa
