## Response to Castle Adequacy Review Response #3

# Carl B Mount and Associates, Inc. LLC

## Memo

**Re:** Continental Materials Corporation/Castle Aggregate, Pikeview Quarry, Permit M-1977-211, Amendment 04, Review of February 7, 2020 Operator Adequacy Answer to DRMS Third Adequacy Review and DRMS Fourth Adequacy Review.

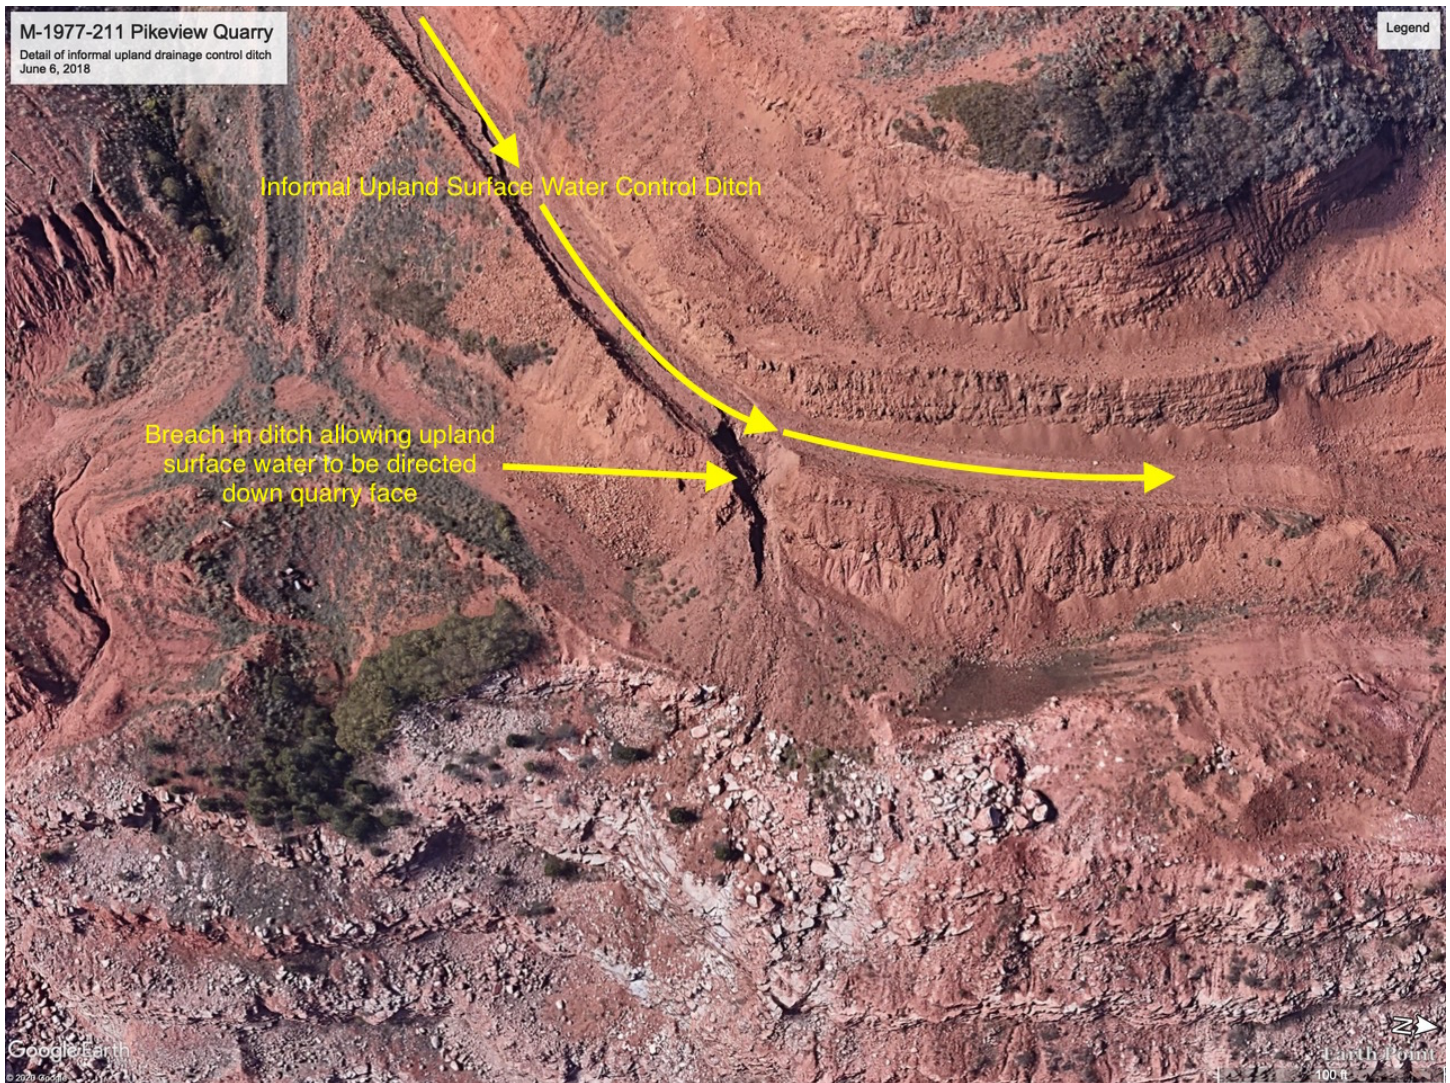
The failure of the northern diversion is what caused water to cascade down the quarry wall in 2015. This ditch looks like it is still not repaired as of 2018 (see Figure 1). It is now obvious that this approach leads to consistent failure of the upland diversion ditches. Why is DRMS not requiring designs for this structure at this point and requirements that the structure be built to those designs?

Figure 1. From Google Earth aerial photo of June 6, 2018 showing informal upland drainage ditch breached in approximately 2015 and still not repaired as of 2018. Above west quarry highwall, north side.

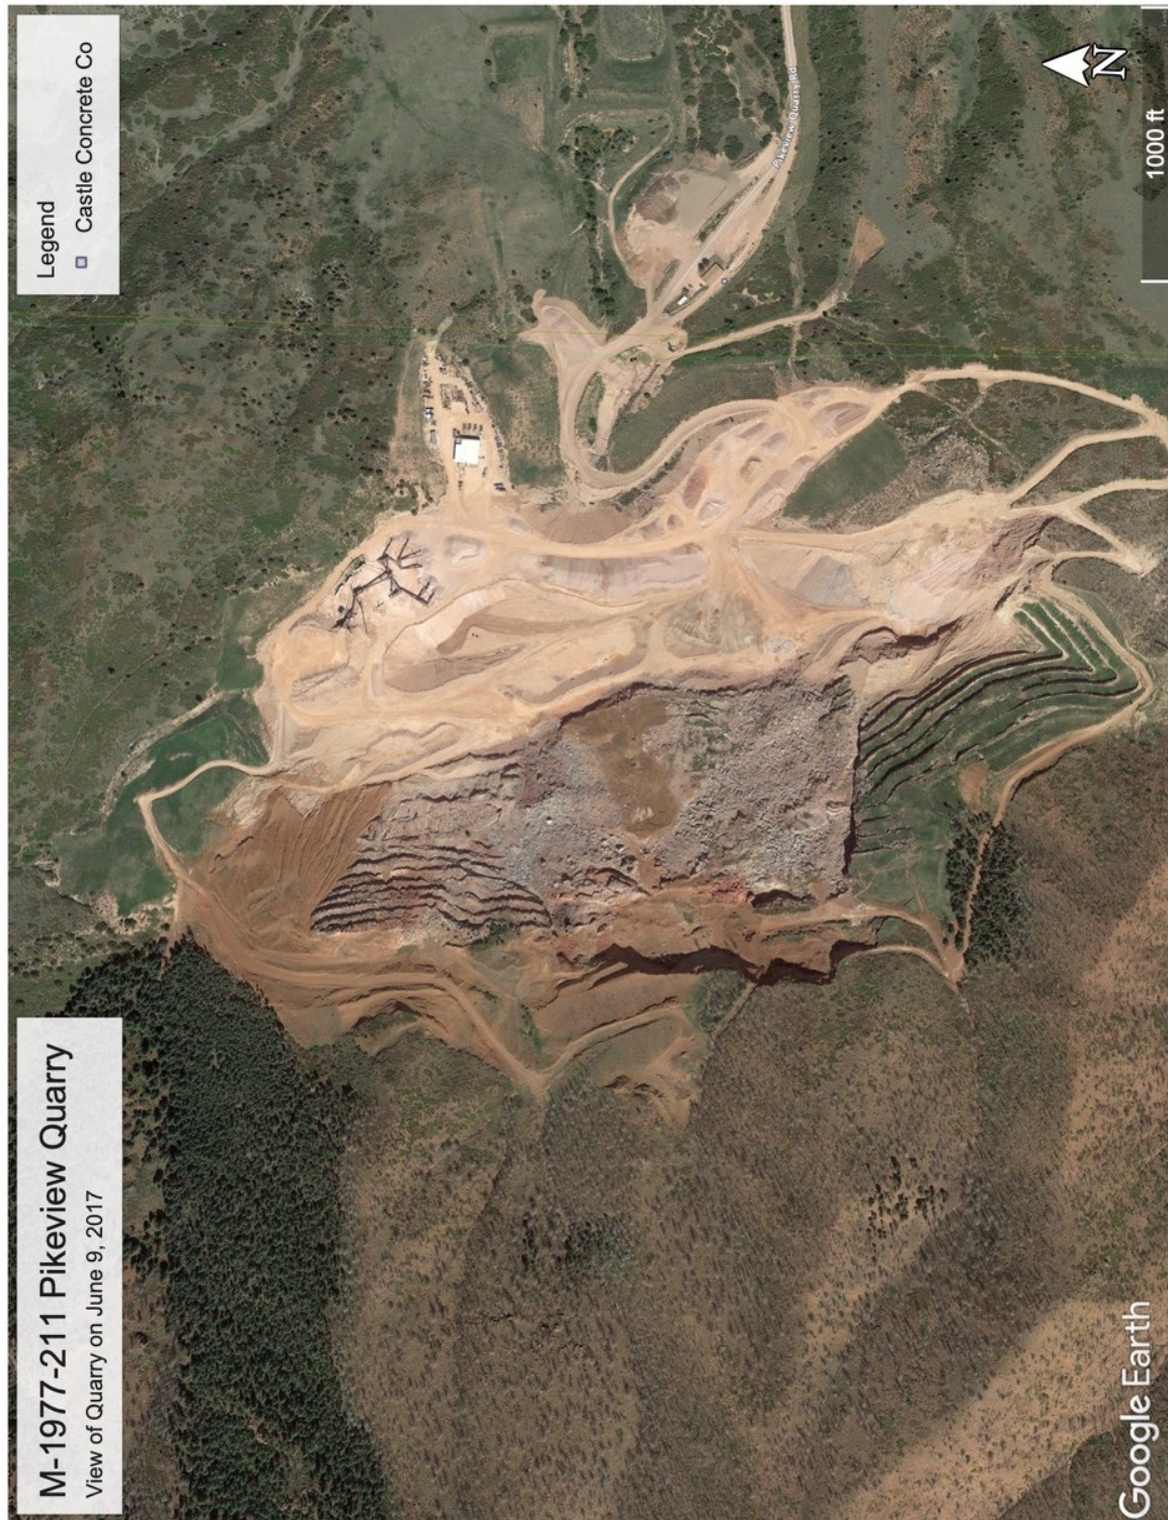
Aerial photos of 2017 (Figure 2) and 2018 (Figure 3 - whole quarry; Figures 4 and 5 - detail) indicate a scarp above the southernmost hanging block at the top of the highwall. The Sawatch clay layer underlies the hanging block located on the south side of the western highwall. Exponent deemed the clay layer the primary failure cause for the December 2, 2008 and related slides. In other words, we are not talking about safety factors of unconsolidated materials such as exist in the body of already failed material but a special condition of a clay layer in the upper part of the Sawatch Formation that could lead to sudden and unexpected sliding of now hanging material above that layer now that the buttressing blocks of material below this have already failed and slid downslope. An additional complicating and destabilizing factor is that the scarp and the separation of materials at the top of the block will probably allow additional surface water to flow directly to the clay layer and further lubricate and destabilize this block.

Figure 2 – Pikeview Quarry conditions on June 9, 2017.

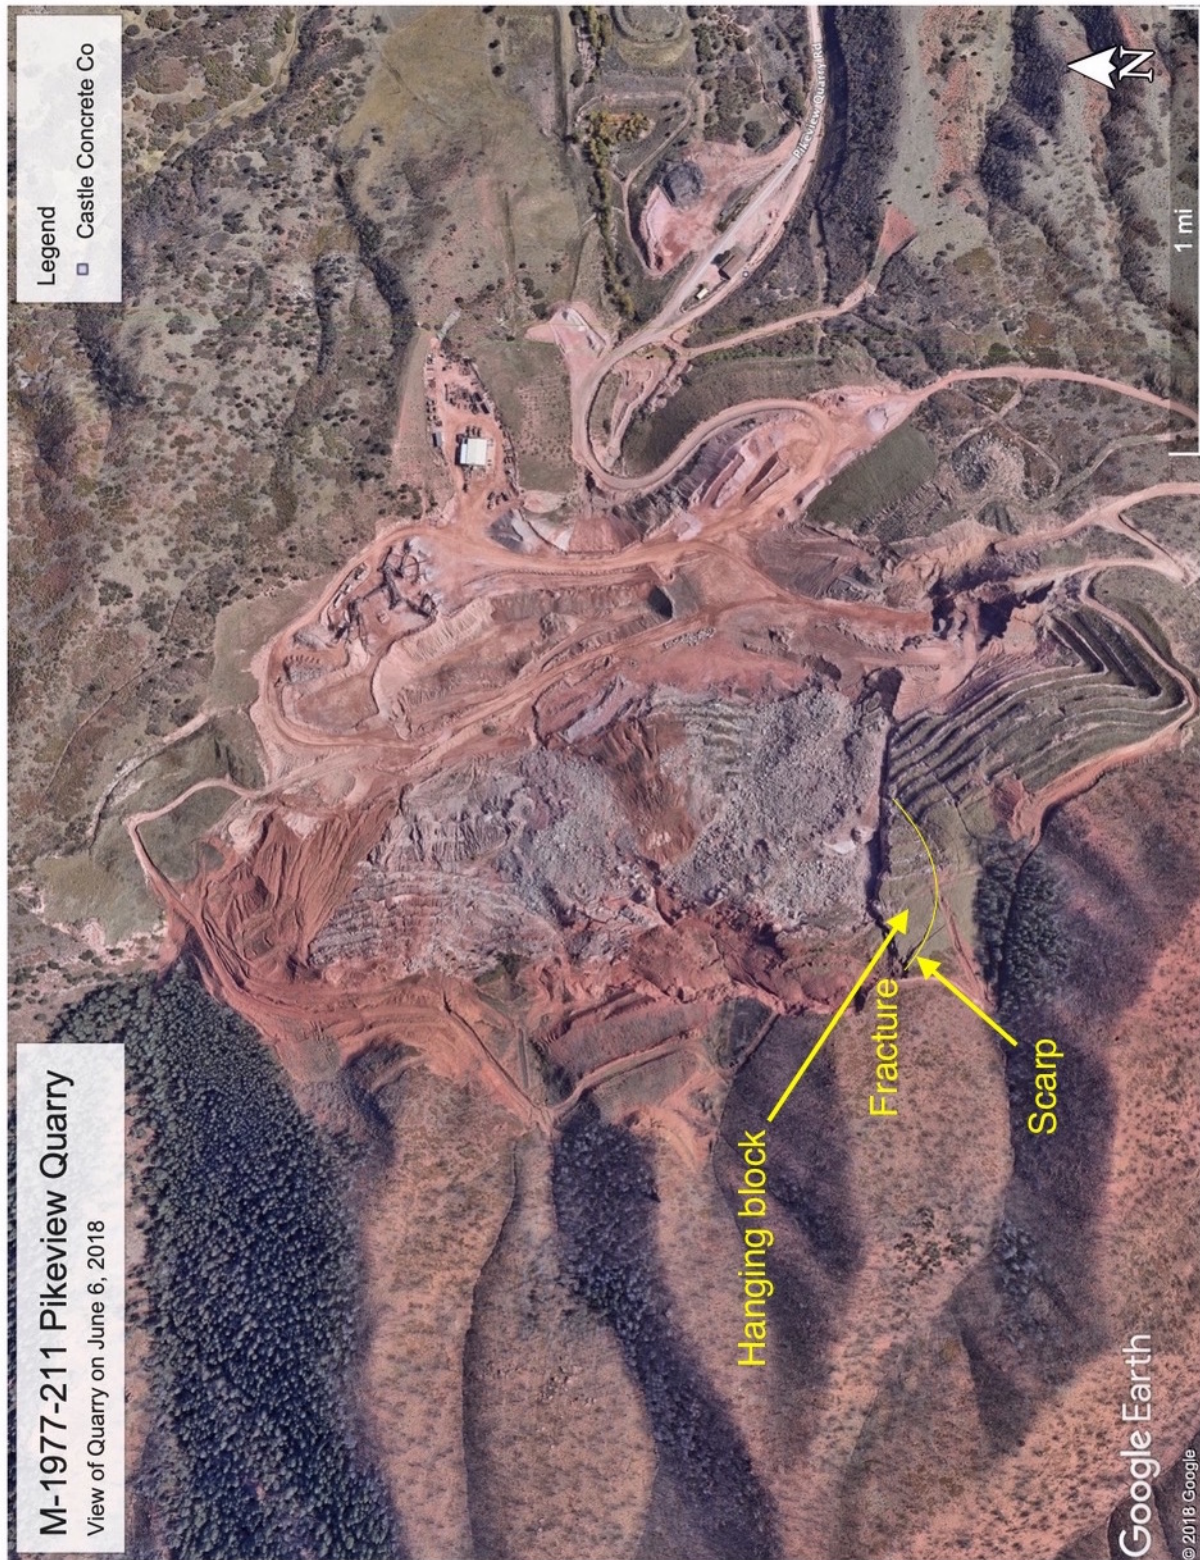
Figure 3 – Pikeview Quarry conditions on June 6, 2018.

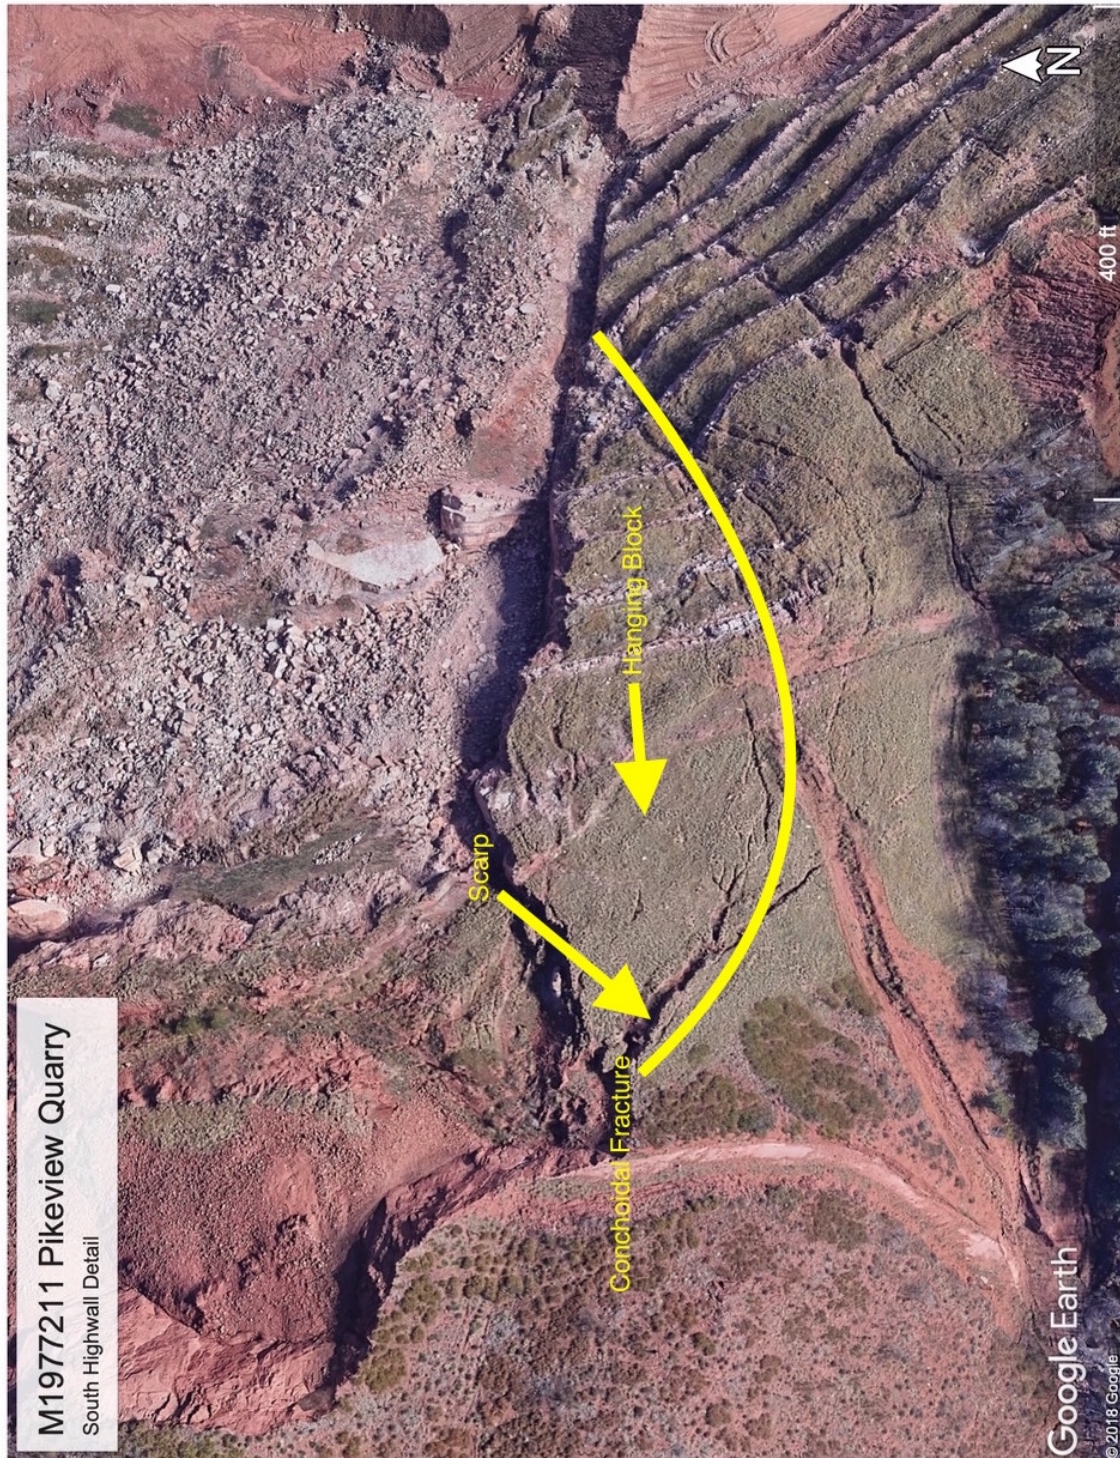
Figure 4 – Pikeview Quarry – Detail of conchoidal fractures in the south part of the West Highwall, 2018.

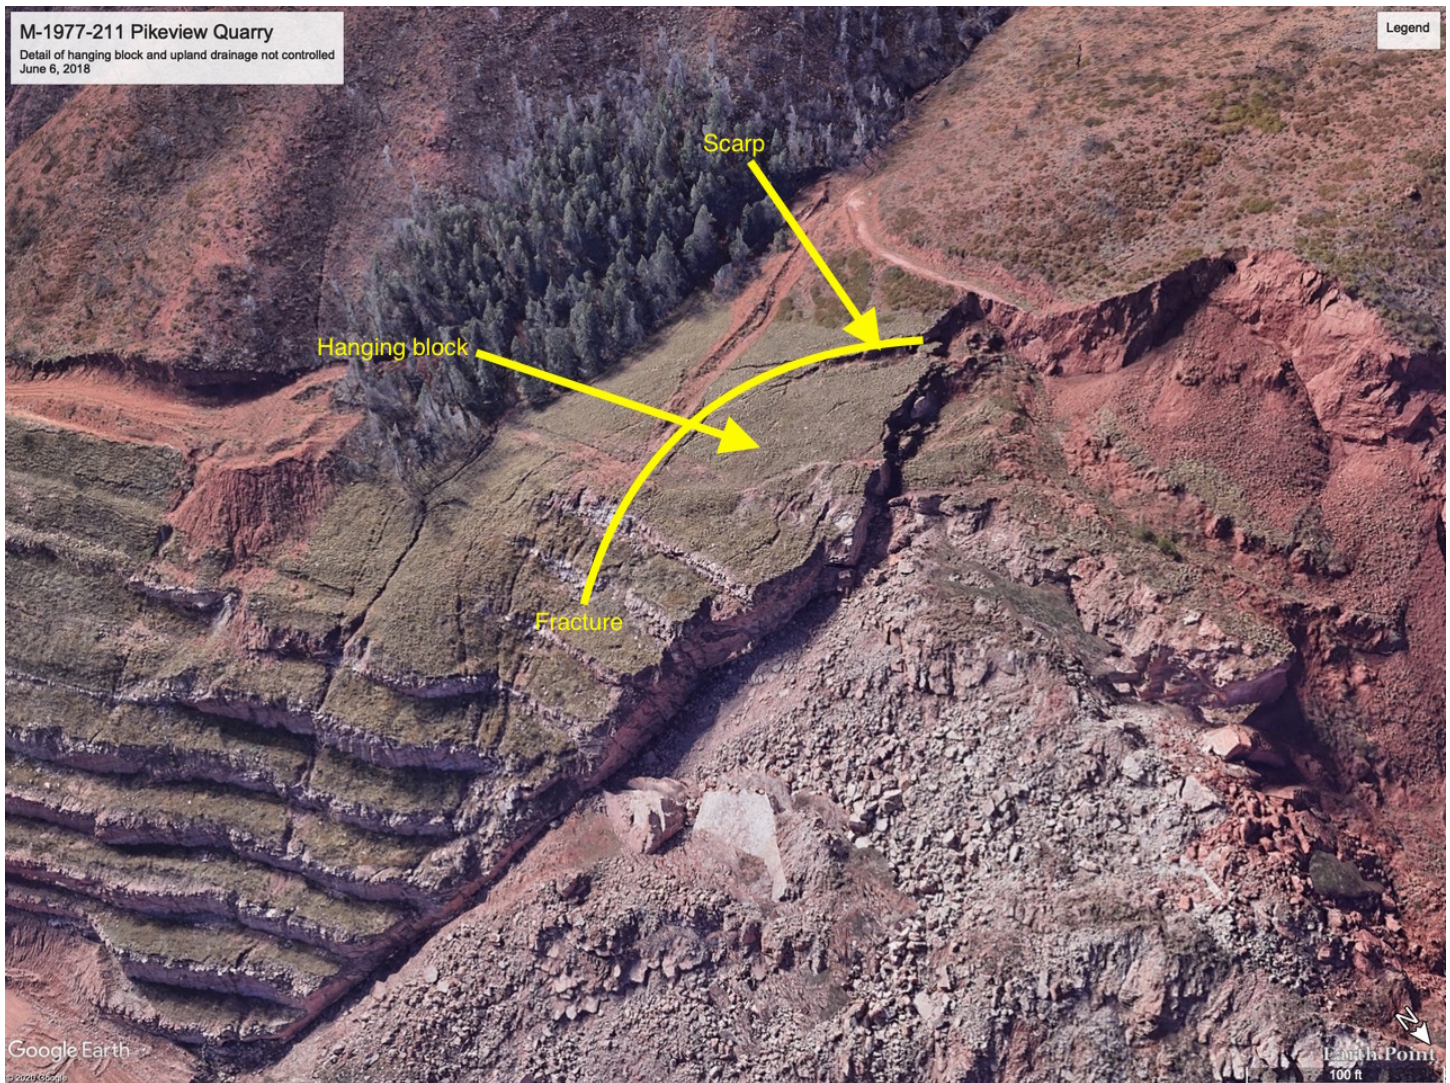
Figure 5. Oblique aerial photo from Google Earth showing detail of south most hanging block at top of west highwall. Scarp above block and block noted by arrows and conchoidal fracture denoted by line.

One of the ways to determine whether this block is presently moving is for CMC to produce long-term prism monitoring data for the possible hanging block of limestone material (prisms P66, P70, T1). DRMS must request that CMC produce this data to ensure worker safety and/or unnecessary problems that will not be covered by the reclamation bond.

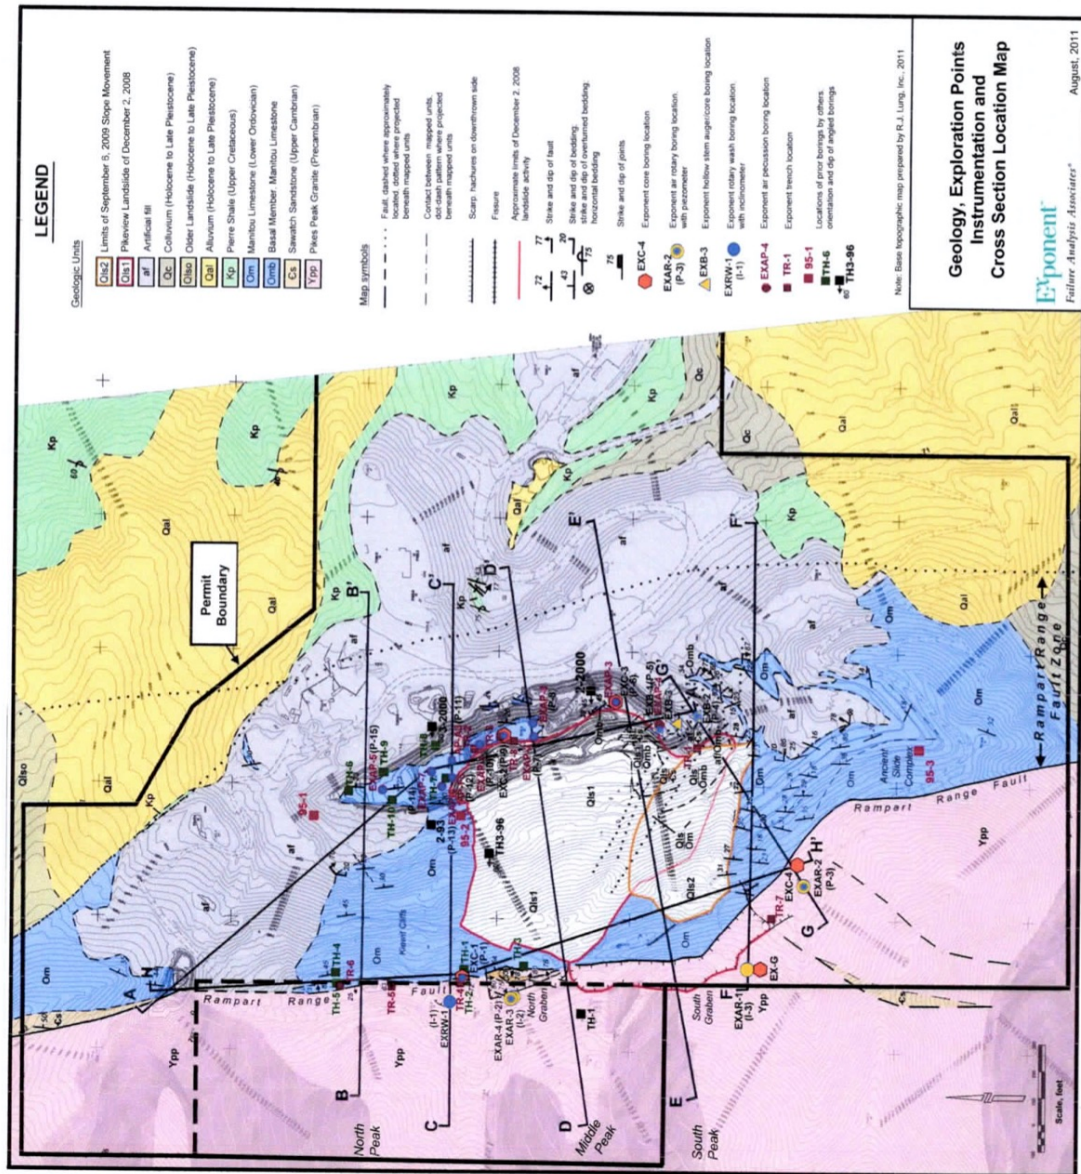
The Exponent Report of 2011 includes a cross-section in Appendix 39 (G-G') that is indeed drawn along the slope gradient and probably intersects part of the present hanging block of limestone in the southern part of the west highwall of the quarry (Figures 6 and 7). After reading this part of the Exponent Report, the concern of instability of this rather large block of material only grows larger because it clearly shows that this is a hanging block and the block could slide in the near future if not properly buttressed, avoided, or handled in some other appropriate way. CMC and DRMS need to recognize this to protect worker safety and address this concern.

Figure 7 – From Exponent Report (2011), Appendix 39. Cross Section G-G' showing limestone hanging block on top of clay layer that was the primary cause of the December 2, 2008 slide and subsequent slides.
