## TR application 7, for Cross Gold Mine (m1977-410) a Geotechnical Stability Exhibit in accordance with Rule 6.5(3)

## **Technical Revision No. 7**

## Technical Memorandum

| <b>SUBJECT:</b> Idaho Tunnel Portal – Slope Stability Analysis | | | |

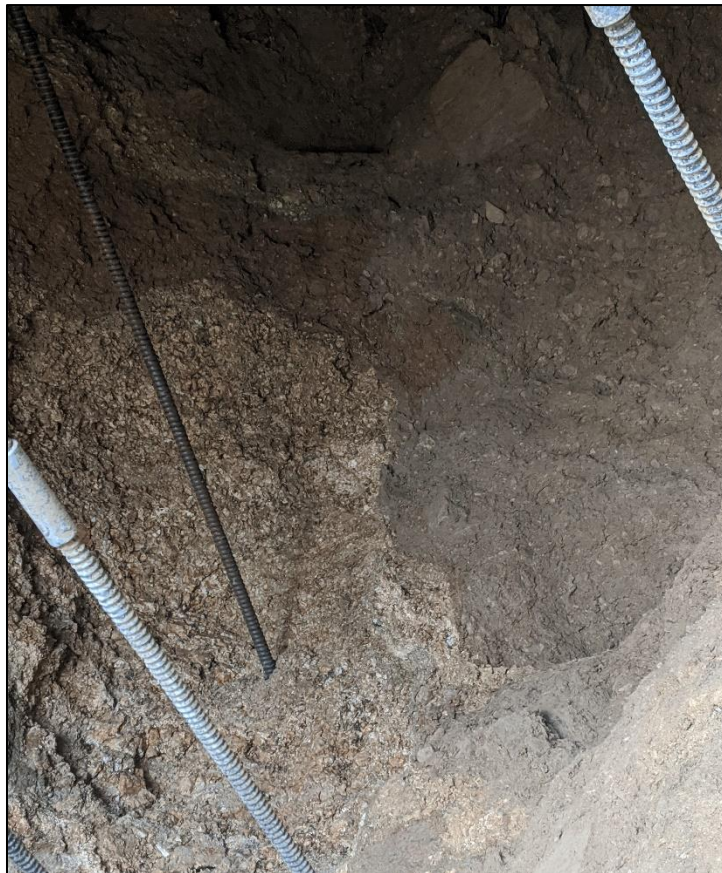
Regolith and colluvial soils are exposed in the collapse void above the tunnel horizon (Photograph 5), excavation wing walls (Photograph 6), and the Caribou Road cut. This material is interpreted as similar to the “Alluvial Rock” depicted on Figure 1.

***Photograph 5 – Regolith and colluvium exposed in the walls of the collapse void. The threaded bars are some of the spillings which were installed before enlarging the portal excavation.***

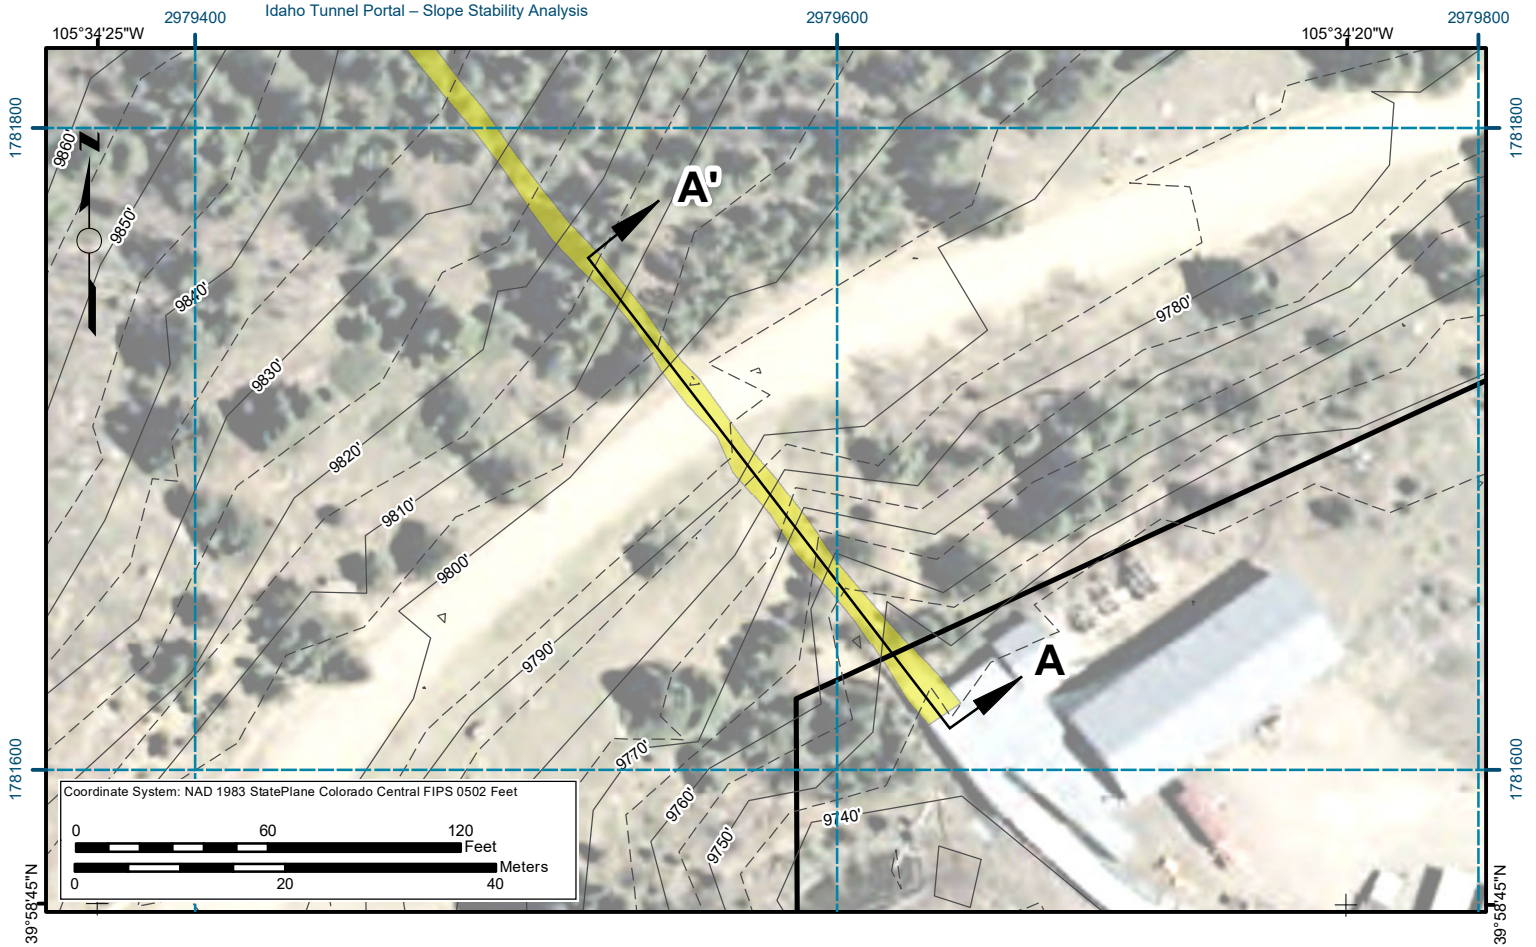
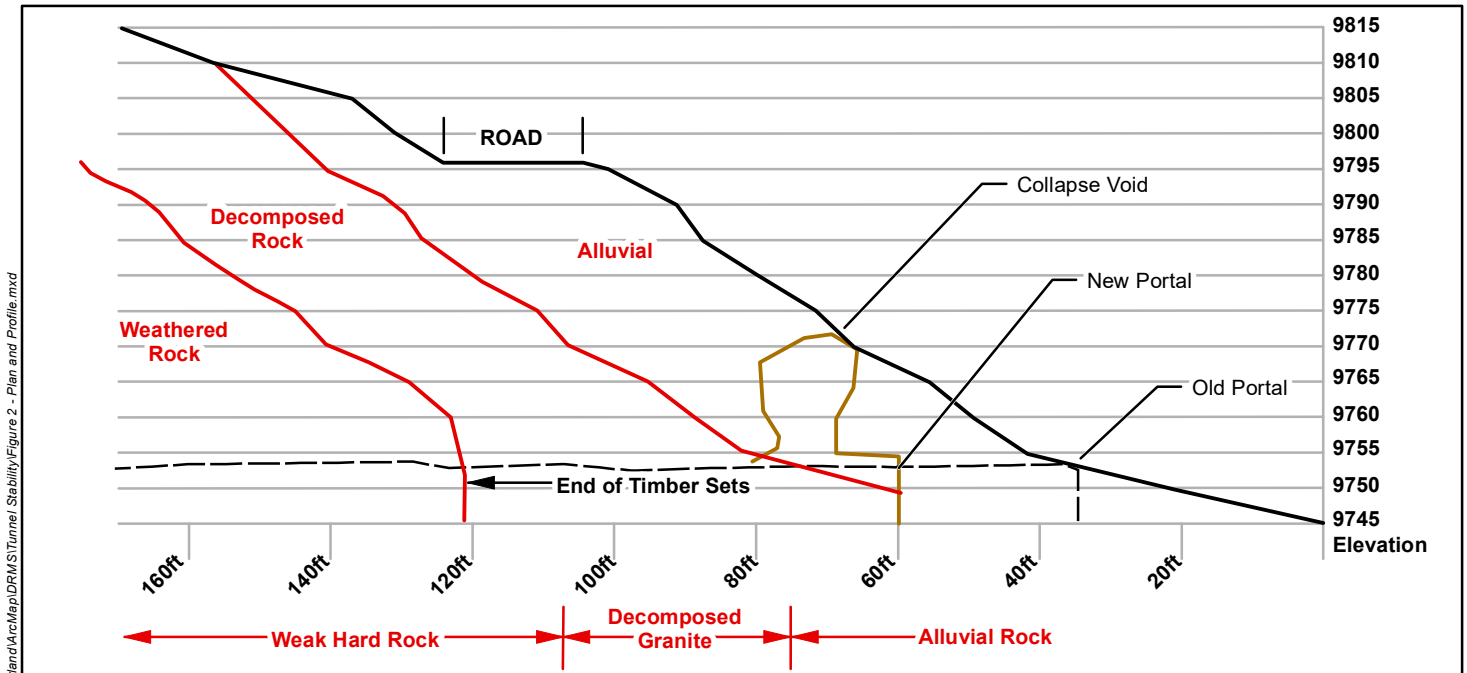
| Check: | JST | 05/06/20 | | Figure 2 | | | |

Figure 2 presents a plan and profile of the Idaho Tunnel based on 10-ft topographic contours of the original ground surface. Superimposed on this figure are the approximate position of the rehabilitated tunnel portal following excavation.

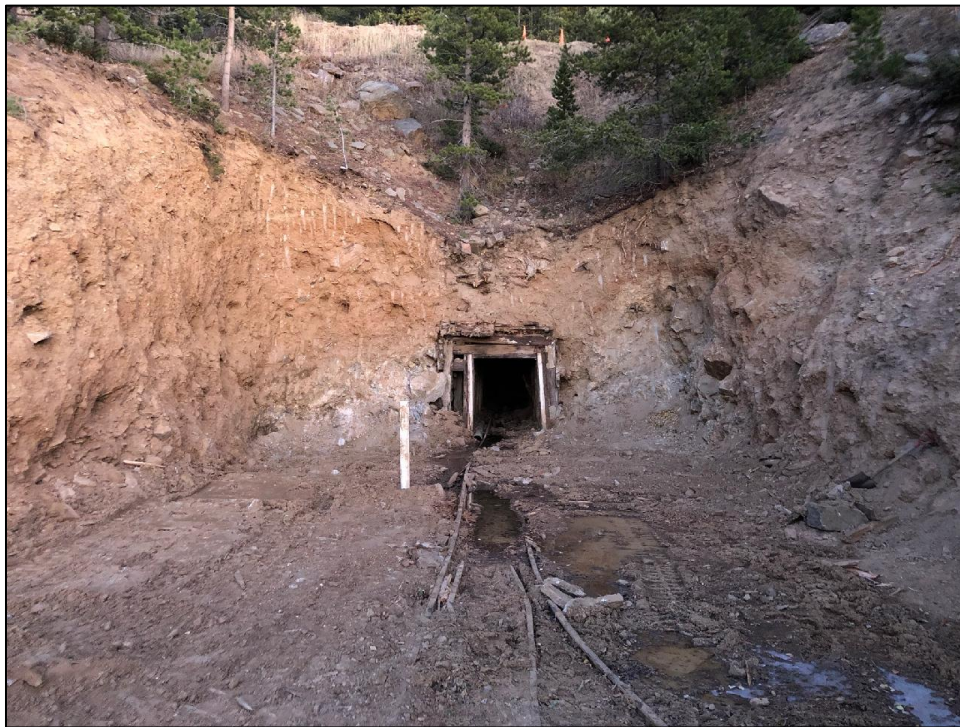
The material encountered during portal excavation and currently exposed in the wing walls consisted of regolith and colluvium, with some decomposed rock encountered at depth. The excavated slopes stood unsupported following excavation and were dry at the time (Photograph 7). The maximum height at the taller left (south) wing wall is 28 ft, sloping at an angle of 70-80 degrees from horizontal. The top of the excavation is approximately 40 ft from County Road 128 (Caribou Road) at the closest point and 20 ft lower in elevation. This creates potential long-term concerns for stability of the road.

***Photograph 7 – Idaho Tunnel Portal following excavation***

The excavated slope above the portal opening and wing walls were reinforced with 10- and 20-ft soil nails, 6-gauge wire mesh, and nominal 6-inches of fiber-reinforced shotcrete. Grouted threadbar spillings were also installed at 12-inch spacing above the portal. These were reportedly 35 ft long, extending into harder ground and grouted. Unfortunately, little as-built documentation is available.

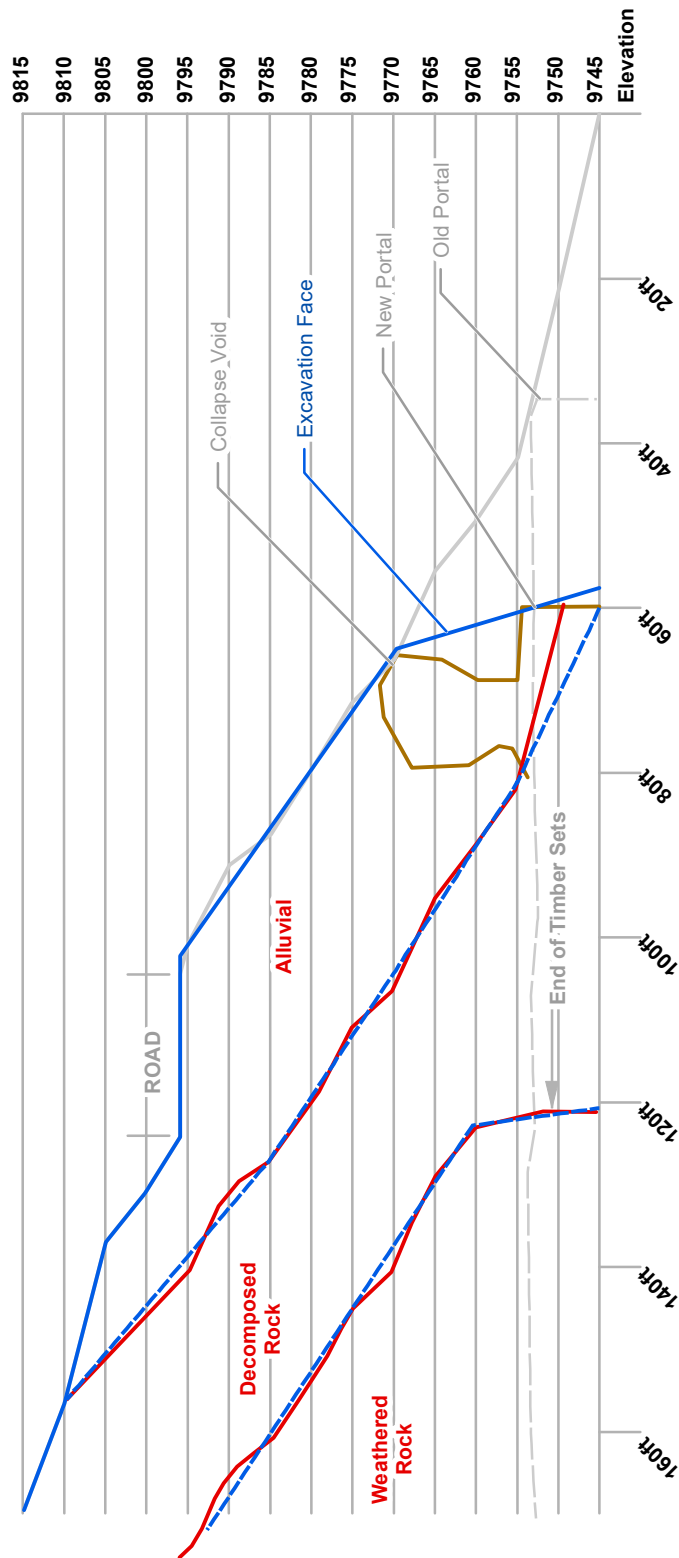
| Check: | JST | 05/06/20 | | Figure 3 | | | |

An idealized representative two-dimensional cross-section was considered for analysis. This section consisted of the profile along the axis of the tunnel included on Figure 2, at the maximum cut slope on the left (south) side of the portal excavation. The idealized slope consisted of a 28-ft high excavation at an angle of 75-degrees then natural ground sloping at approximately 40 ft to the edge of the 20-ft wide County Road. Figure 3 presents the idealized slope stability cross-section superimposed on the tunnel profile section.

This layered profile was then carried up the height of the slope for the stability analysis section as depicted on Figure 3. In reality, these layers are likely thickest at the toe of the slope down at the portal level and taper in thickness moving higher up the slope and this assumption will also be conservative.

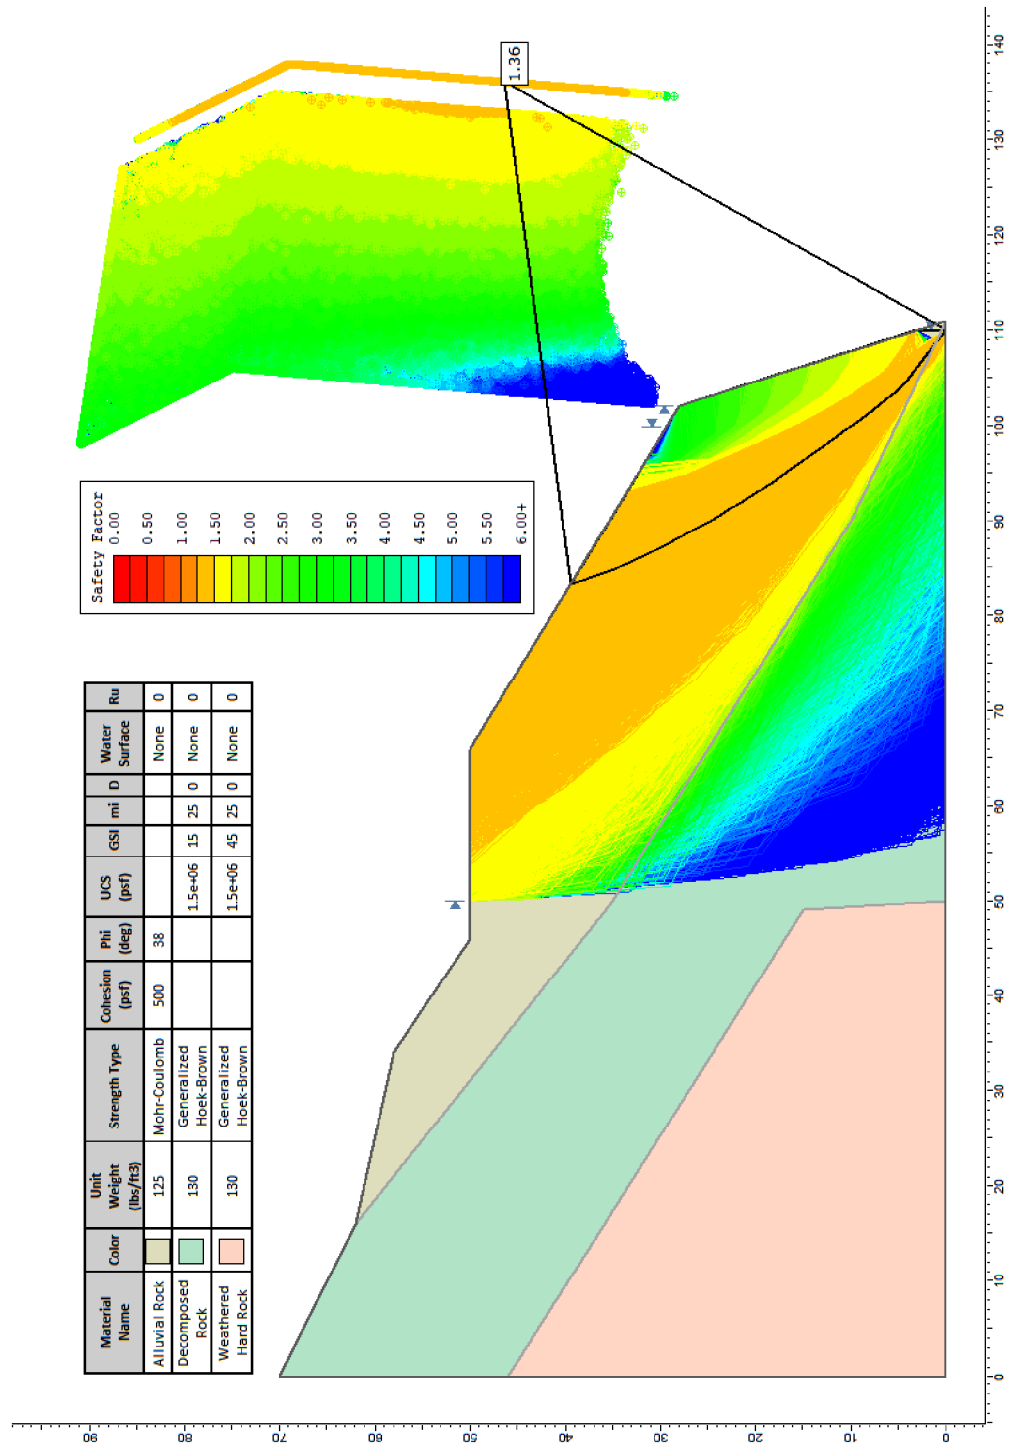
Analysis of the slope under drained conditions indicates a minimum Factor of Safety (FoS) failure surface of 1.36 for a non-circular failure of the excavation slope. The minimum FoS for a failure surface which intersects the County Road was only slightly higher at 1.37. Figure 4 presents a summary of these stability analysis results and includes the critical failure surface as well as a summary plot of all trial failure surfaces color-coded by FoS. These analyses demonstrate that the lower FoS failure surfaces pass entirely through the colluvium and regolith soil materials due to the slope geometry. The position of the weak hard rock and decomposed rock beneath the slope has little to no effect on the overall stability.
