**PERMIT INFORMATION**

<b>Permit Number:</b> C-1981-028 <b>Mine Name:</b> Keenesburg Strip Mine <b>Operator:</b> Coors Energy Company <b>Operator Address:</b> Mr. Danny Kipp 1801 California Street Suite 4600 Denver, CO 80202	<b>County:</b> Weld <b>Operation Type:</b> Surface <b>Permit Status:</b> Active <b>Ownership:</b> Private
	<b>Operator Representative Present:</b>  None
<b>Operator Representative Signature:</b> (Field Issuance Only)

**INSPECTION INFORMATION**

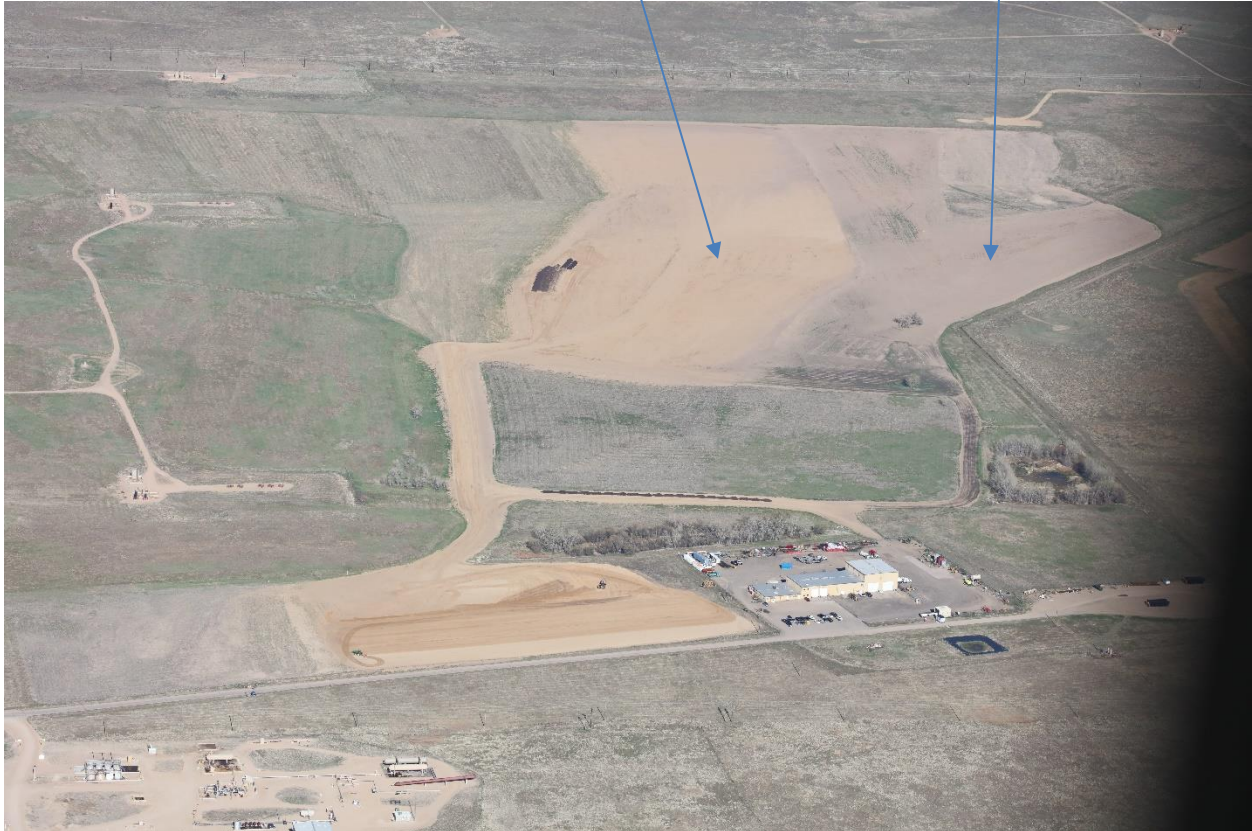
*Reclaimed Long-Term Spoil Area*

*Former topsand piles*

**Looking west at site**

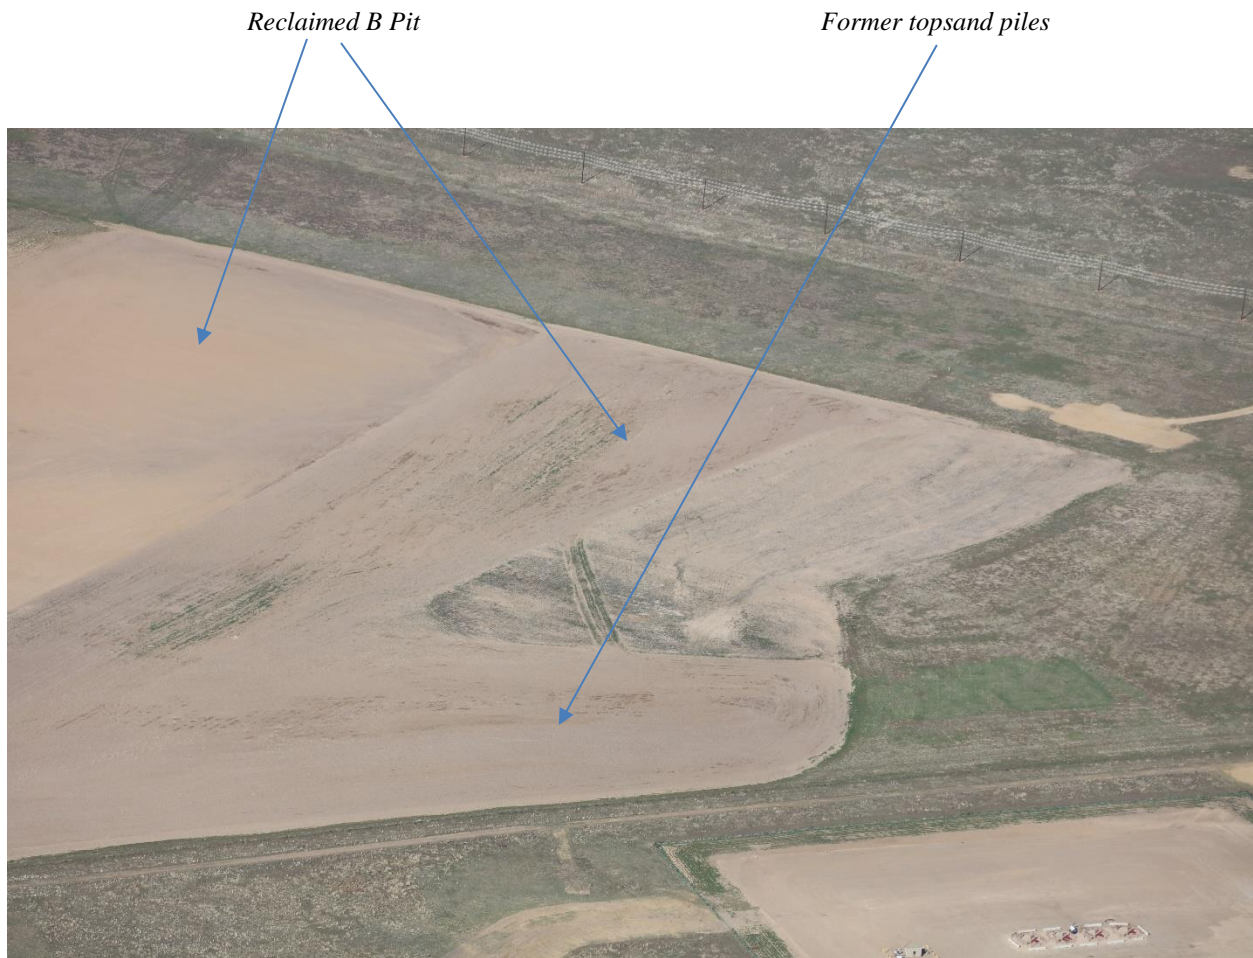
No negative impacts from the mine were detected on off-site areas. This includes areas adjacent to the north side of the permit area, where recent and current reclamation has been done.

**Northwest portion of reclamation**

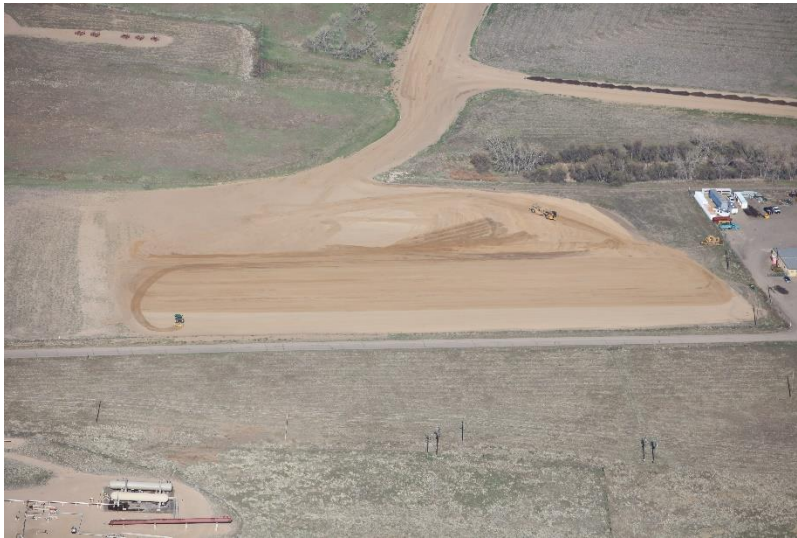
No erosion or other problems were seen at the topsand pile areas. South of the facility area, pile A-1 appears to be completely gone. As noted in past reports, the topsand at the north side of the site (Pile A-3) has all been spread on the reclaimed areas.

**Topsand area south of facilities**

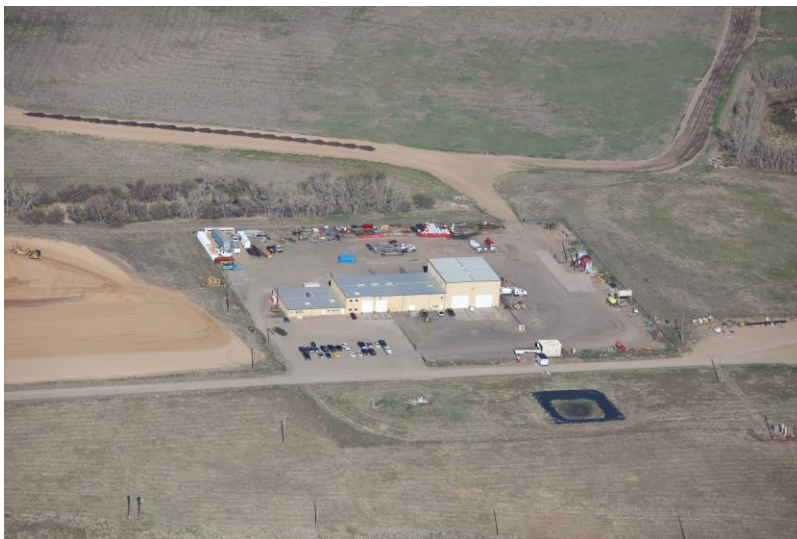
No problems were seen at the facilities area.

**Facilities and Dugout Pond**
