**PERMIT INFORMATION**

<b>Permit Number:</b> C-1981-018 <b>Mine Name:</b> Deserado Mine <b>Operator:</b> Blue Mountain Energy, Inc. <b>Operator Address:</b> Mr. Kurtis Blunt 3607 County Road 65 Rangely, CO, 81648	<b>County:</b> Moffat, Rio Blanco <b>Operation Type:</b> Underground <b>Permit Status:</b> Active <b>Ownership:</b> Private
	<b>Operator Representative Present:</b>  NA
<b>Operator Representative Signature:</b> (Field Issuance Only)

<b>Inspection Start Date:</b> May 6, 2020 <b>Inspection Start Time:</b> 10:08 <b>Inspection End Date:</b> May 6, 2020 <b>Inspection End Time:</b> 10:11		<b>Inspection Type:</b> Aerial Inspection <b>Inspection Reason:</b> Normal I&E Program <b>Weather:</b> Clear	
<b>Joint Inspection Agency:</b>  None		<b>Joint Inspection Contacts:</b>  None	
<b>Post Inspection Agency:</b>  None		<b>Post Inspection Contacts:</b>  None	
<b>Inspector(s):</b>  Clayton Wein  Brock Bowles	<b>Inspector's Signature:</b>  <i>Clayton Wein</i>		<b>Signature Date:</b>  5/8/2020

This was an aerial inspection of the Deserado Mine conducted on May 6, 2020. The photographs were taken by Brock Bowles of the Division and the report was written by Clayton Wein of the Division.

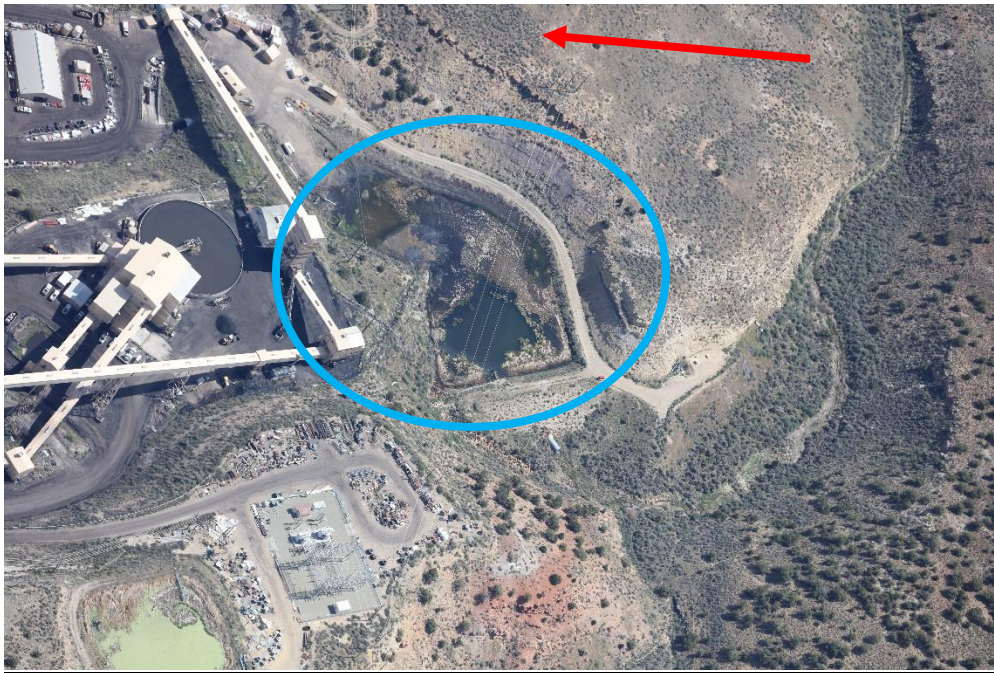
There are three ponds located at the main facilities area of the mine site. The DP-1 Pond (Photo1), the PP-1 Pond and the PP-2 Pond (Photo2). The DP-1 pond is located on the south end of the lower facilities bench. The pond receives all runoff from the facilities benches. The pond was impounding water during the inspection. The inlets to the pond were observed to be clear of obstructions and functioning. The embankment of the pond was vegetated and stable. There were no indications of erosion. The primary outlet of the pond is a riser pipe covered with a trash rack. The outlet appeared to be clear of debris. The emergency spillway was stable and clear of obstructions. The PP-1 Pond is located on the middle facilities bench. The pond was holding water during the inspection. The pond embankments were stable with no erosional features. The PP-2 Pond is located on the western end of the upper facilities bench. The pond was holding water at the time of the inspection. The embankment was vegetated and stable. No erosional features were identified. The spillways for the pond were unobstructed.

**Photo 1:** The DP-1 Pond outlined in the blue circle.

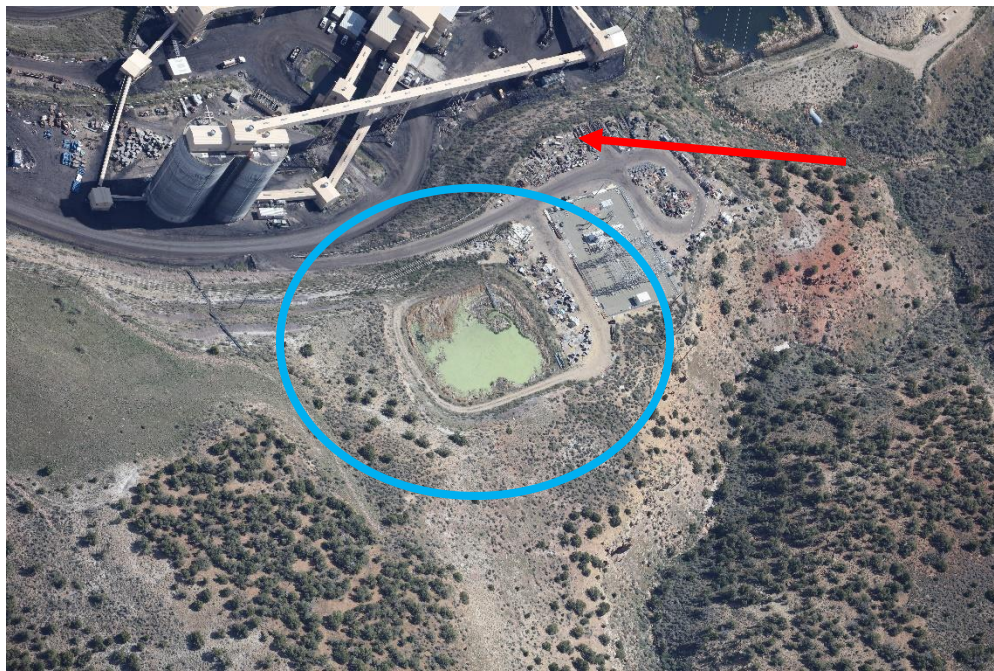
**Photo 2:** The PP-2 Pond outlined in the blue circle.

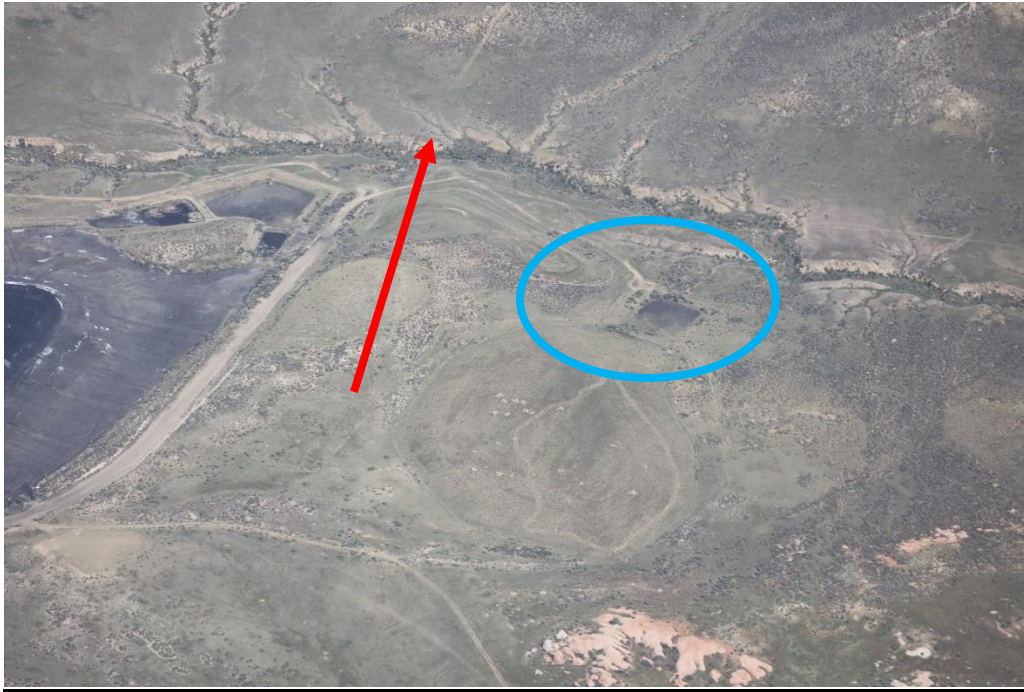
The RP-1 Pond is located to the north of the reclaimed RP-1 refuse pile (Photo 3). The pond was dry during the inspection. The inlets to the pond were clear. The embankment for the pond was stable with vegetation and there were no indications of erosion. The spillways were clear of debris.

**Photo 3:** The RP-1 Pond outlined in the blue circle.

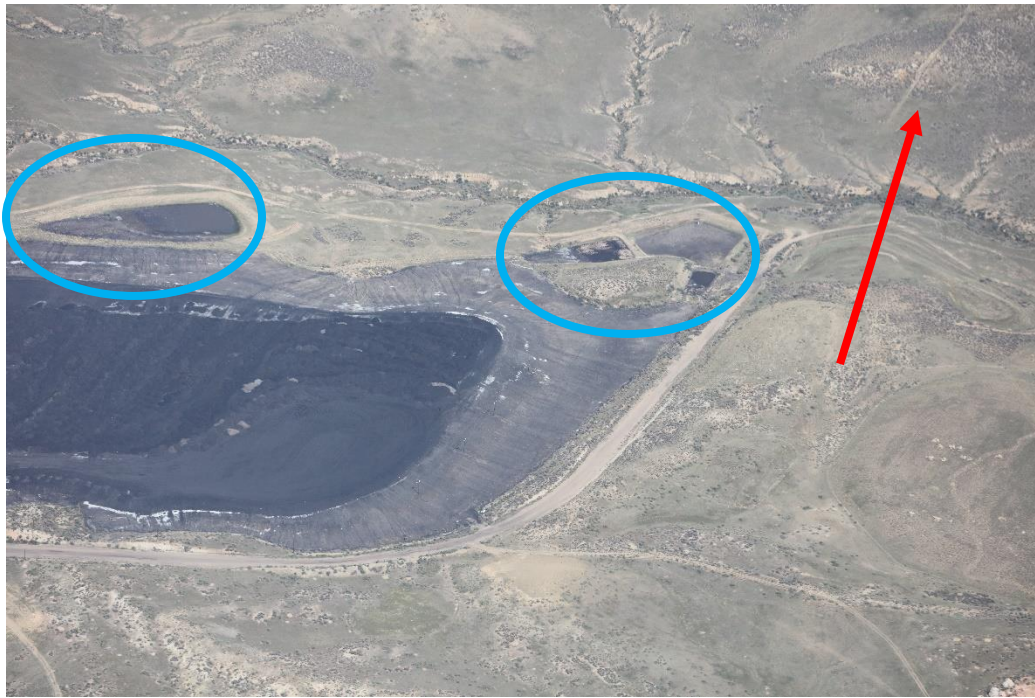
There are two ponds located at the RP-2/3/4 refuse pile, the RP-2/3 Pond and the RP-4 Pond. The RP-2/3 Pond is located at the base of the northeast corner of the RP-2/3/4 pile (Photo 4). The pond consists of three cells, the west cell, the main cell and the east cell. The east and west cells appeared to be damp during the inspection. There was no indication of discharge into the main cell. The embankments of the east and west cells were vegetated and stable. There were no erosional features seen. The main cell of the pond was dry. The spillways were clear of debris. The embankments of the main cell were stable with vegetation and there were no erosional features identified. The RP-4 pond is located at the northwest corner of the RP-2/3/4 pile (Photo 4). The pond was observed to be dry during the inspection. The inlets to the pond were free of debris. The embankments of the pond were stable and vegetated. No indications of erosional features were observed.

**Photo 4:** The RP- 2/3 Pond and the RP-4 Pond outlined in blue circles.

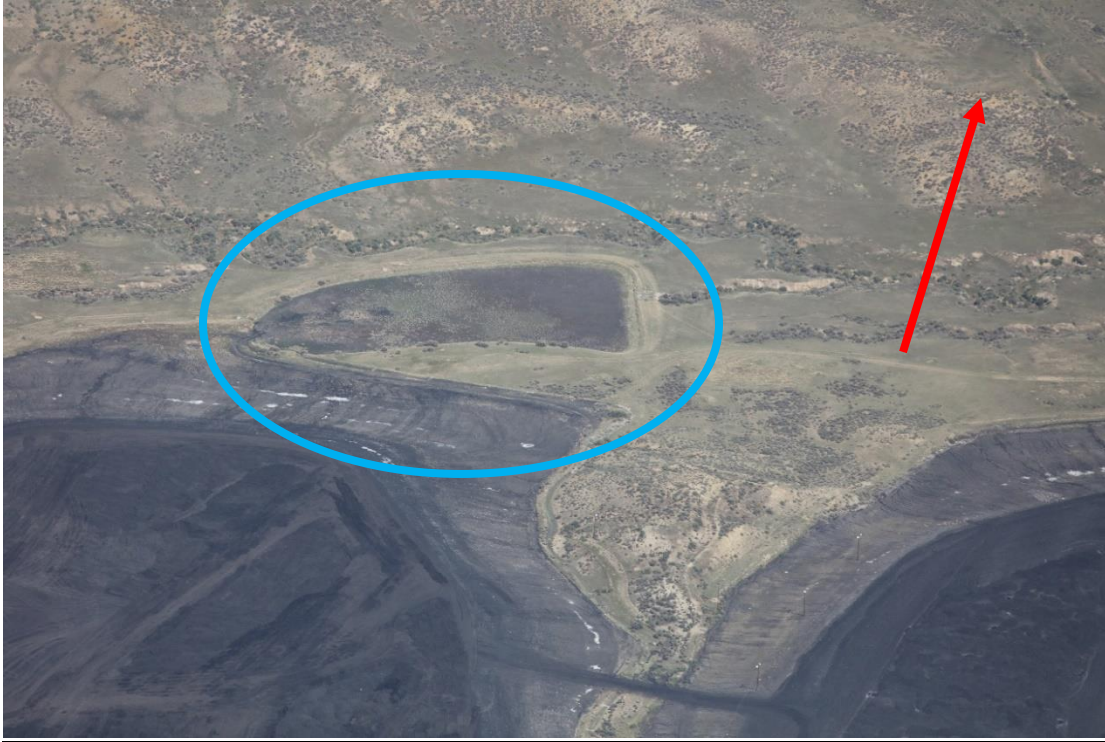
There is one pond located to the northwest of the RP-5a refuse pile. The RP-5 pond was dry (Photo 5). The inlets to the pond were clear and stable. The embankments of the pond were vegetated and stable. There were no erosional features. The spillways for the pond were also clear of obstructions.

**Photo 5:** The RP-5 Pond outlined in the blue circle.

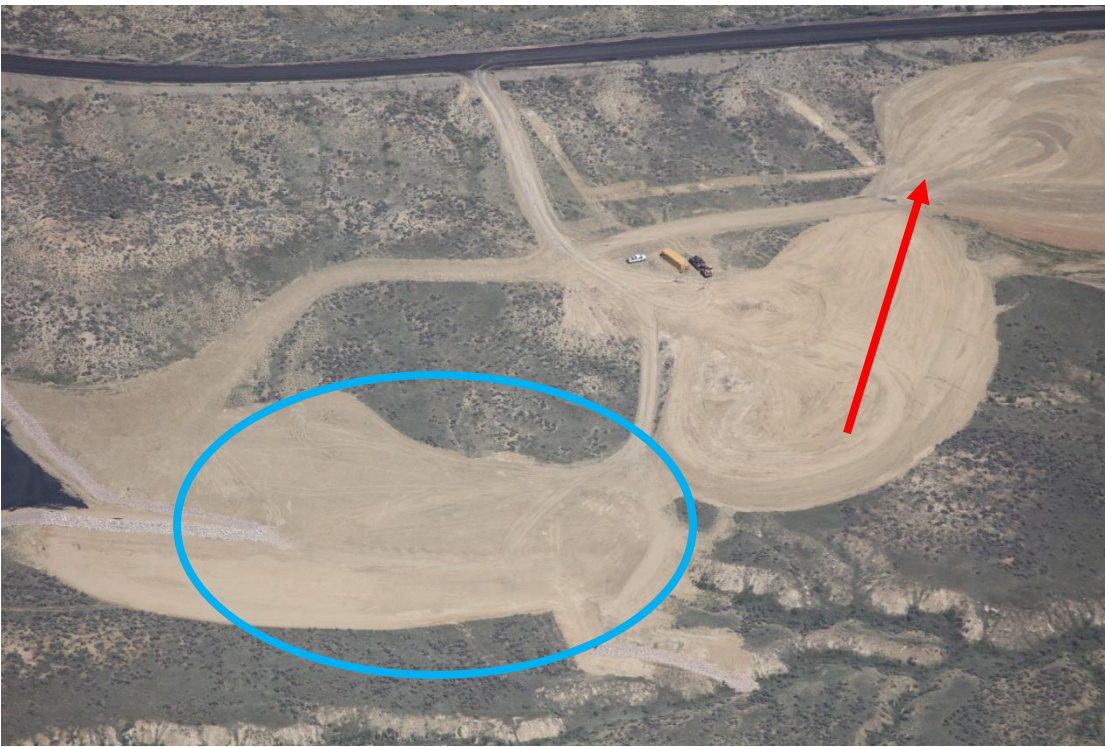
There is one pond located at the RP-A refuse disposal area (Photo 6). The pond was observed to be dry. The pond is relatively new and has not had time for mature vegetation to grow on the embankment. The embankment was stable and there were no observed erosional features. The spillways appeared to be in good condition. The inlets to the pond were clear of debris.

**Photo 6:** The RP-A Pond outlined in the blue circle.

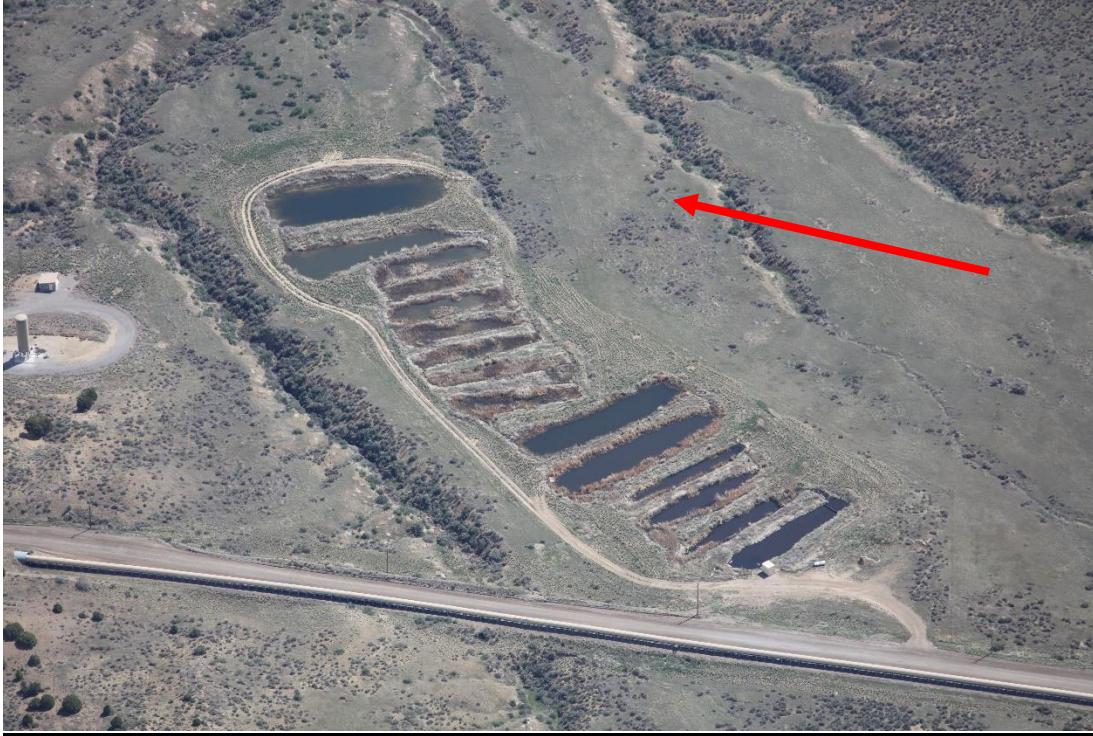
All cells of the B Seam Dewatering System #1 were holding water during the inspection (Photo 7). The series of cells create an artificial wetland. The embankments of the cells in the system were stable with vegetation. There were no observed indications of erosion. The outlet of the Last Chance Pond was clear of debris.

**Photo 7:** The B Seam Dewatering System No. 1.

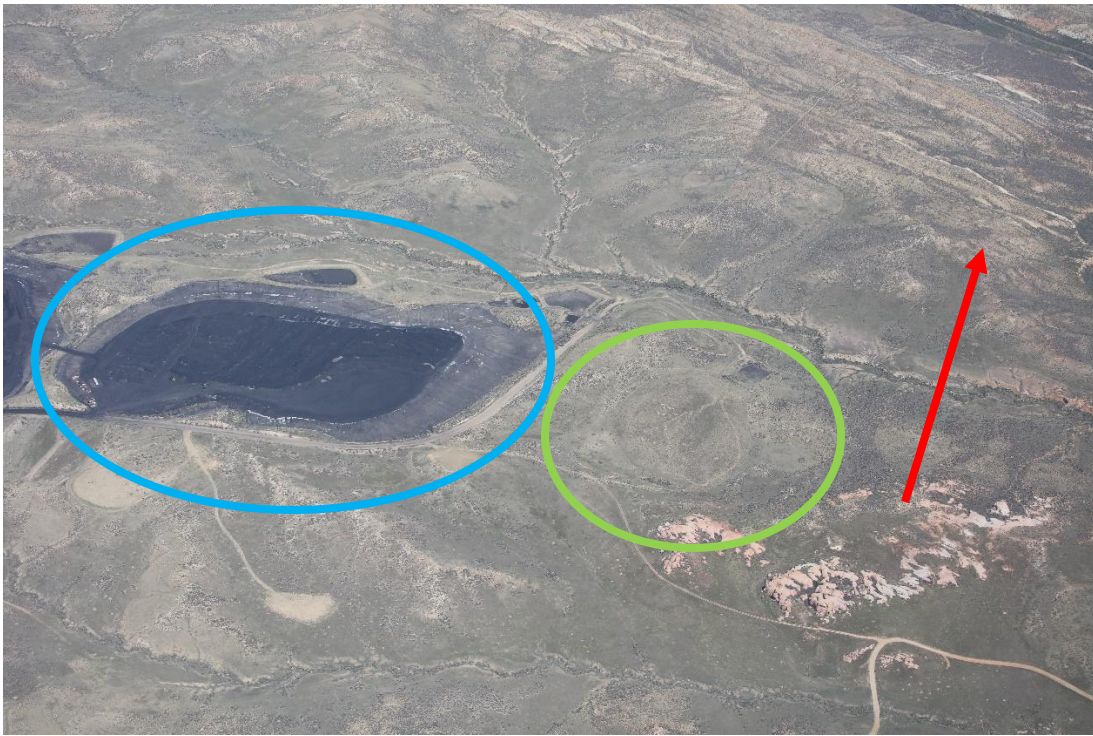
The Deserado Mine has three active refuse piles, The RP-2/3/4 Pile (Photo 8), the RP-5a Pile (Photo 9) and the RP-A Pile (Photo 10). The refuse on RP-2/3/4 appeared to be spread out and compacted. The slopes of the pile were stable with only minor erosional features on it. The slopes of the pile has many rills. These rills have

been documented in previous division inspections. The rills do not impact the stability of the pile. Any material that has eroded off the slopes is caught by the perimeter ditches and routed to either the RP-2/3 Pond or the RP-4 Pond. Material cleaned out from these ponds is placed on the refuse piles. The RP-4 refuse pile Appeared to have the majority of the refuse stockpiled on it spread out. The slopes of the pile are similar to those on RP-2/3/4. They are stable with minor rills. The rills on the slopes are not affecting the stability of the pile. Material was being actively placed on the RP-A Refuse Pile. Refuse material has only recently started to be placed at the site. The material appeared to be stable and no off-site impacts were observed.

The RP-1 Refuse Pile is the only reclaimed refuse pile at the mine site (Photo 8). The pile was stable and vegetated during the inspection. There were no indications of erosion. The perimeter ditches were dry and stable. No obstructions were observed.

**Photo 8:** The RP- 1 Pile in green circle and the RP-2/3/4 Pile in the blue circle.

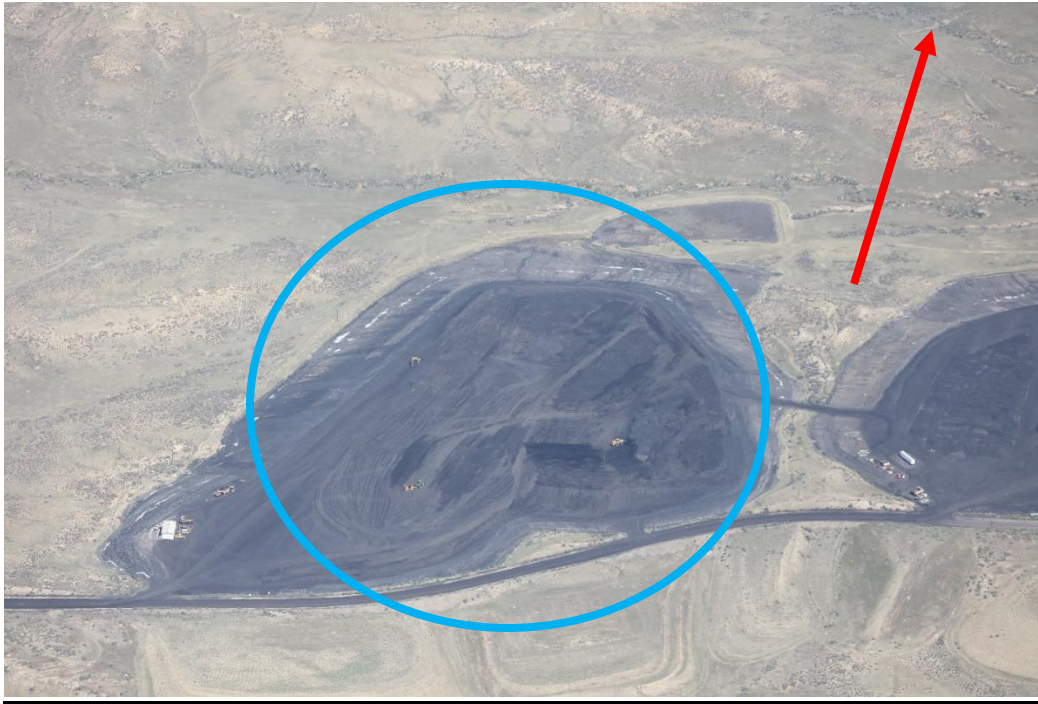
**Photo 9:** The RP- 5a refuse pile outlined in the blue circle.

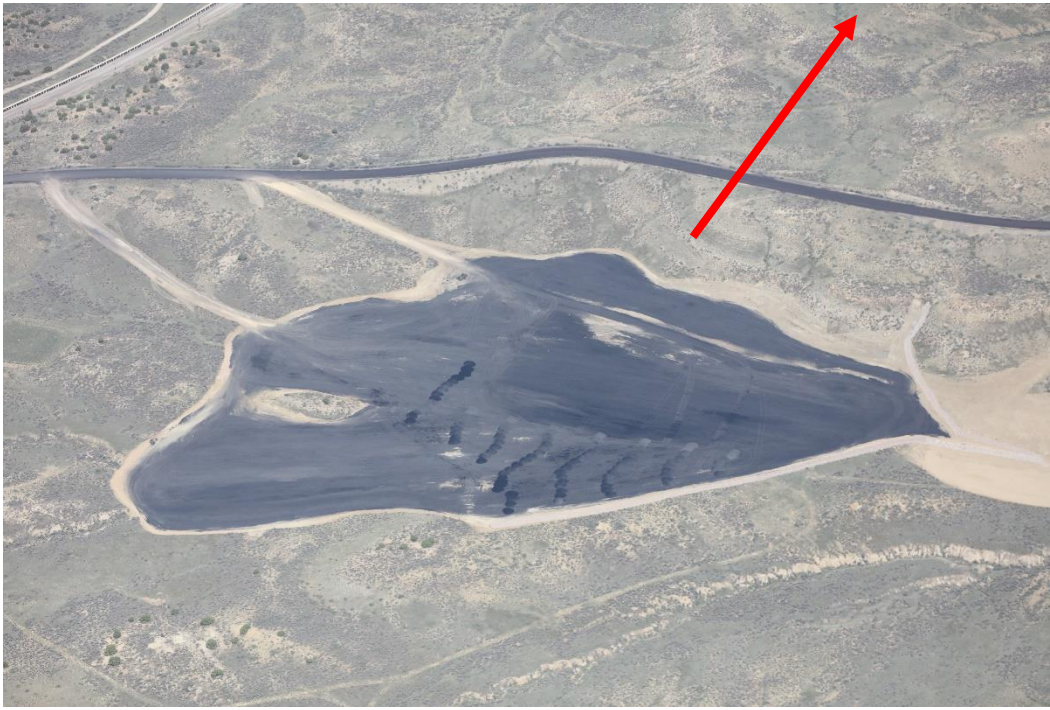
**Photo 10:** The RP-A Refuse Pile.

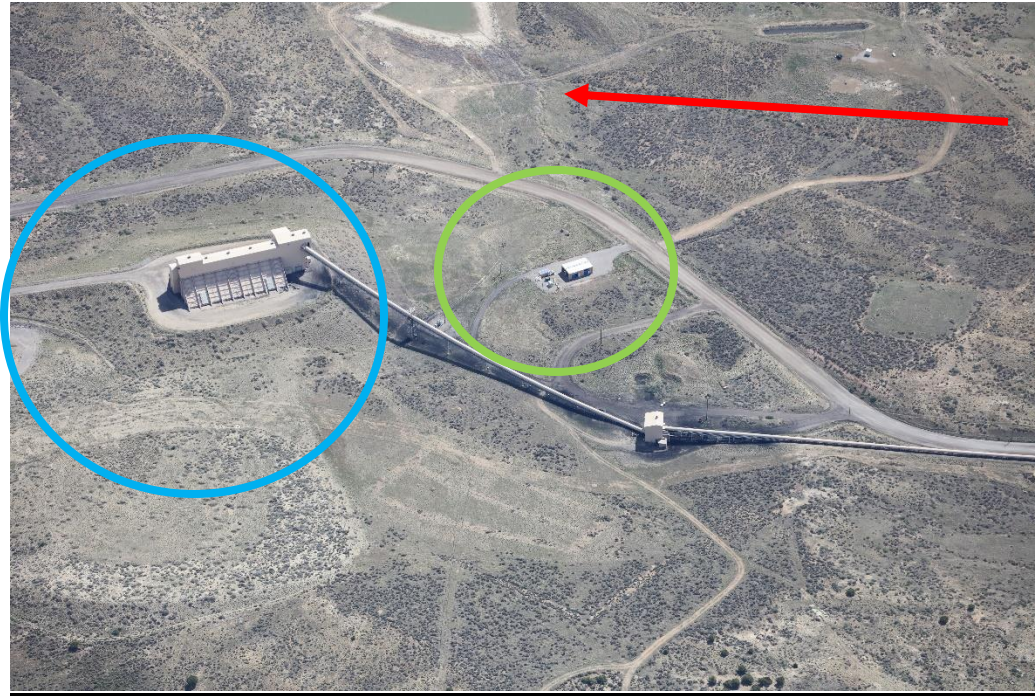
- The Slot Storage (Photo 11)
- Nitrogen Plant #2 (Photo 11)
- RDH-4
- Conveyor transfer buildings
- Water storage tanks (Photo 12)
- Radio Tower and the West Mains Vent Shaft (Photo 12)

Support facilities on the site were well kept. There were no erosional features observed on the site's pads. No off-site impacts were observed.

**Photo 11:** The Slot Storage facility in the blue circle and the Nitrogen Plant #2 in the green circle.

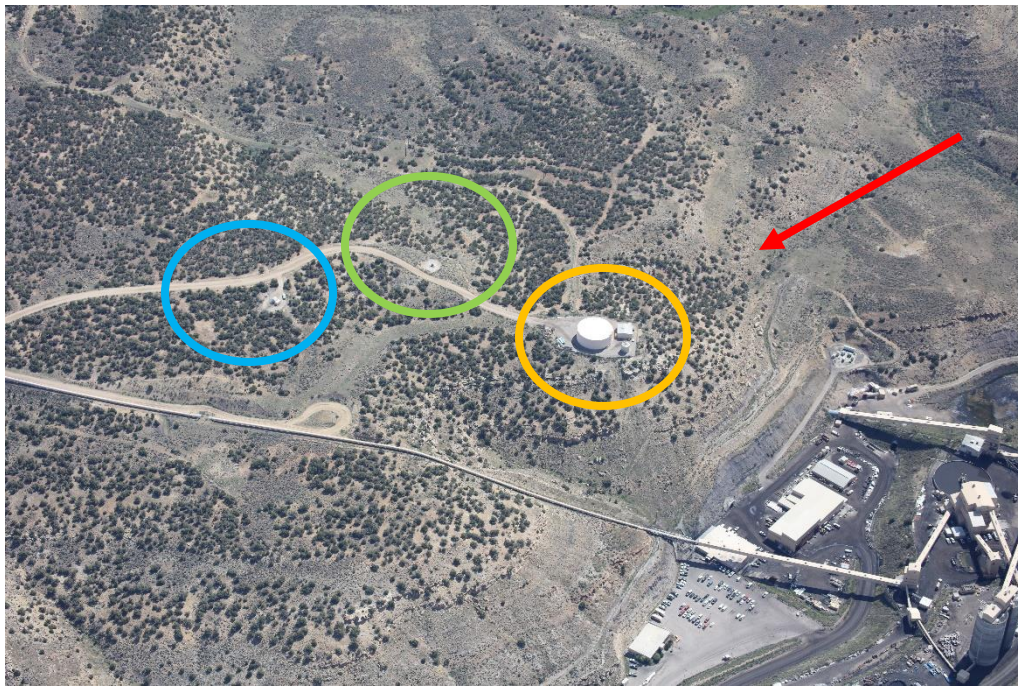
**Photo 12:** The Radio Tower (blue circle), the West Mains Vent Shaft (green Circle and the Water Storage Tanks (Orange circle).
