## MEMORANDUM

RE: Cross Gold Mine, Permit No. M-1977-410, Technical Revision No. 7 (TR-07)  
Request for Technical Review

**MINERALS PROGRAM INSPECTION REPORT**  
**PHONE: (303) 866-3567**

| <b>MINE NAME:</b><br>Cross Gold Mine | <b>MINE/PROSPECTING ID#:</b><br>M-1977-410 | <b>MINERAL:</b><br>Gold, copper and silver | <b>COUNTY:</b><br>Boulder |

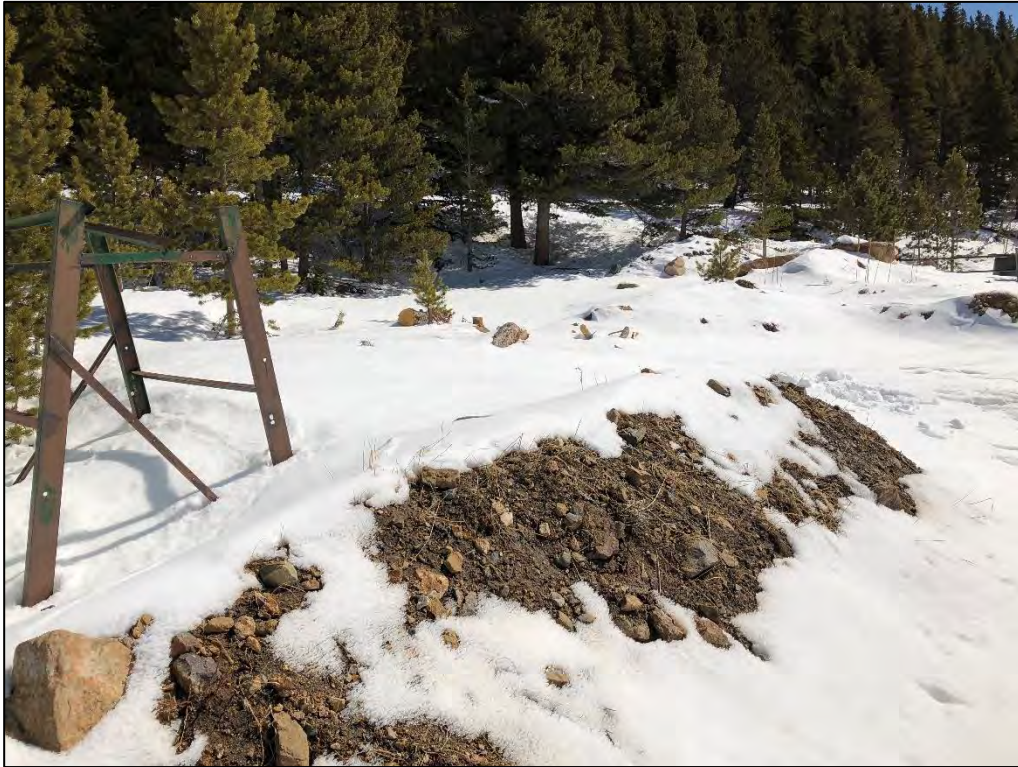
**Photo 1.** View looking east across area located east of storage shed at Caribou Mine, where three old fuel tanks were removed to be crushed for scrap.

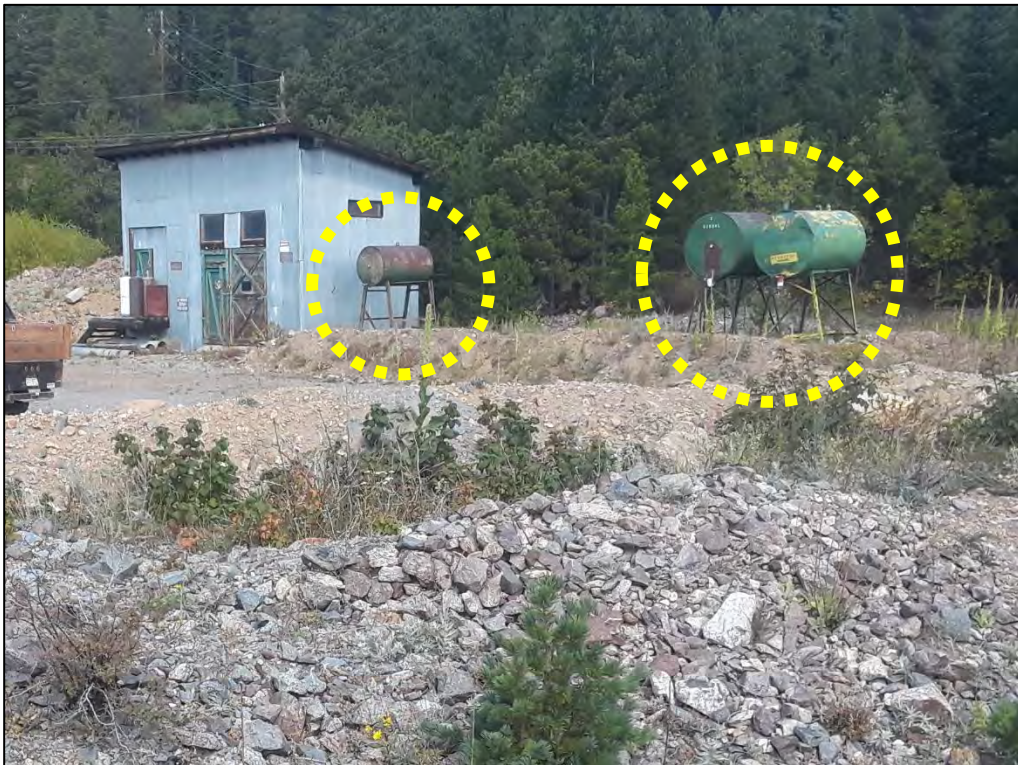
**Photo 2.** View looking north at area east of storage shed at Caribou Mine where three old fuel tanks (circled) were present during Division's September 11, 2018 inspection.

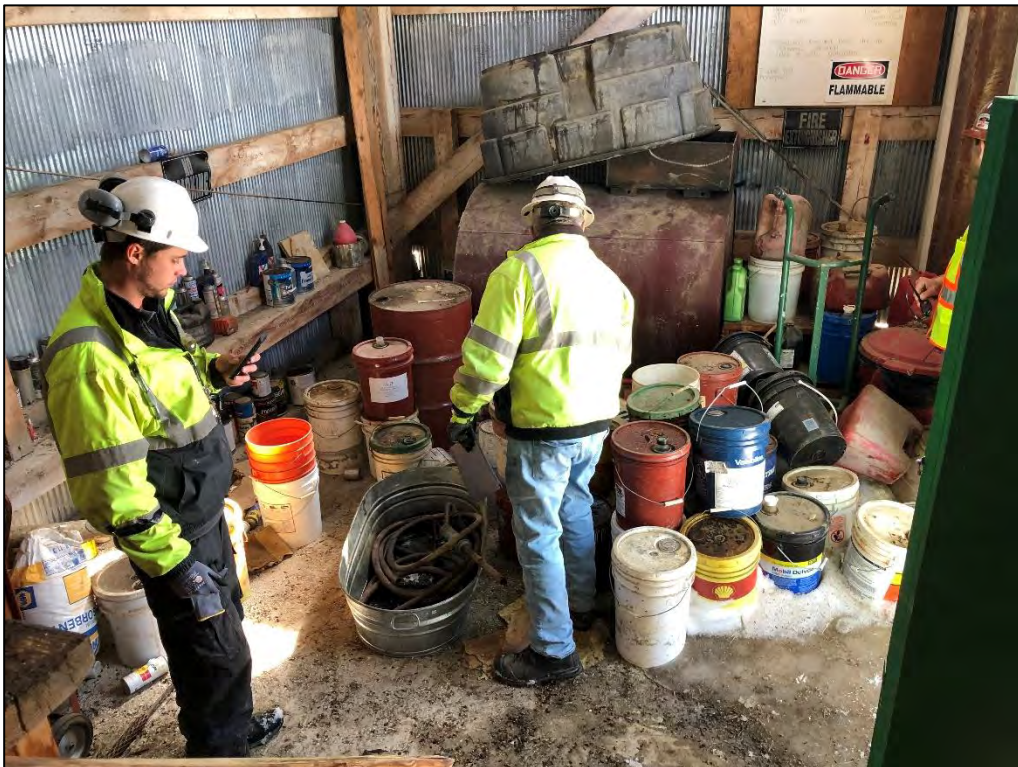
The Division inspected the inside of the storage shed where numerous containers are currently stored, most of them empty. The Division recommends the operator clean up the storage shed as soon as reasonably possible (including the significant amount of rat droppings observed), label and organize the containers, and ensure proper storage of any hazardous substances. The operator indicated plans to tear down this old shed at some point and install a new storage facility, potentially a fabric building. If the new building will have any permanent features (e.g., concrete foundation), prior to constructing the new building, the operator would need to submit a Technical Revision with details of the proposed design and how the building will be reclaimed.

**Photo 4.** View inside storage shed at Caribou Mine where several containers are stored, most of them empty. This shed should be cleaned up, the containers organized and labeled, and any hazardous materials properly stored.

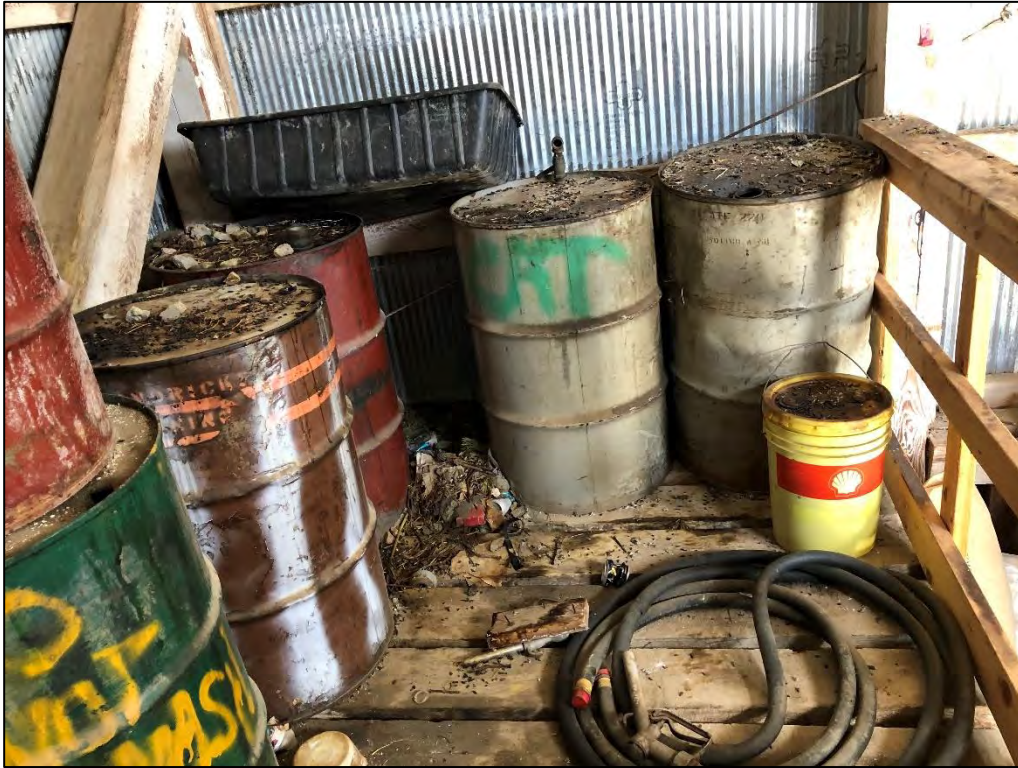
**Photo 5.** View inside storage shed at Caribou Mine where several containers are stored, most of them empty. This shed should be cleaned up, the containers organized and labeled, and any hazardous materials properly stored.

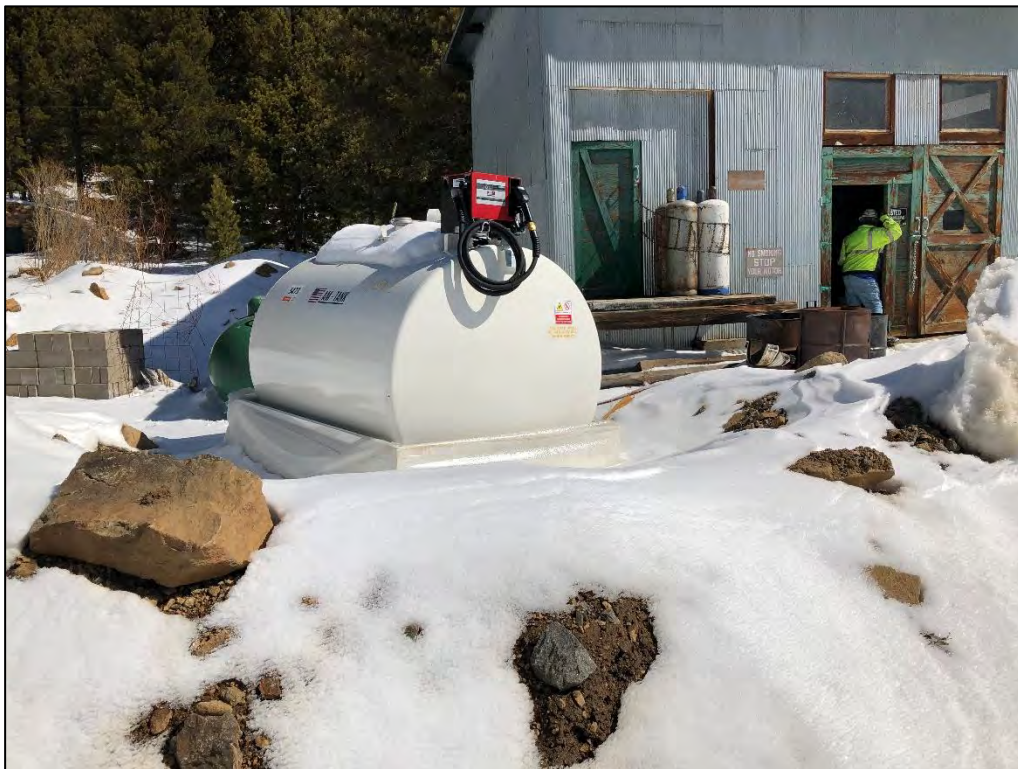
**Photo 6.** View looking north at new double-walled diesel fuel tank with secondary containment currently stored near the storage shed. This tank is not in use at this time.

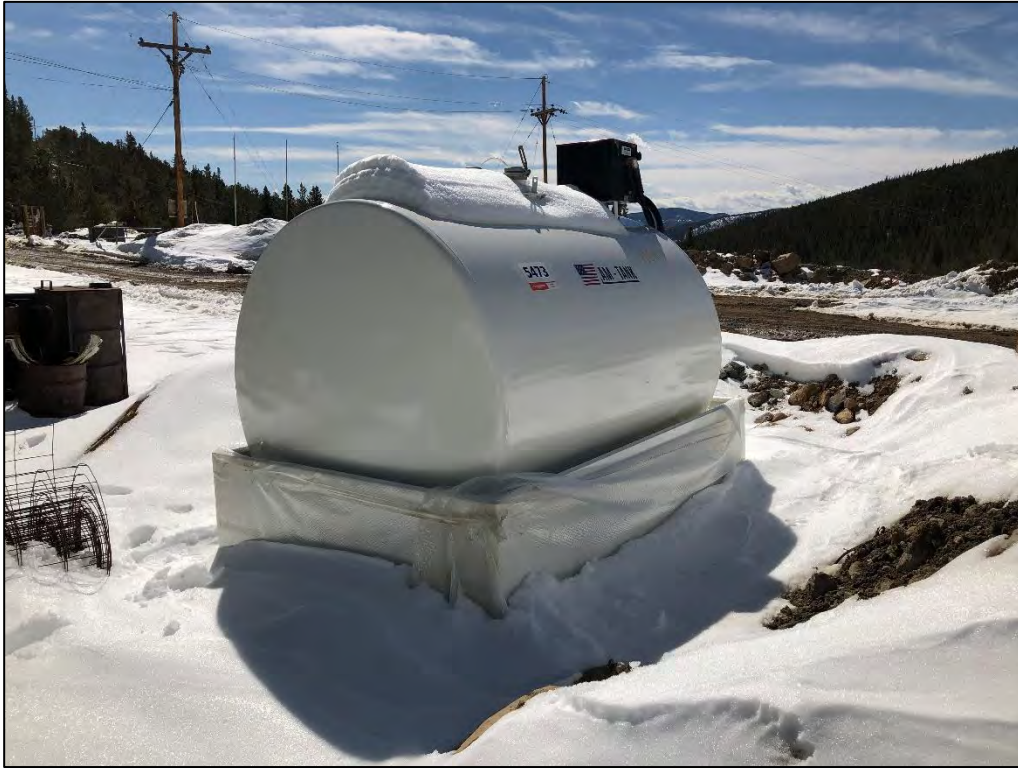
**Photo 7.** View looking south at new double-walled diesel fuel tank with secondary containment currently stored near the storage shed. This tank is not in use at this time.

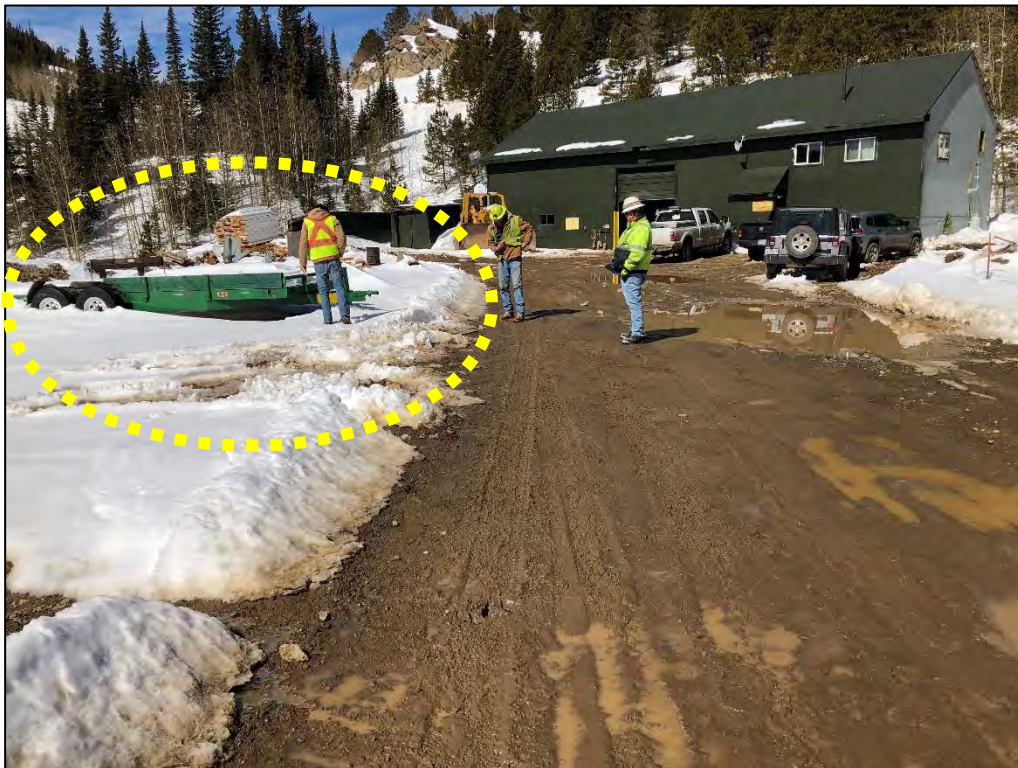
**Photo 8.** View looking west toward Caribou Mine office building, showing location where the old diesel tanks were crushed (circled).

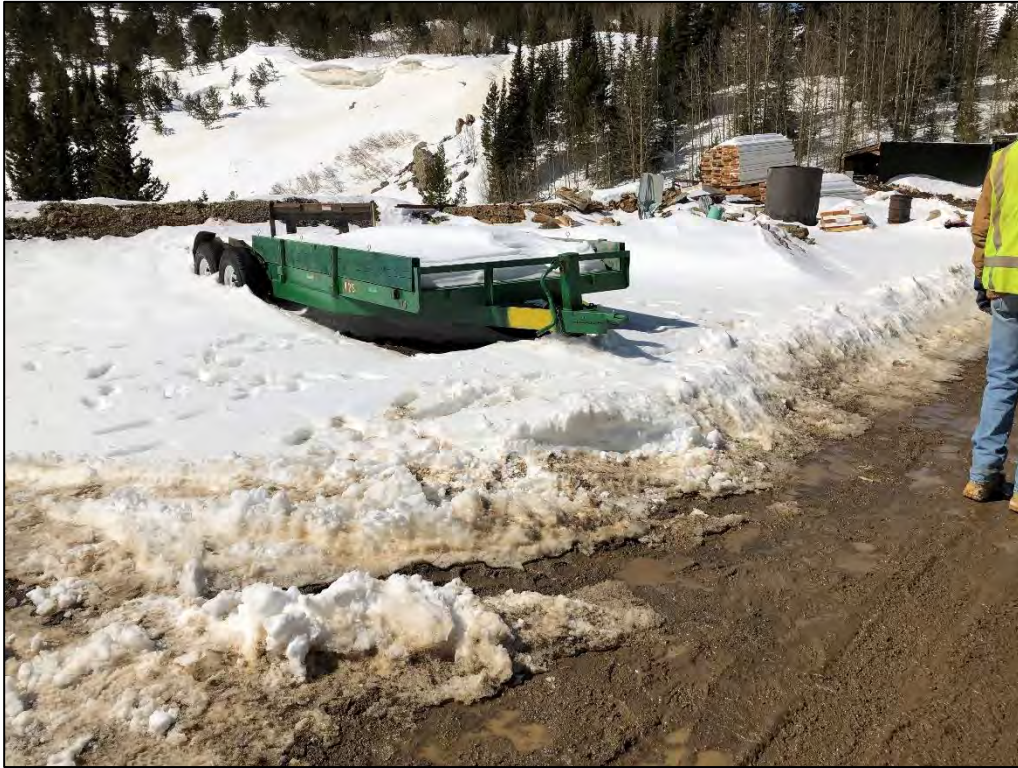
**Photo 9.** Closer view of area at Caribou Mine where the old fuel tanks were crushed. No evidence of fuel discharged to the ground surface was observed.

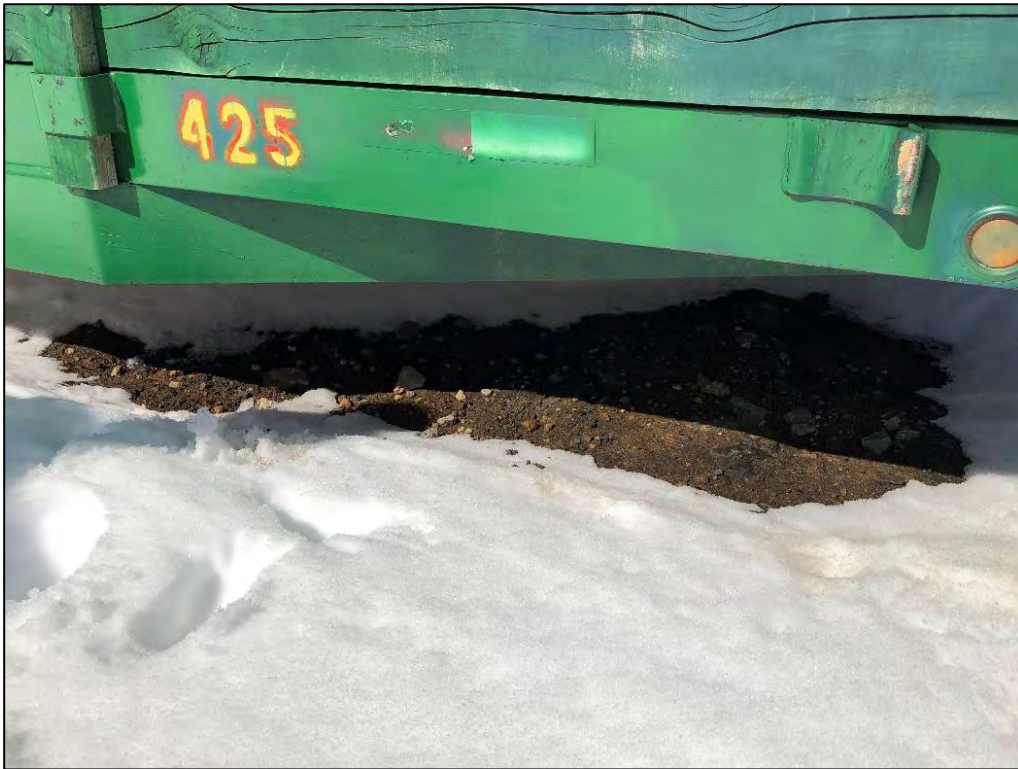
**Photo 10.** View of ground surface beneath trailer parked in area where old fuel tanks were crushed. No evidence of fuel discharged to the ground surface was observed.

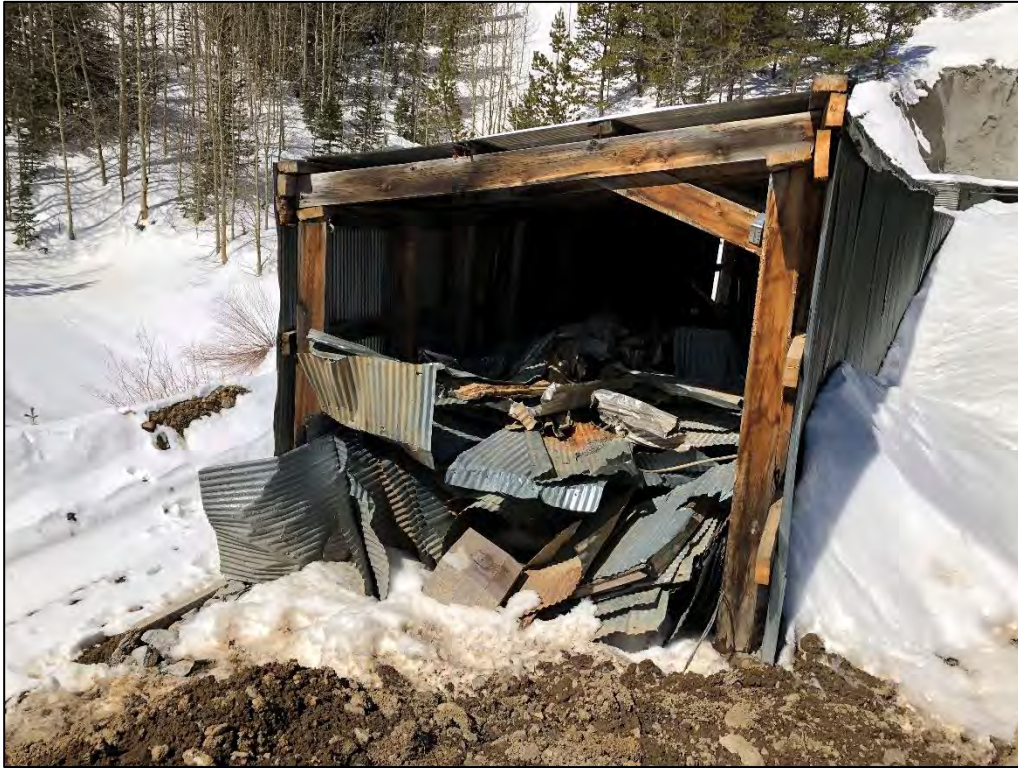
**Photo 11.** View of remaining portion of snowshed at Idaho Tunnel with scrap from demolished portion stored inside.

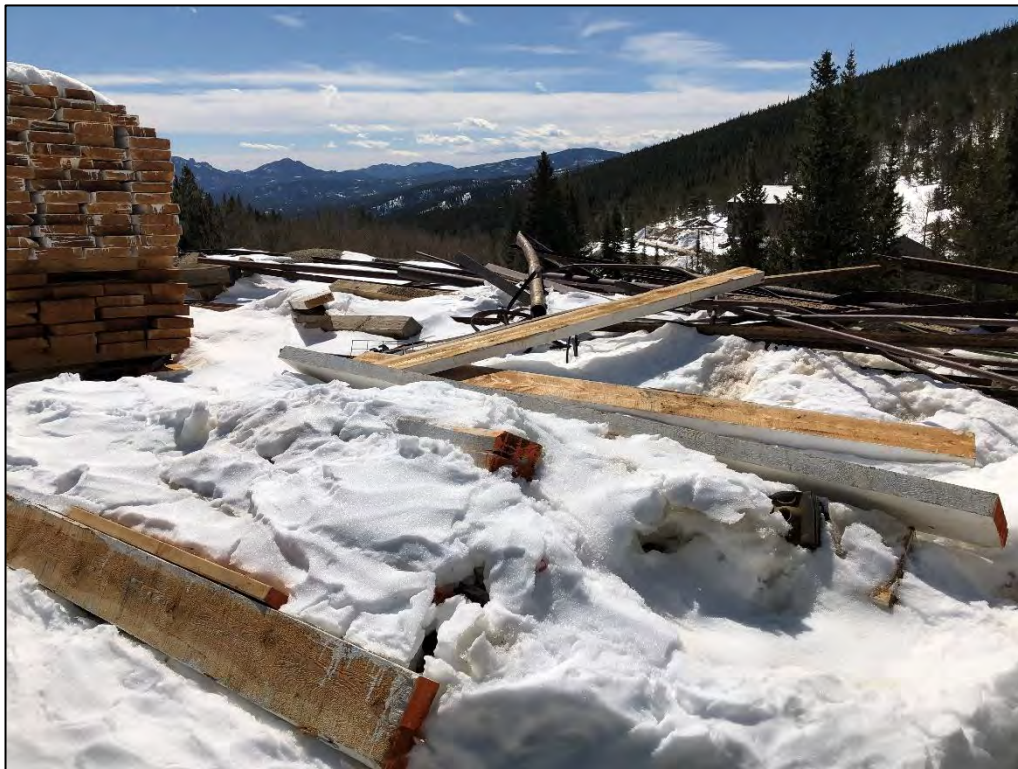
**Photo 12.** View looking southeast across area where Idaho Tunnel snowshed was demolished, now being used for storage of new lumber for tunnel stabilization project and various pieces of scrap.

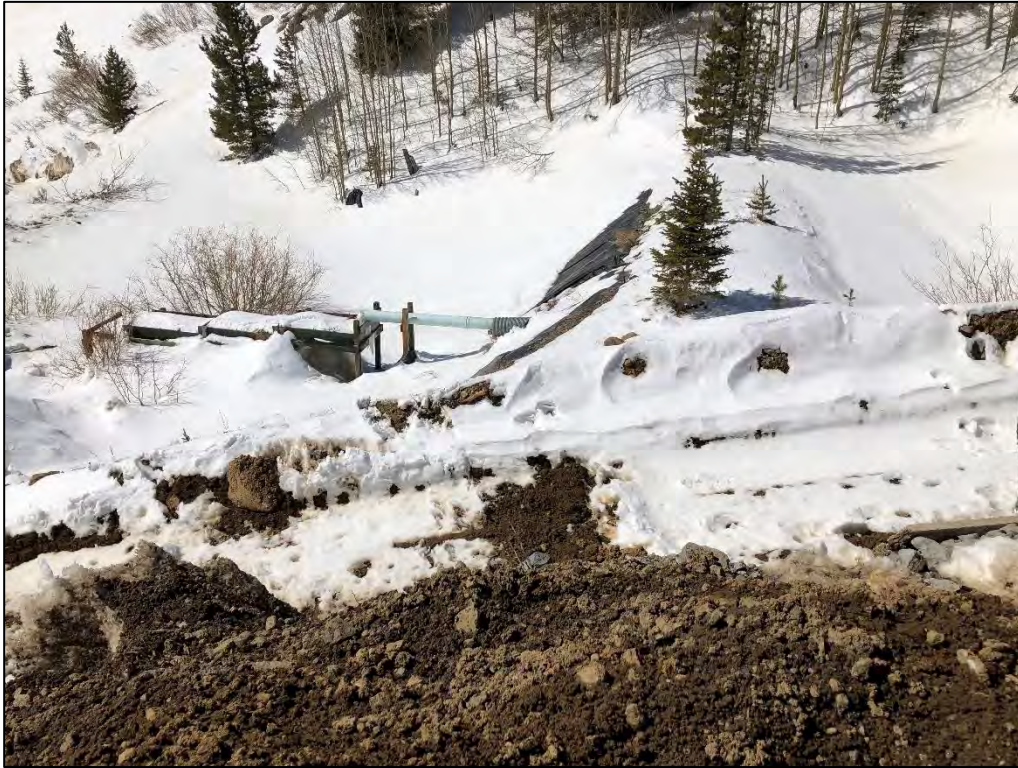
**Photo 13.** View looking west across area where three plastic lined ponds are present near Caribou Mine. A pipeline emerges from lower embankment of middle pond to discharge into lower larger pond. According to operator, these ponds have not been used in many years.

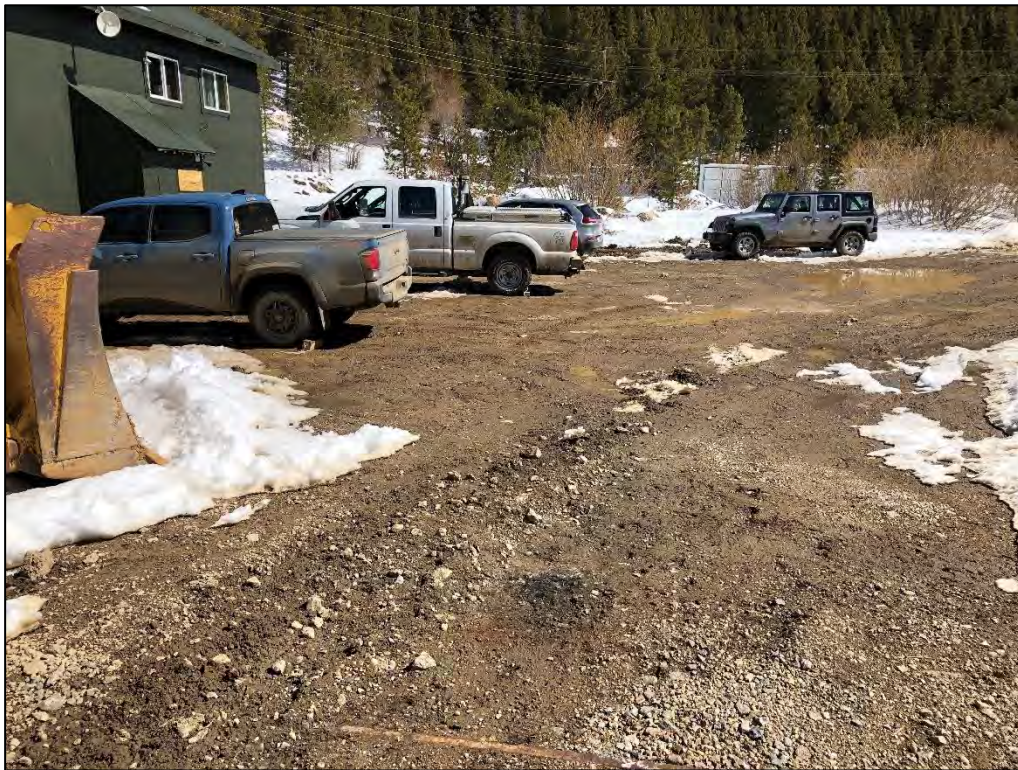
**Photo 14.** View looking northeast across Caribou Mine parking area where some minor oil staining was observed.

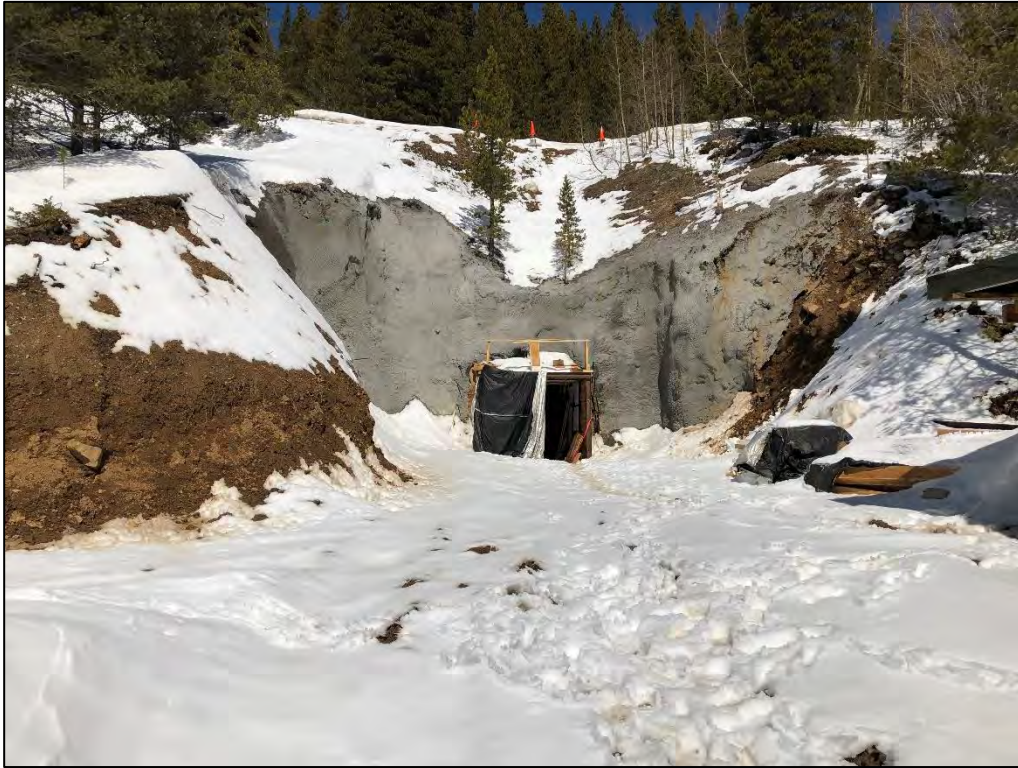
to the southeast approximately 30 feet below Caribou Road. Shotcrete was recently applied on the slope around the portal. However, according to the operator, the shotcrete is not adequately stabilizing the slope, and further stabilization methods will be required. The operator has constructed a steel frame entrance to the portal with wood siding. The Division observed the portal from the entrance, noting the unstable conditions which have been attributed to the historic rotting timbers inside the portal and freeze/thaw cycles of water in the surrounding substrate. A large ice sheet was observed hanging from the roof inside the portal. The Division observed water flowing from the portal, but was not able to track its flow path due to the snow cover. The Division also observed an above ground section of the new 8 inch pipeline that was recently installed after the old pipeline was damaged during the excavation project.

**Photo 15.** View looking northwest at Idaho Tunnel excavation area, showing new portal location approximately 50-60 feet back from remaining snowshed. Portal daylights to the southeast and is approximately 30 feet below Caribou Road. Note shotcrete applied to slope.

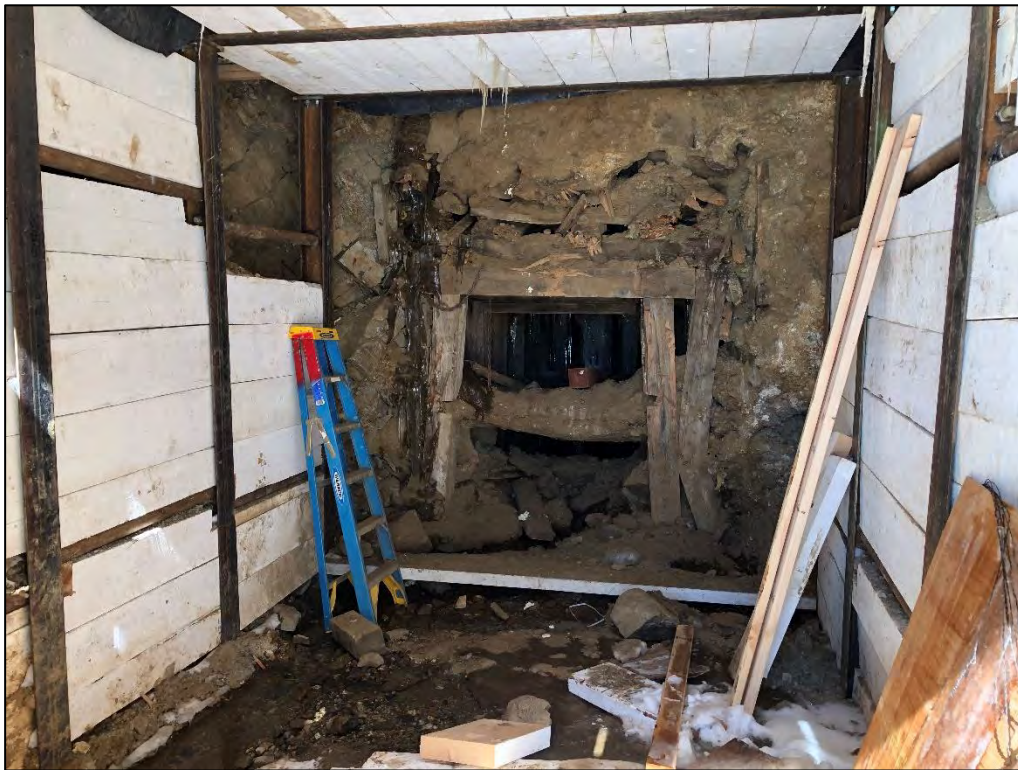
**Photo 16.** View inside new steel frame entrance constructed around Caribou Mine portal. Water was draining from the portal during the inspection (bottom, left).

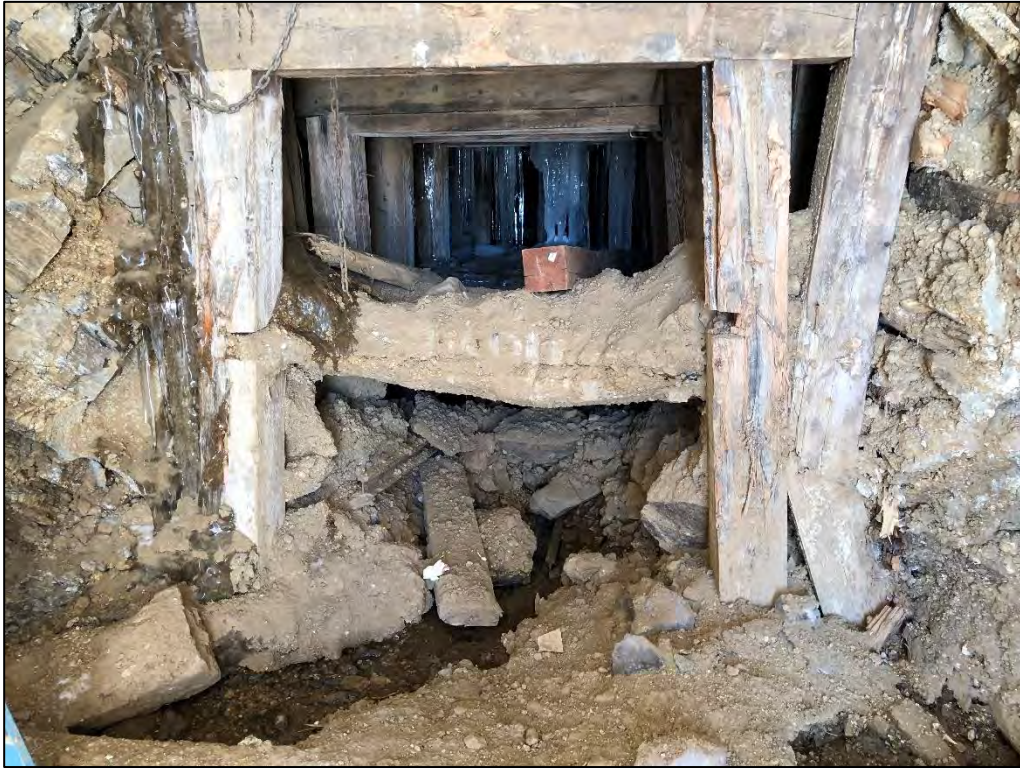
**Photo 17.** Closer view inside Caribou Mine portal, showing historic rotting timbers and large ice sheet hanging from roof inside adit.

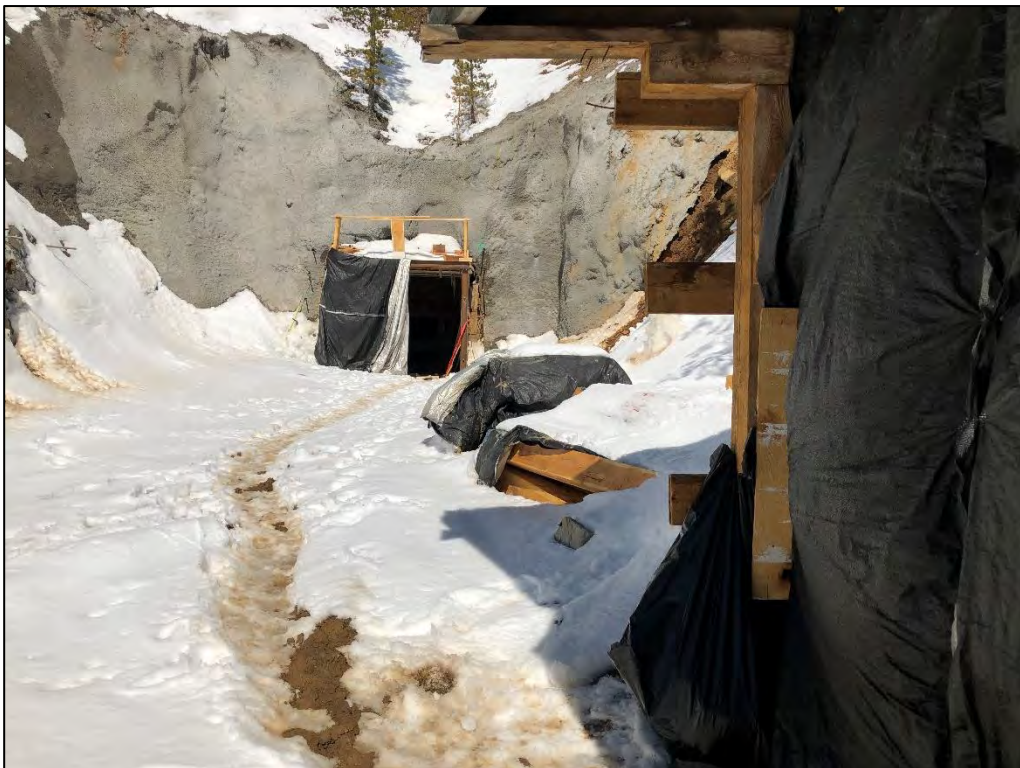
**Photo 18.** View looking northwest from edge of remaining Idaho Tunnel snowshed toward new portal location approximately 50-60 feet ahead.

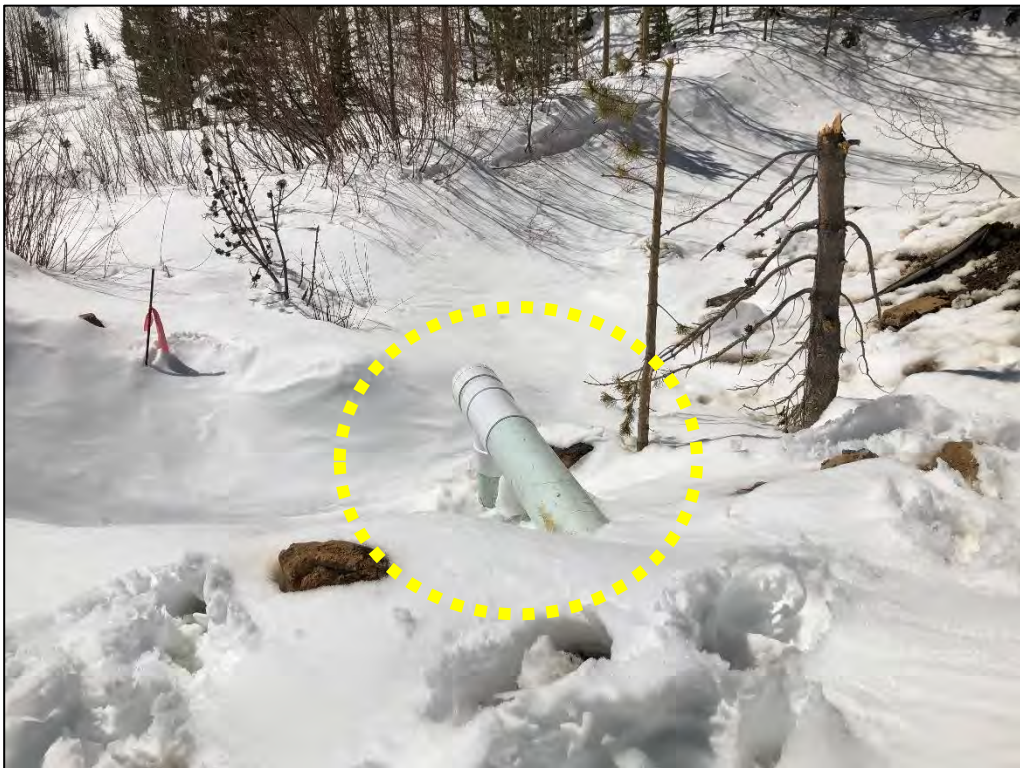
**Photo 20.** View looking southwest at new section of pipe (circled) installed to direct Caribou Mine drainage to pond #2, after old pipe was broken during excavation project.

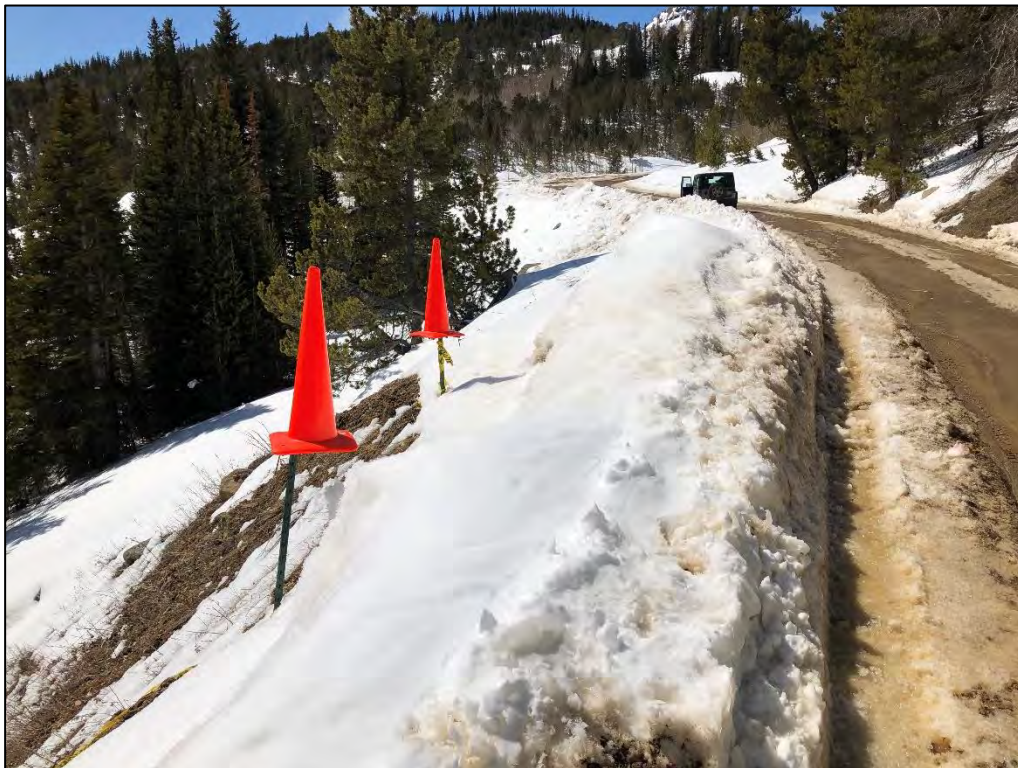
**Photo 22.** View looking southwest across Caribou Road, showing edge of slope with Caribou Mine portal very close to road (within approximately 10 feet).

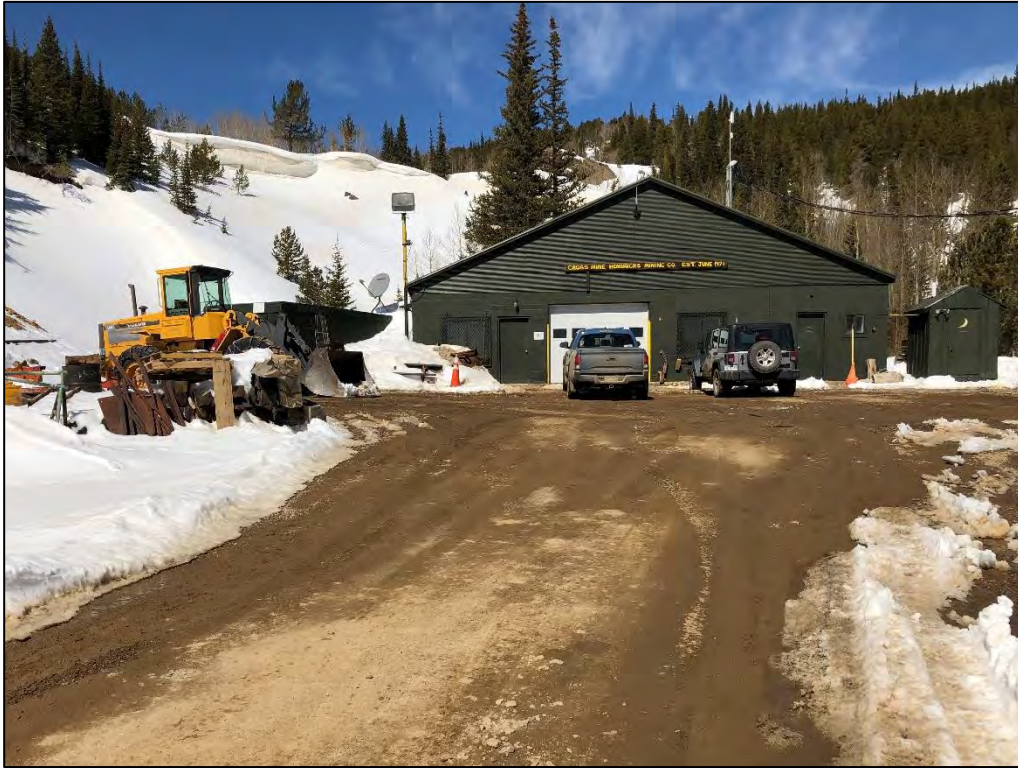
**Photo 23.** View looking northwest toward Cross Mine office building and parking area. Some minor oil staining was observed in the parking area.

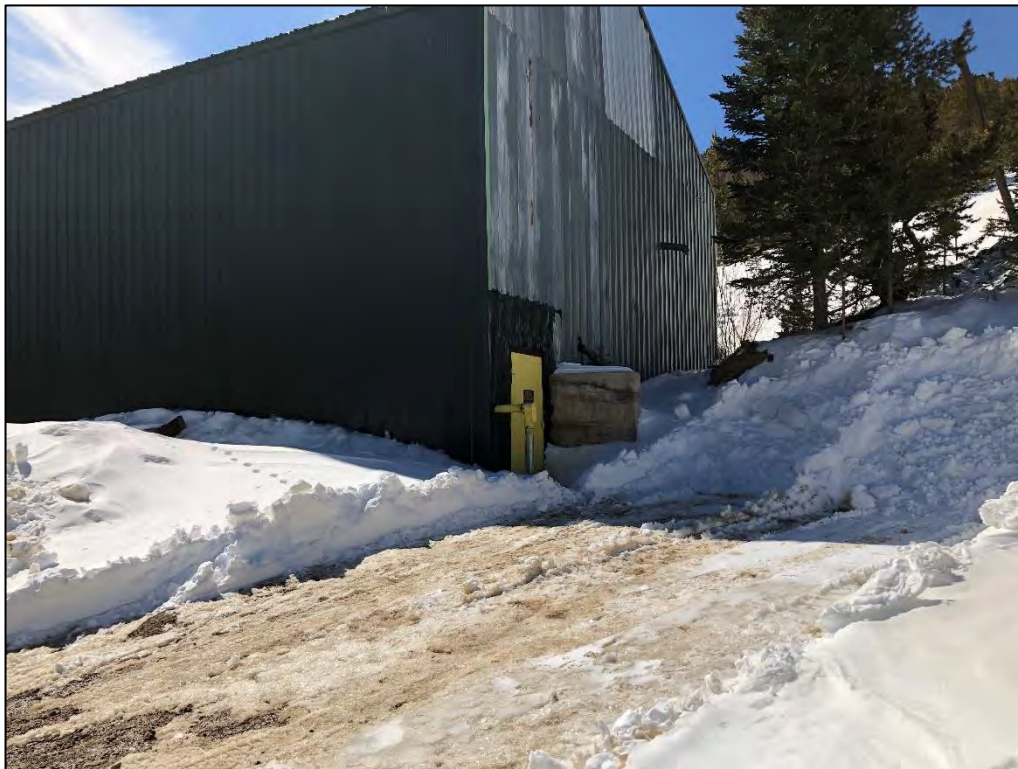
The Division also inspected the Cross Mine area where the complaint alleges that oil from vehicles and equipment is drained onto the ground. The area described in the complaint is located just north of the large warehouse building. The Division observed no evidence the operator is discharging oil from vehicles and equipment to the ground in this area. The Division did observe minor oil staining in the Cross Mine parking area, as was observed at the Caribou Mine. Inside of the warehouse building, the Division observed a floor drain near an air compressor unit, and dark staining on the floor surrounding the drain. According to the operator, no oil has been directly poured down the drain. However, the adjacent air compressor does leak oil which goes down the drain. The operator stated that automatic transmission fluid has been poured down the drain. The operator did not provide an estimated frequency for this activity, or any estimated volumes. The operator could not provide the Division with details of the floor drain design, including the final destination of any fluids that enter the drain (e.g., holding tank, daylighted open drain). Therefore, the operator must immediately cease using this floor drain until more details can be provided to the Division on its design and how any substances captured by the drain system are managed. If the operator cannot provide this information, the drain shall be permanently sealed and evidence demonstrating this was done provided to the Division. Information on any floor drains or sumps utilized by the operation shall be included in the Technical Revision required for the problem discussed below (Problem #3).

**Photo 24.** View looking west at area north of Cross Mine warehouse building where complaint alleges vehicle and equipment oil is discharged to the ground. No evidence of oil discharged to the ground was observed in this area.

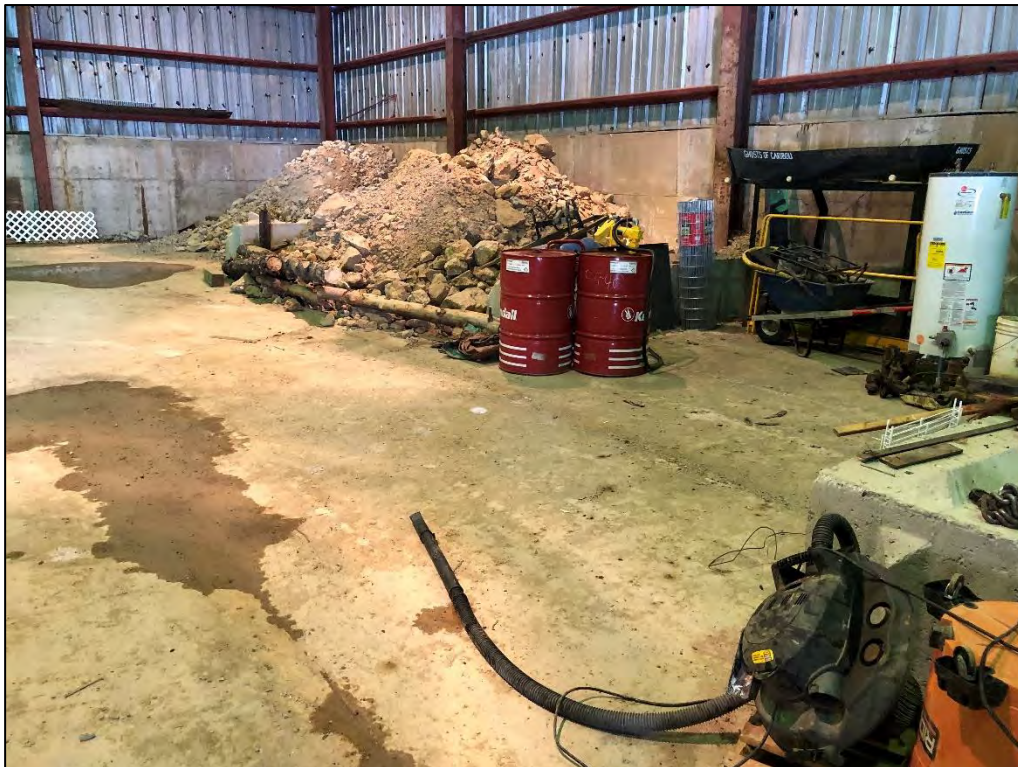
**Photo 26.** View looking southeast inside Cross Mine warehouse building. Note ore material stored inside (background, center).

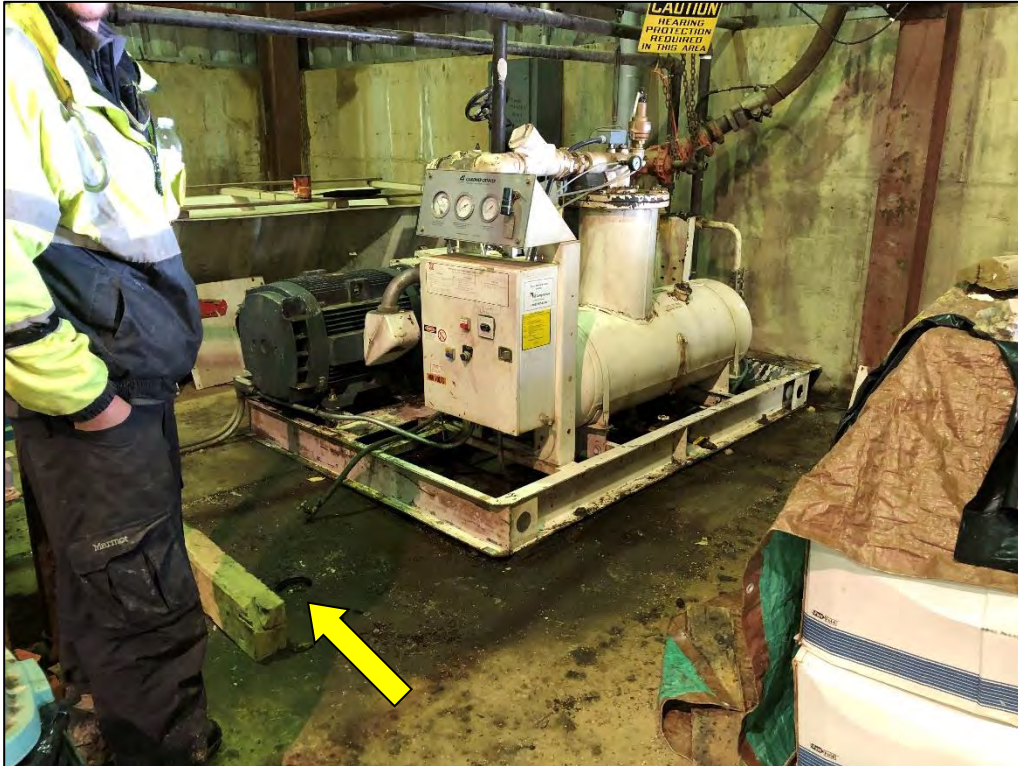
**Photo 27.** View looking at northern portion of Cross Mine warehouse building where floor drain (indicated) is located, near air compressor.

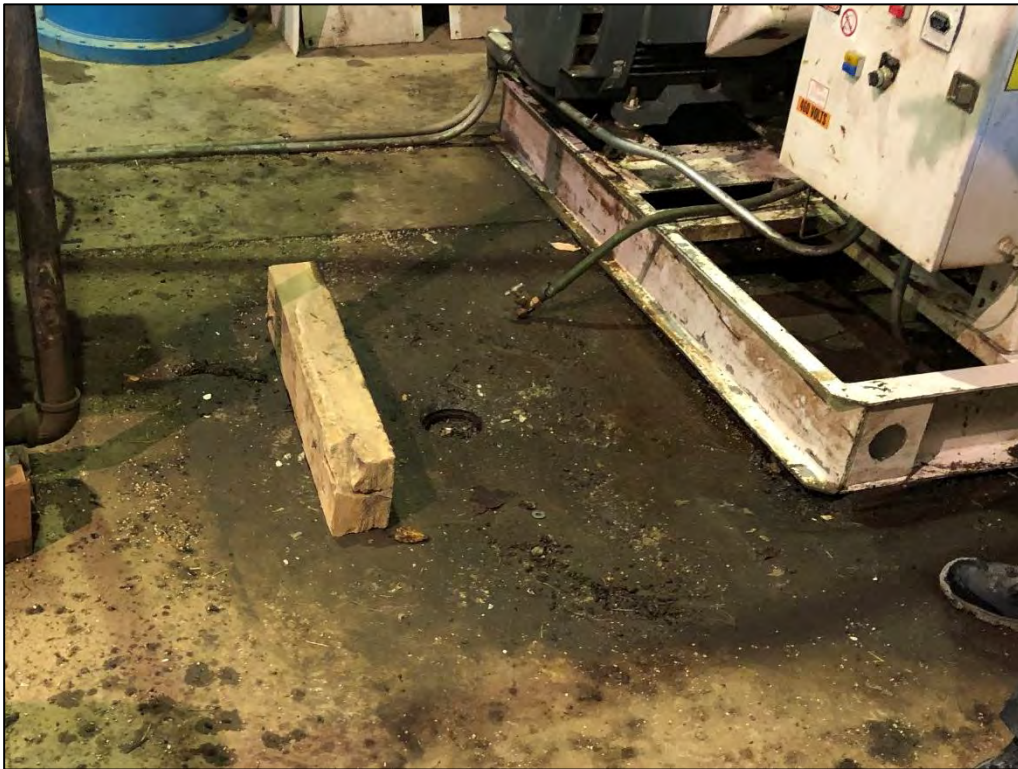
**PROBLEM #3:** The operation does not have an approved Spill Prevention, Control, and Countermeasure (SPCC) plan or approved fuel/oil storage locations for the site. Additionally, the Division observed a floor drain in the Cross Mine warehouse building which has been used for draining fluids to an unknown location. If the operator cannot provide details on the floor drain, including where it drains, and how any fluids captured by this system are managed, use of this drain must cease immediately until these details can be provided, or the drain must be permanently sealed. Given the site is situated at the headwaters of Coon Track Creek (which eventually drains to Barker Meadow Reservoir) and also includes jurisdictional wetlands, the operator must have a plan in place to prevent any oil or fuel spills or contaminated runoff from reaching these water features. This is a problem at this time pursuant to Section 20.3 of the Policies of the Mined Land Reclamation Board (see enclosed policies) pertaining to oil and fuel spill containment structures, and pursuant to Rule 3.1.6(1) and C.R.S. 34-32-116(7)(g), which require disturbances to the prevailing hydrologic balance of the affected land and of the surrounding area and to the quantity or quality of water in surface and groundwater systems both during and after the mining operation and during reclamation to be minimized.

**Photo 28.** Closer view of floor drain inside Cross Mine warehouse building which must be permanently sealed if operator cannot describe how substances captured by this drain system are managed.

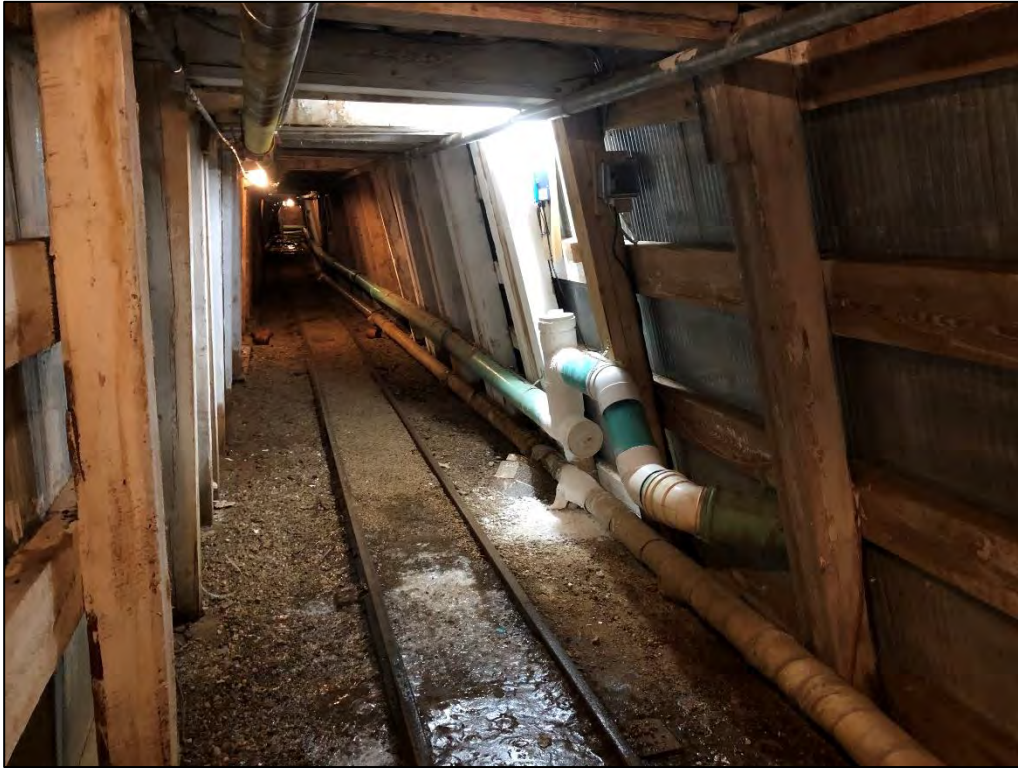
**Photo 29.** View looking northwest inside Cross Mine snowshed, showing pipe (at right) directing mine drainage to pond #1 for lime treatment. Note lit area (at right) where continuous flow meter is installed.

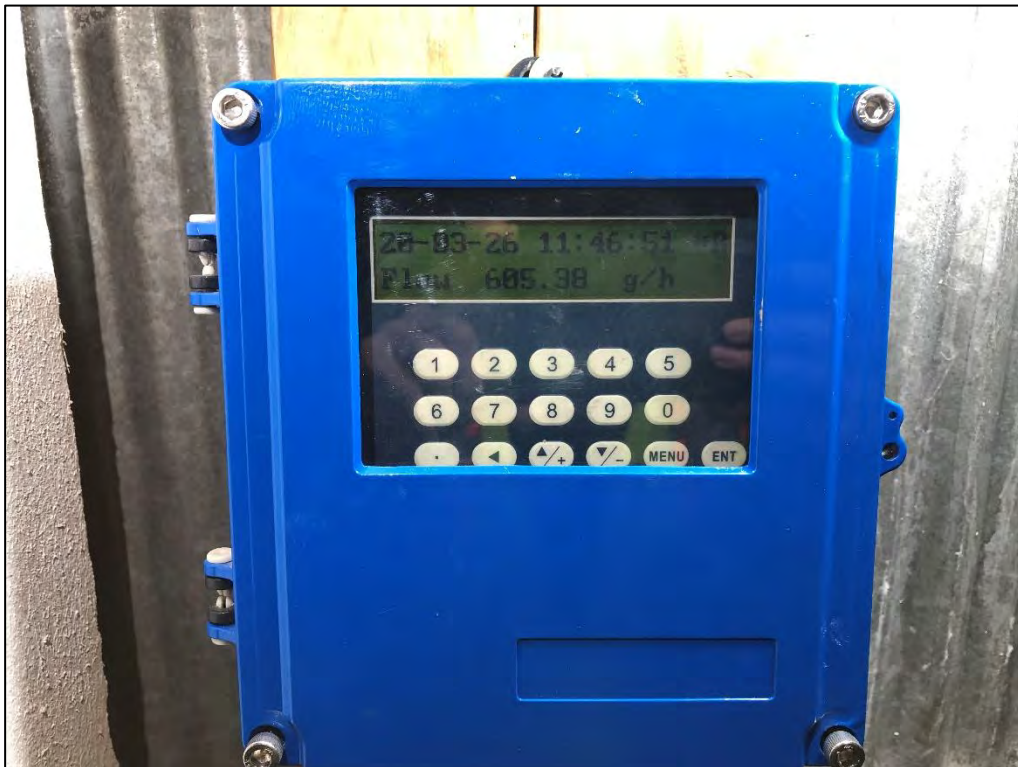
**Photo 30.** View of continuous flow meter installed inside Cross Mine snowshed to monitor discharge rate from this mine. Note discharge rate was 600 gph (10 gpm) during inspection. Caribou Mine discharge is measured by subtracting Cross Mine discharge rate from combined discharge rate at pond #2.
