## MEMORANDUM

RE: Cross Gold Mine, Permit No. M-1977-410, Technical Revision No. 7 (TR-07)  
Request for Technical Review

**MINERALS PROGRAM INSPECTION REPORT**  
**PHONE: (303) 866-3567**

| <b>MINE NAME:</b><br>Cross Gold Mine | <b>MINE/PROSPECTING ID#:</b><br>M-1977-410 | <b>MINERAL:</b><br>Gold, copper and silver | <b>COUNTY:</b><br>Boulder |

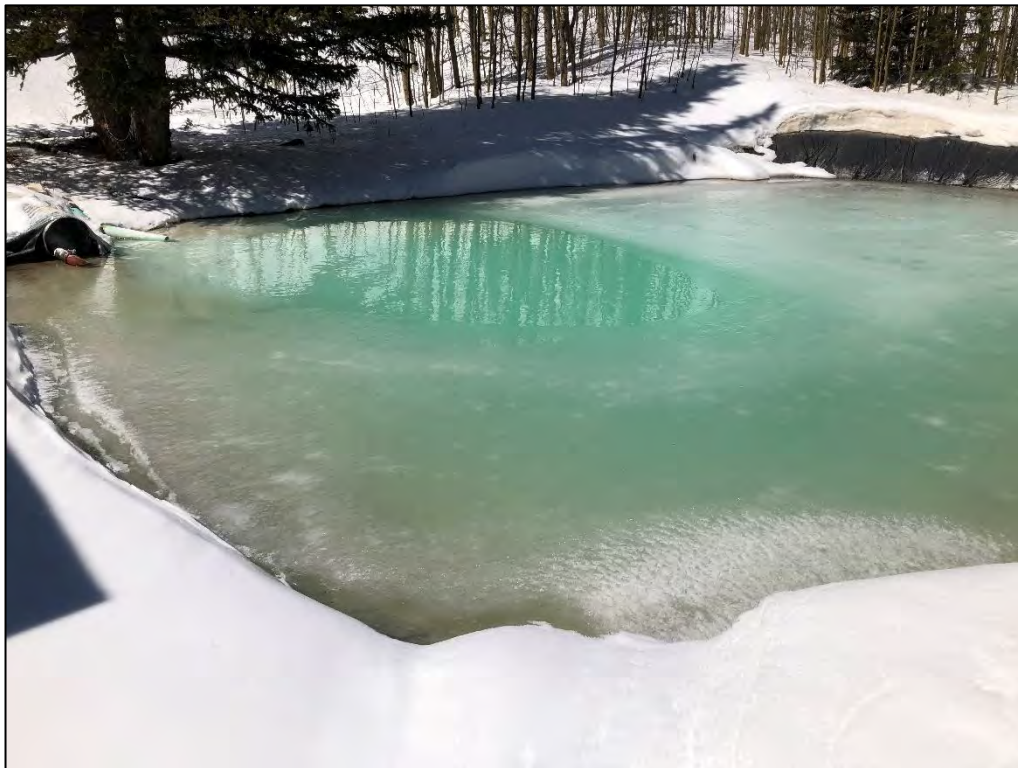
**Photo 32.** View looking northwest across lined pond #1 in which Cross Mine drainage is discharged for lime treatment before being routed to lined pond #2.

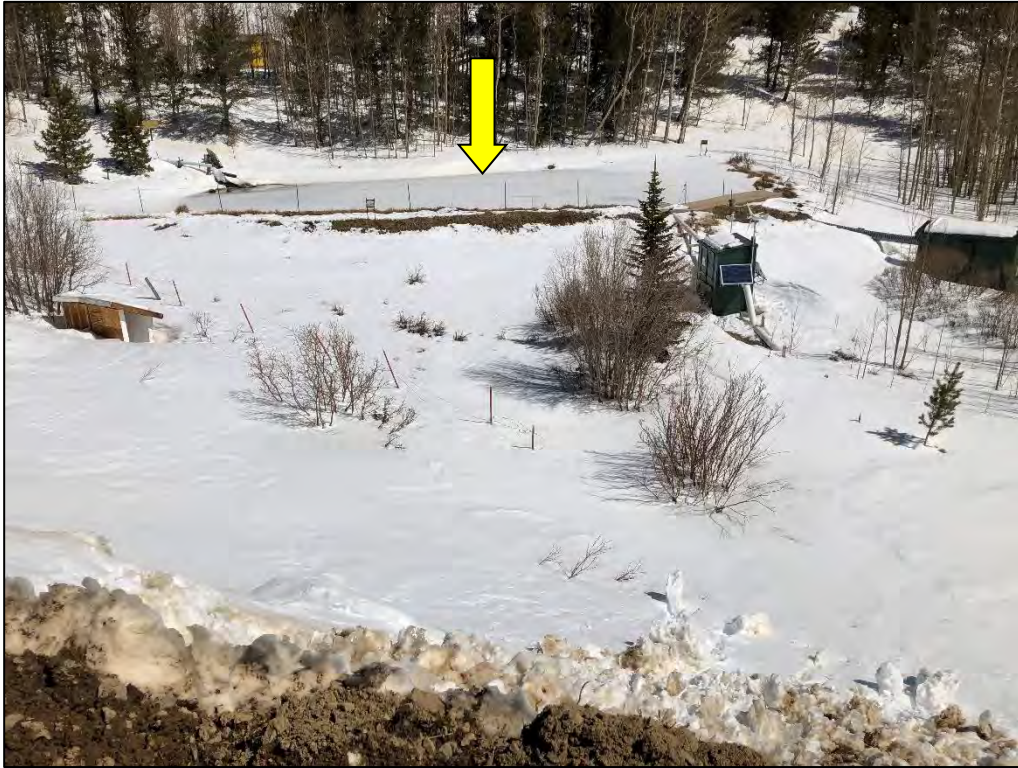
**Photo 33.** View looking northeast at lined pond #2 (indicated) where mine drainage from Cross Mine and Caribou Mine is directed before discharging at permitted outfall on Coon Track Creek. Note shed structures installed (at right) for water management system.

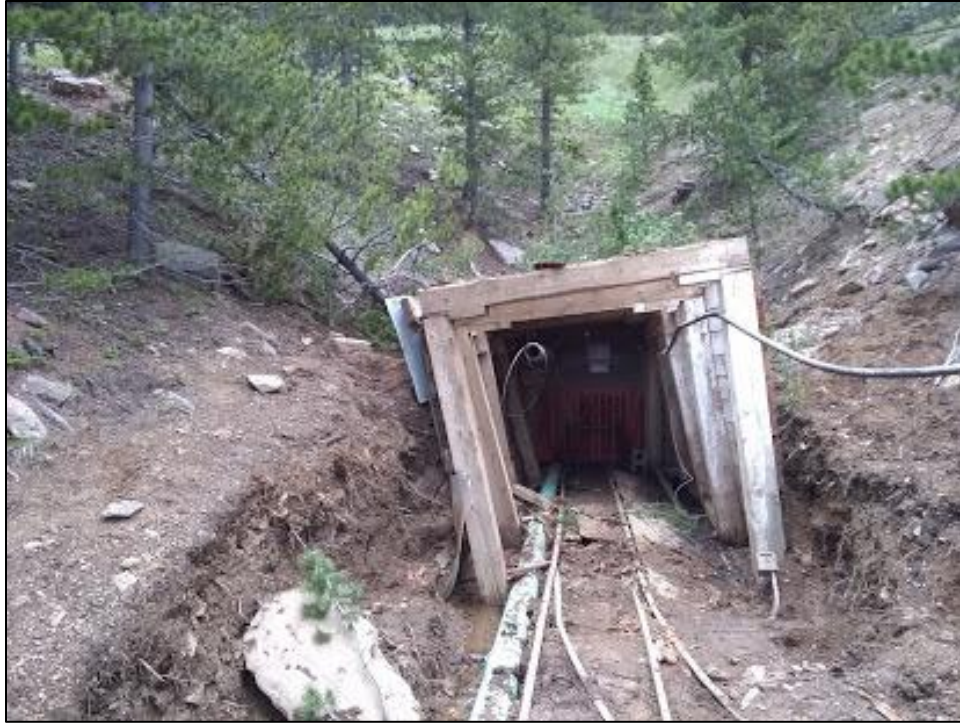
Entrance to the Idaho Tunnel at the mine site was in such a state of neglect and disrepair from long-term gradual deterioration that it was not safe to enter and operate the mine water system per the approved permit. In particular, the timber ground supports at the portal were tilted dangerously askew and the ground slopes adjacent to the portal also exhibited signs of shallow slope failures and sloughing, such as titled trees (Photograph 1).

***Photograph 1 – Idaho Tunnel Portal prior to Rehabilitation***

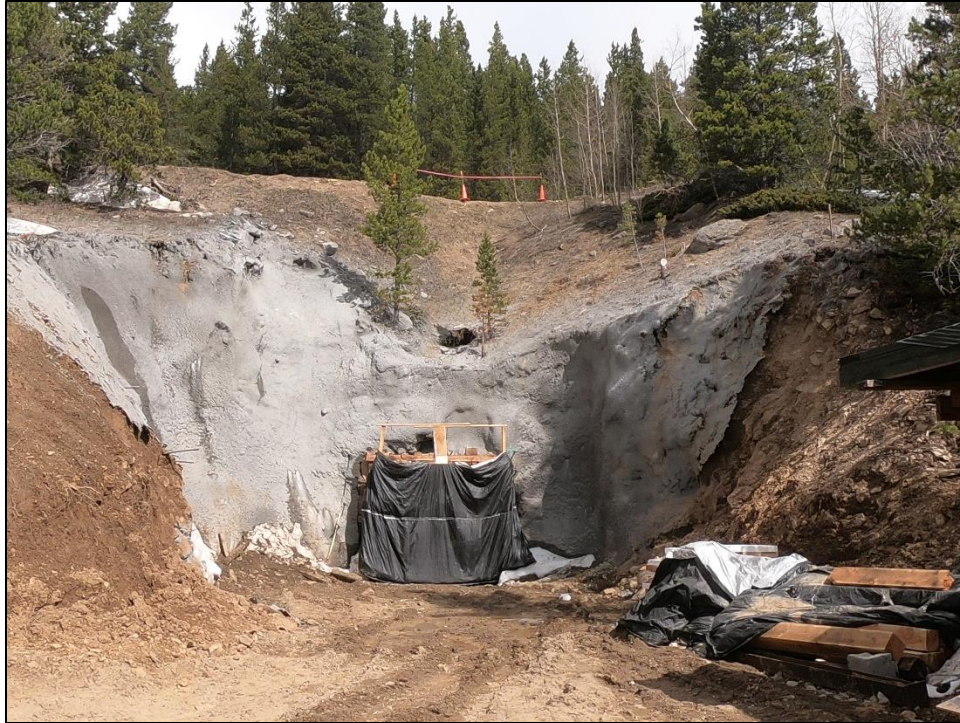
In December 2019 a roof collapse occurred a short distance into the tunnel during initial rehabilitation efforts by Harrison Western. The roof failure occurred in an 11-12 ft section of unsupported ground as the tunnel opening was being enlarged through a section of mixed soil and decomposed gneiss. The collapse completely blocked the mine opening, crushed the pipe carrying the flow of mine water, and daylighted in the slope below County Road 128 (Caribou Road), leaving a large remnant void above the tunnel opening which estimated to be approximately 65 cubic yards.

***Photograph 2 – Current Condition of the Idaho Tunnel Portal. The three safety cones and caution tape at the top of the slope mark the edge of Country Road 126 (Caribou Road). The crown hole over the void is visible between the two small trees above the portal.***

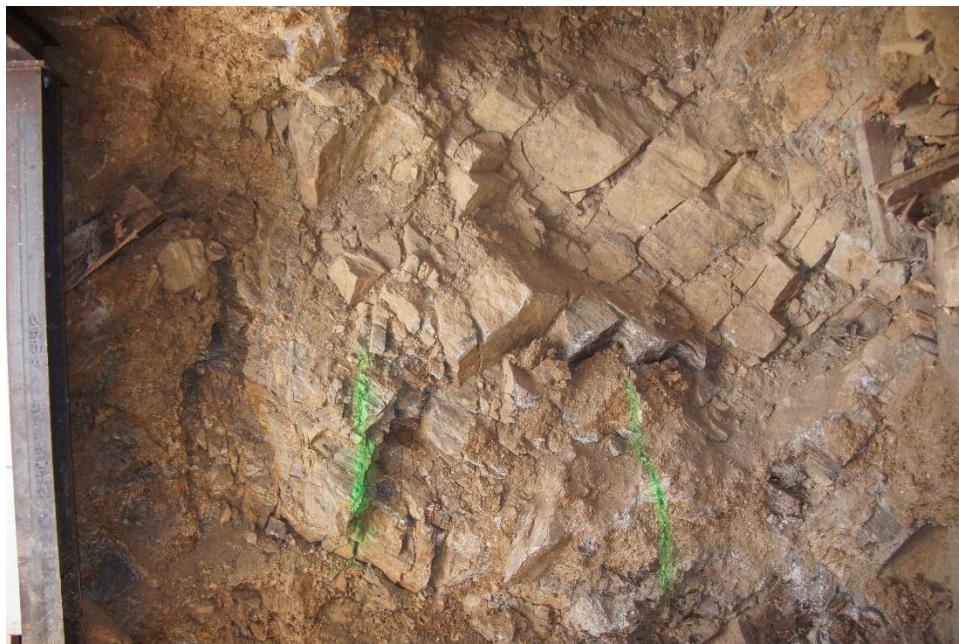
Geology exposed in the initial portal excavation and collapse void includes fractured and weathered blocky gneiss in the left wall or ‘rib’ when looking into the tunnel (Photograph 3). This material is interpreted as similar to the “Weak Hard Rock” depicted on Figure 1.

***Photograph 3 – Weathered and fractured gneiss in the left rib beneath the portal collapse. Green paint marks at 4-ft intervals mark the approximate location for the next steel sets.***

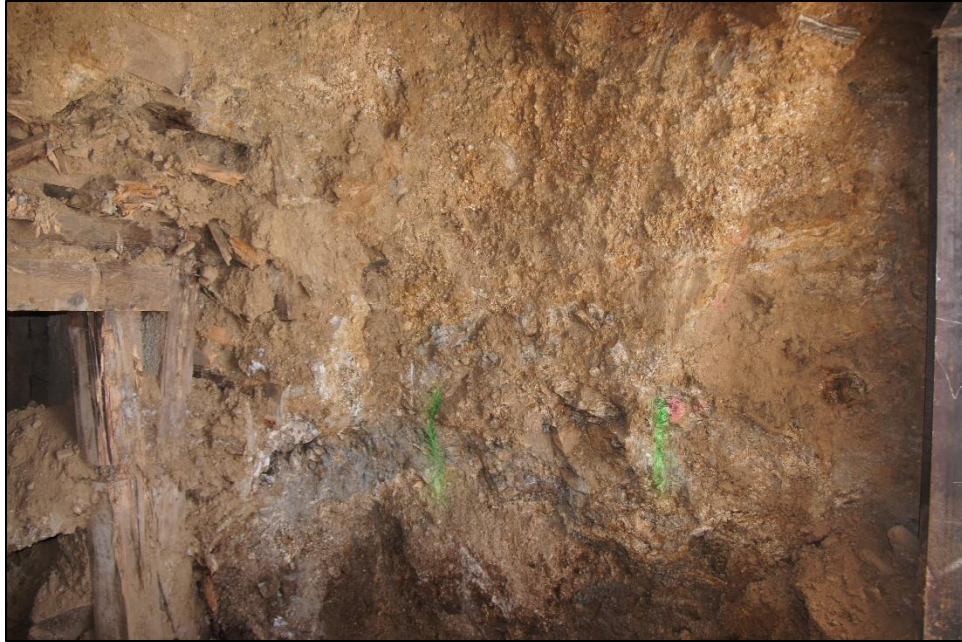
The right rib of the portal in the area of the collapse occurs in granular decomposed gneiss overlying deeply weathered blocky gneiss (Photograph 4). This material is interpreted as similar to the “Decomposed Granite” depicted on Figure 1.

***Photograph 4 – Decomposed gneiss overlying weathered and fractured gneiss in the right rib beneath the portal collapse. Green paint marks the approximate location of the next steel sets at 4-ft intervals.***

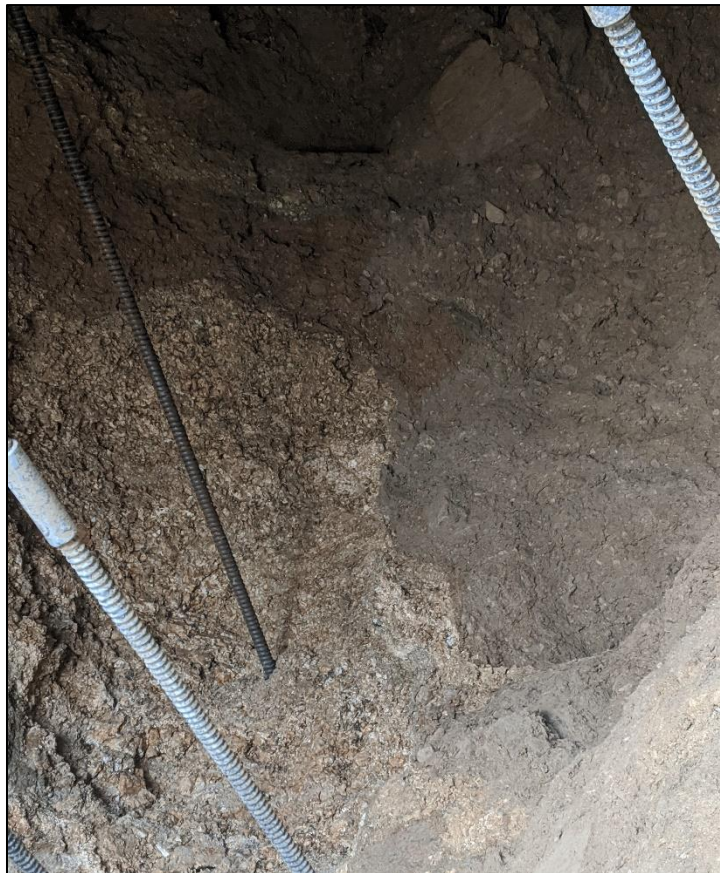
***Photograph 5 – Regolith and colluvium exposed in the walls of the collapse void. The threaded bars are some of the spillings which were installed before enlarging the portal excavation.***

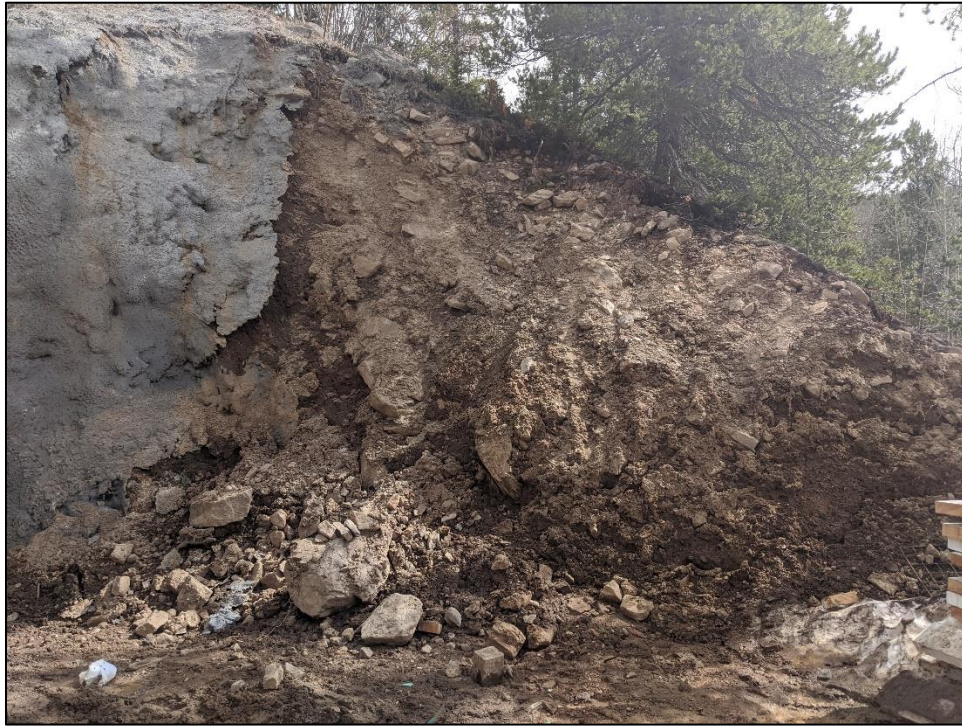
***Photograph 6 – Regolith and colluvium exposed in the right (north) wing wall of the portal excavation.***

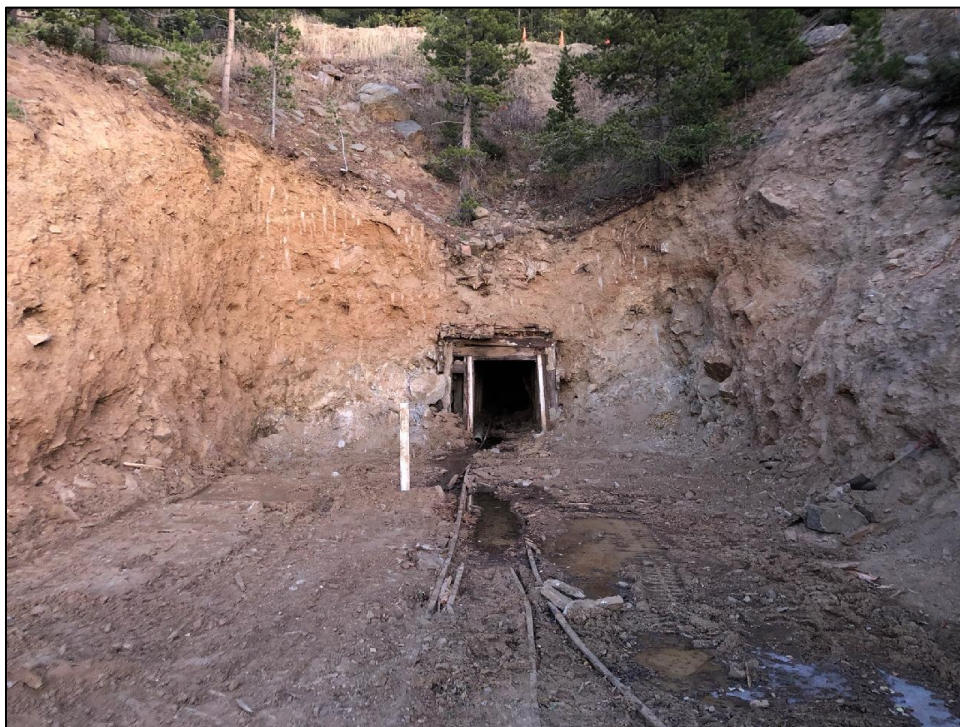
The material encountered during portal excavation and currently exposed in the wing walls consisted of regolith and colluvium, with some decomposed rock encountered at depth. The excavated slopes stood unsupported following excavation and were dry at the time (Photograph 7). The maximum height at the taller left (south) wing wall is 28 ft, sloping at an angle of 70-80 degrees from horizontal. The top of the excavation is approximately 40 ft from County Road 128 (Caribou Road) at the closest point and 20 ft lower in elevation. This creates potential long-term concerns for stability of the road.

***Photograph 7 – Idaho Tunnel Portal following excavation***

The excavated slope above the portal opening and wing walls were reinforced with 10- and 20-ft soil nails, 6-gauge wire mesh, and nominal 6-inches of fiber-reinforced shotcrete. Grouted threadbar spillings were also installed at 12-inch spacing above the portal. These were reportedly 35 ft long, extending into harder ground and grouted. Unfortunately, little as-built documentation is available.
