COLORADO
Division of Reclamation,
Mining and Safety
Department of Natural Resources

Permit Number: C-1981-041 Mine Name: Roadside Portals Operator: Snowcap Coal Company, Inc. Operator Address: MS Tonya Hammond P.O. Box 1430 Palisade, CO 81526	County: Mesa Operation Type: Underground Permit Status: Active Ownership: Private
	Operator Representative Present: NA
Operator Representative Signature: (Field Issuance Only)

Inspection Start Date: May 6, 2020 Inspection Start Time: 11:42 Inspection End Date: May 6, 2020 Inspection End Time: 11:43		Inspection Type: Aerial Inspection Inspection Reason: Normal I&E Program Weather: Clear	
Joint Inspection Agency: None		Joint Inspection Contacts: None	
Post Inspection Agency: None		Post Inspection Contacts: None	
Inspector(s): Clayton Wein Brock Bowles	Inspector's Signature: <i>Clayton Wein</i>		Signature Date: 5/11/2020

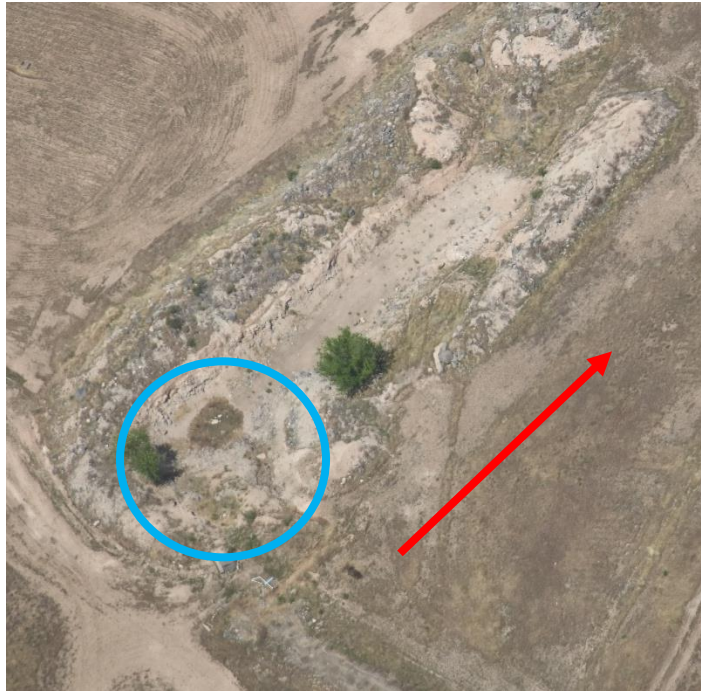
Evidence of recent flow into Carey Pond was seen (Photo 1). There appeared to be a damp spot in the bottom of the pond connected to damp soil from the inlet to the pond. Evidence of flow in the landowner's ditches was seen at the south end of the Tract 70 Mesa (Photo 2). There was no evidence of flow through the ditches located at the north end of the Tract 70 Mesa (Photo 3).

Photo 1: The Carey pond, outlined in the blue circle is the damp area indicating recent flow of water and water in the bottom of the pond.

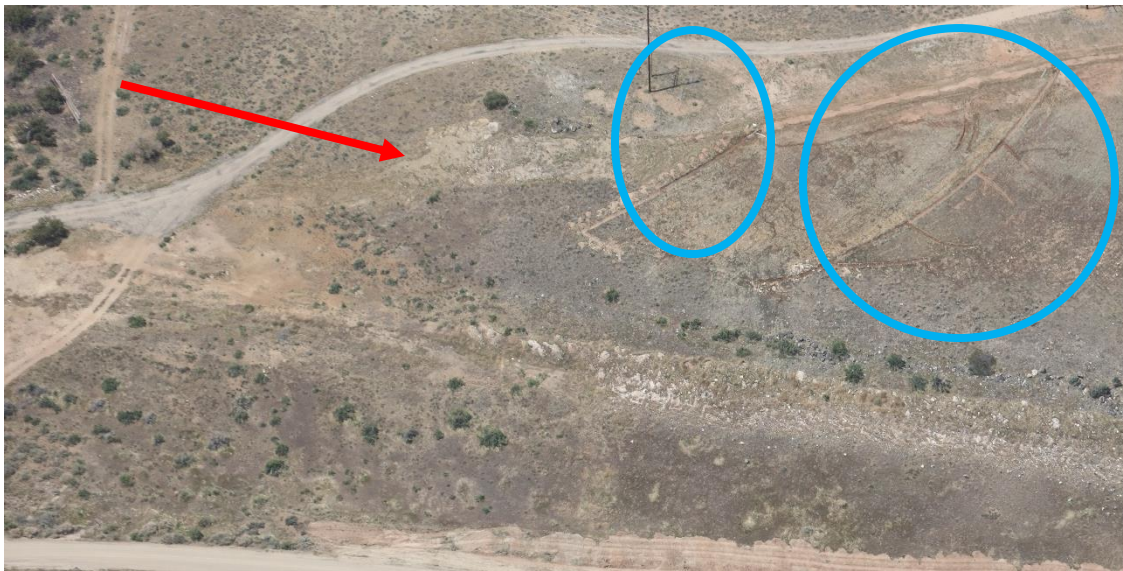
Photo 2: The south end of the Tract 70 Mesa. The blue circles outline the damp locations in the ditches.

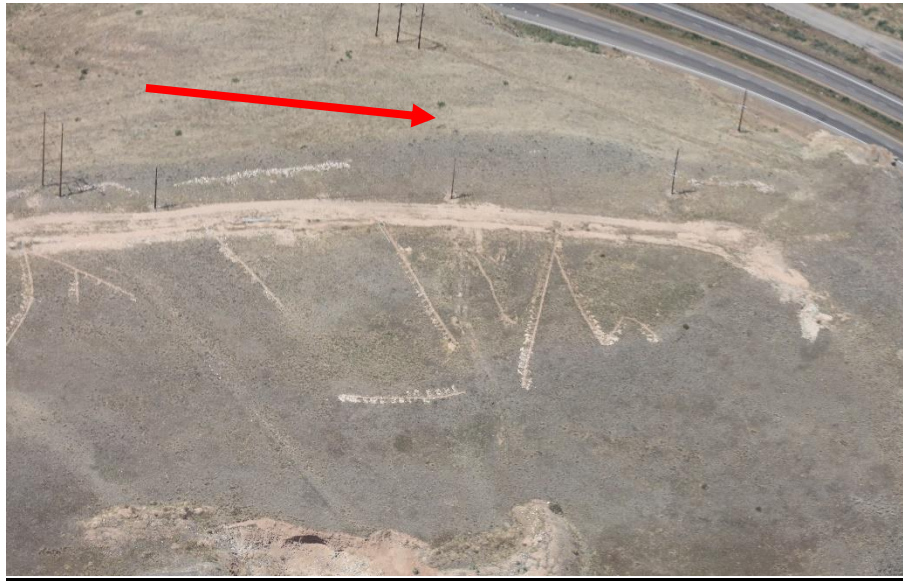
Photo 3: The north end of the Tract 70 Mesa. The ditches located at the north end of the mesa were observed to be dry.

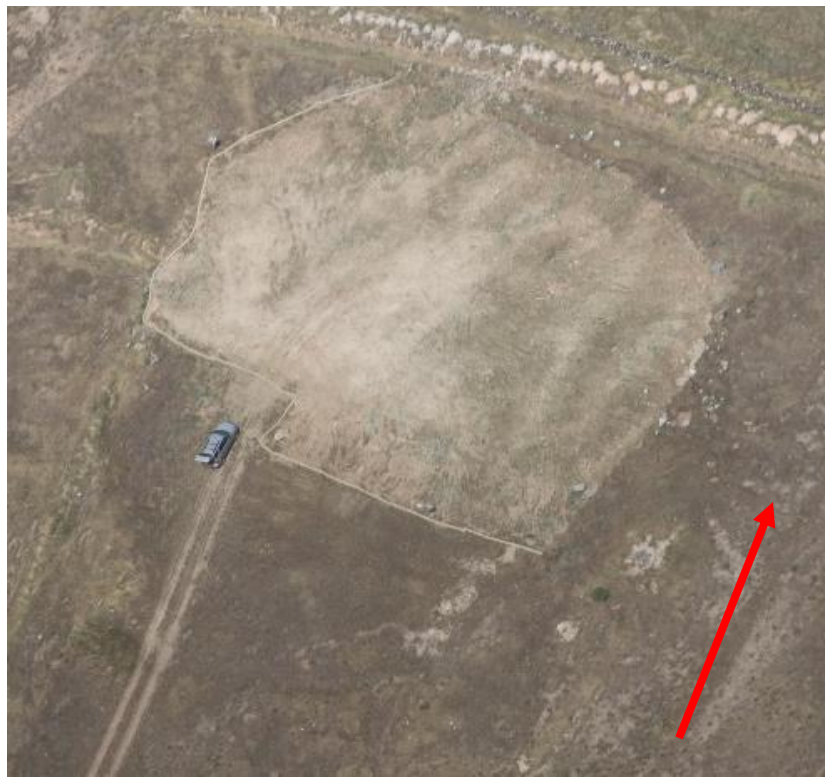
The only permitted disturbance remaining at the mine site is associated with the area repaired under TR-69. The area is located to the south of the reclaimed portals and Kokopelli Fruitstand, on top of the mesa. The area has been reclaimed since November of 2019. The site was backfilled to approximate original contour, topsoiled and then reseeded. The site was stable and there were no indications of erosion (Photo 4). There were

no indications of settling at the surface. Vegetation seeded in the fall has started to grow at the site. There were no indications of re-disturbance to the site.

Photo 4: The TR-69 repair area. Vegetation can be seen greening and growing in at the site. No off-site impacts had occurred.
