MINERALS PROGRAM INSPECTION REPORT PHONE: (303) 866-3567

MINE NAME: Penrose Pit	MINE/PROSPECTING ID#: M-1987-131	MINERAL: Sand and gravel	COUNTY: Fremont
INSPECTION TYPE: Monitoring	INSPECTOR(S): Timothy Cazier	INSP. DATE: February 13, 2020	INSP. TIME: 11:50
OPERATOR: Fremont Paving & Redi-Mix, Inc.	OPERATOR REPRESENTATIVE: John Paul Ary & Jodi Schreiber	TYPE OF OPERATION: 112c - Construction Regular Operation

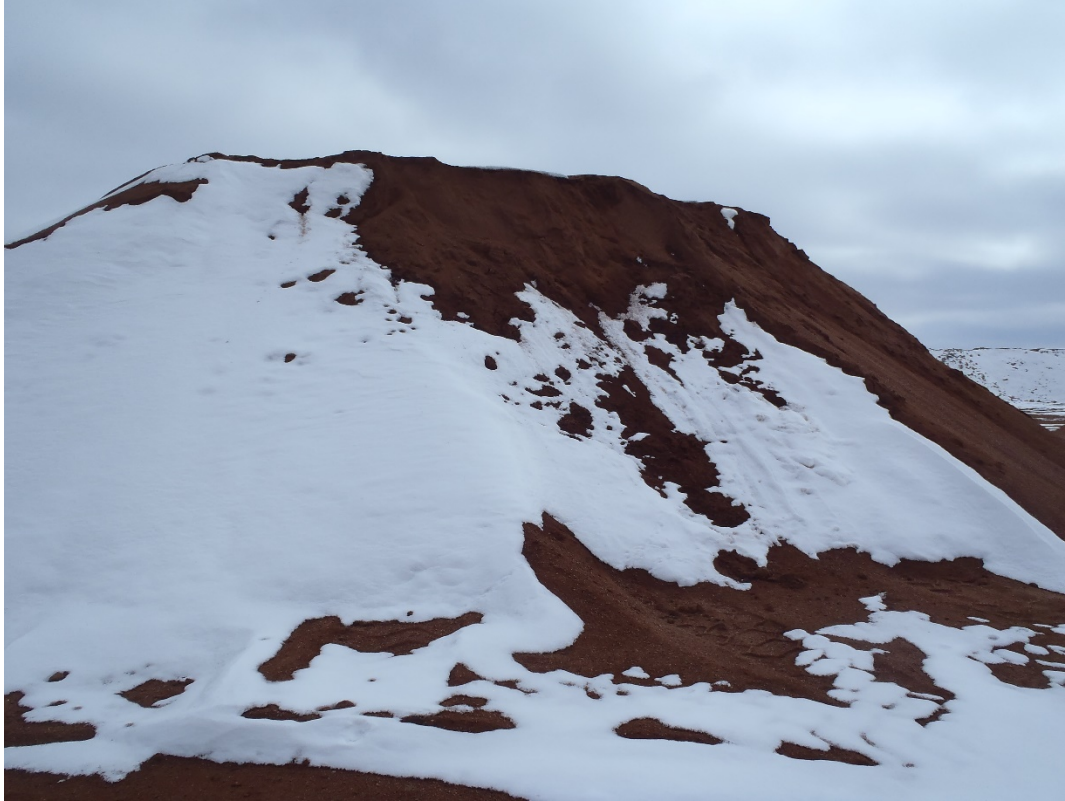
Backfilling and Grading: Sufficient overburden (see **Photo 1**) appeared to be available for backfill material.

Photo 1. One observed overburden stockpile.

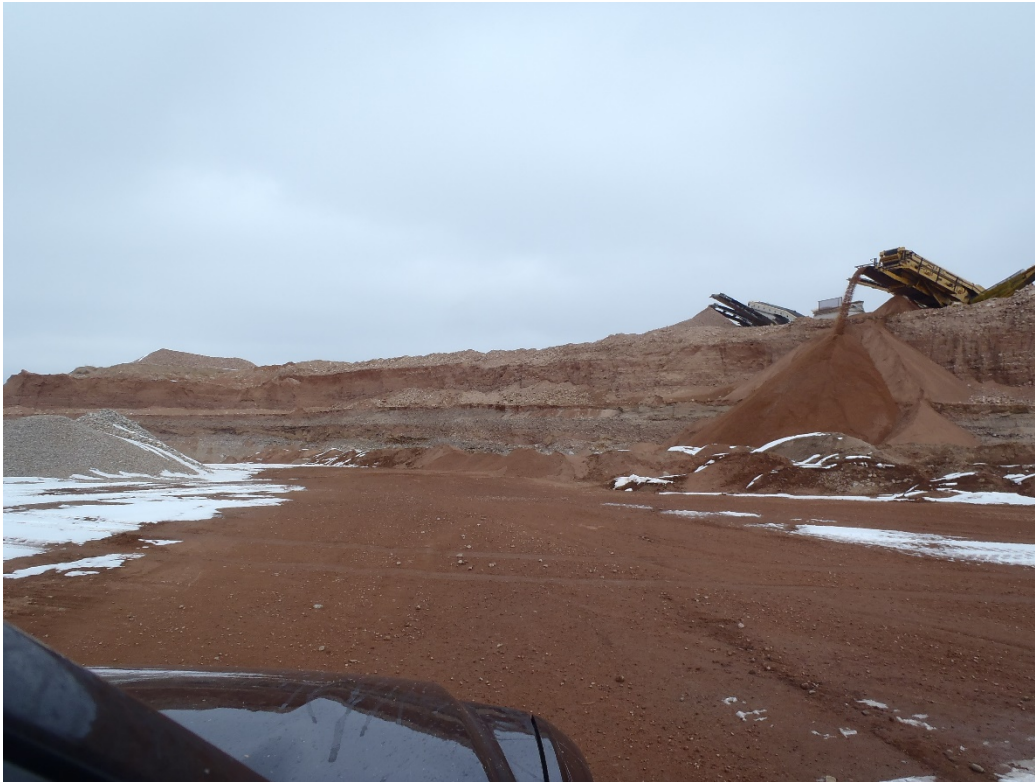
Gen. Compliance with Mine Plan: The maximum allowed disturbed area is 150 acres. Google Earth was used to measure the historically disturbed area, which was estimated to be approximately 122 acres, based on 2018 imagery. Highwalls appeared stable (see **Photos 2 and 3**).

Support Facilities On-site: A screen plant, crusher, and loader were observed on site (see **Photos 2 and 4**). Mr. Ary stated the screens and crusher were portable.

Photo 2. North end of active highwall and operating screen plant (looking NE).

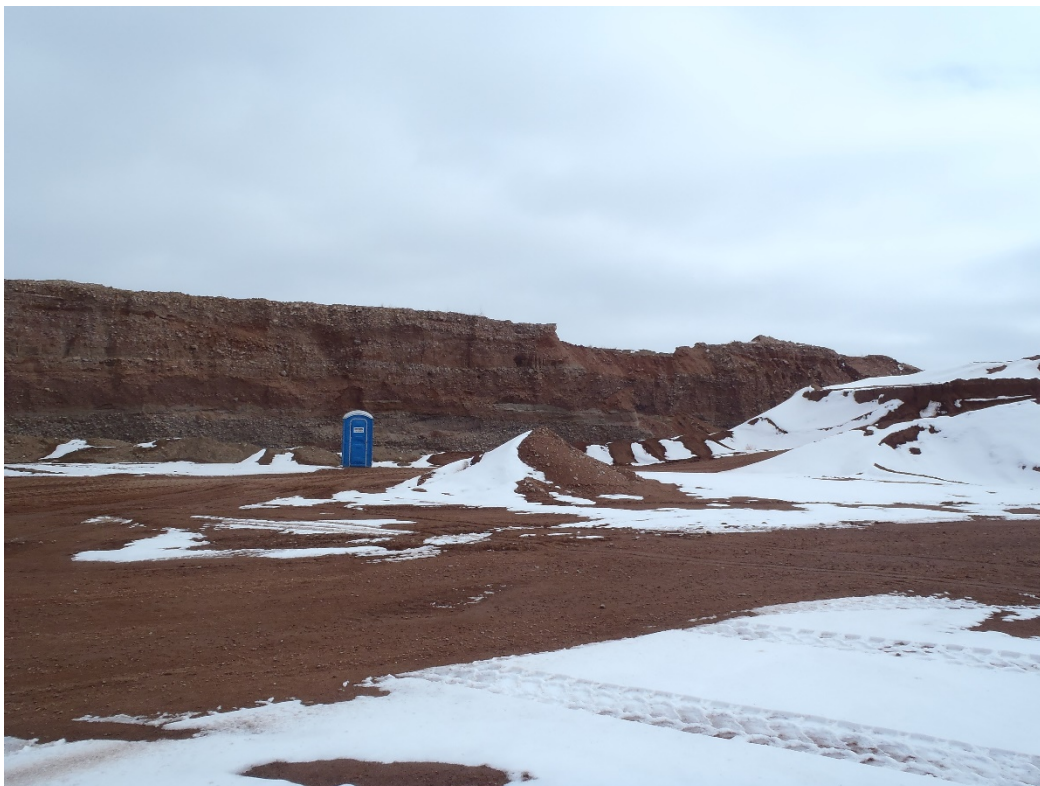
Photo 3. South end of active highwall (looking SE).

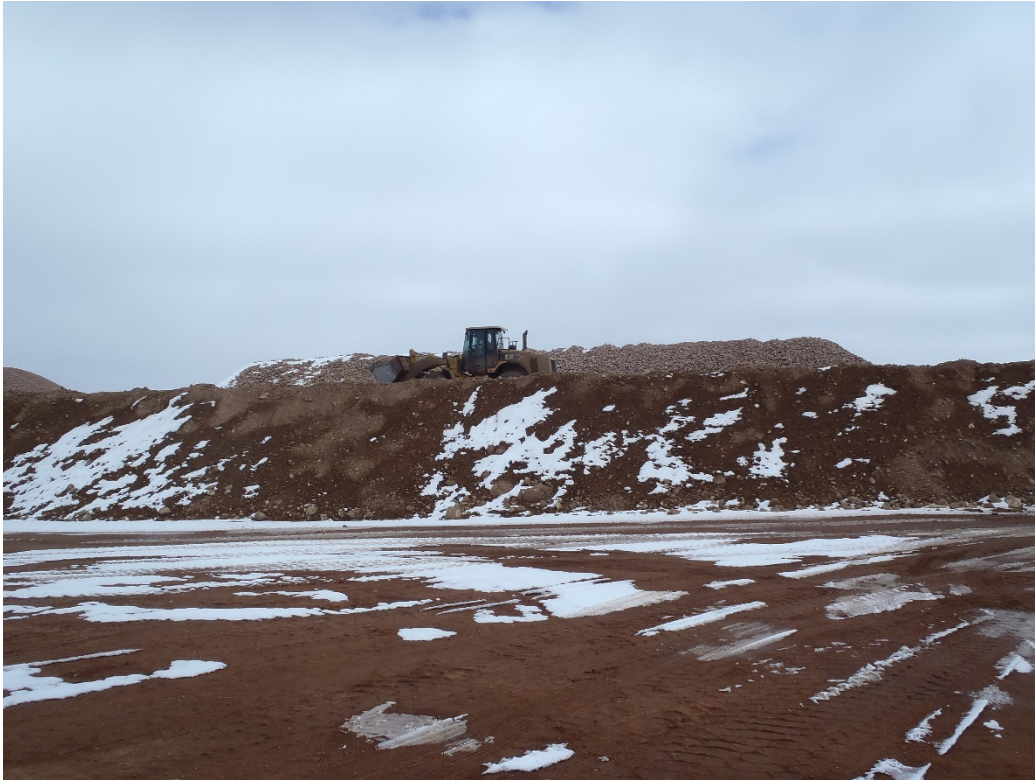
Photo 4. Operating loader (above topsoil storage).

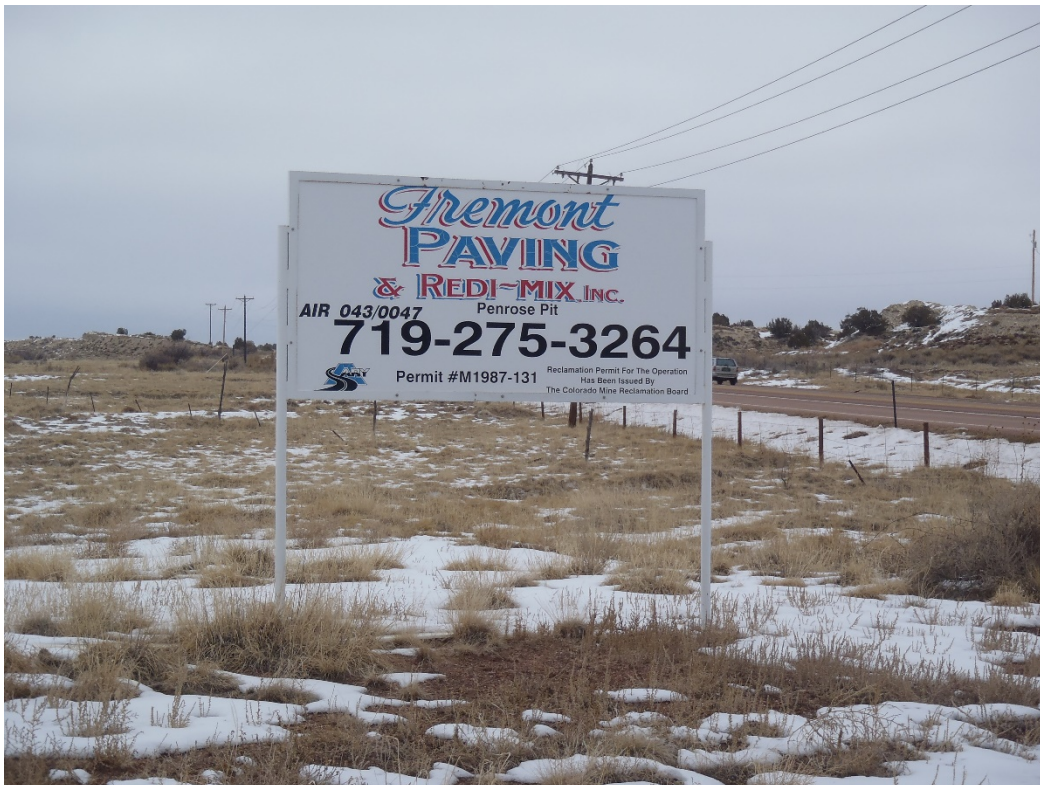
Photo 5. Permit sign near entrance from Hwy 115.

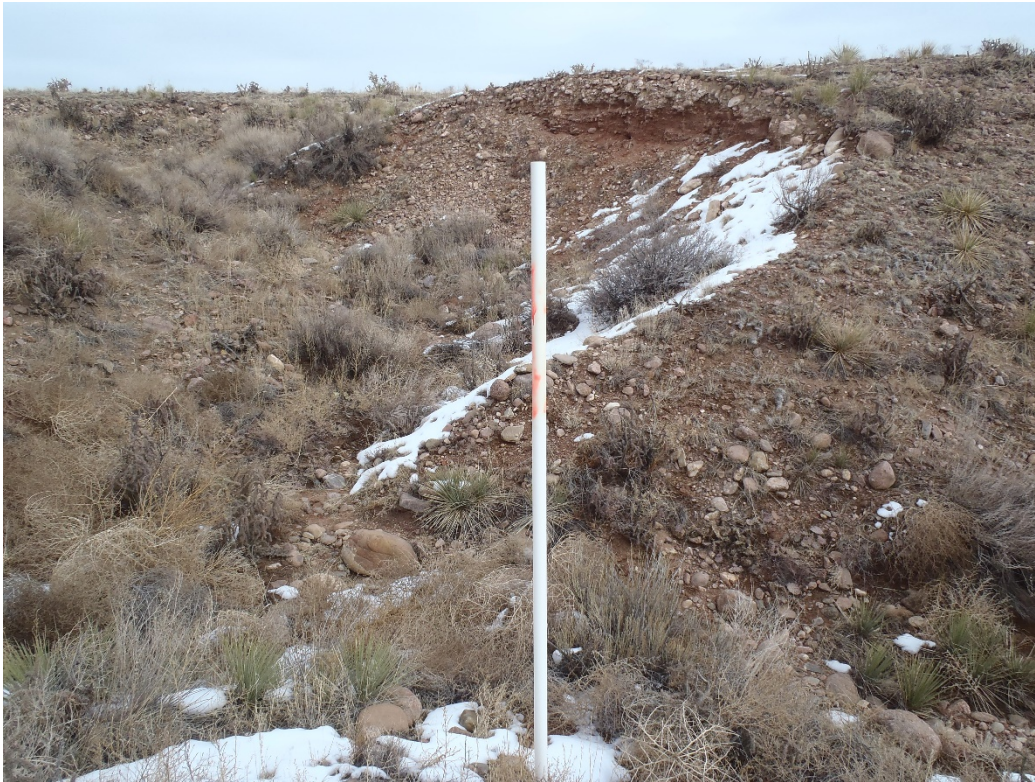
PROBLEM/POSSIBLE VIOLATION: Problem: The affected area boundary markers are missing or incorrectly placed. This is a problem for failure to maintain boundary markers around the affected area as required by Section 3.1.12(2) of the rule.

Signs and Markers: The permit sign was properly posted (see **Photo 5**), however affected area boundary markers were very limited (see **Photo 6**) and insufficient to delineate the approved areas for disturbance. **The insufficient boundary markers are cited as a problem on page 1 of this report.**

Photo 6. One of two observed affected area boundary markers (between Phase 4 and 5).

CORRECTIVE ACTIONS: The operator shall conduct a survey and replace the boundary markers in the correct location(s). The operator shall provide proof to the Division that this has been done by the corrective action date.

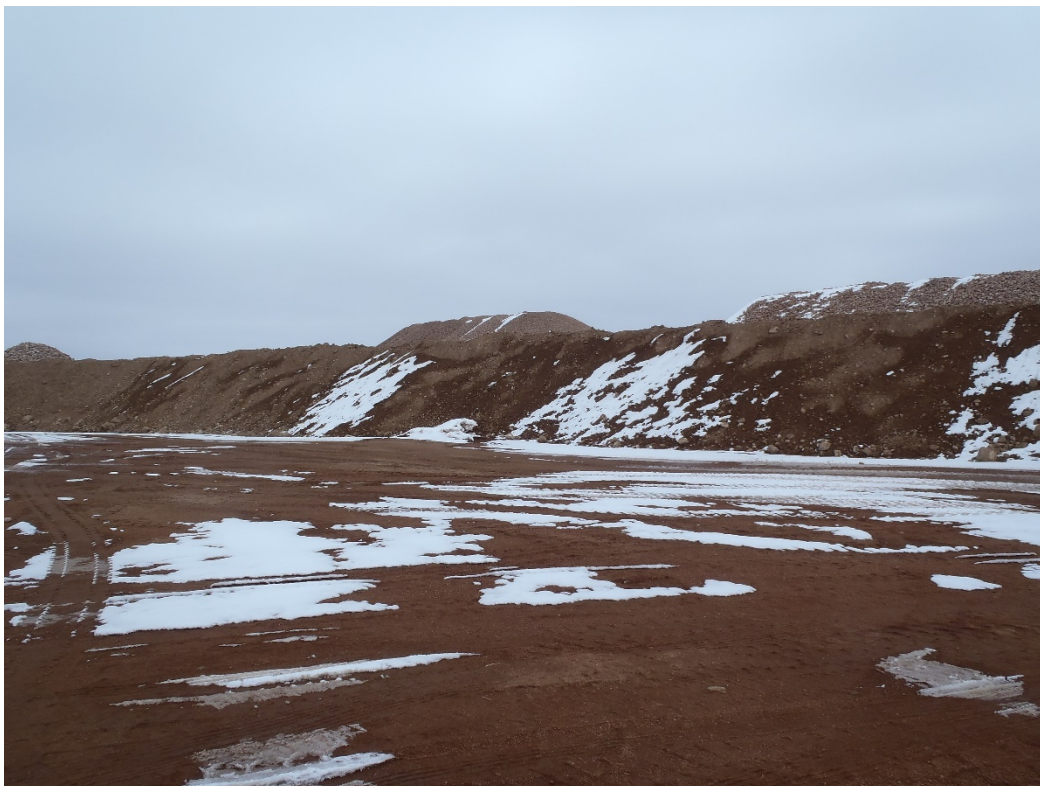
Topsoil: A topsoil stockpile was observed on the east side of the working area (see **Photo 7**).

Photo 7. Topsoil stockpile on east side of working area.
