PERMIT INFORMATION

Permit Number: C-1982-056 Mine Name: Foidel Creek Mine Operator: Twentymile Coal, LLC Operator Address: Ms Miranda Kawcak 29515 Routt County Road No. 27 Oak Creek, CO 80467	County: Routt Operation Type: Underground Permit Status: Active Ownership: Private
	Operator Representative Present: None
Operator Representative Signature: (Field Issuance Only)

Inspection Start Date: May 6, 2020 Inspection Start Time: 08:45 Inspection End Date: Inspection End Time:	Inspection Type: Coal Partial Inspection Inspection Reason: Normal I&E Program Weather: Clear
Joint Inspection Agency: None	Joint Inspection Contacts:
Post Inspection Agency: None	Post Inspection Contacts:
Inspector(s): Tabetha Lynch Brock Bowles	Inspector's Signature:

This was an aerial inspection of the Foidel Creek Mine; DRMS Permit No. C-1982-056, operated by Twentymile Coal, LLC. (TC). The photos were taken by Brock Bowles on 5/6 and the inspection report was written by Tabettha Lynch with the Colorado Division of Reclamation, Mining, and Safety (Division).

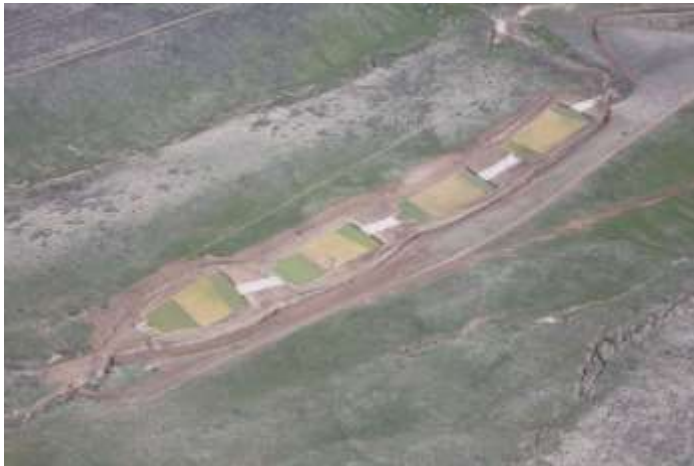
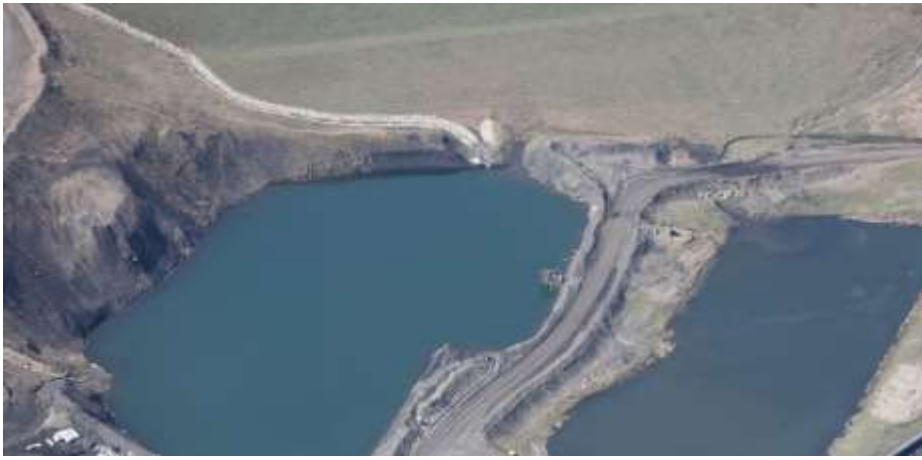
All ponds appear to be holding water and streams appear to be running high or flooding per normal for spring conditions. The passive treatment ponds are holding water. Surrounding banks and ditch area will need to be seeded and stabilized. A few erosional features are visible but the area appears in good condition in the aerial photos.

The pit ponds and underdrains appear to be discharging.

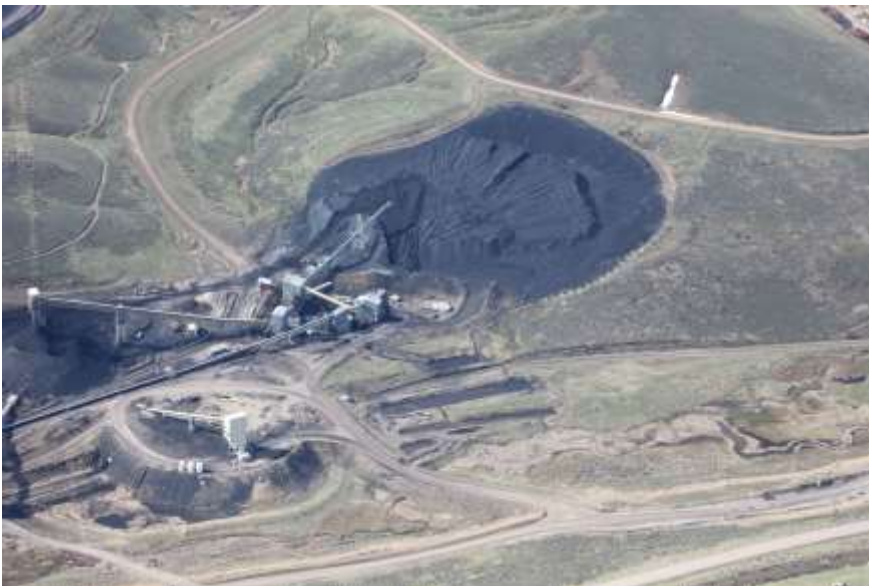
Bob pile and topsoil pile appear stable. Pond B is holding water and appears to be discharging. Pond C appears to have some water but does not appear to be discharging.

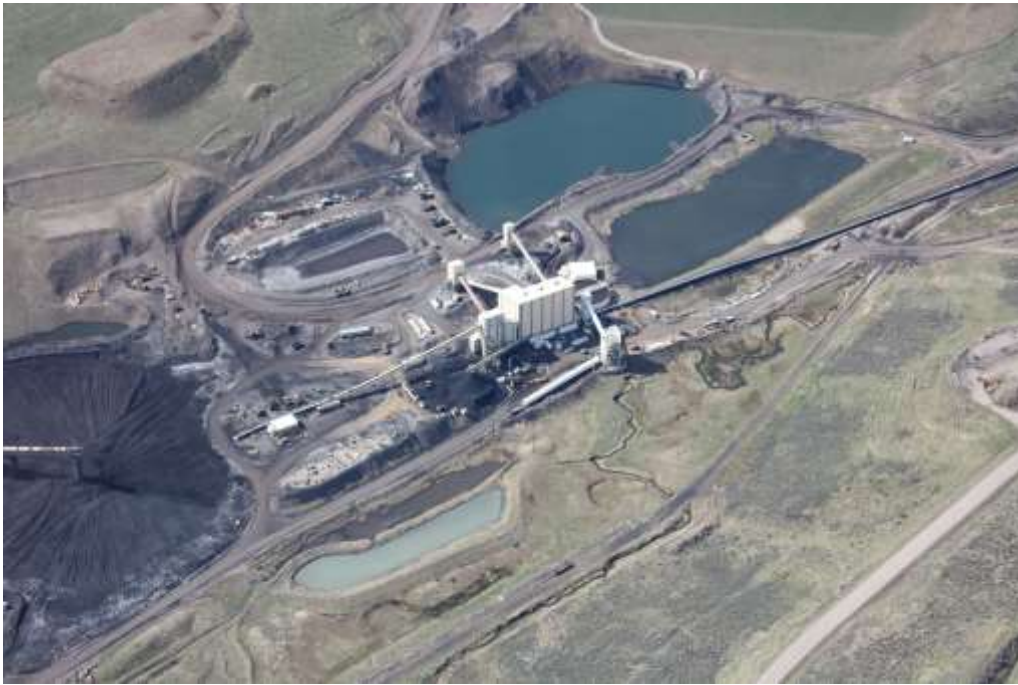
Ponds D and E appears to be holding water and discharging.. Construction on stocker coal building appears to be progressing. One tube appears to be up and one ready to install.
