<b>Permit Number:</b> C-2009-087 <b>Mine Name:</b> Peabody Sage Creek Mine <b>Operator:</b> Peabody Sage Creek Mining, LLC <b>Operator Address:</b> Ms Mirdanda Kawcak 29515 Routt County Road 27 Oak Creek, CO 80467	<b>County:</b> Routt <b>Operation Type:</b> Underground <b>Permit Status:</b> Temporary Cessation <b>Ownership:</b> Private
	<b>Operator Representative Present:</b>  None
<b>Operator Representative Signature:</b> (Field Issuance Only)

<b>Inspection Start Date:</b> May 6, 2020 <b>Inspection Start Time:</b> 09:00 <b>Inspection End Date:</b> May 6, 2020 <b>Inspection End Time:</b> 09:05		<b>Inspection Type:</b> Coal Partial Inspection <b>Inspection Reason:</b> Normal I&E Program <b>Weather:</b> Clear	
<b>Joint Inspection Agency:</b>  None		<b>Joint Inspection Contacts:</b>	
<b>Post Inspection Agency:</b>  None		<b>Post Inspection Contacts:</b>	
<b>Inspector(s):</b>  Tabetha Lynch  Brock Bowles	<b>Inspector's Signature:</b>

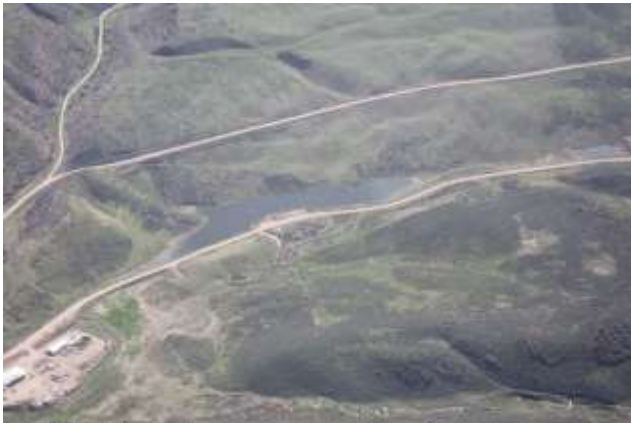
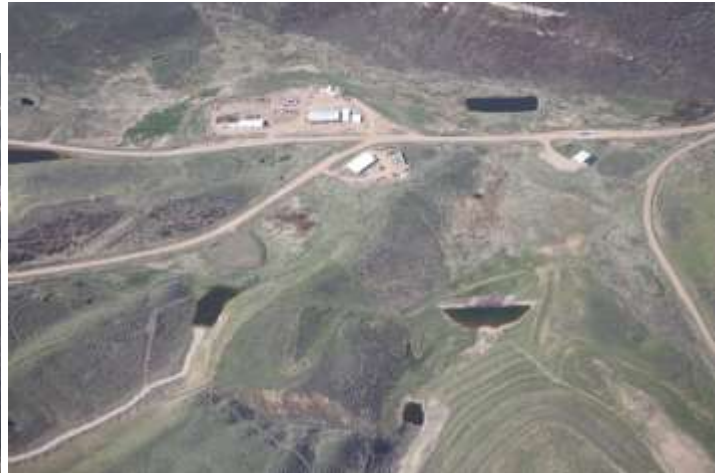
Ponds appear to be holding water and discharging. No large erosional features were notes from observation of the aerial photos.

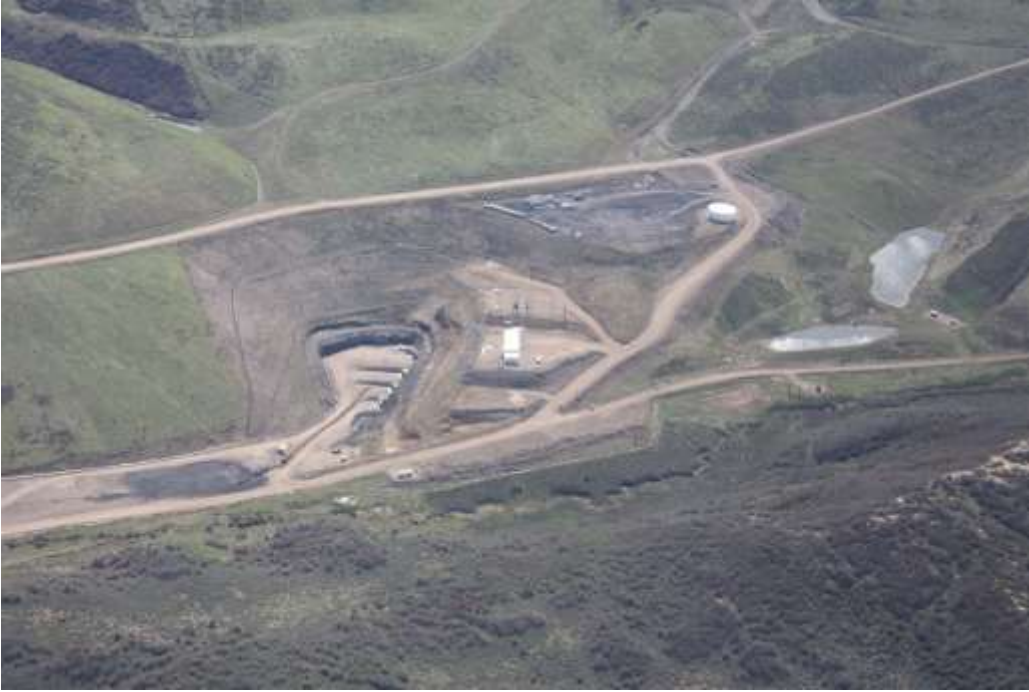
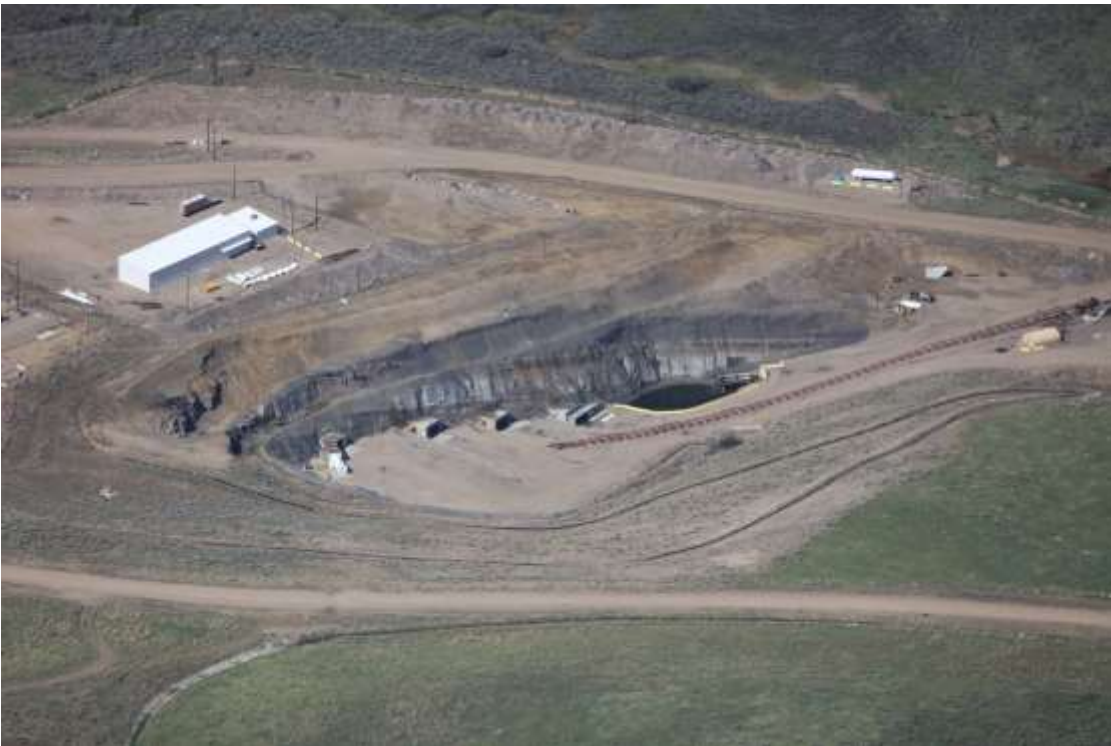
Portal area appears stable. Some activity appears to be occurring onsite, which was being used as a

staging area for the Foidel Creek mine stoker coal construction.
