PERMIT INFORMATION

Permit Number: C-1992-081 Mine Name: Hayden Gulch Loadout Operator: Hayden Gulch Terminal, LLC Operator Address: Ms Miranda Kawcak P.O. Box 670 Hayden, CO 81639	County: Routt Operation Type: Loadout Permit Status: Active Ownership: Private Operator Representative Present: None
Operator Representative Signature: (Field Issuance Only)

Inspection Start Date: May 6, 2020 Inspection Start Time: 09:00 Inspection End Date: Inspection End Time:	Inspection Type: Coal Partial Inspection Inspection Reason: Normal I&E Program Weather: Clear	
Joint Inspection Agency: None	Joint Inspection Contacts:	
Post Inspection Agency: None	Post Inspection Contacts:	
Inspector(s): Tabetha Lynch Brock Bowles	Inspector's Signature:

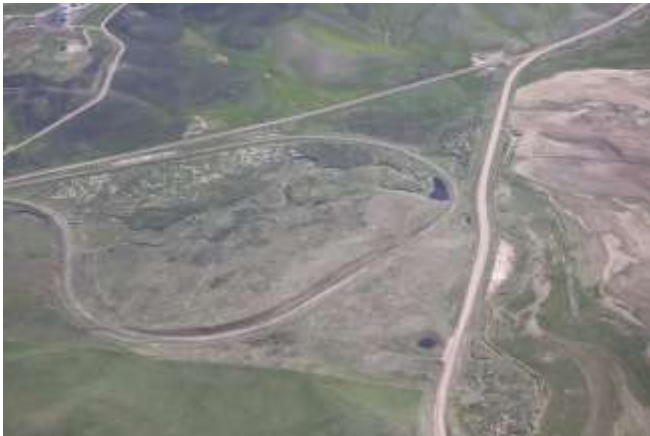
Ponds appear to be holding water but not discharging. Little dry creek is flowing and does not appear to be flooding. No erosional features were noted from the aerial photos.

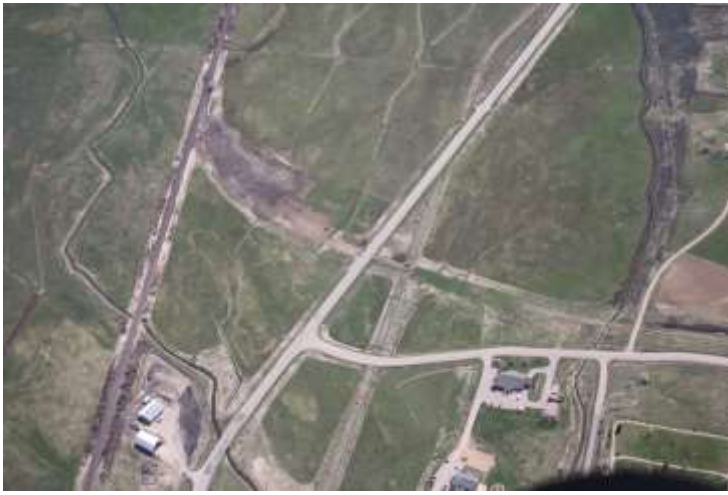
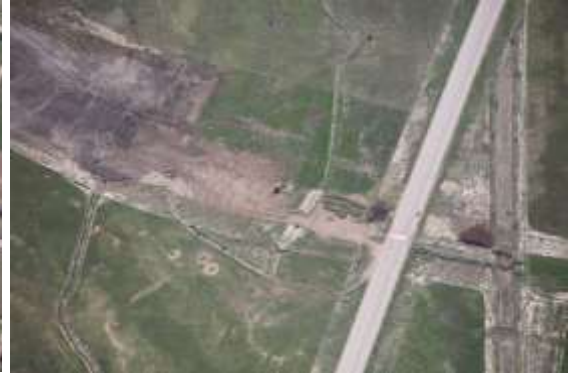
Parking lot appears to be growing over in weeds. Rail across Hwy 40 is currently still present. It appears ballast has been removed from the North side of Hwy 40 and reclamation working is occurring.
