MINERALS PROGRAM INSPECTION REPORT
PHONE: (303) 866-3567

MINE NAME: Ross Pit	MINE/PROSPECTING ID#: M-1990-134	MINERAL: Gravel	COUNTY: Moffat
INSPECTION TYPE: Aerial Inspection	INSPECTOR(S): Clayton Wein	INSP. DATE: May 6, 2020	INSP. TIME: 09:19
OPERATOR: James H & Kathleen H Ross	OPERATOR REPRESENTATIVE: NA	TYPE OF OPERATION: 110c - Construction Limited Impact	
REASON FOR INSPECTION: Normal I&E Program	BOND CALCULATION TYPE: None	BOND AMOUNT: \$15,545.00	
DATE OF COMPLAINT: NA	POST INSP. CONTACTS: None	JOINT INSP. AGENCY: None	
WEATHER: Clear	INSPECTOR'S SIGNATURE:

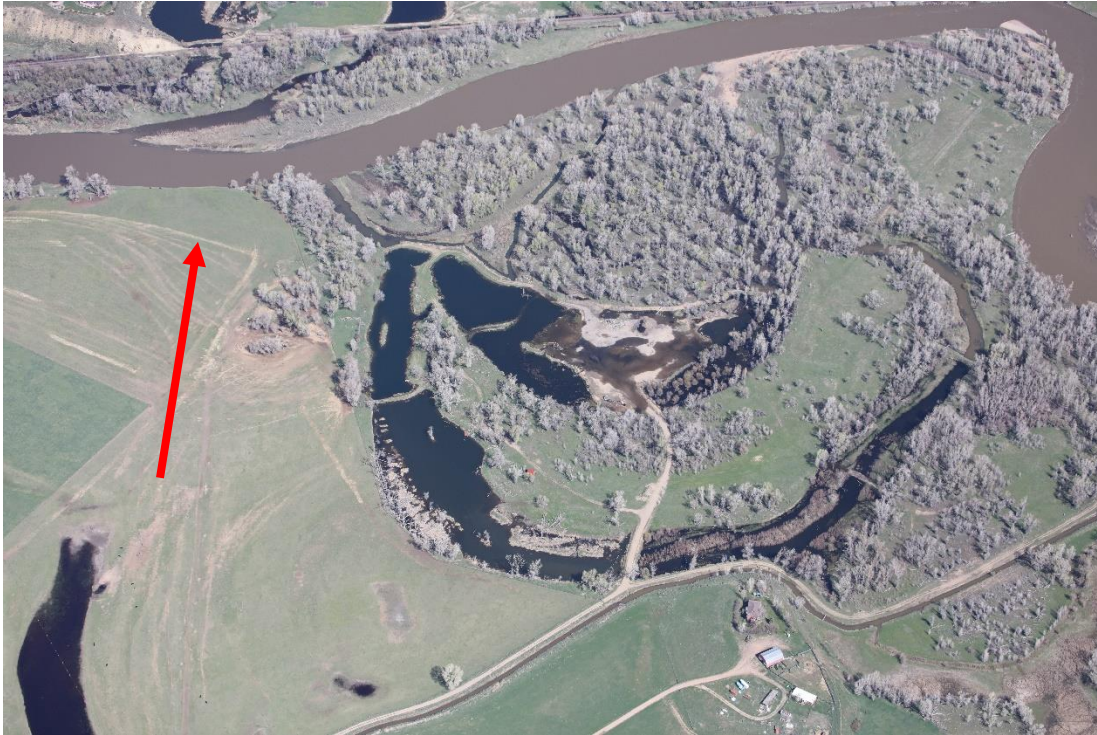
Photo 1: An overview of the M-1990-134 permit area.

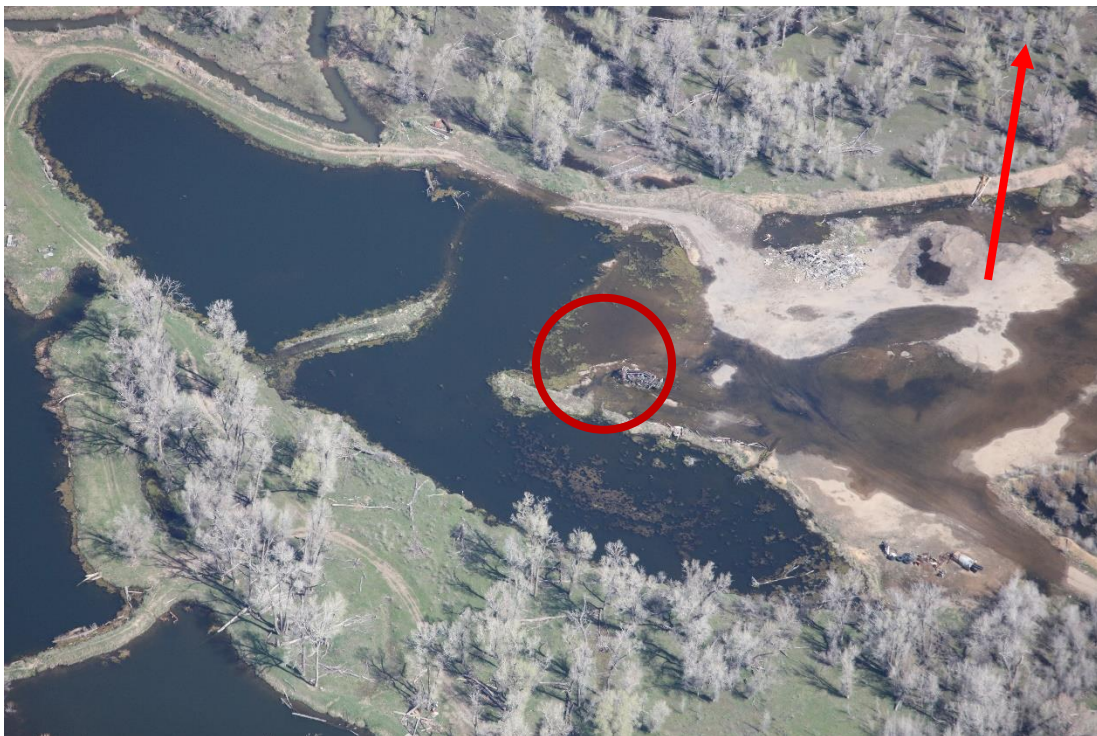
Photo 2: The western portion of the site, most areas were inundated with groundwater. The piece of equipment in the water is outlined in the red circle.

There appeared to be a minimal amount of equipment stored on site. The equipment was staged in an area of the site above the water level. A crusher appeared to be partly submerged in water at the west-central portion of the site (Photo 2). **Please remove this piece of equipment from the flooded portion of the pit by September 1, 2020. Please submit photographs to the Division of the completed task.** Previous Division Inspections indicate that this piece of equipment may be inoperable. There was not any fuel observed to be stored at the mine site. The pit will need to be drained before operations can resume.

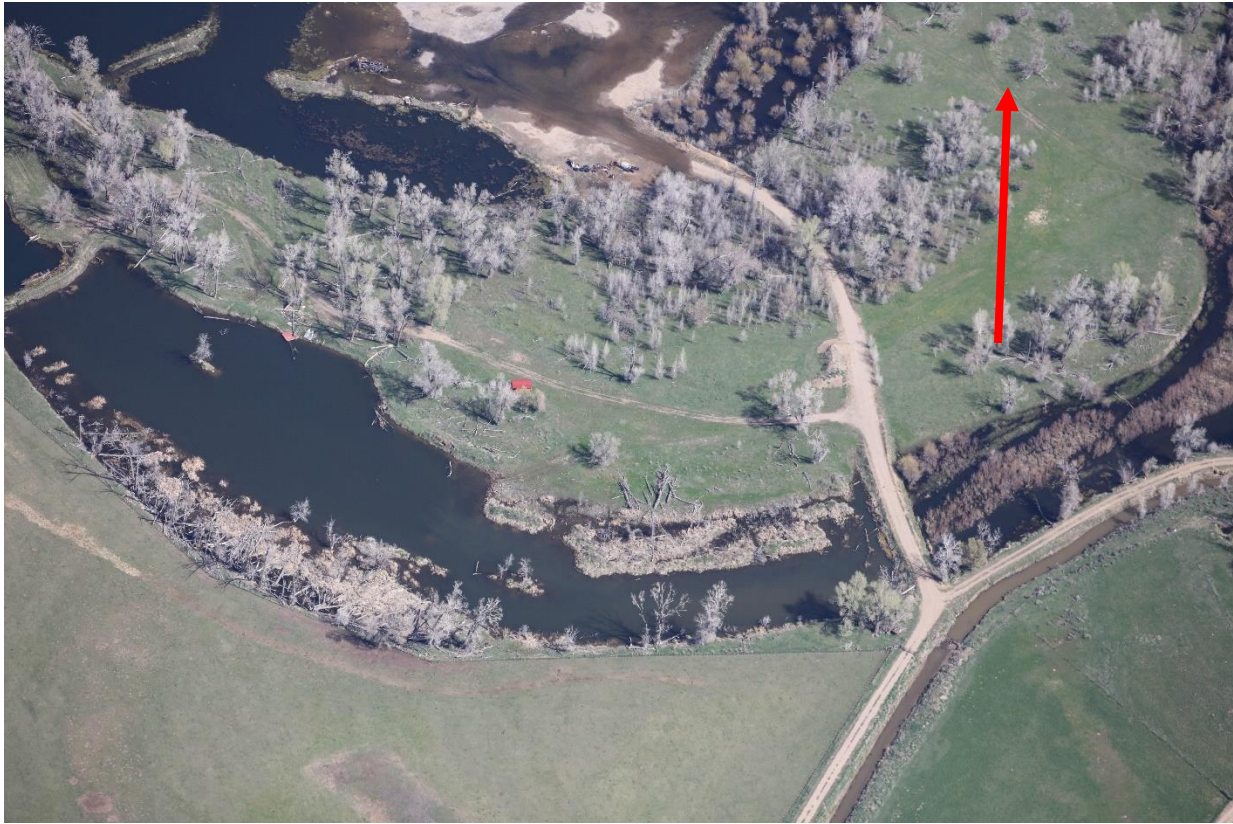
The site is located in close proximity to the Yampa River. Due to spring runoff and high groundwater levels, most of the mine site was inundated of water. Only a small portion of the middle of the site was above water level. The southern portion of the site is bordered by an oxbow of the river. The level of the groundwater had flooded the oxbow as well. Access to the site could be made through the entrance; however, most of the site would be inaccessible due to the water levels. The portion of the road above water level was in good repair and stable.

Photo 3: The southern portion of the mine site. This portion of the site included the inundated oxbow.

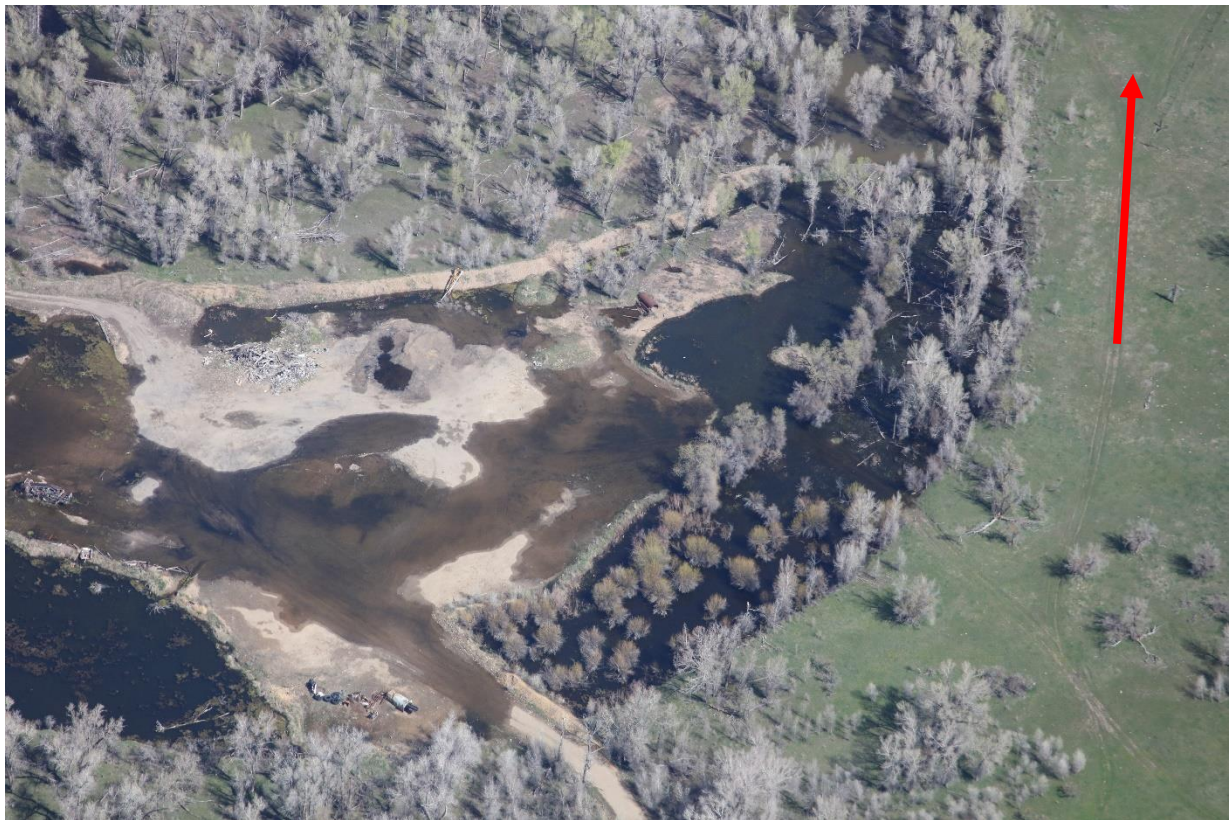
Photo 4: The eastern portion of the site, inundated with groundwater.
