MINERALS PROGRAM INSPECTION REPORT PHONE: (303) 866-3567

MINE NAME: Cresson Project	MINE/PROSPECTING ID#: M-1980-244	MINERAL: Gold	COUNTY: Teller
INSPECTION TYPE: Aerial Inspection	INSPECTOR(S): Timothy Cazier	INSP. DATE: May 18, 2020	INSP. TIME: 08:06
OPERATOR: Cripple Creek & Victor Gold Mining Company	OPERATOR REPRESENTATIVE: None	TYPE OF OPERATION: 112d-3 - Designated Mining Operation

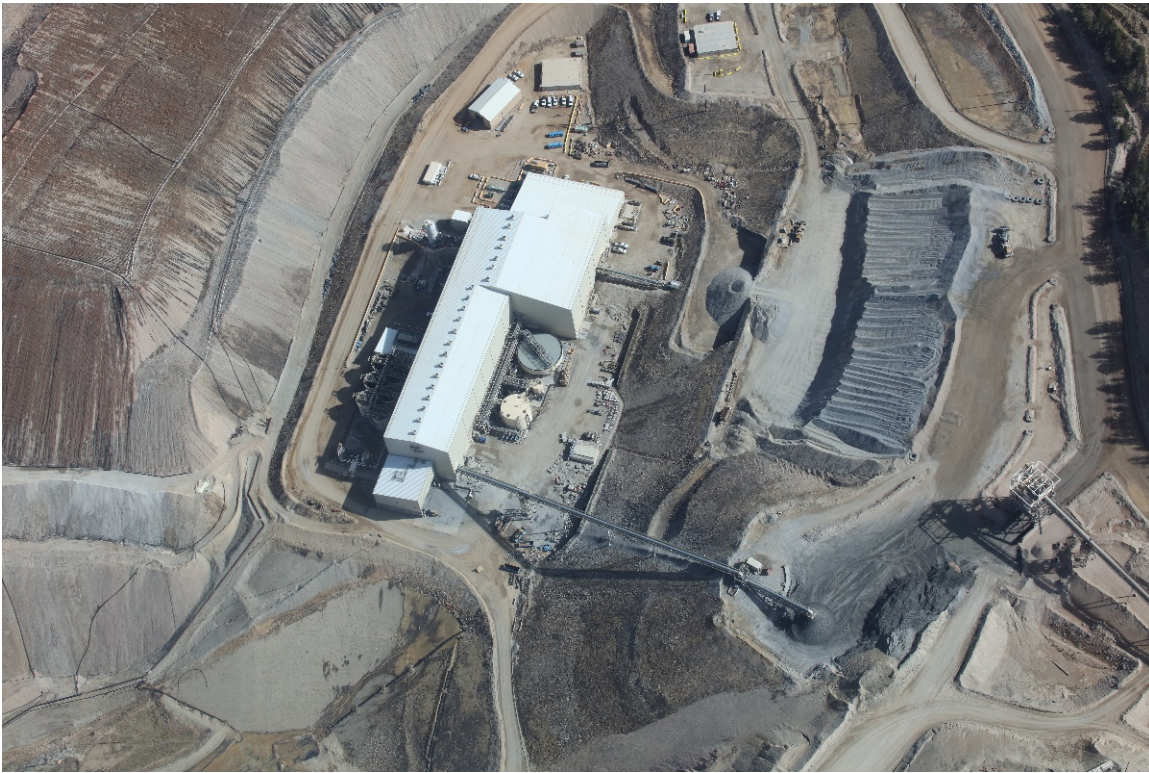
High Grade Mill: The purpose was to perform a visual inspection for leaks, spills and secondary containment problems. Both the east (see **Photo 1**) and west (**Photo 2**) sides of the mill exterior were inspected with no observable impact on the secondary containment.

Photo 1. East side of High Grade Mill (looking north).

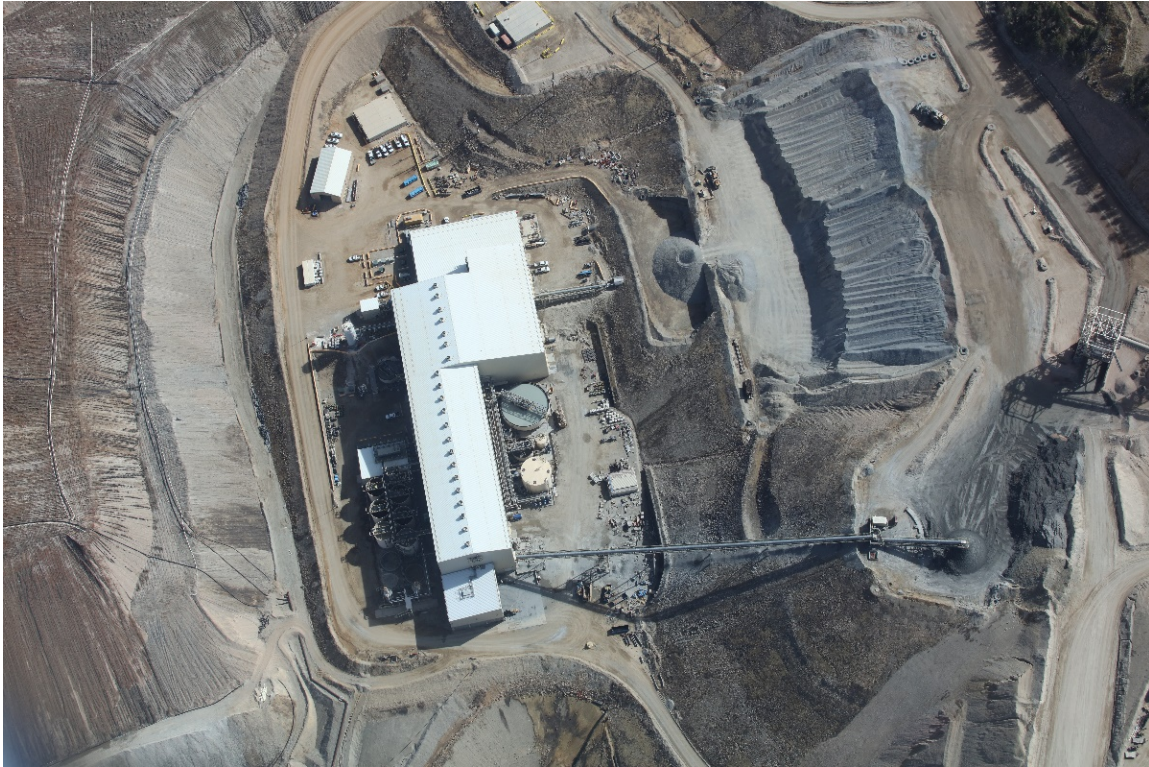
Photo 2. West side of High Grade Mill (looking NNE).

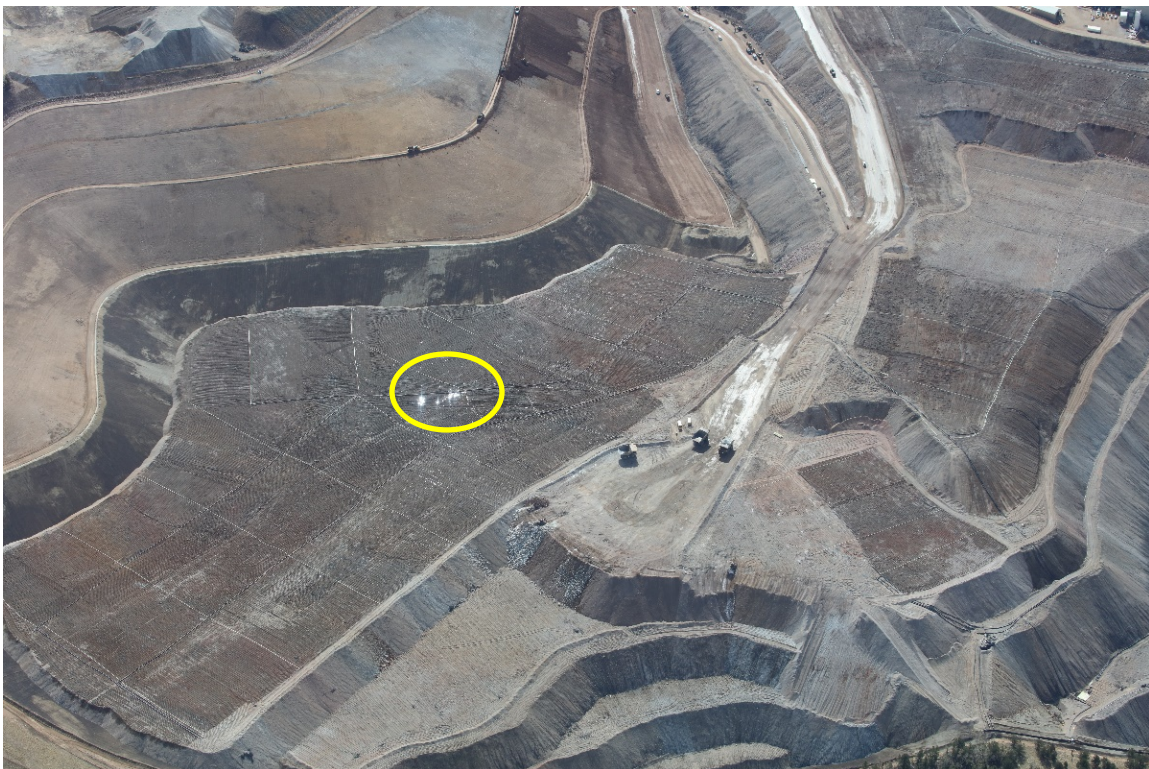
PROBLEM/POSSIBLE VIOLATION: Problem: Process solution ponding was observed in areas greater than the 3 ft x 3 ft on both VLF1 and VLF2 in multiple areas. The 3 ft x 3 ft ponding limitation is a condition of the approved wildlife protection plan.

Squaw Gulch Valley Leach Facility (VLF 2): Ponded process solution was observed in the active leach areas (estimated 9,900 level, **Photo 3**) and ponded water was observed on the 9,650 level (**Photo 4**) above ADR2. Both are a potential wildlife attractants and on the lined area of VLF2, therefore subject to the wildlife protection plan. **The VLF2 ponding is included in the cited Problem on Page 1 of this report.** The progression of ore stacking on the north side of VLF2 was observed to be in compliance with the stacking plan approved in TR-103 (**Photo 5**). VLF2, Phase 3 construction – placing soil liner fill (SLF) was also observed (**Photo 6**).

Photo 3. VLF2 – ponded water (circled) on estimated 9900 level (looking east).

CORRECTIVE ACTIONS: Provide photographic documentation of eliminating the areas of ponded solution by the Corrective Action Due Date.

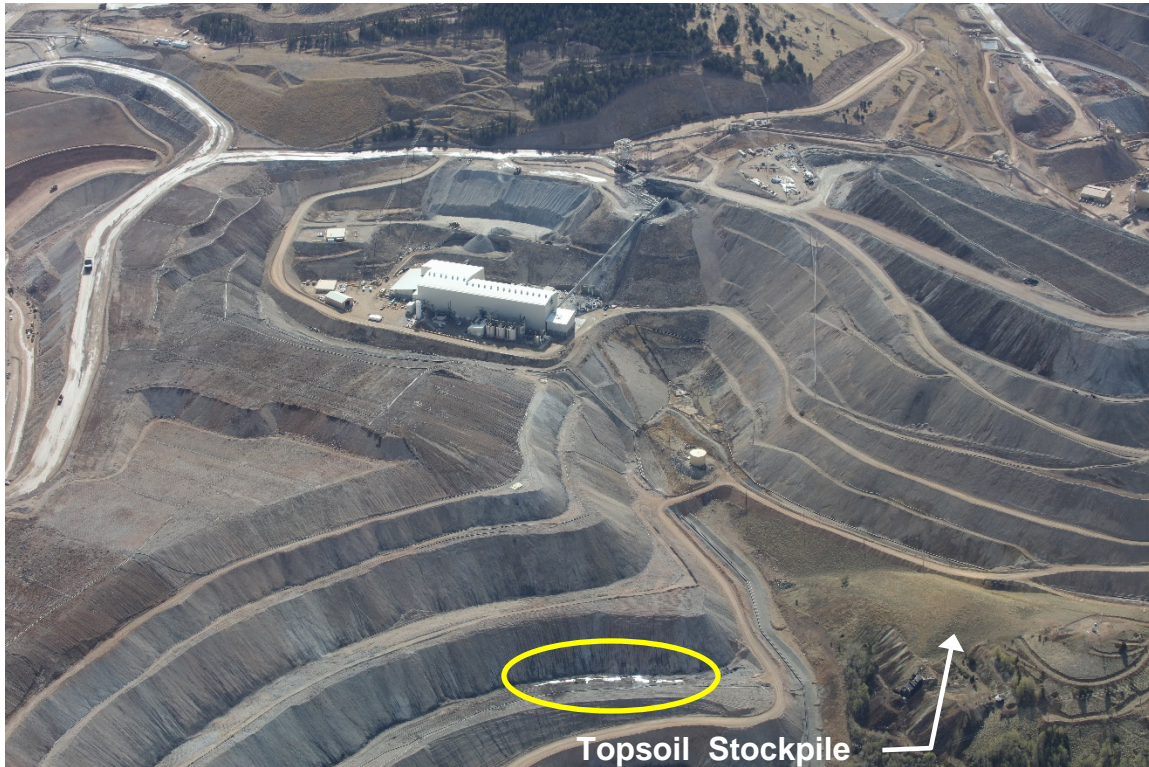
Photo 4. VLF2 – ponded water (circled) on estimated 9650 bench (looking east)

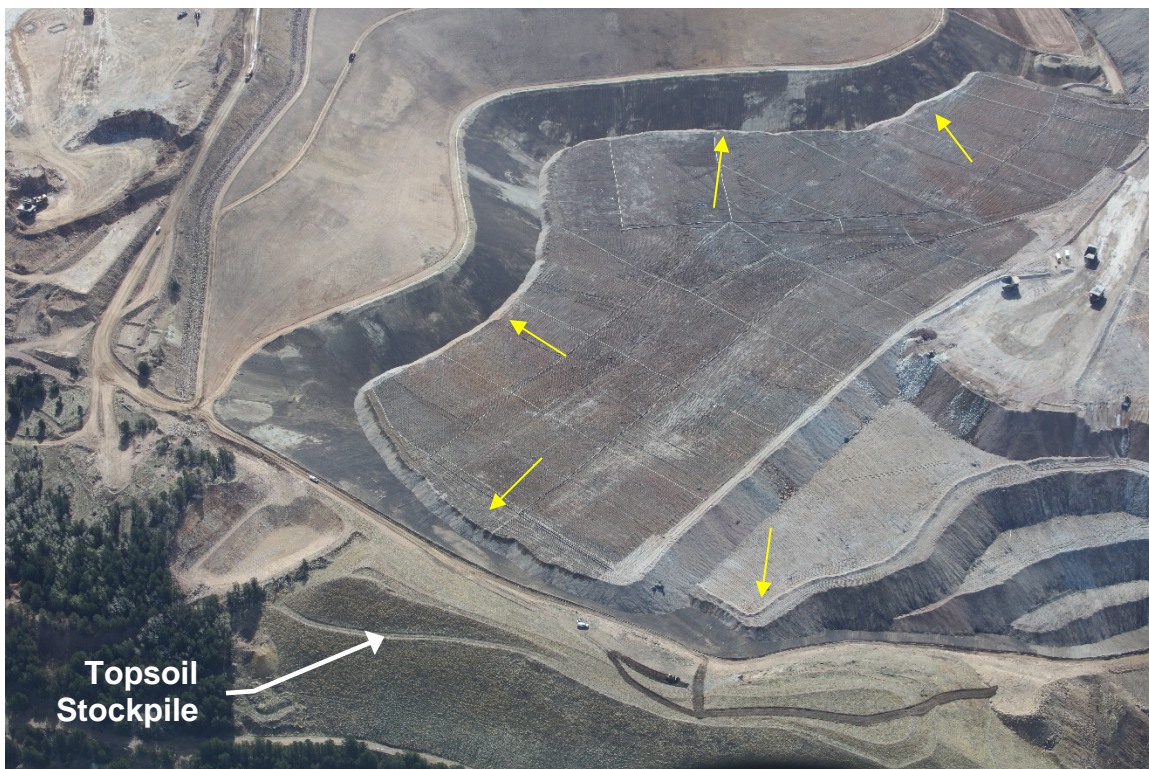
Photo 5. Ore stacking towards DCF protected liner on the north end of VLF2 (looking east).

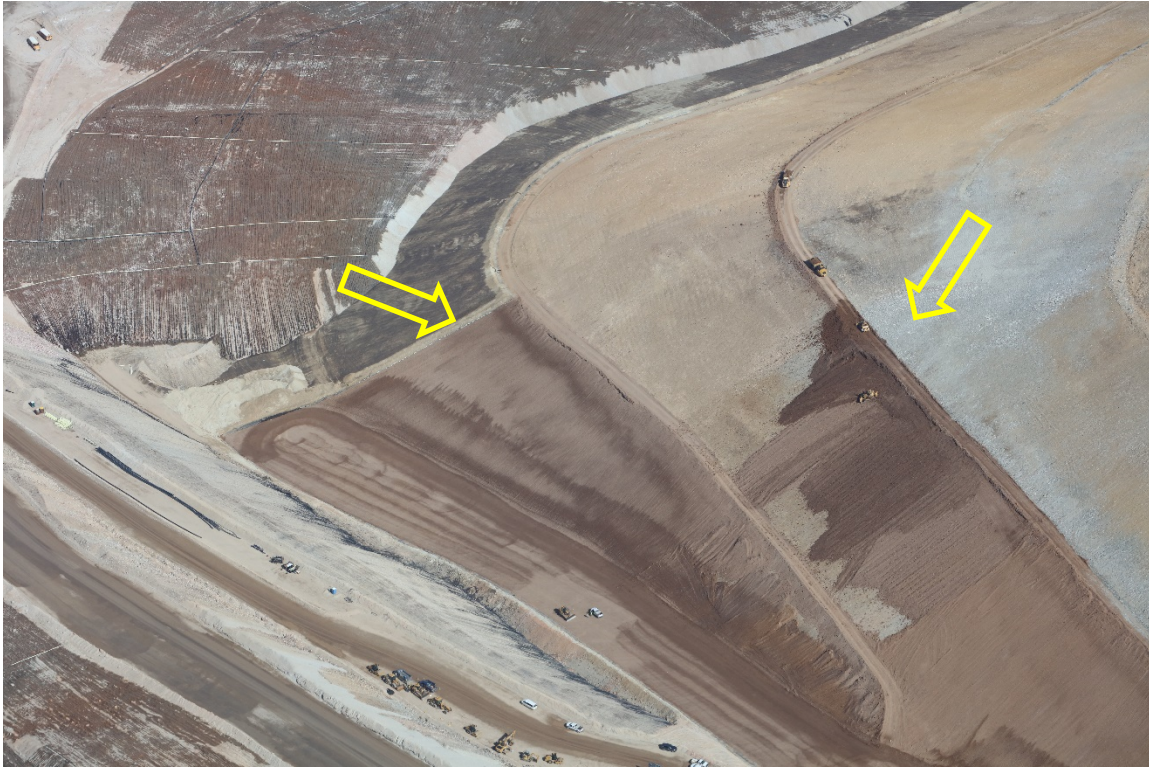
Photo 6. VLF2 Phase 3 construction – SLF placement.

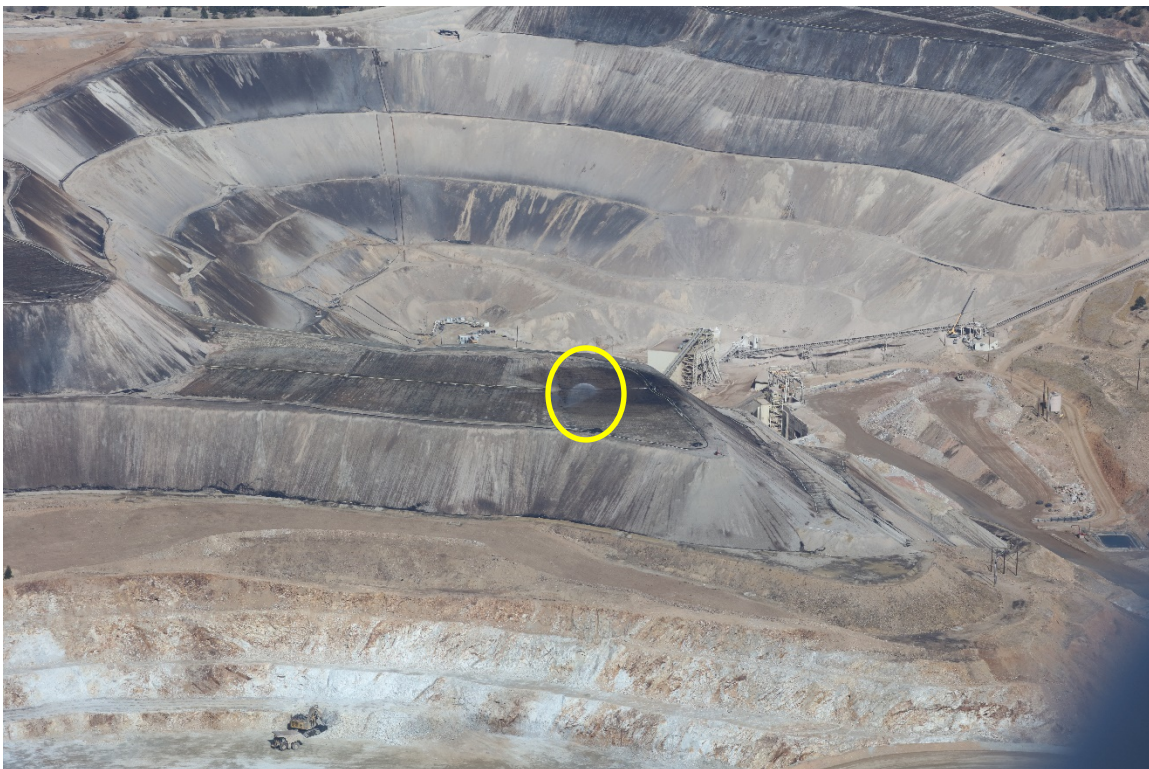
Arequa Gulch Valley Leach Facility (VLF1): Solution ponding was observed on the 10,300 level (**Photo 7**) and on the 10,400 level (**Photos 8 and 8A**). High capacity pivoting sprinklers were observed applying process solution on the south side of VLF1 (**Photo 9**). The majority of these sprinklers appear to be causing significant ponding on the bench immediately below each one (**Photo 9A**). **The VLF1 solution ponding is included in the cited Problem on Page 1 of this report.** Finally, a large area with a white substance (**Photo 10**) was observed northwest of the Process Solution Enhancement System (PSES) which was previously believed to be snow during our March 2020 aerial inspection (reference Photo 10 in the inspection report dated March 23, 2020). The Division plans to follow-up on this observation as part of the next on site visit. An overview of VLF1 is presented in **Photo 11** for comparison with previous aerial inspection reports.

Photo 7. VLF 1 (NE end of 10,300 level) – ponded process solution observed (looking NW).

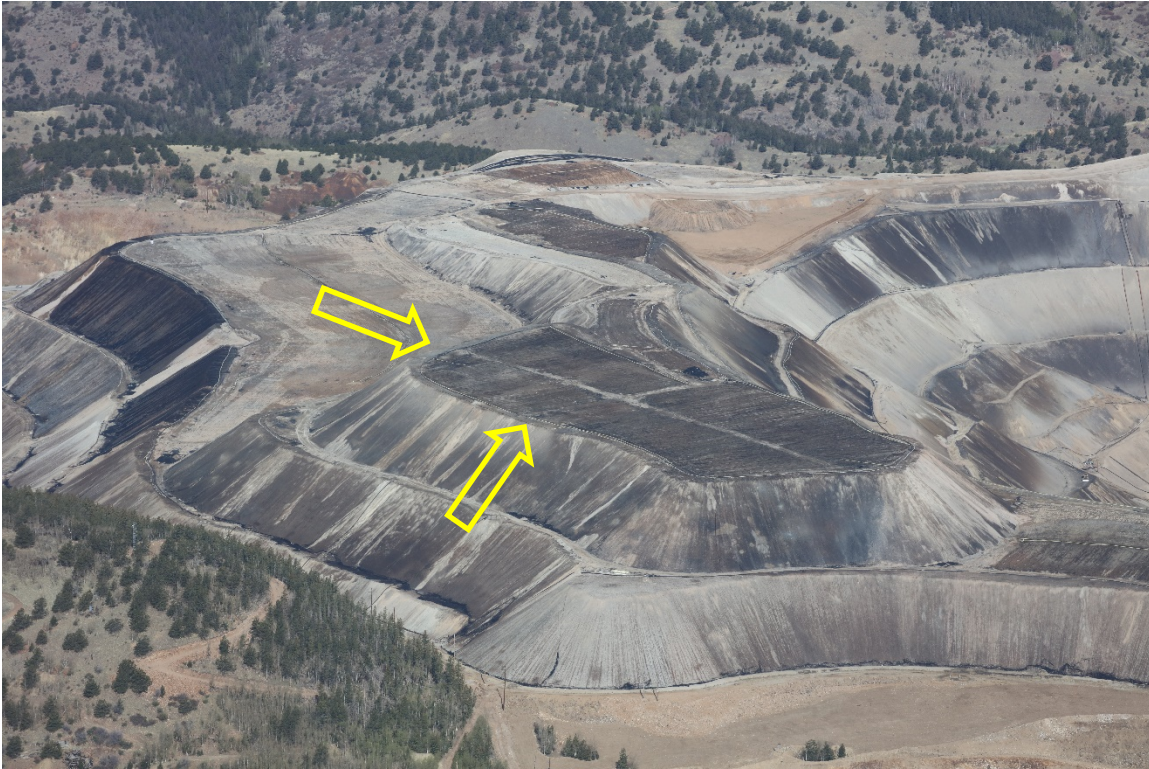
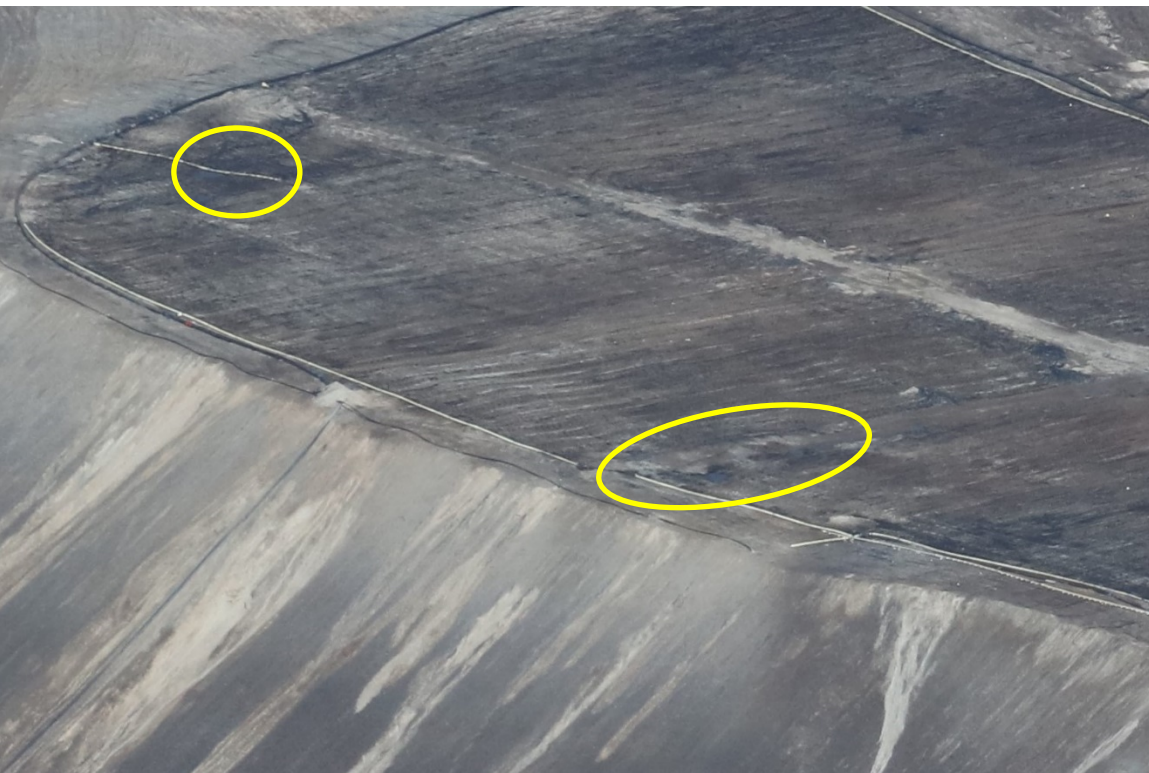
Photo 8. VLF 1 (east end of 10,400 level) – ponded process solution observed (looking NW).

Photo 8A. VLF 1 (east end of 10,400 level) – ponded process solution observed (looking NW).

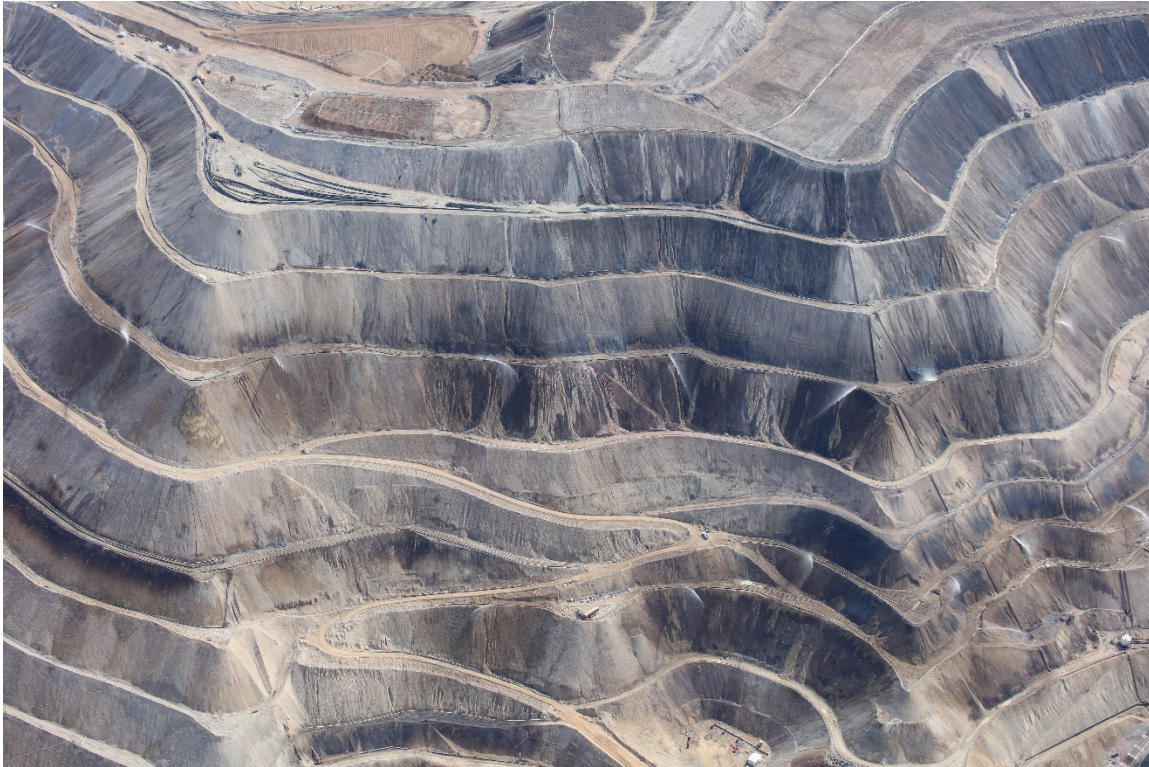
Photo 9. VLF 1 – High capacity pivoting sprinklers (looking east).

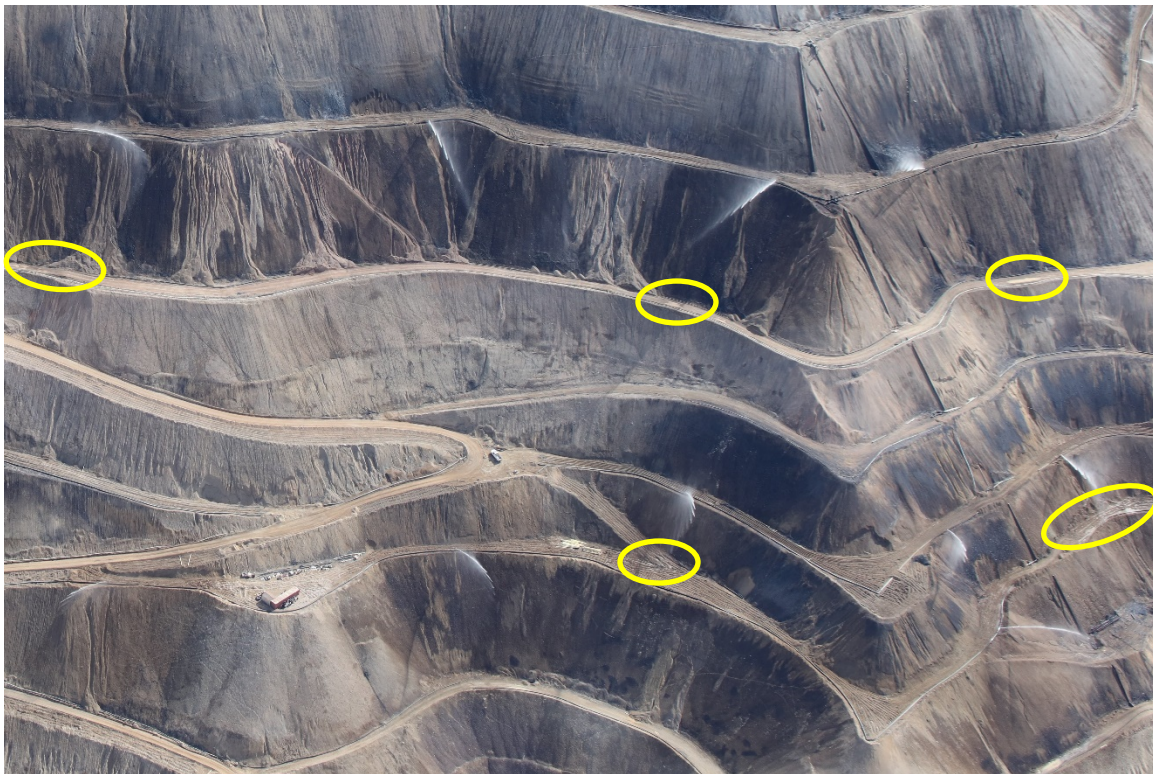
Photo 9A. VLF 1 ponded solution below pivoting sprinklers (looking east).

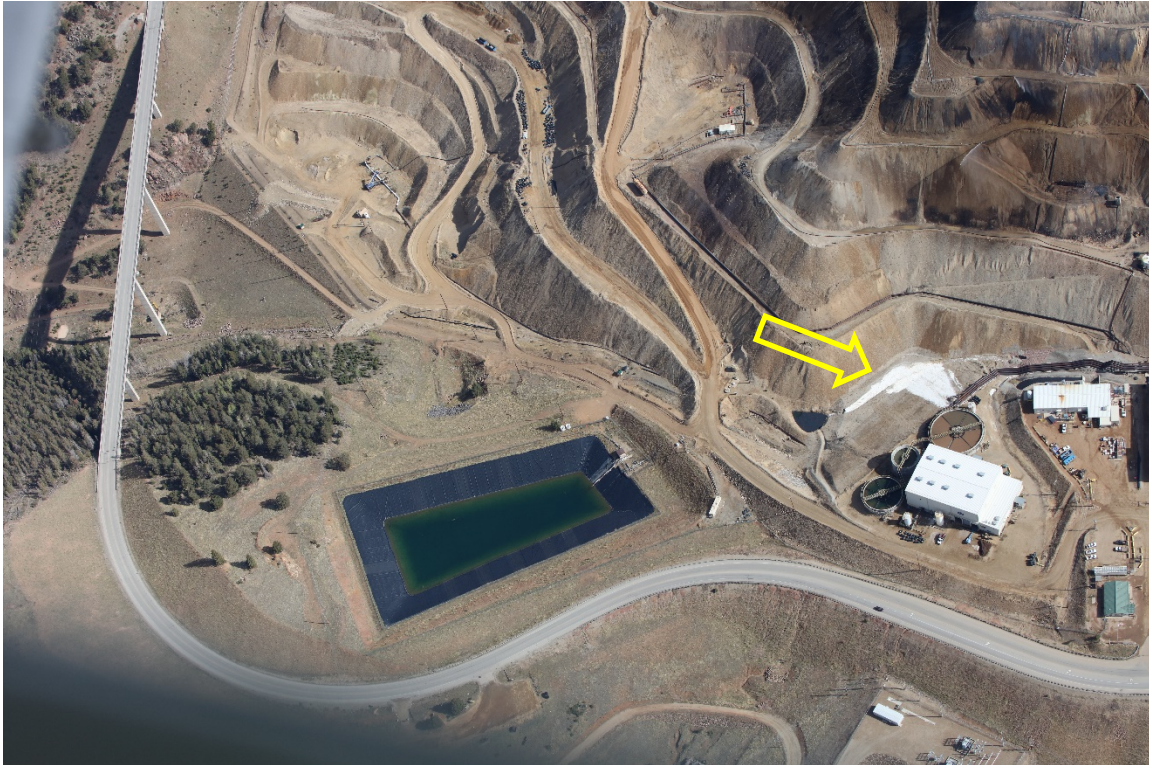
Photo 10. Large area with white substance between PSES and VLF1 (looking north).

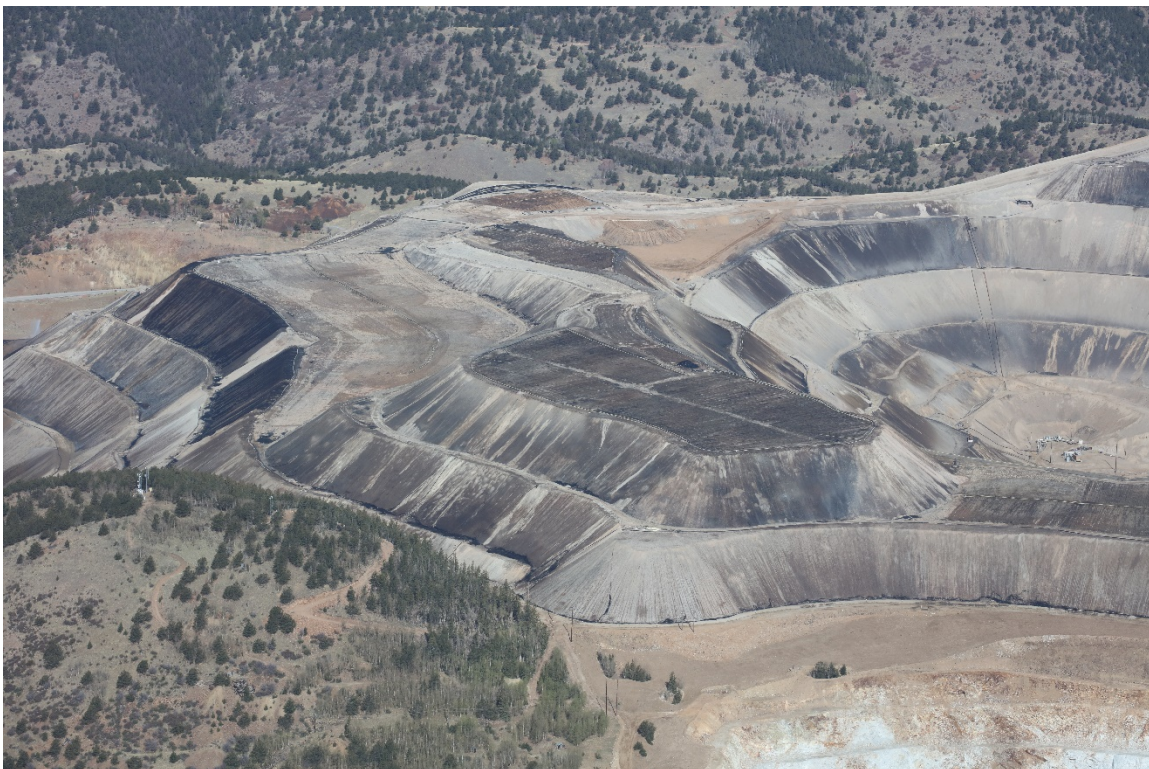
Photo 11. VLF1 overview (looking west).

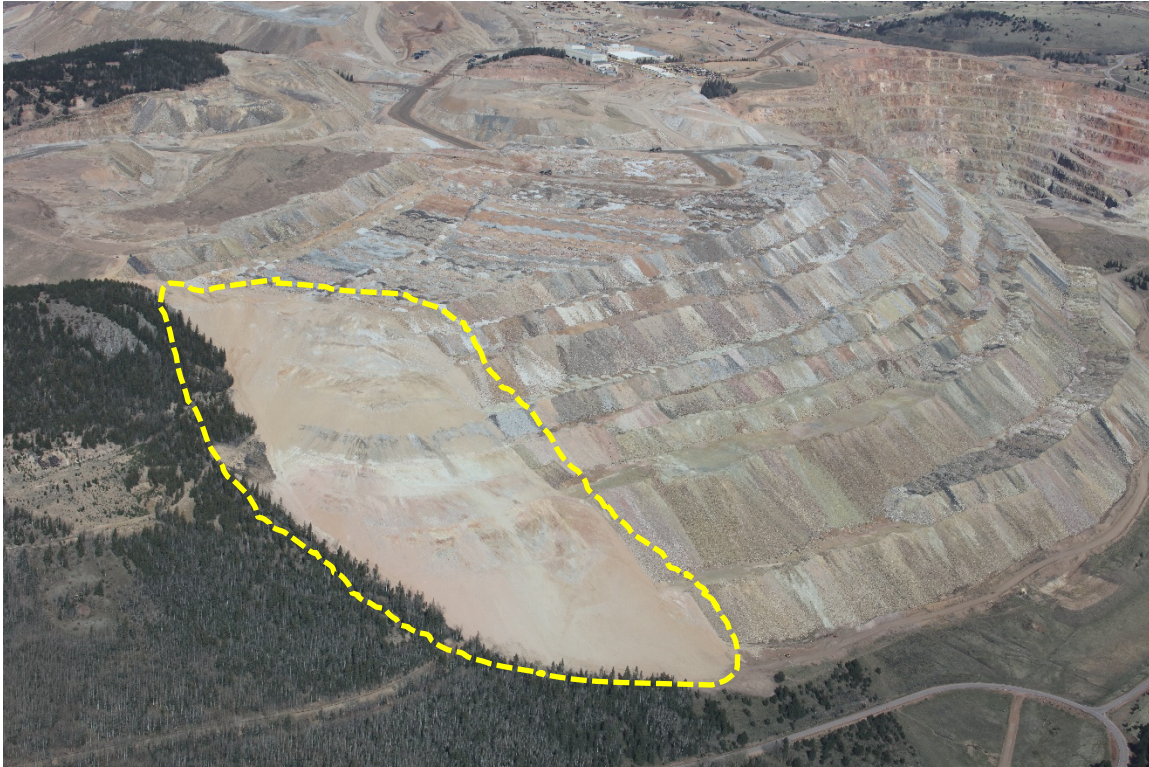
East Cresson Overburden Storage Area (ECOSA) / Altman Backfill Reclamation: Reclamation grading was observed on the south end of the ECOSA (**Photo 12**). Large rills and gullies were observed in the Altman Backfill reclamation area (**Photos 13 and 13A**). The largest gully has a significant fan of deposited sediment on the bench below it. Based on Rules 1.1(59), 3.1.5(3), 3.1.6(3), the Division would not be able to release reclamation in this condition. [We recommend repair and cite this as an example for limiting the distance between reclaimed stormwater catch benches and cross channels to something closer to 200 to 250 horizontal feet \(~100 vertical feet\).](#)

Photo 12. South ECOSA reclamation - grading (looking west).

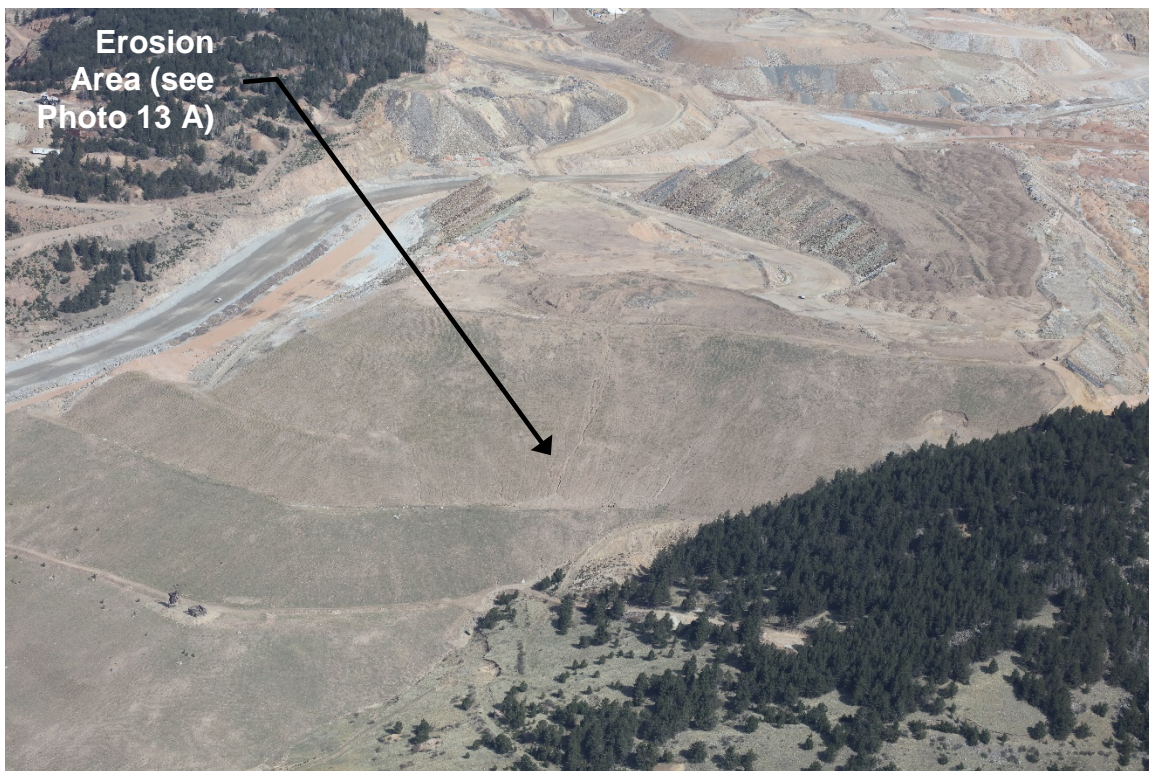
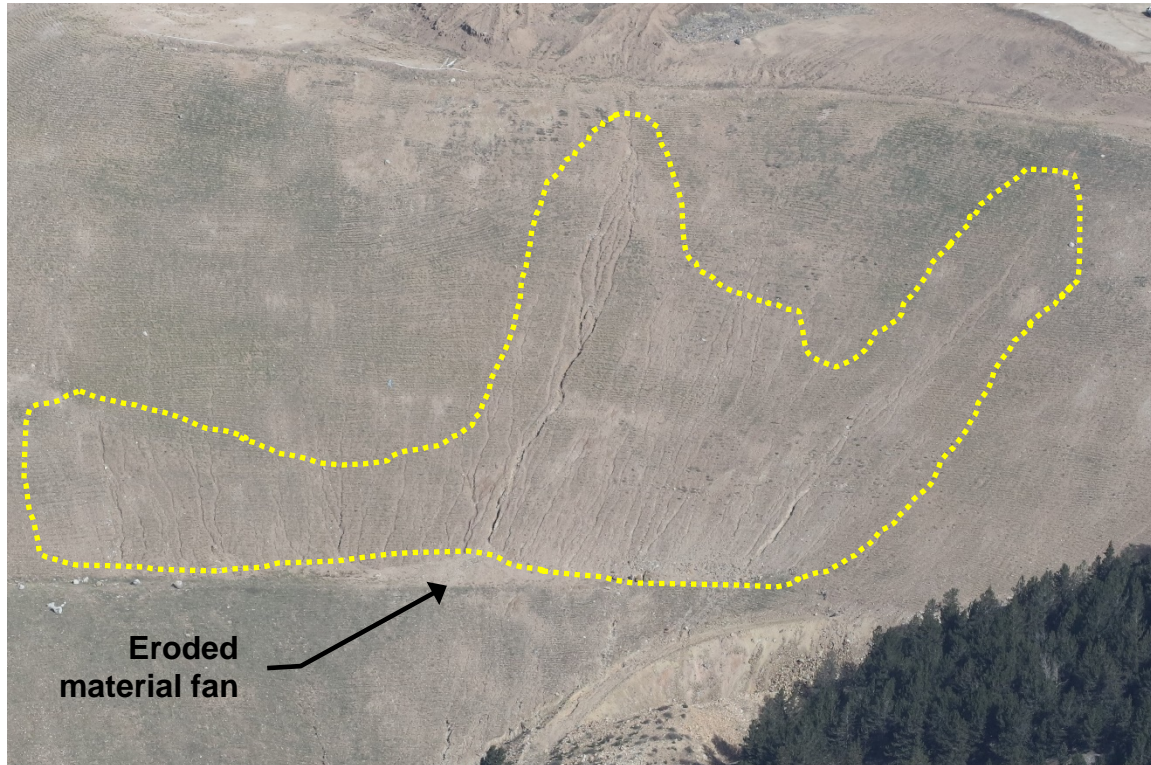
Photo 13. Altman backfill reclamation area (looking NW).

Photo 13A. Altman backfill erosion features (looking NW).

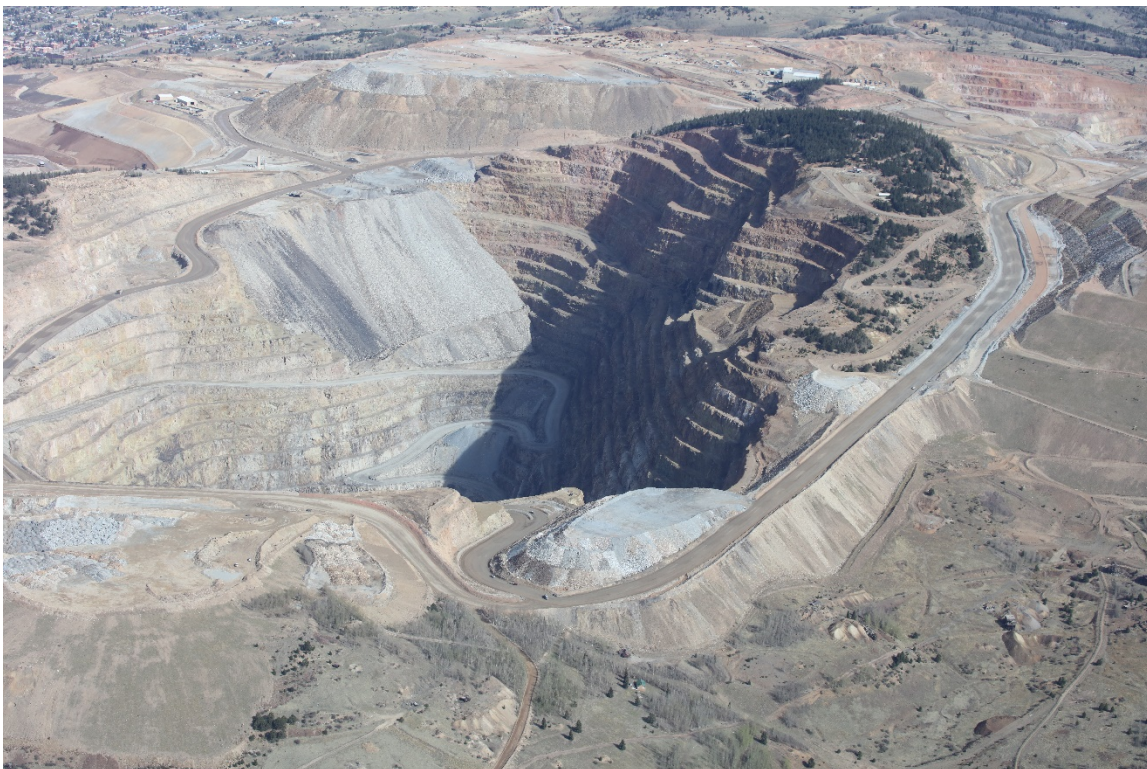
Photo 14. Main Cresson Pit (looking NW, Altman backfill on right).

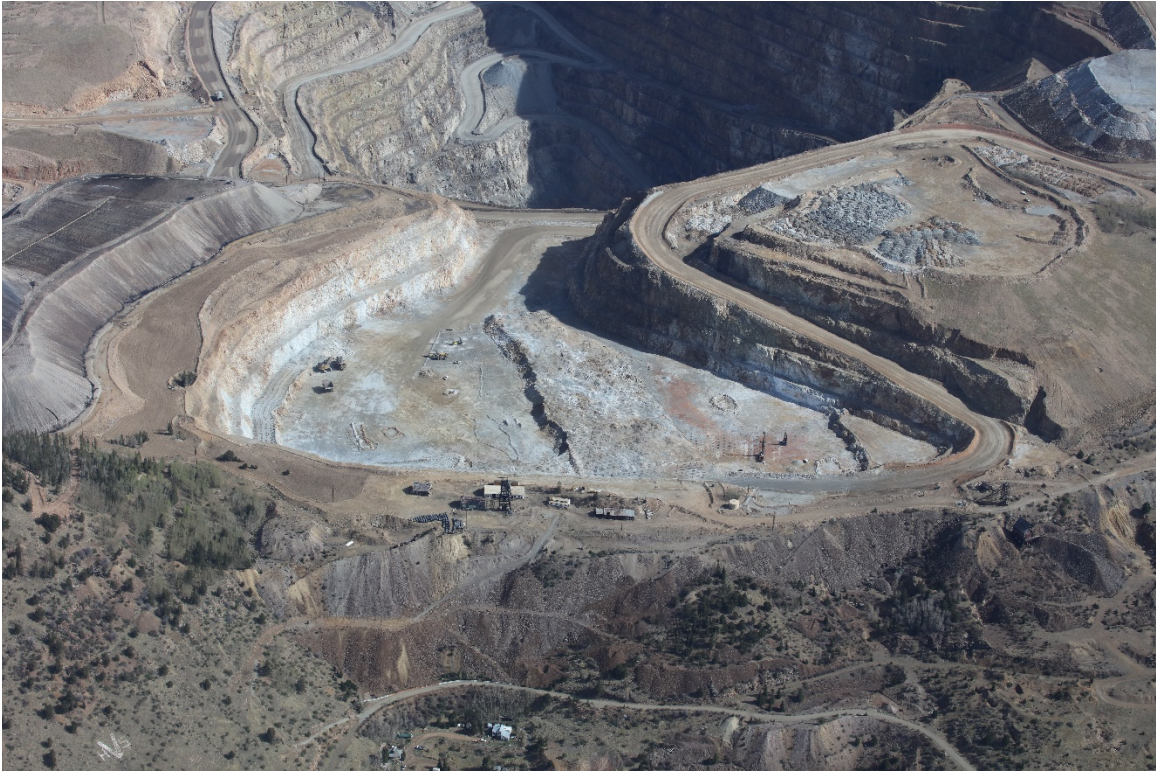
Photo 15. South Cresson Pit (looking north, Main Cresson beyond).

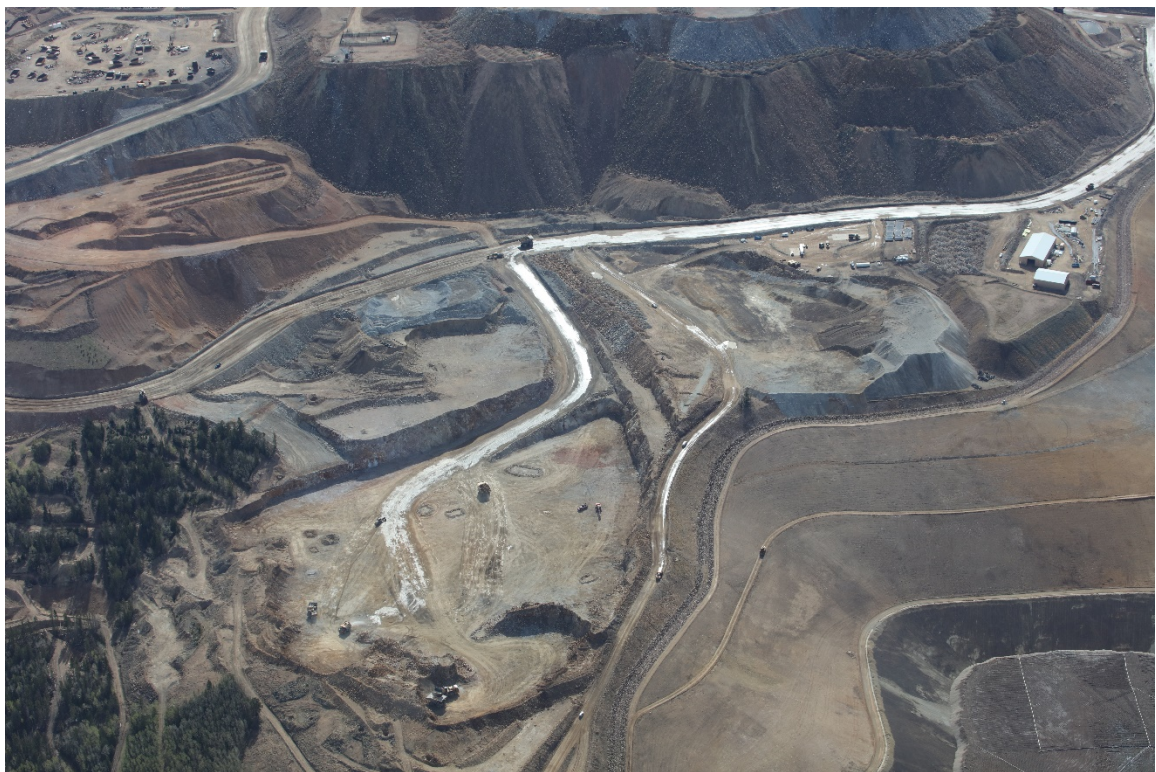
Photo 16. Schist Island Pit (looking east, VLF2 on left).

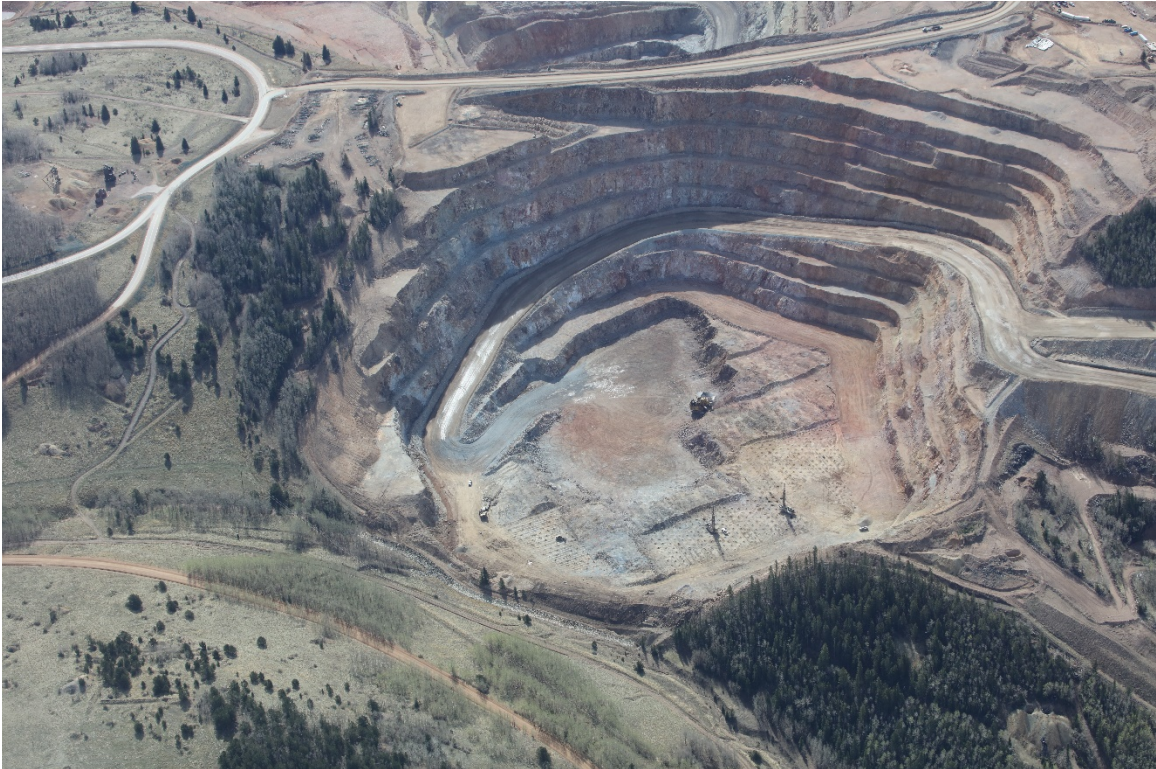
Photo 17. Globe Hill Pit (looking east, WHEX pit beyond).

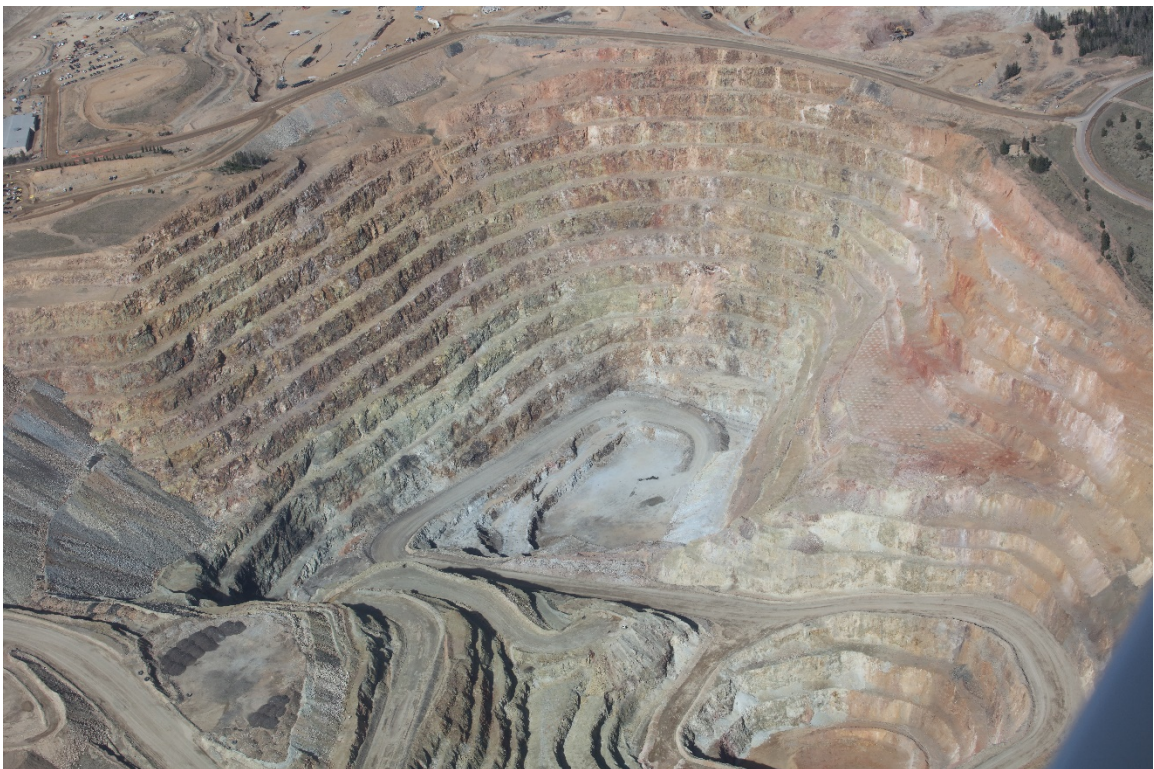
Photo 18. WHEX Pit (looking west).
