PERMIT INFORMATION

Permit Number: C-1981-012 Mine Name: New Elk Mine Operator: New Elk Coal Company, LLC Operator Address: Mr Louis Head 12250 Highway 12 Weston, CO 81091	County: Las Animas Operation Type: Underground Permit Status: Active Ownership: Private Operator Representative Present: NA			
Operator Representative Signature: (Field Issuance Only)

INSPECTION INFORMATION

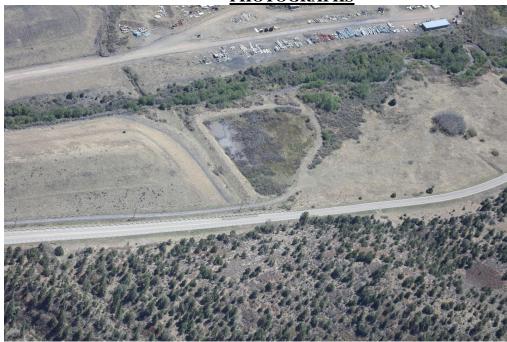
Photo 1: Pond 004A

Ponds 001A, 004A, 006A, 007A, and 008A were inspected. Ponds 001A and 007A were observed with significant amount of water. No problems were noted with embankments or spill ways.

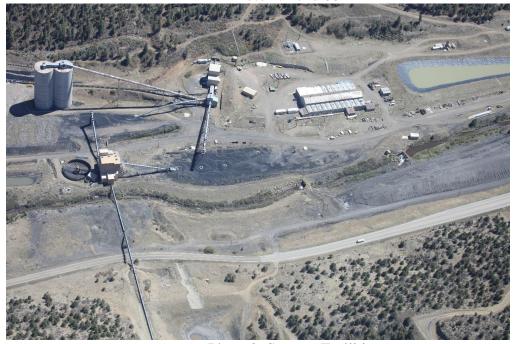
Photo 2: Support Facilities

No issues were noted with any support structure.

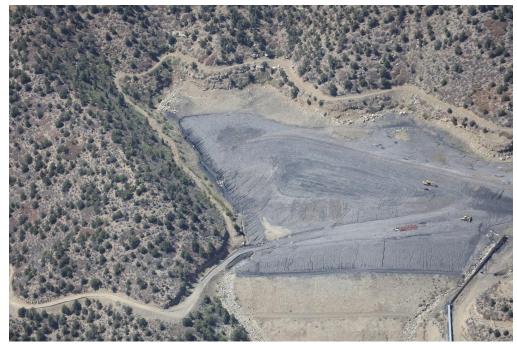
Photo 3: RDA

The RDA, Developmental Waste Pile and DWDA 2 appeared stable with no significant rills or erosion noted. The erosional issues noted in previous inspection of the RDA appear to have been stabilized.
