COLORADO
Division of Reclamation,
Mining and Safety
Department of Natural Resources

Permit Number: C-1996-084 Mine Name: Lorencito Canyon Mine Operator: New Elk Coal Company, LLC Operator Address: Mr Louis Head 12250 Highway 12 Weston, CO 81091	County: Las Animas Operation Type: Surface Permit Status: Permanent Cessation Ownership: Private
	Operator Representative Present: Nick Mason & Vince Massarotti
Operator Representative Signature: (Field Issuance Only)

Inspection Start Date: May 20, 2020 Inspection Start Time: 14:00 Inspection End Date: May 20, 2020 Inspection End Time: 16:00	Inspection Type: Coal Partial Inspection Inspection Reason: Normal I&E Program Weather: Clear
Joint Inspection Agency: None	Joint Inspection Contacts:
Post Inspection Agency: None	Post Inspection Contacts:
Inspector(s): Daniel Cunningham	Inspector's Signature:

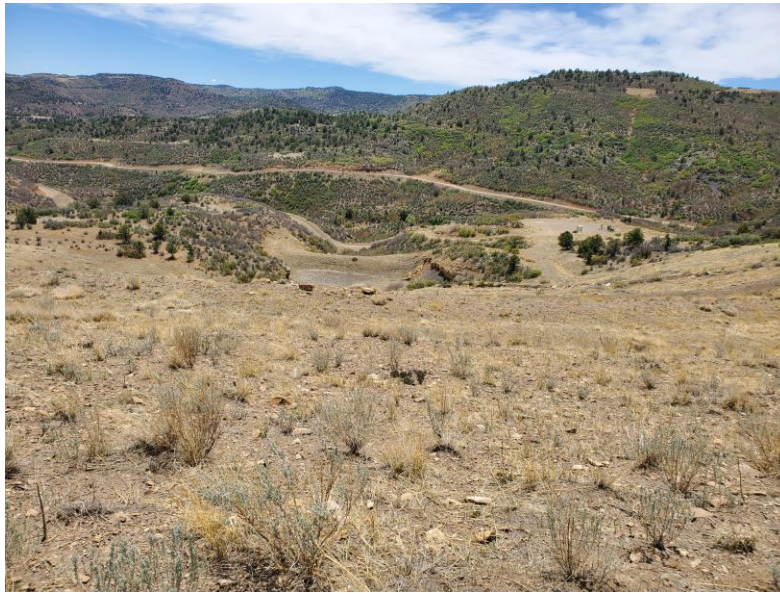
Photo 1: Above Fill 9

Fill 9 was inspected. No erosional issues were noted during the inspection. The vegetation on Fill 9 look good except for a few areas of diffuse knapweed. NECC stated that they plan to spray Lorencito once New Elk Mine was finished being sprayed.

Good vegetation was established on Fill 9.

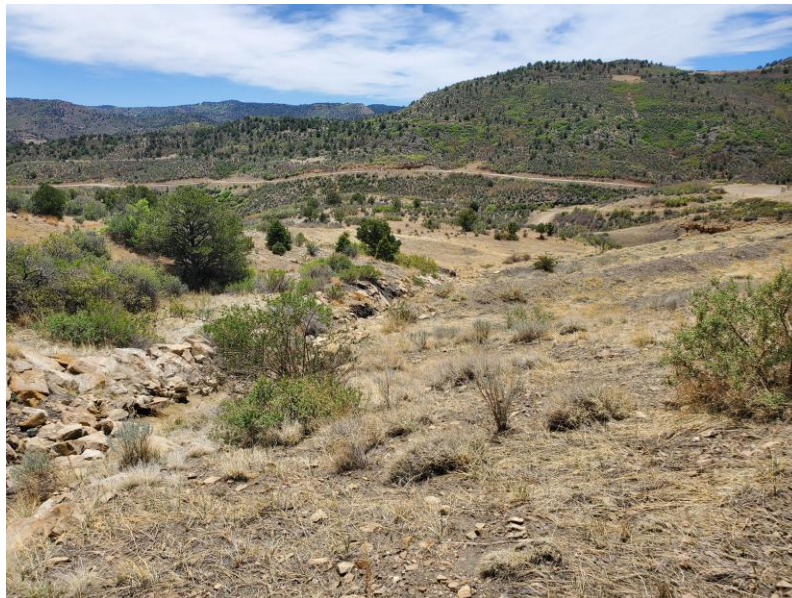
Photo 2: Diversion Ditch 94

Ditches 92, 94, and 75 were inspected. All ditches were clear of debris and appear stable.
