## Seneca II-W (C-1982-057) and Yoast Mine (C-1994-082) Inspection Reports

<b>Permit Number:</b> C-1994-082 <b>Mine Name:</b> Yoast Mine <b>Operator:</b> Seneca Property LLC <b>Operator Address:</b> Ms. Miranda Kawcak 29515 Routt County Road No. 27 Oak Creek, CO 80467	<b>County:</b> Routt <b>Operation Type:</b> Surface <b>Permit Status:</b> Permanent Cessation <b>Ownership:</b> Private
	<b>Operator Representative Present:</b>  None
<b>Operator Representative Signature: (Field Issuance Only)</b>

<b>Inspection Start Date:</b> May 21, 2020 <b>Inspection Start Time:</b> 12:30 <b>Inspection End Date:</b> May 21, 2020 <b>Inspection End Time:</b> 15:00		<b>Inspection Type:</b> Coal Partial Inspection <b>Inspection Reason:</b> Normal I&E Program <b>Weather:</b> Clear	
<b>Joint Inspection Agency:</b>  None		<b>Joint Inspection Contacts:</b>  None	
<b>Post Inspection Agency:</b>  None		<b>Post Inspection Contacts:</b>  None	
<b>Inspector(s):</b>  Jared Ebert	<b>Inspector's Signature:</b>

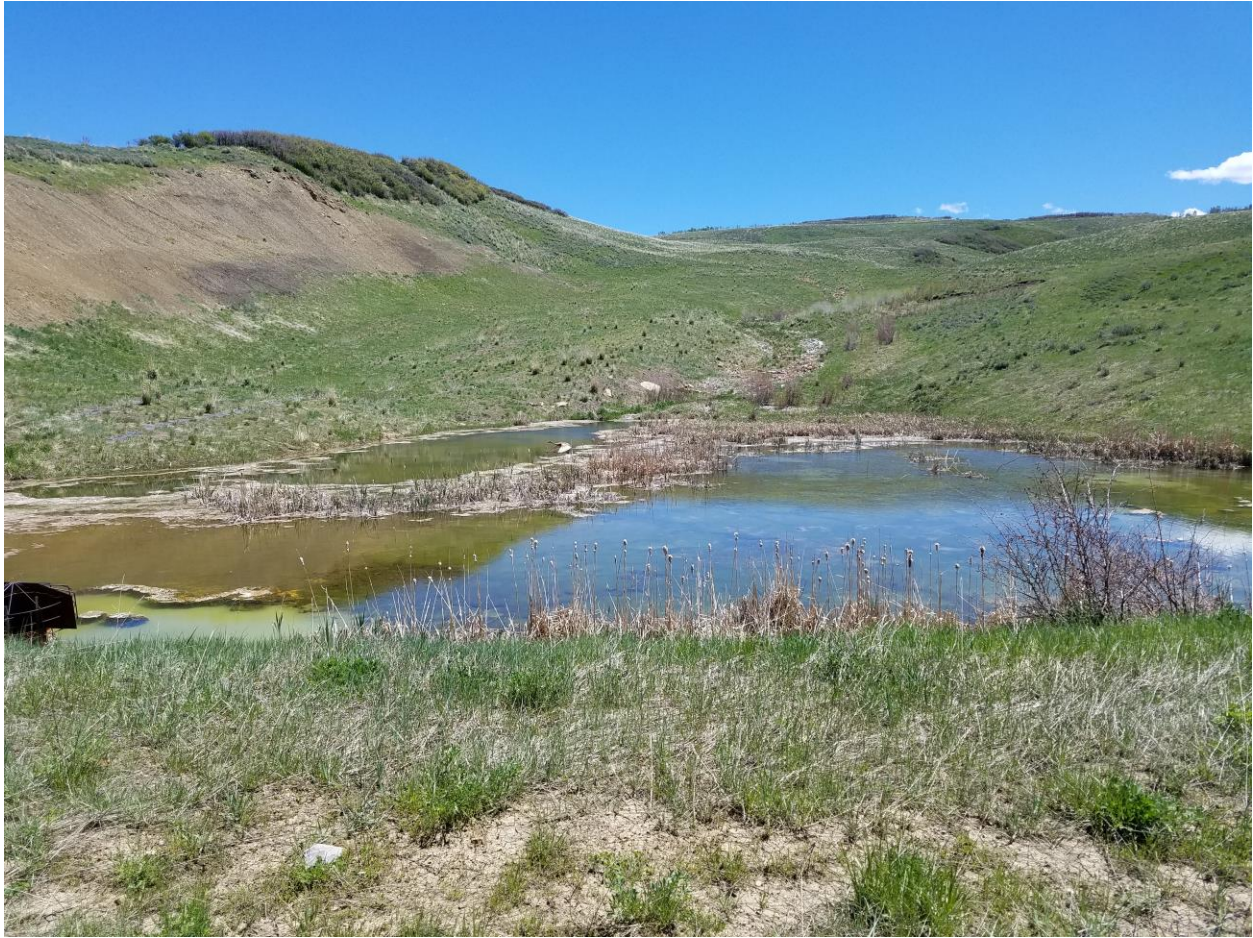
*Figure 1. Pond 012, drainage YPM-6-3*

Pond 012 was holding water and discharging. The embankment was stable and vegetated. The primary and emergency spillways were clear and functional.

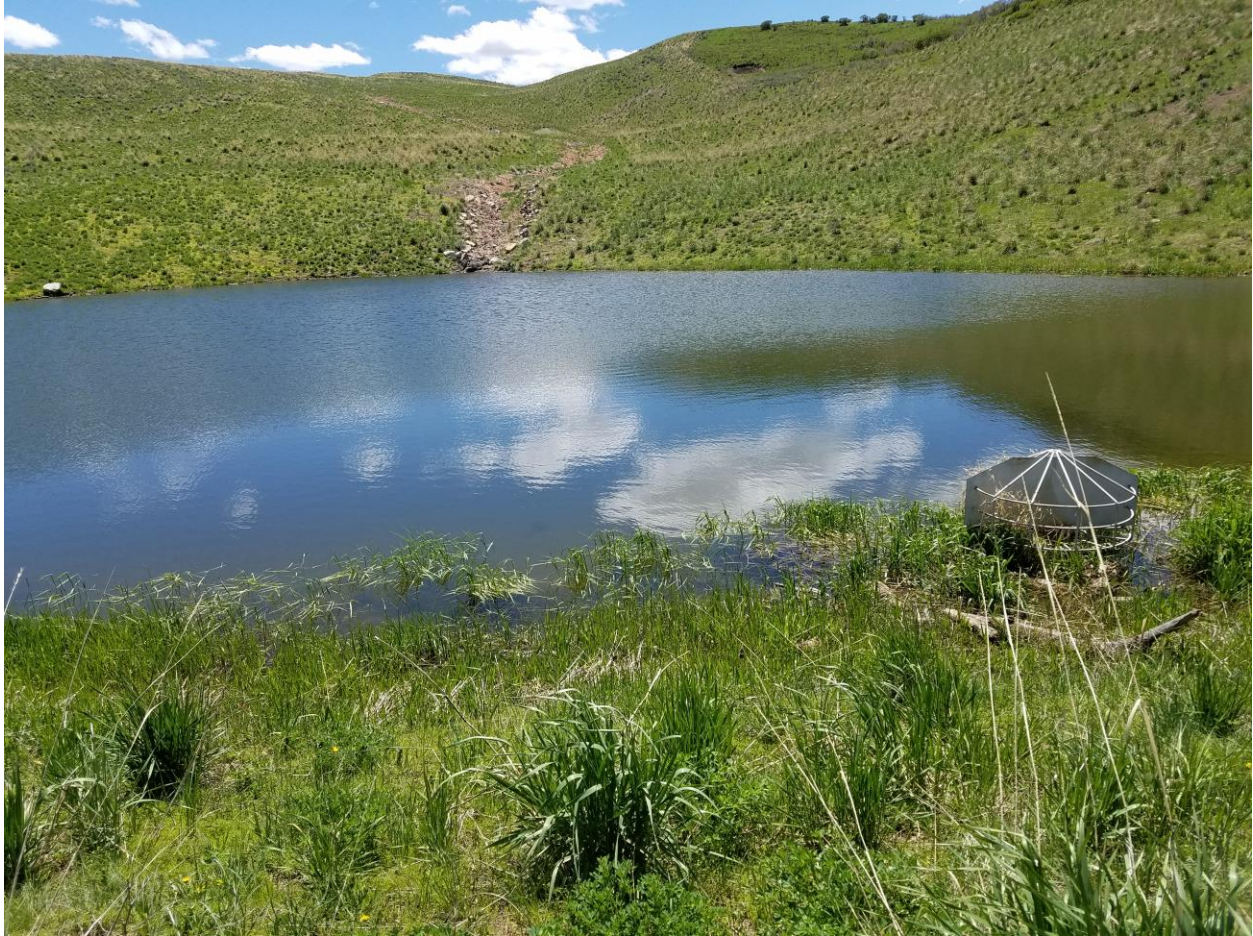
*Figure 2. Pond 012A, drainage YPM-5-1.*

Pond 012A was also holding water and discharging.

Drainages YPM-5-1, YPM-1-2, YPM-1-3, YPM-6-1 and YPM-6-2 were walked and observed. These drainages were rock-lined and appeared stable.

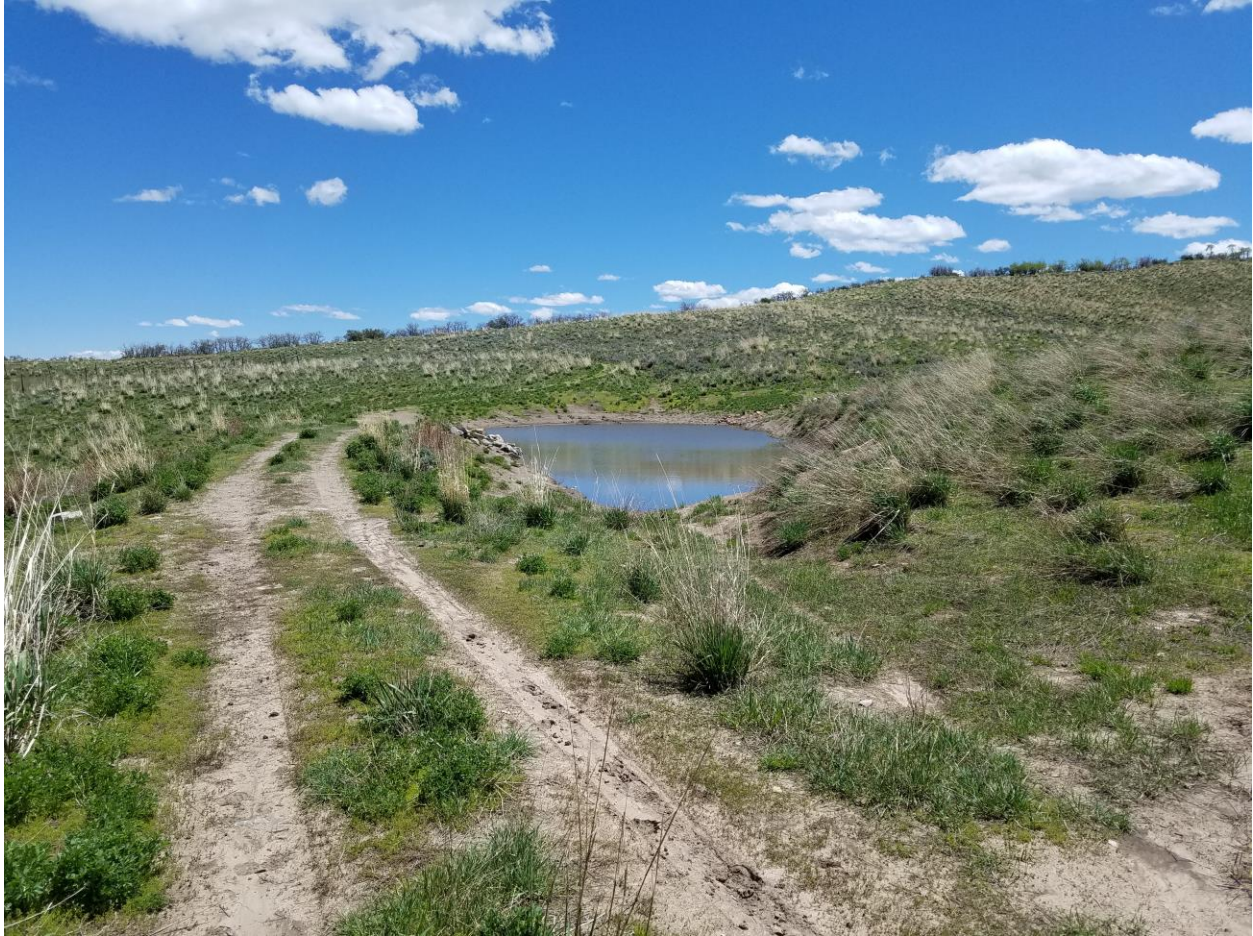
*Figure 3. Stock pond ST-1*

Stock pond ST-1 was observed. The pond was holding water.

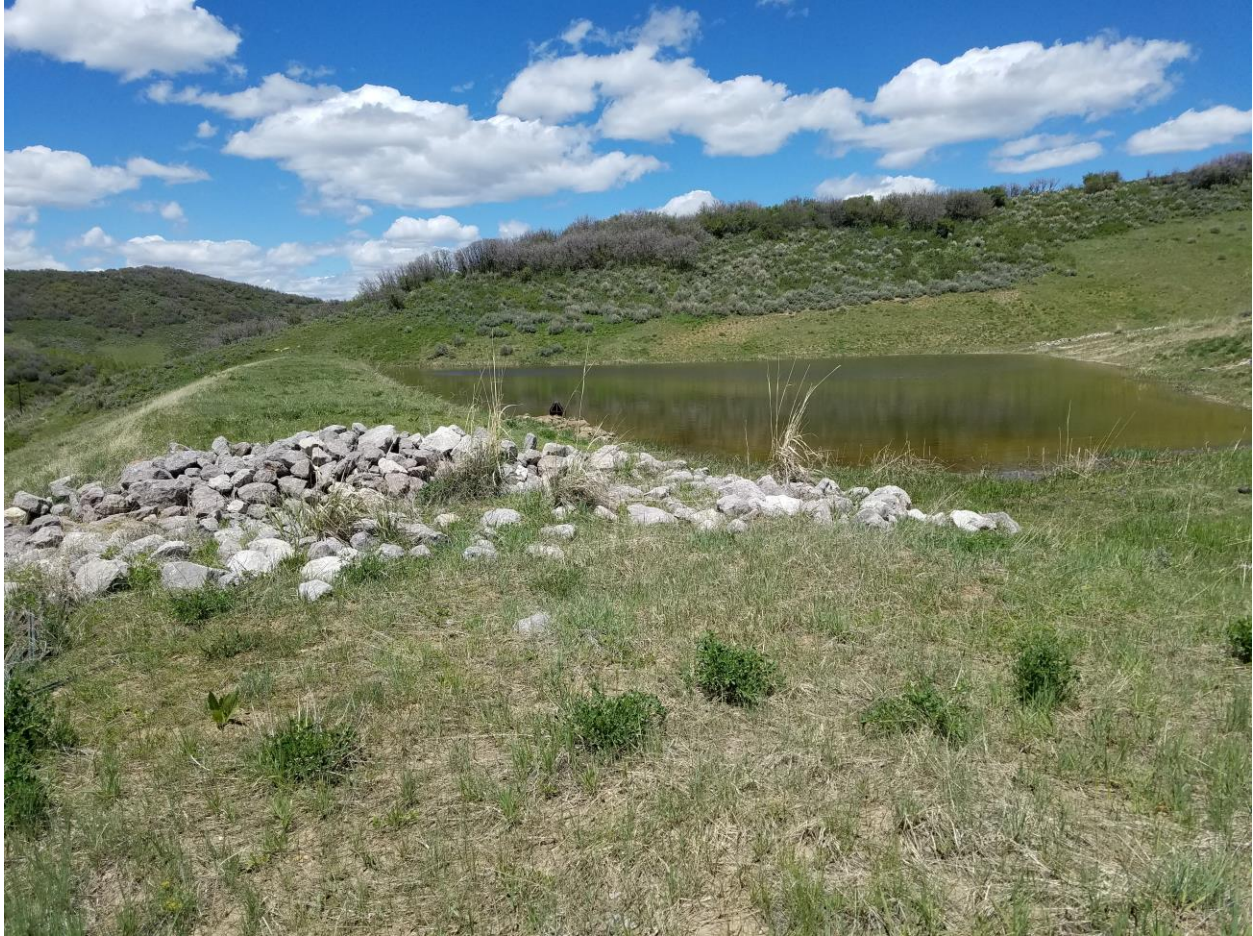
*Figure 5. Pond 013*

Pond 013 was holding water and discharging slightly at the discharge pipe. The embankment was stable and vegetated. The primary and emergency spillways were clear and functional.

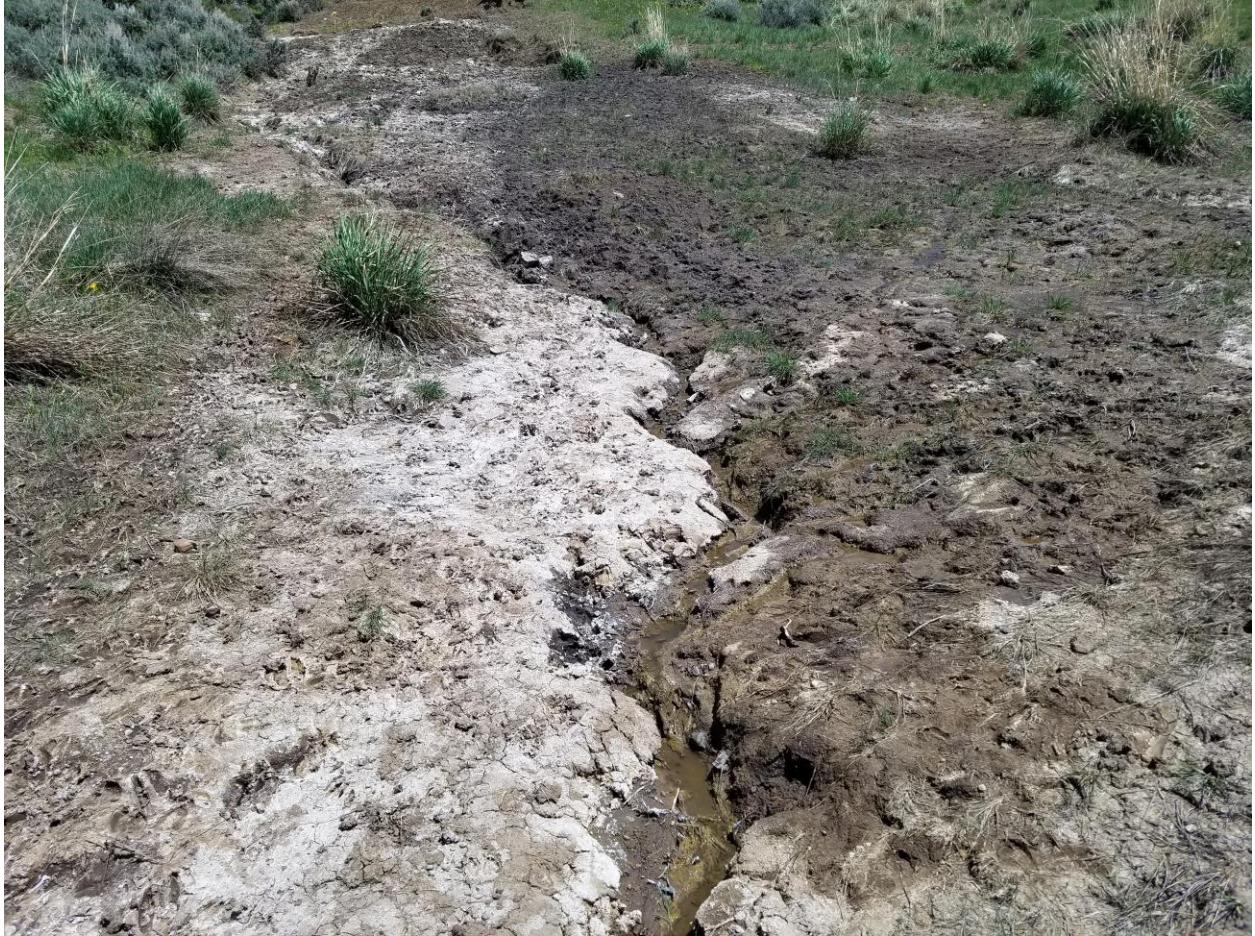
*Figure 6. Seep above Pond 013*

The seep above pond 013 was observed. The seep was flowing and numerous wildlife tracks were observed around the seep area.

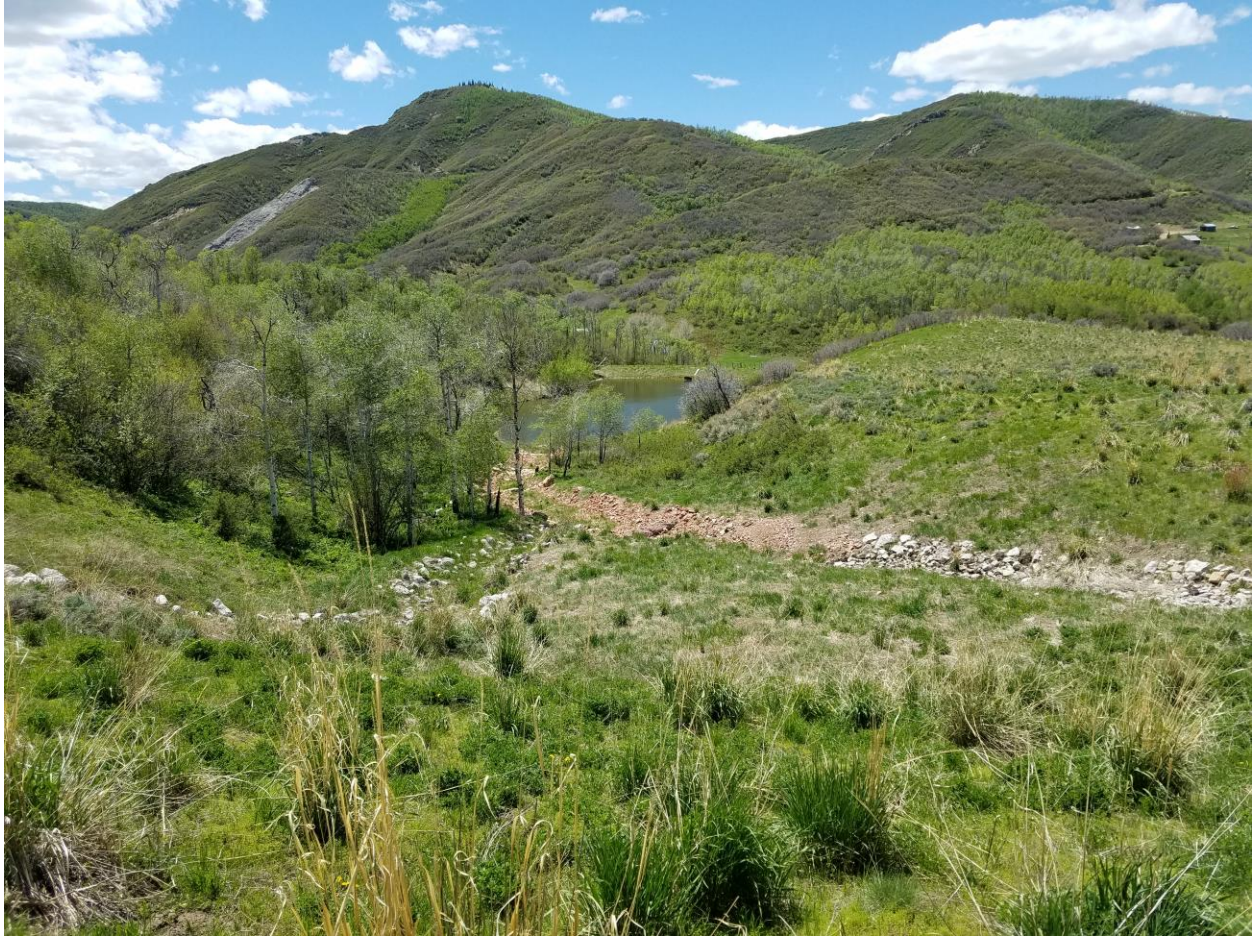
*Figure 7. Pond 014, drainage YPM-3-2 and 3-2a*

Pond 014 was holding water and discharging slightly from the flume. The embankment was stable and vegetated. The primary and emergency spillways were clear and functional.

Drainages YPM-4-2, YPM-4-17 and YPM3-2 were walked and observed. These drainages were rock-lined and stable.
