MINERALS PROGRAM INSPECTION REPORT
PHONE: (303) 866-3567

MINE NAME: Langston Property	MINE/PROSPECTING ID#: M-2020-023	MINERAL: Borrow Material	COUNTY: Fremont
INSPECTION TYPE: Illegal(Unpermitted Operation)	INSPECTOR(S): Timothy Cazier	INSP. DATE: May 12, 2020	INSP. TIME: 10:15
OPERATOR: Mike Langston	OPERATOR REPRESENTATIVE: Mike & Zac Langston	TYPE OF OPERATION: ILL - Illegal	
REASON FOR INSPECTION: Citizen Complaint	BOND CALCULATION TYPE: None	BOND AMOUNT: No Bond Held	
DATE OF COMPLAINT: April 22, 2020	POST INSP. CONTACTS: Other Agency – City of Florence	JOINT INSP. AGENCY: None	
WEATHER: Foggy	INSPECTOR'S SIGNATURE:

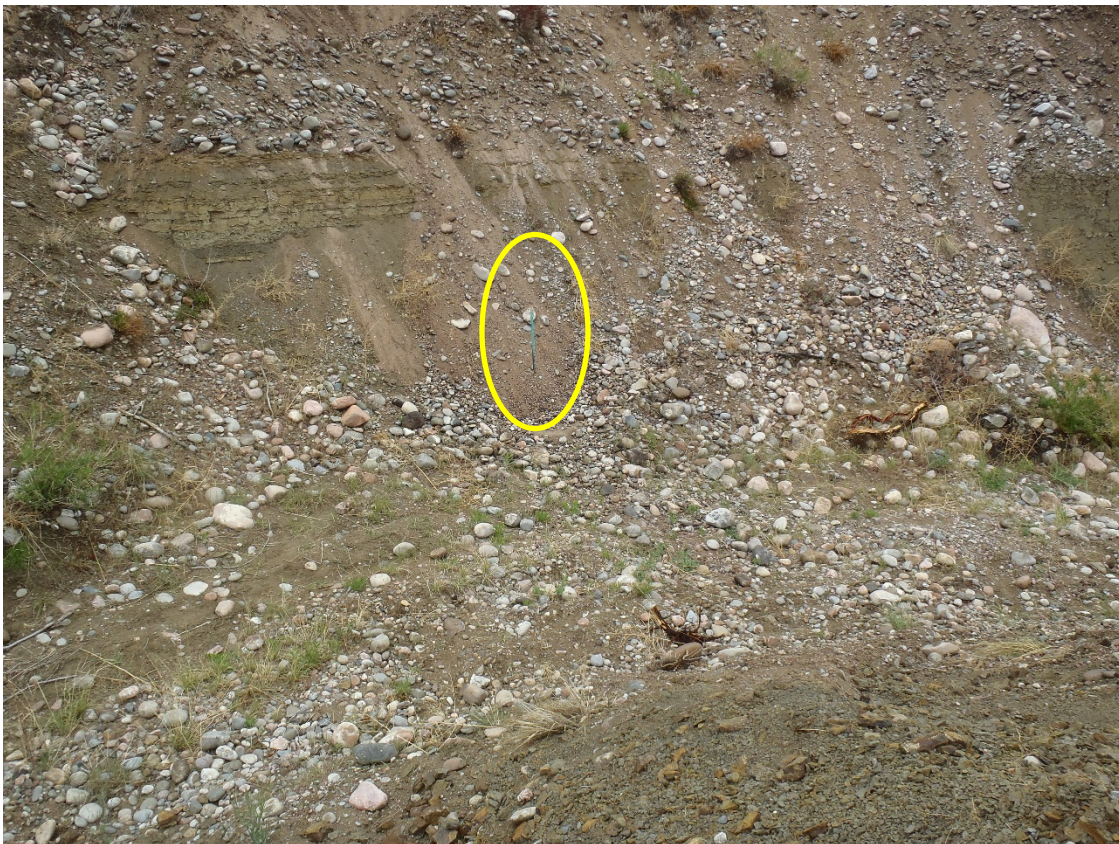
Mike Langston owns the property from which material has been removed and transported to his permitted operation (M-1992-051/Florence Sand and Gravel Pit) about one mile to the southeast. Mr. Langston stated he has a long term plan to potentially develop the site. There is a sanitary sewer line (and easement) running from the southeast towards the northwest through the property. Mr. Langston explained when the sewer line was installed by the Fremont Sanitation District (FSD), a deep trench had been left. A Google Earth historical image review indicated the trench was there in the earliest available image (10/8/1999). Several manholes were observed and T-posts (**Photo 1**) partially mark the alignment of the sewer line. Mr. Langston pointed out the aging trench was raveling and burying manhole covers, thereby limiting maintenance access. Based on his plan for potential development and the benefit to the FSD for maintenance, Mr. Langston entered into a "hand shake" agreement with the FSD to develop a road alongside the sewer line and layback the slopes to a stable configuration. The laid back slopes appeared to have been topsoiled, but had not been seeded (**Photo 2**). The current effort is focused on the east side of the sewer line and is nearly complete from an earthworks perspective. Only a small area remains to complete the grading work for the road towards the south end of the active area (**Photo 3**). The crest of the excavation showed limited disturbance beyond that required to lay back the slope (**Photo 4**). The Langstons confirmed all material removed from the site had been hauled to their permitted area for backfill at that location and not sold. The material removed exhibited some clays/weathered shale (**Photo 5**), not suitable for selling without washing and the permitted site is a dry operation. The Langstons estimated between 500 and 1,000 CY of material had been removed.

Photo 1. T-post in bottom of trench marking sanitary sewer (looking NW – note raveling slope).

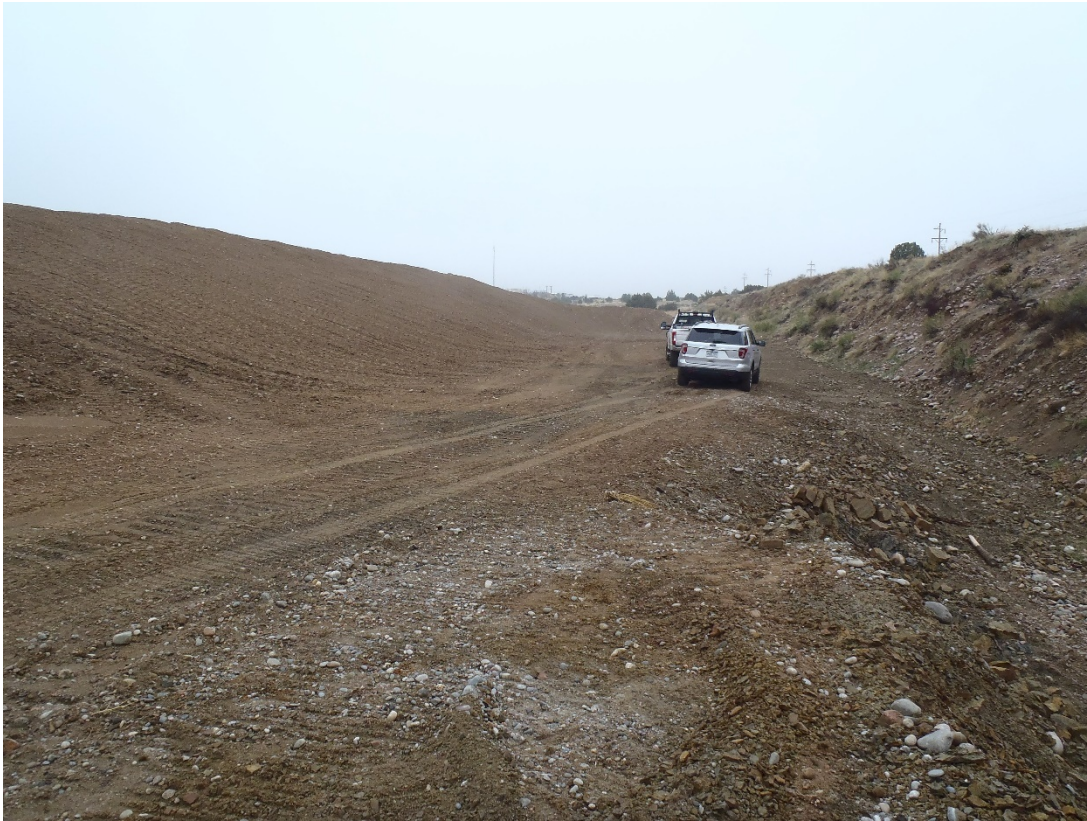
Photo 2. Graded and topsoiled east side (looking SE – trench on right).

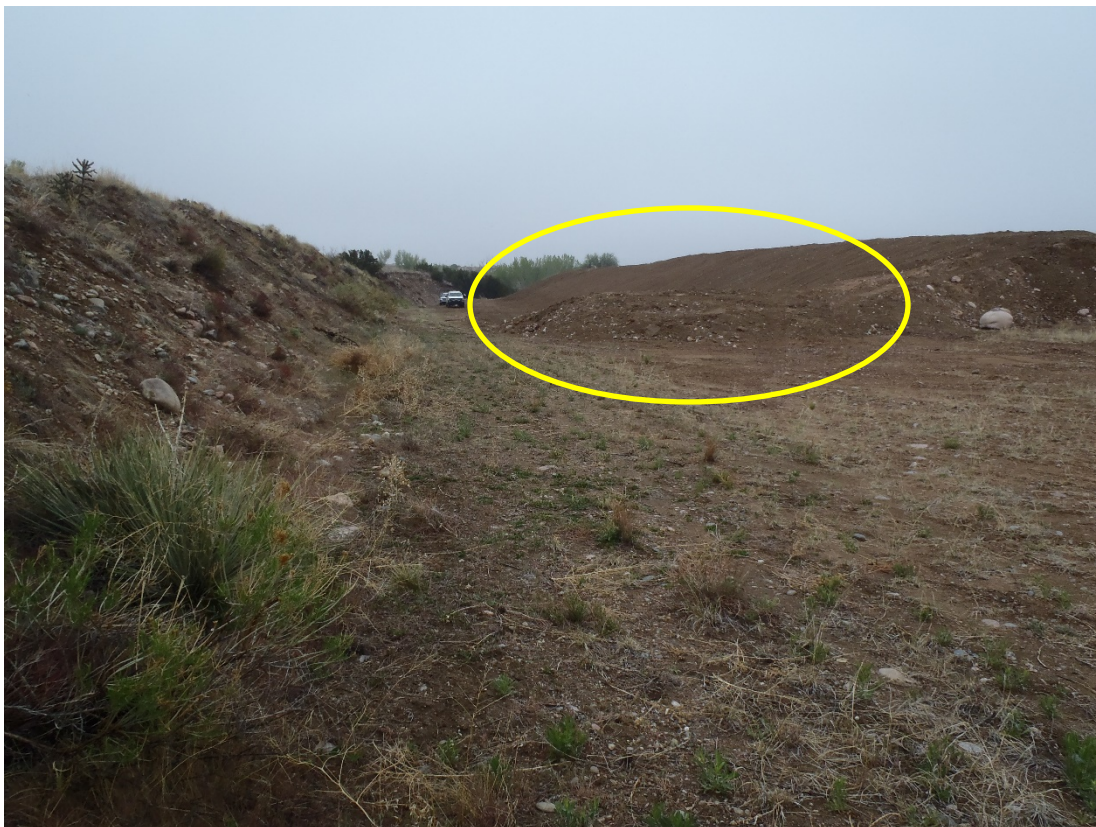
Photo 3. Small area needing grading to match existing grades (south end of active area, looking NW).

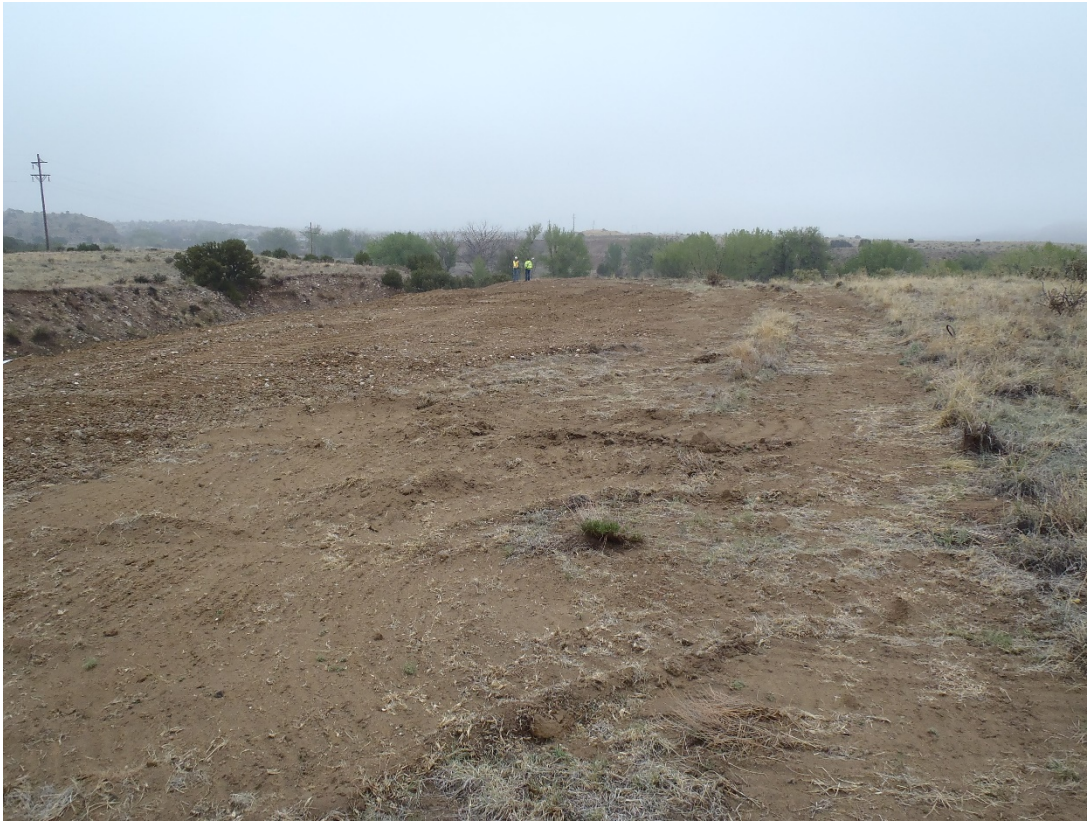
Photo 4. Crest on east side (looking NW, trench in upper left).

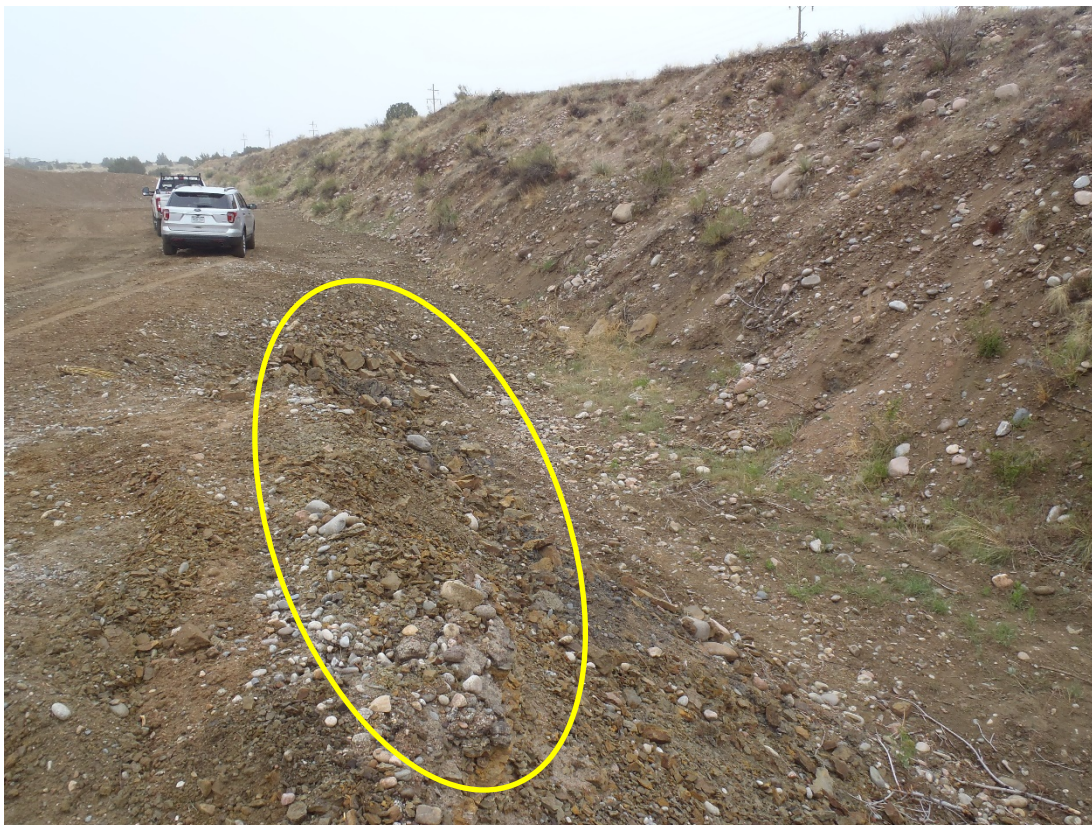
Photo 5. Typical clays/weathered shale in resident material (north end of trench, looking SE).

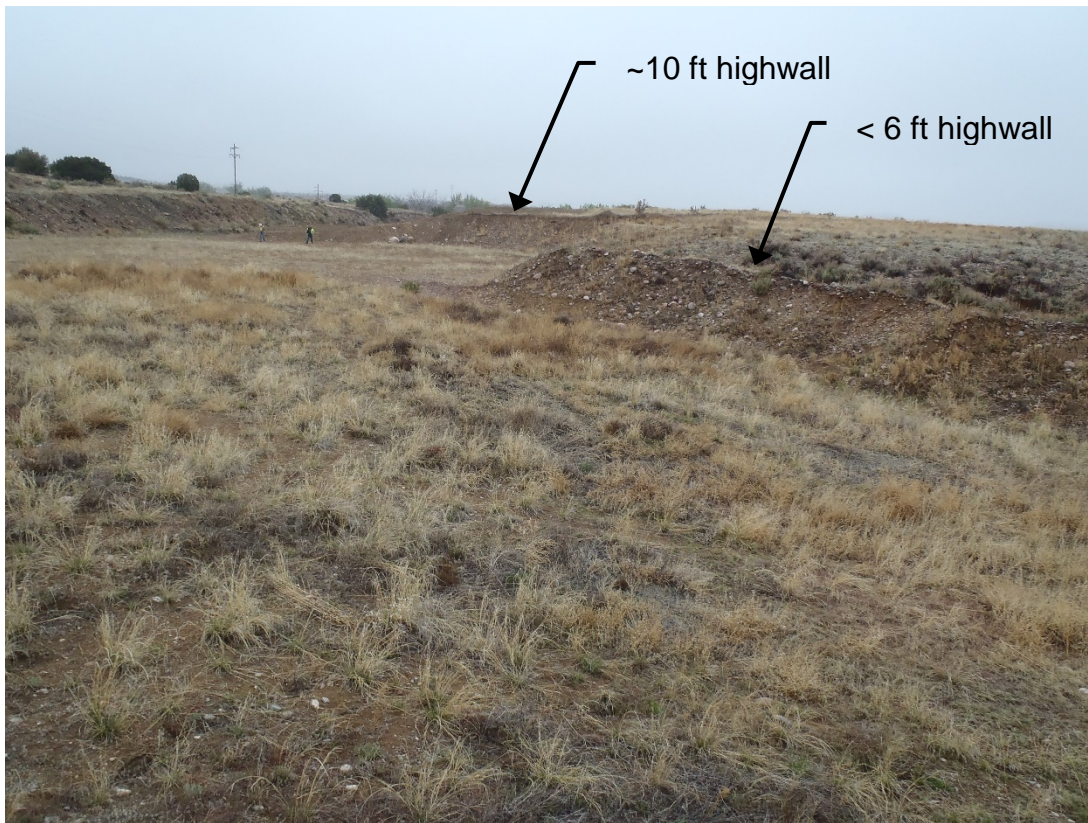
The south end of the site has a larger excavation footprint (see attached **Post Inspection Map**). The floor of the excavation is mostly self-reclaimed with established vegetation. The edges of the southern disturbed area are still angle of repose highwalls varying in height from less than 6 feet on the south end to near 10 feet on the north (**Photo 6**). The Langstons could not recall when this area was excavated. A review of Google Earth historical images indicate the disturbance occurred after 2013 and probably in 2016.

Photo 6. Larger footprint floor of south end "highwalls" (looking NW).

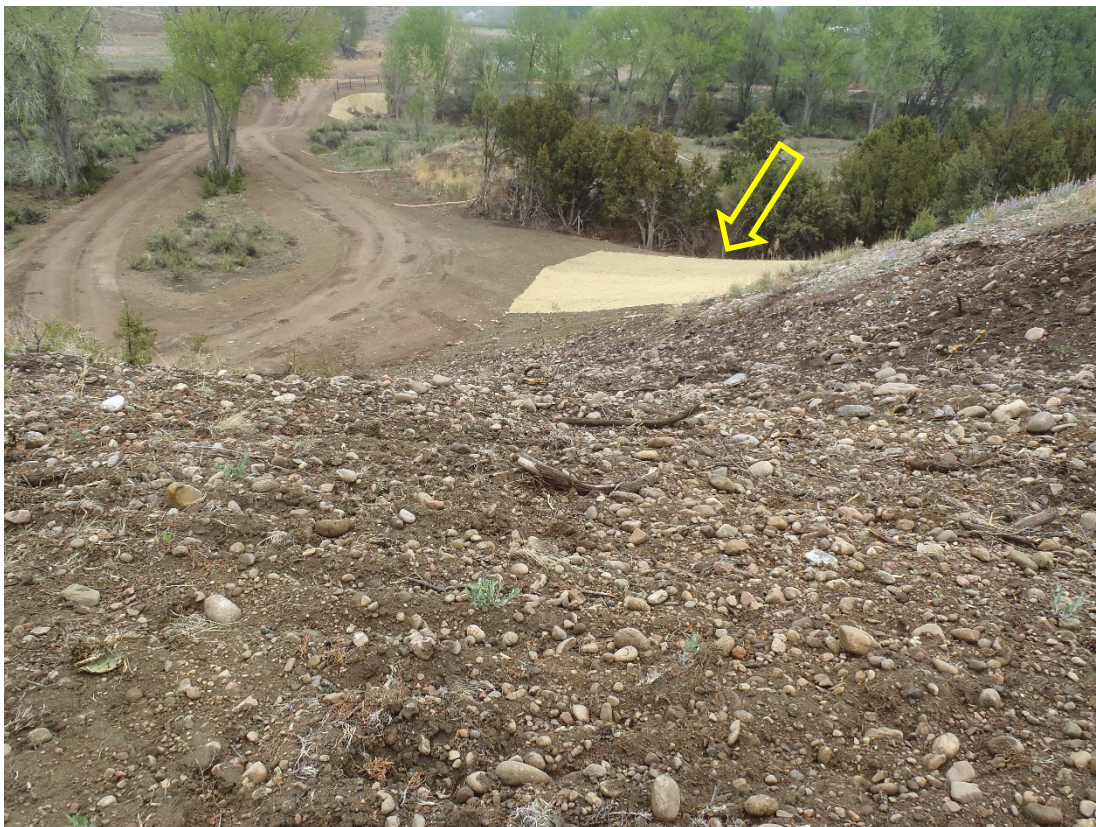
The disturbed area and access road extents were obtained on site using a handheld Trimble Juno 3B GPS unit. No explosives were being used. Exposed groundwater was not observed, nor was any standing water observed. No processing had taken place on site and adequate backfill is available for stabilizing the remaining slopes by pushing the existing material down. A portion of the hill on the north had been grubbed for potential access (**Photo 7**), but determined to be too steep after the tree removal. Some of the area had erosion control blankets installed.

Photo 7. Grubbed area (north end, looking north from crest, Note erosion control blanket).
