MINERALS PROGRAM INSPECTION REPORT
PHONE: (303) 866-3567

MINE NAME: Chambers Gravel Pit	MINE/PROSPECTING ID#: M-1979-075	MINERAL: Sand and gravel	COUNTY: Garfield
INSPECTION TYPE: Surety Release Inspection	INSPECTOR(S): Amy Yeldell	INSP. DATE: May 21, 2020	INSP. TIME: 09:00
OPERATOR: Oldcastle SW Group, Inc	OPERATOR REPRESENTATIVE: Jason Burkey	TYPE OF OPERATION: 112c - Construction Regular Operation	
REASON FOR INSPECTION: Surety Release Requested	BOND CALCULATION TYPE: None	BOND AMOUNT: \$14,360.00	
DATE OF COMPLAINT: NA	POST INSP. CONTACTS: None	JOINT INSP. AGENCY: None	
WEATHER: Clear	INSPECTOR'S SIGNATURE:

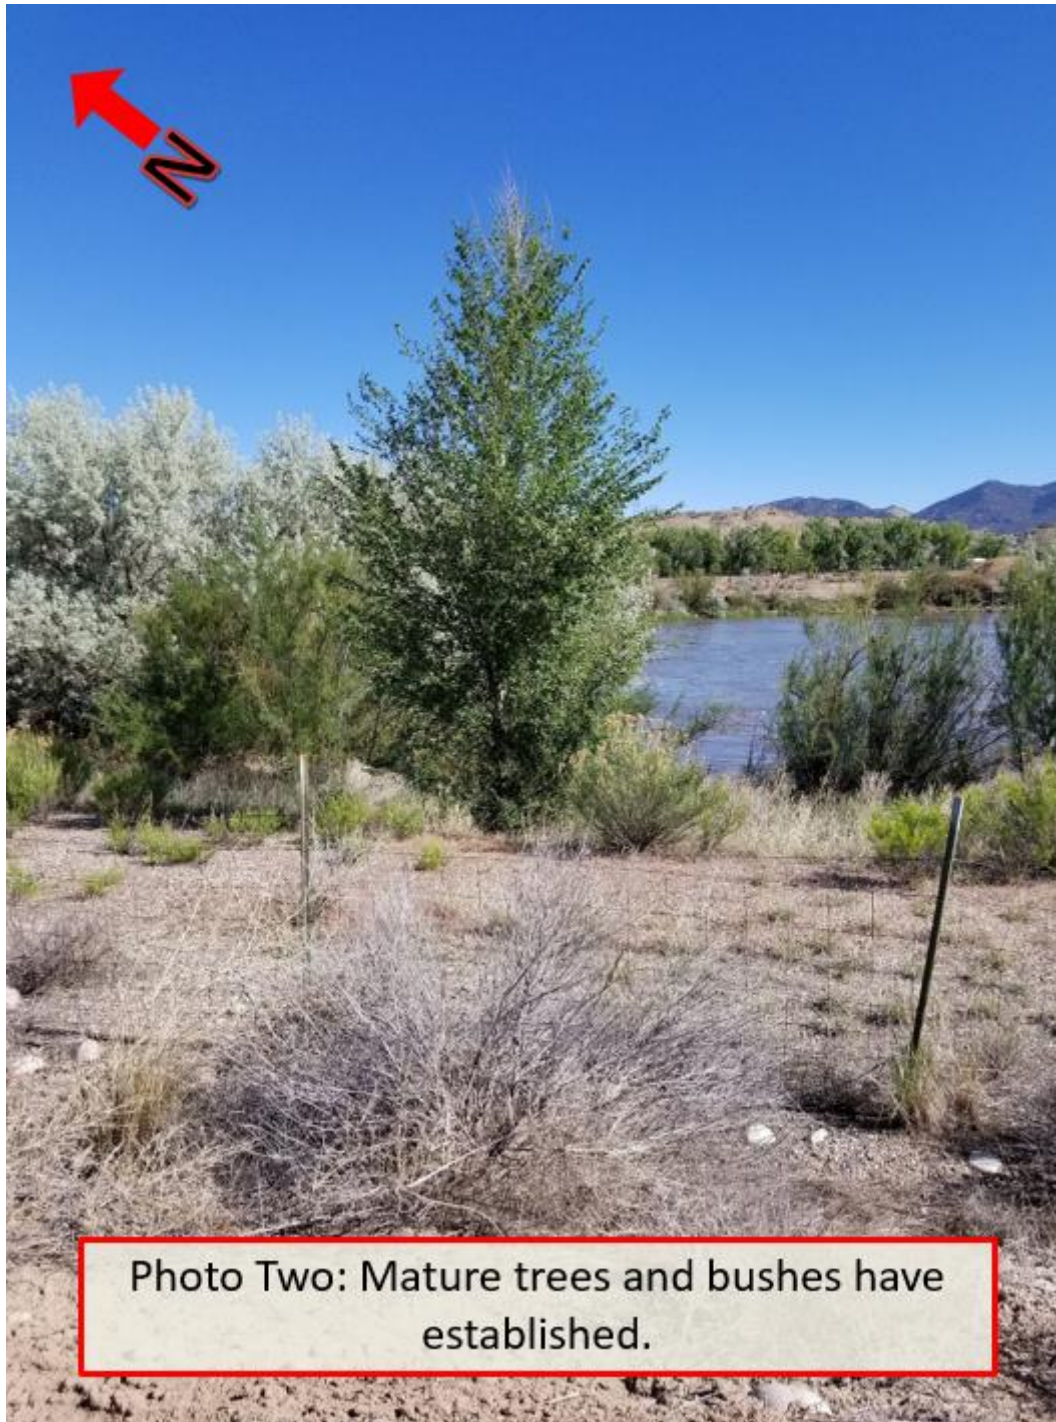
Photo Two: Mature trees and bushes have established.
