MINERALS PROGRAM INSPECTION REPORT
PHONE: (303) 866-3567

MINE NAME: Unpermitted Operation	MINE/PROSPECTING ID#: M-2020-025	MINERAL: Gold	COUNTY: Montrose
INSPECTION TYPE: Illegal(Unpermitted Operation)	INSPECTOR(S): Dustin Czapla	INSP. DATE: May 1, 2020	INSP. TIME: 12:00
OPERATOR: Gregg Morrill	OPERATOR REPRESENTATIVE: Gregg Morrill	TYPE OF OPERATION: ILL - Illegal

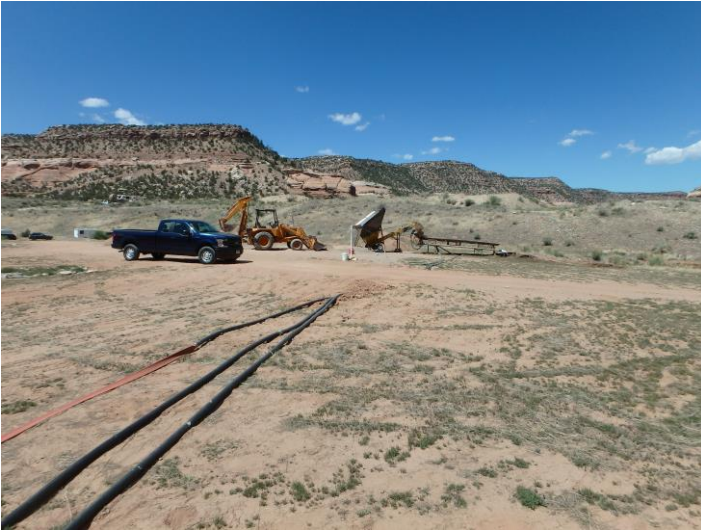
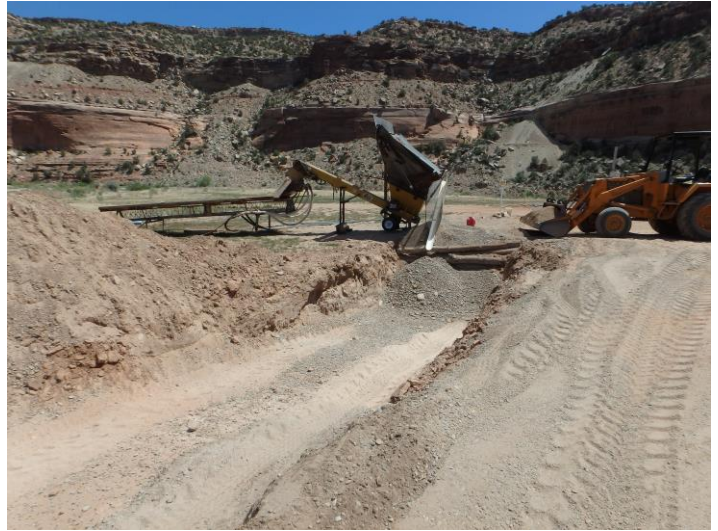
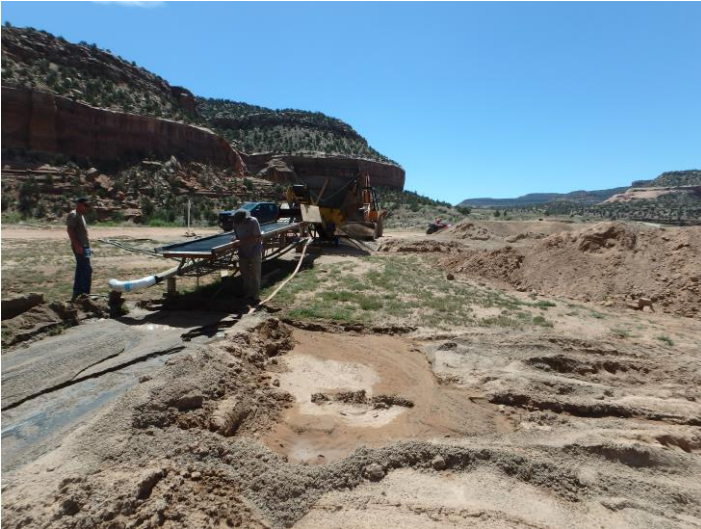
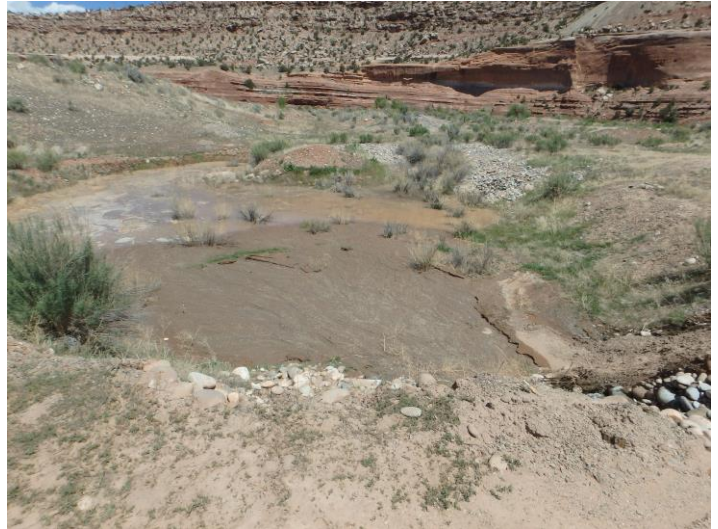
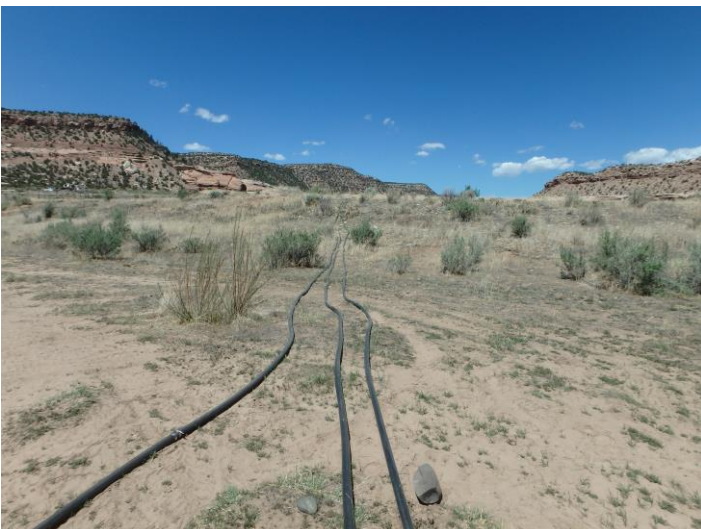
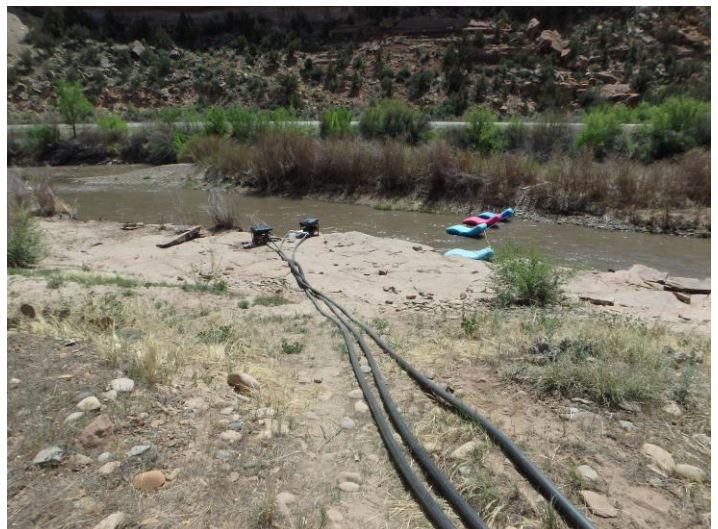
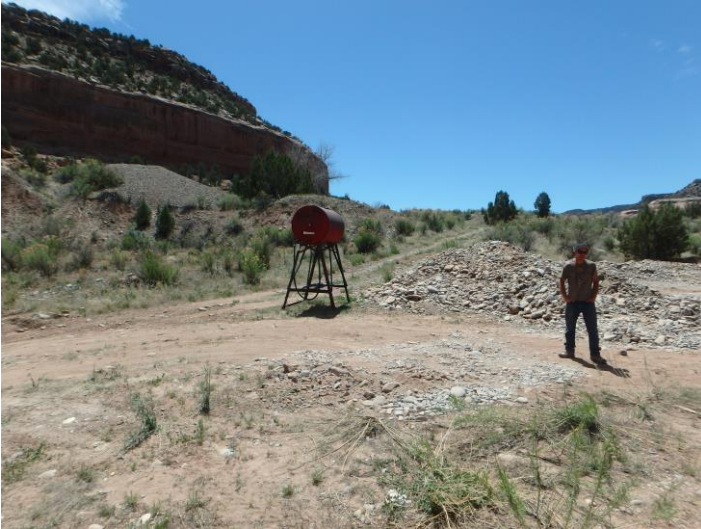
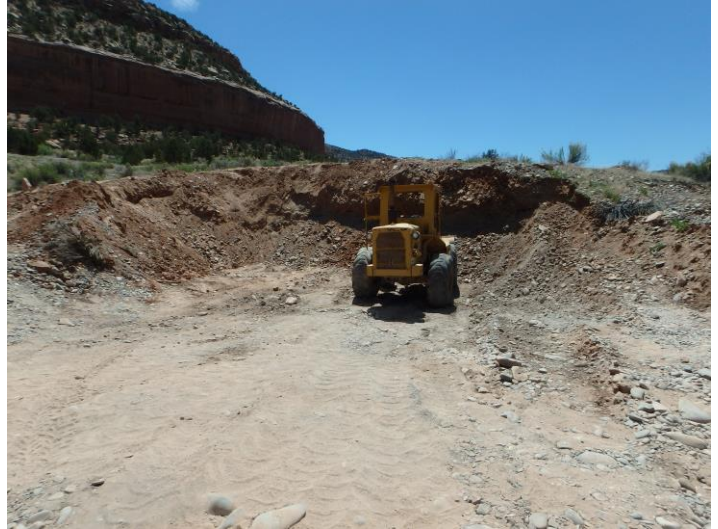
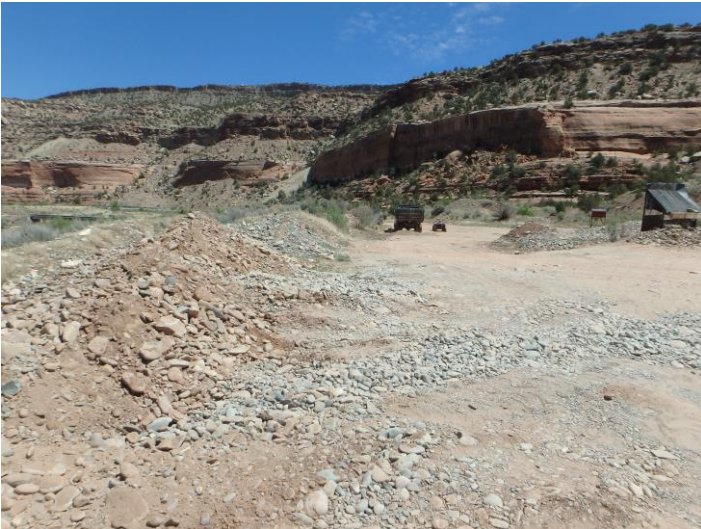
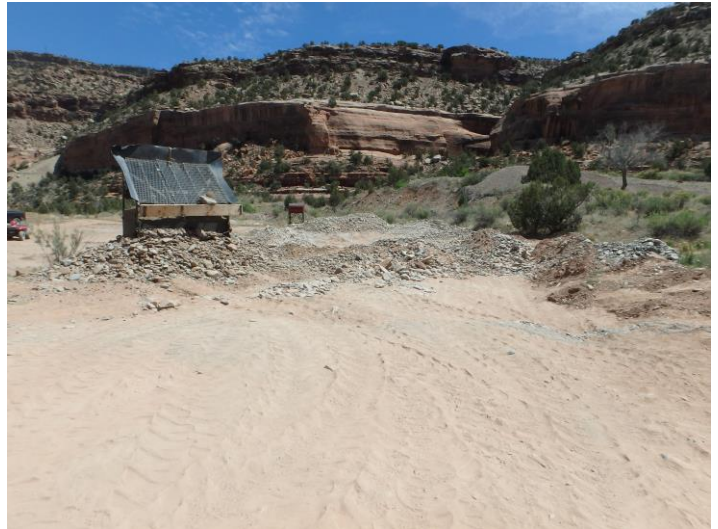
PHOTOGRAPHS

This inspection was conducted in response to a citizen complaint received on April 28, 2020. The complaint indicated that there was a mining operation being conducted without a permit. The site is located approximately six miles northwest of Uravan, in Montrose County, near the intersection of Hwy 141 and County Road R13. The operation has disturbed areas on both sides of Hwy 141. A processing area has been established on the west side of the highway. The process area includes a gas powered screen and sluice box system, stockpile area and settling pond. Water for the system is pumped from the Dolores River. It was determined during this inspection that the Operator does not possess appropriate water rights for the water use. The mining area is located on the east side of the highway. The mining area contained a screening and loadout area, fuel storage and highwall. Material is mined from this area, screened and loaded into a dump truck, then hauled across the highway to the process area. The fuel stored in this area was not in a secondary containment structure. The operation has disturbed approximately two acres. During this inspection the Operator was informed of the requirement to obtain a permit issued by the Colorado Mined Land Reclamation Board (Board) prior to conducting a mining operation in the State of Colorado. An enforcement hearing for this matter will be scheduled at a future Board meeting. Notice of the hearing will be sent separate from this report. Photographs of the site, showing the conditions observed during this inspection, are included this report.
