MINERALS PROGRAM INSPECTION REPORT
PHONE: (303) 866-3567

MINE NAME: Mid-Continent LST	MINE/PROSPECTING ID#: M-1982-121	MINERAL: Limestone	COUNTY: Garfield
INSPECTION TYPE: Monitoring	INSPECTOR(S): Amy Yeldell	INSP. DATE: May 21, 2020	INSP. TIME: 12:00
OPERATOR: RMR Aggregates, Inc.	OPERATOR REPRESENTATIVE: Bobby Wagner	TYPE OF OPERATION: 112c - Construction Regular Operation	
REASON FOR INSPECTION: Normal I&E Program	BOND CALCULATION TYPE: None	BOND AMOUNT: \$366,179.00	
DATE OF COMPLAINT: NA	POST INSP. CONTACTS: DRMS	JOINT INSP. AGENCY: None	
WEATHER: Clear	INSPECTOR'S SIGNATURE:

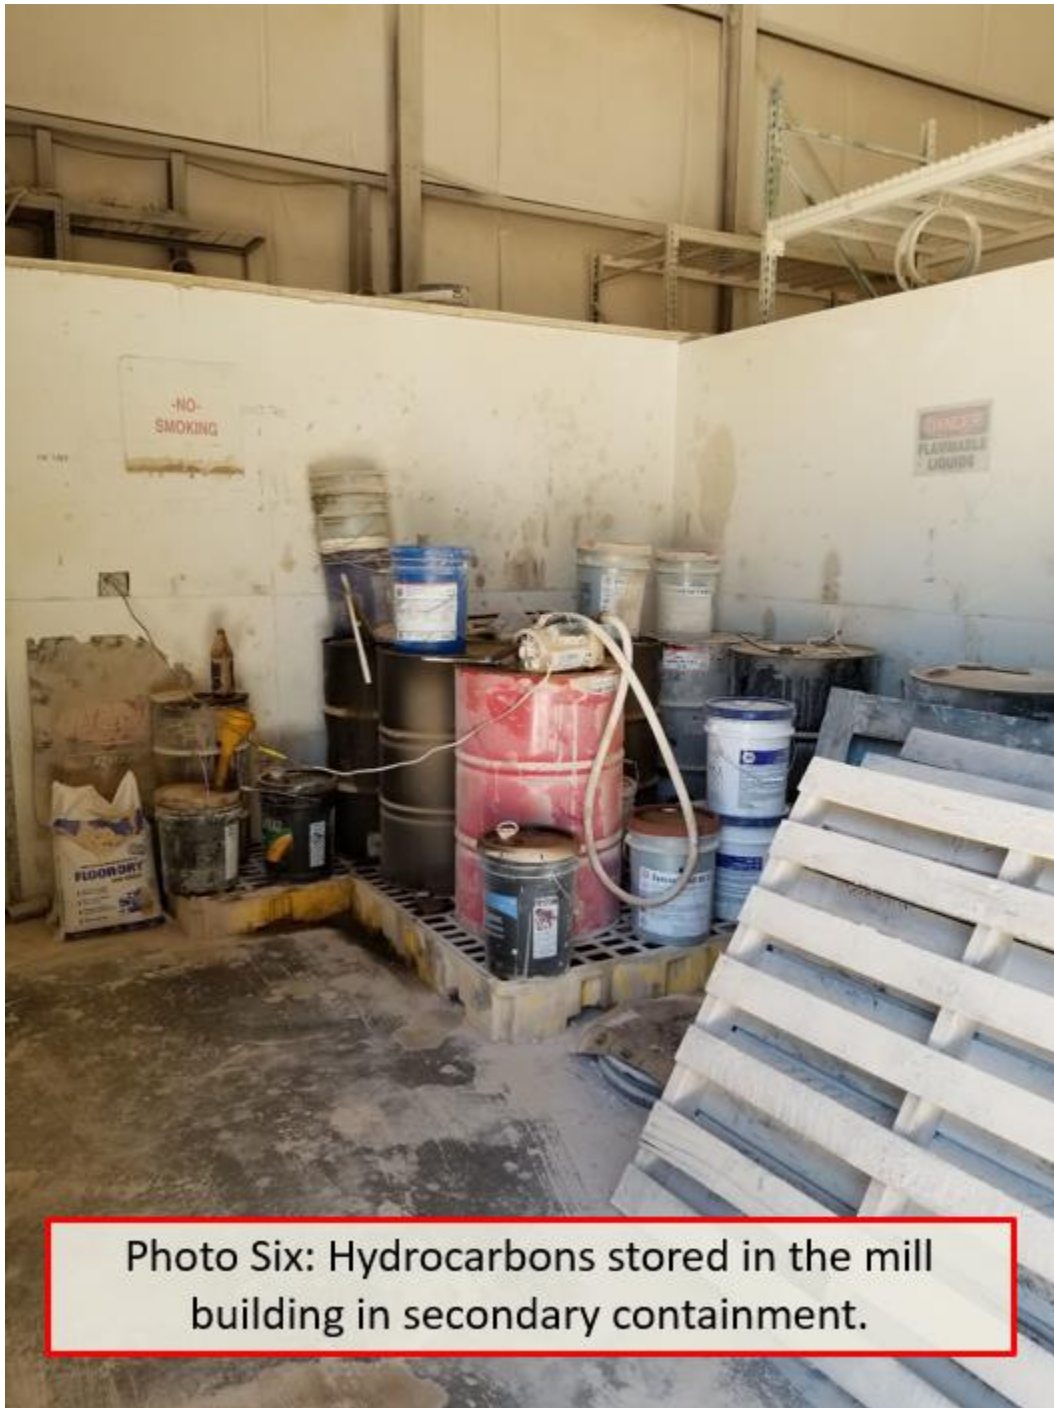
Photo Six: Hydrocarbons stored in the mill building in secondary containment.
