MINERALS PROGRAM INSPECTION REPORT
PHONE: (303) 866-3567

MINE NAME: SPN Pit	MINE/PROSPECTING ID#: M-2020-006	MINERAL: Gravel	COUNTY: Huerfano
INSPECTION TYPE: Preoperation Inspection	INSPECTOR(S): Patrick Lennberg	INSP. DATE: May 21, 2020	INSP. TIME: 10:00
OPERATOR: Fremont Paving & Redi-Mix, Inc.	OPERATOR REPRESENTATIVE: None	TYPE OF OPERATION: 112c - Construction Regular Operation	
REASON FOR INSPECTION: Preoperation Inspection	BOND CALCULATION TYPE: Complete Bond	BOND AMOUNT: No Bond Held	
DATE OF COMPLAINT: NA	POST INSP. CONTACTS: None	JOINT INSP. AGENCY: None	
WEATHER: Clear	INSPECTOR'S SIGNATURE:

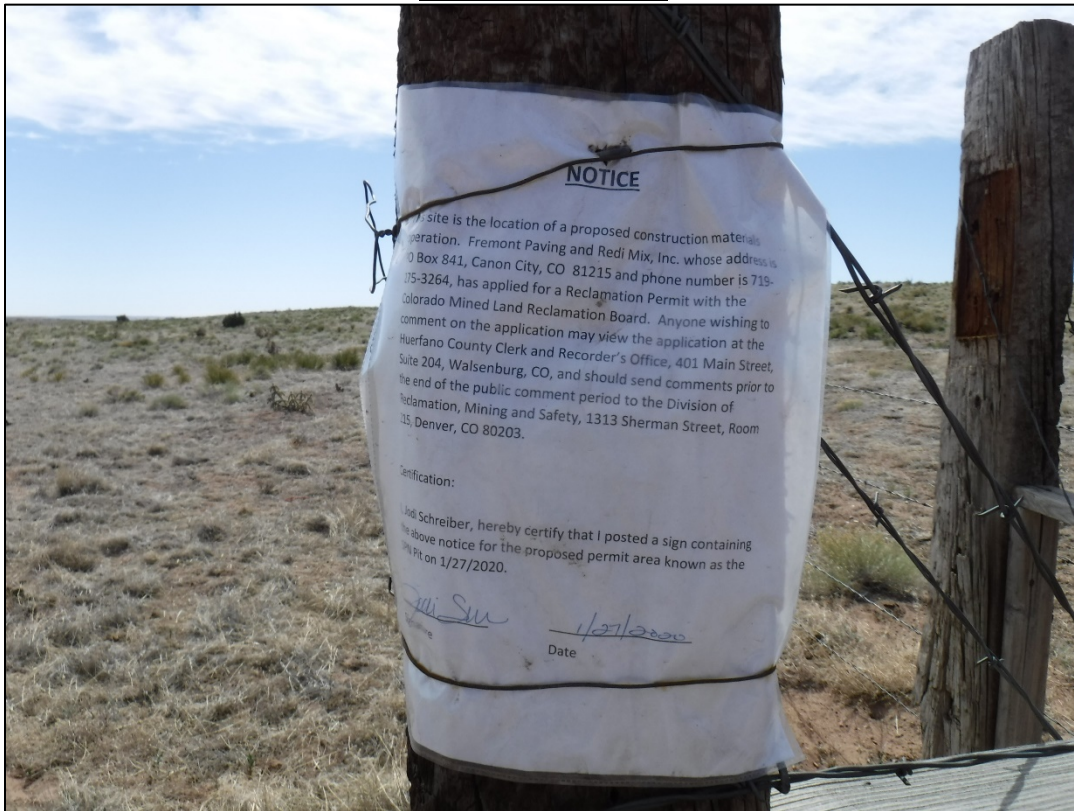
Photo 1: Notice sign posted at or near the proposed mine entrance

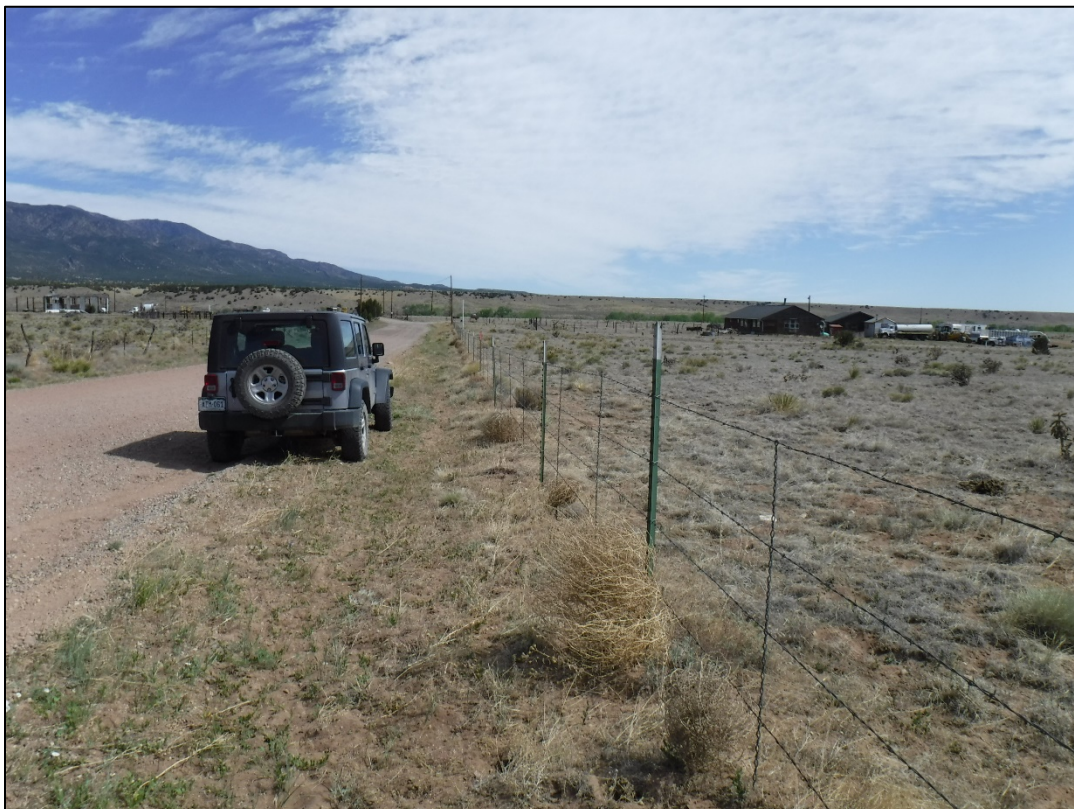
Photo 2: Looking north along the western permit adjacent to County Road 614

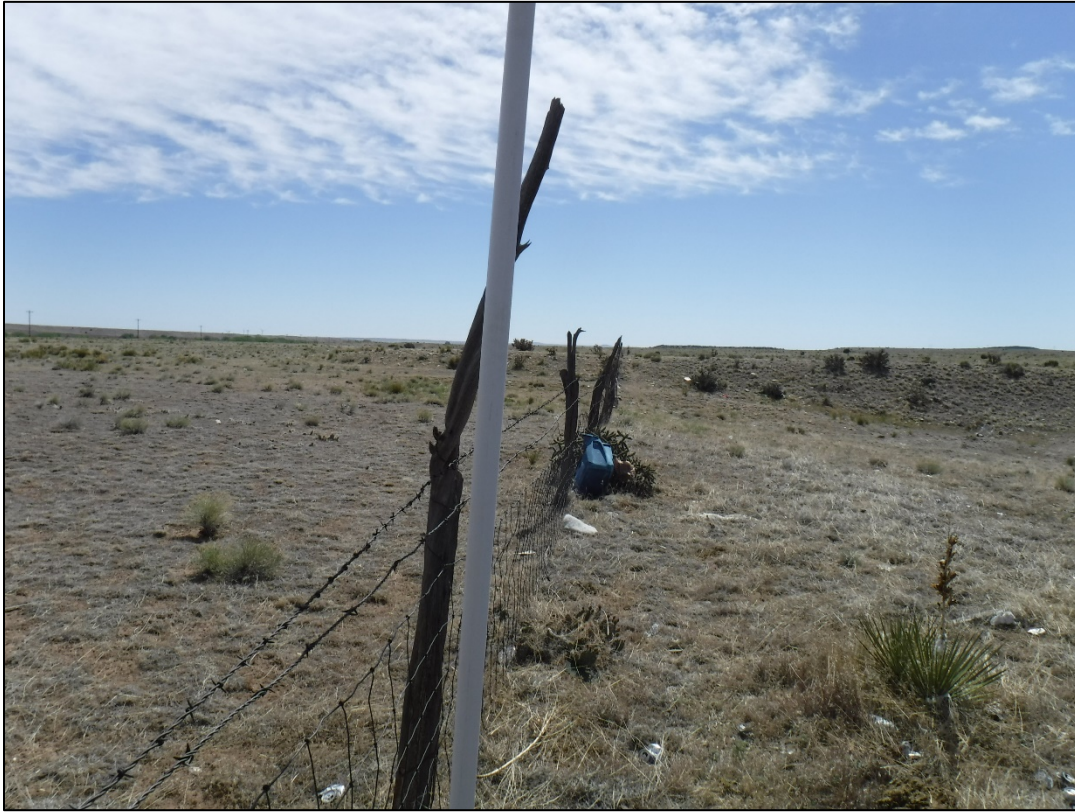
Photo 3: Typical permit boundary marker, pictured is the northwest corner east of residence

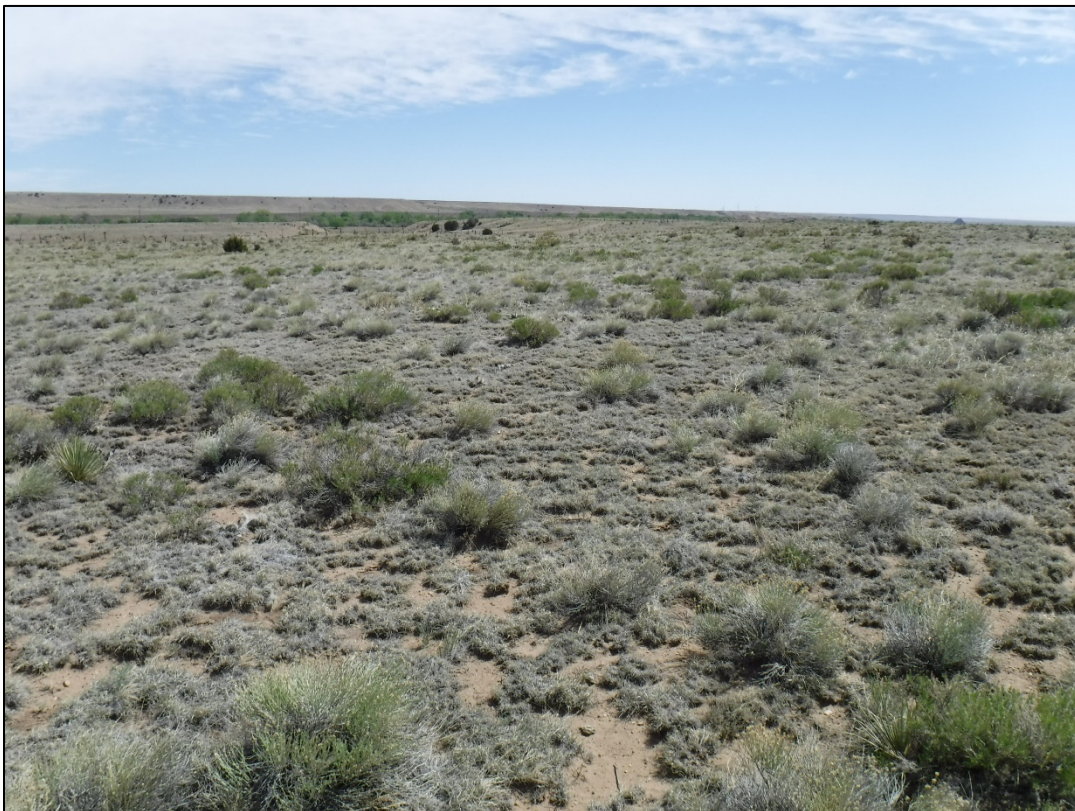
Photo 4: Typical vegetation found at the site and surrounding land

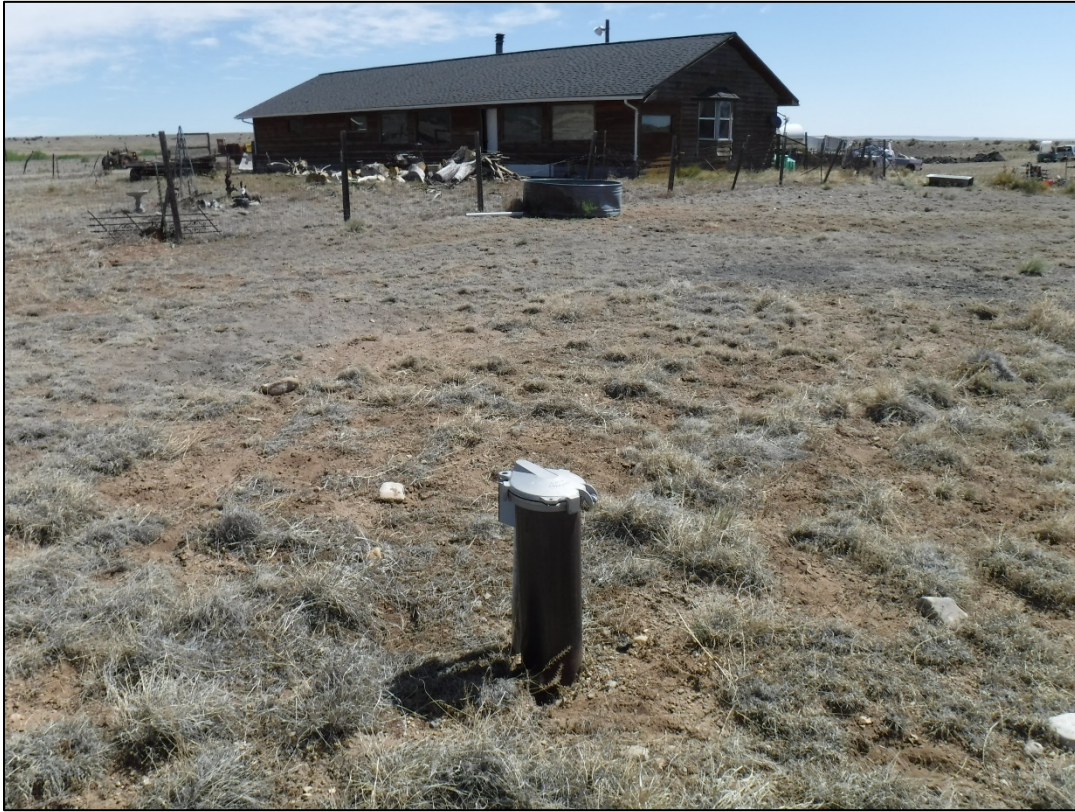
The permit notice was clearly posted at the mine entrance along County Road 614 and the proposed permit boundary was marked with 2-inch PVC casing. The permit area is currently rangeland that is characterized by native grasses and cacti with some yucca. All structures observed during the inspection were accurately depicted on the maps within the permit application except for the domestic water well. The applicant was able to get a structure agreement for the well included in Adequacy Response #2 (May 27, 2020) but the well was not labelled on the maps and will be a follow up item for Adequacy #3.

Photo 5: Domestic water well

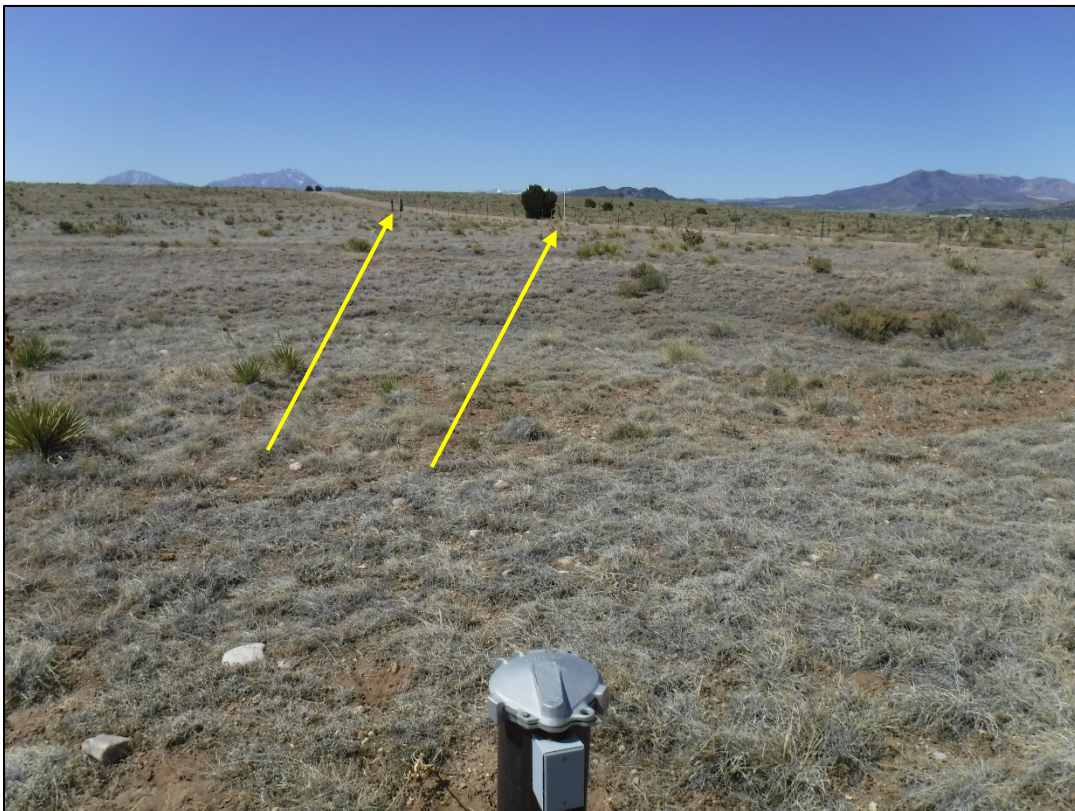
Photo 6: Domestic water well relative to permit boundary markers (yellow arrows)
